Subject: BAR Action - 632 W MAin Street - February 17, 2016

BAR 16-02-02
632 W Main Street
Tax Parcel 029001000
Pat Punch, Building Goodness Foundation, Applicant/Delevan First Baptist Church, Owner
Partial demolition conversion of a window to a door, ADA ramp

CITY OF CHARLOTTESVILLE BOARD OF ARCHITECTURAL REVIEW STAFF REPORT February 17, 2016

Narrative for Proposed First Baptist Church Exit Door and Walkway

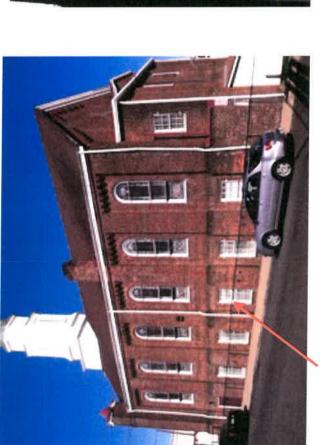
West facade, First Baptist Church.

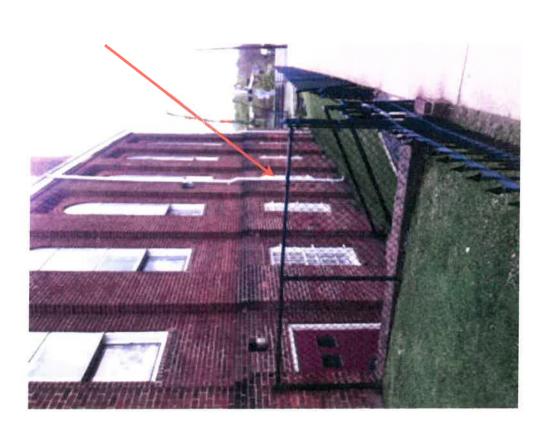
West facade, from the sidewalk on West Main Street, showing existing door and proposed.

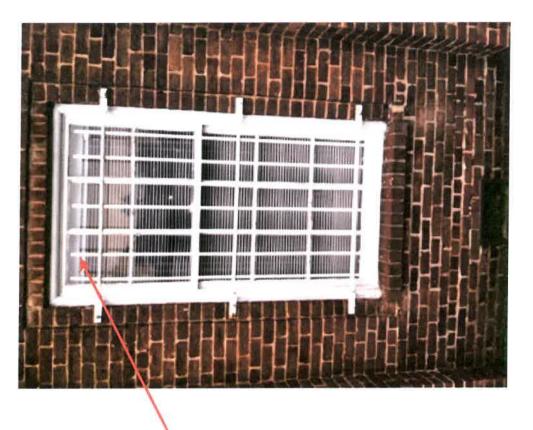
Window detail. Note that ceiling is dropped below window head inside.

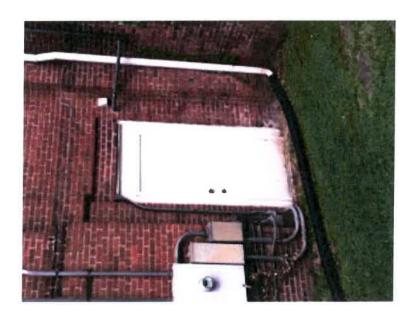
East service entrance. Most likely was a window at some point.

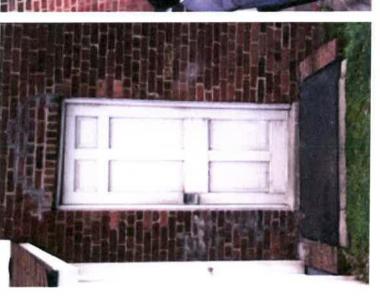
Rear door

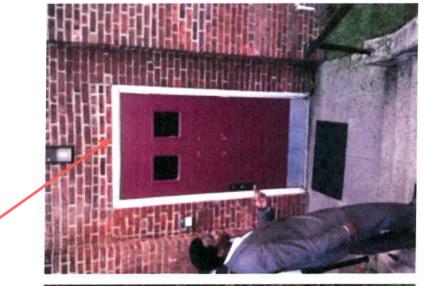
Existing door to basement public area. (Note removal of header course)
