BAR 18-02-05
501 West Main Street
Tax Parcel 320175000, 320176000, 320177000
Quirk Hotel, Owner/ Jennifer D. Mullen, Esq., Applicant
Additional demolitions

**CITY OF CHARLOTTESVILLE
BOARD OF ARCHITECTURAL REVIEW
STAFF REPORT
February 21, 2018**

Partial Demolition and Proposed Massing

Re: 501 W. Main Street – Selective Partial Demolition at Porch Addition

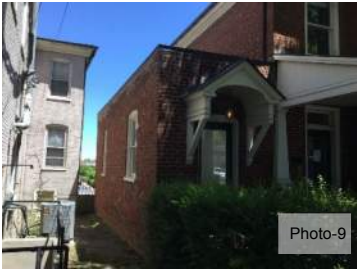
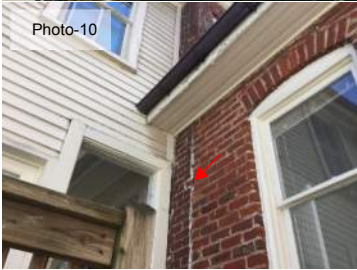
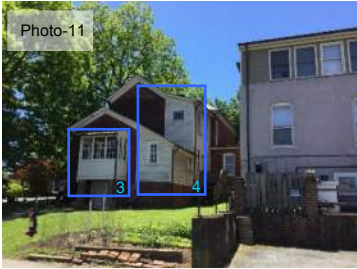
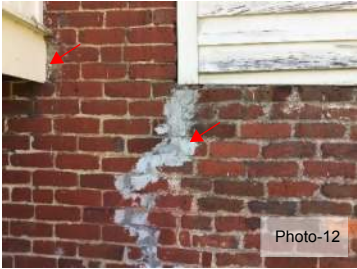
There exists 3 distinct additions to the structure. **Structure-2** (photo-9) is a small office addition that was constructed by adding three masonry bearing walls. The short walls are sparsely toothed into the existing walls (photo-10). We noted that the joint between the two structures exhibits high movement and has been treated with a flexible sealant. This is indicative of a structurally separate element that could be removed without harm to the existing structure. Some local masonry patching should be expected both at the walls as well as at the roof rafter tie in.

Structure-3 is small covered stair platform. The platform is structured by two beams that span from masonry piers into masonry pocket cut into the existing wall (photo-12). The porch and stair could readily be removed with only minor patching at the beam pockets.

Structure-4 is identified on the sketch herein (photo-11) but is not proposed to be demolished at this time. This structure is either an enclosure of an existing covered porch and stair or an entirely separate structure. Unlike the rest of the structure it is a wood framed and clad addition. We noted the highest degree of deterioration at this portion of the structure. The deterioration is a result of poor initial construction, wood rot, differed maintenance and water washing through the mortar joints. There is also cracking at the masonry foundation wall at the joint of this structure. Given the poor condition of this addition we recommend that this portion be demolished, of not it will require rebuilding in-kind. If removed it would restore structural symmetry to the remainder of the building.

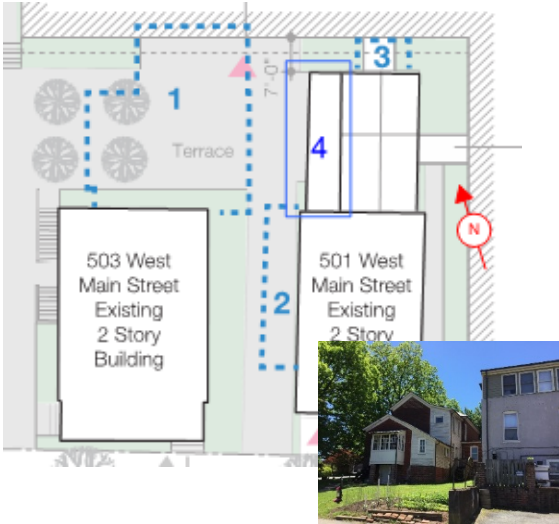
Area-4, Porch Addition

This correspondence is to provide you with a summary of our recent site visit to 501 W.. Main Street in Charlottesville, VA 22901. We visited the site to review the condition of the porch addition to the W. Main street structure. This portion is the northern part of area 4 in the figure below.

This structure appears to be an enclosure of an existing covered porch and stair or an entirely separate structure. Unlike the rest of the structure it is a wood framed and clad addition. We noted the highest degree of deterioration at this portion of the structure.

The deterioration is a result of poor initial construction, wood rot, differed maintenance and water washing through the mortar joints. There is also cracking at the masonry foundation wall at the joint of this structure.

In our opinion removal of the addition (highlighted) will lessen the demand on the wall. This along with necessary rebuilding of the openings will

The proposed selective demolition can be carried out without structural ill effect to the existing original structures. In the case of the porch addition the removal will have a beneficiary effect on the portion of the structure to remain.

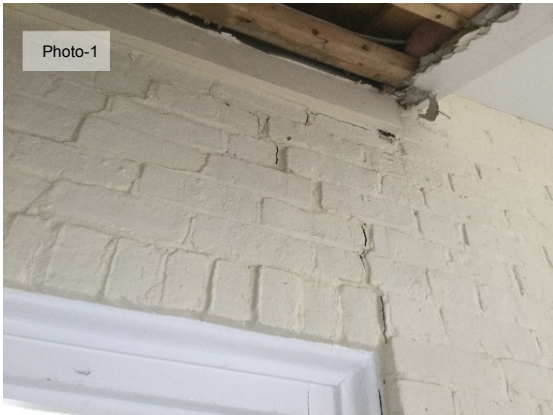
At an interior (but likely originally an exterior) doorway we observed cracking and displacement of the masonry (see photo-1). This is a sign of an ongoing structural problem.

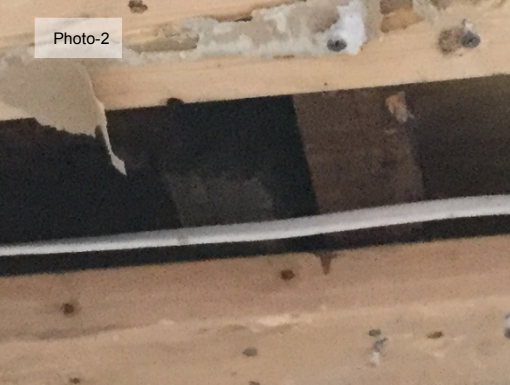
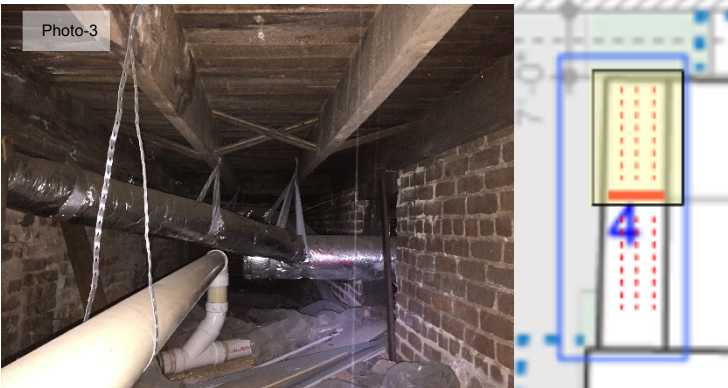
The framing of the roof over this portion in not an extension of the main roof rafters but a scabbed on 2x4 to the original framing (see photo-2). This alone does not significantly increase the load on the wall to account for the cracking observed.

The framing of the floor system for the main portion of the porch and the addition to the covered porch run in the long direction. Both portions frame in to a beam that spans between the exterior and an interior masonry wall. The interior masonry wall where this beam frames if the area where the masonry is cracked above. There are also numerous openings cut into this wall that have also affected its integrity.
