**City of Charlottesville
Board of Architectural Review
Staff Report
April 19, 2022**

BAR 22-04-03

707 West Main Street, TMP 320156000

Project: Storefront window replacement

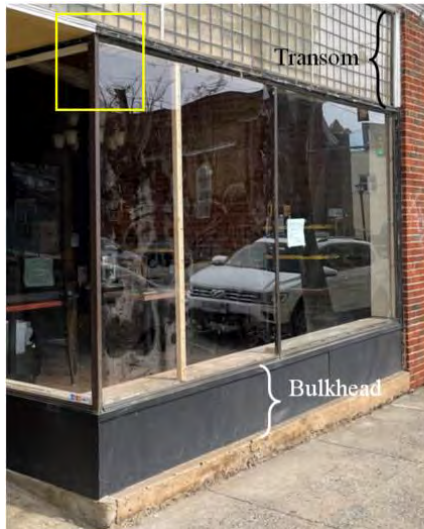
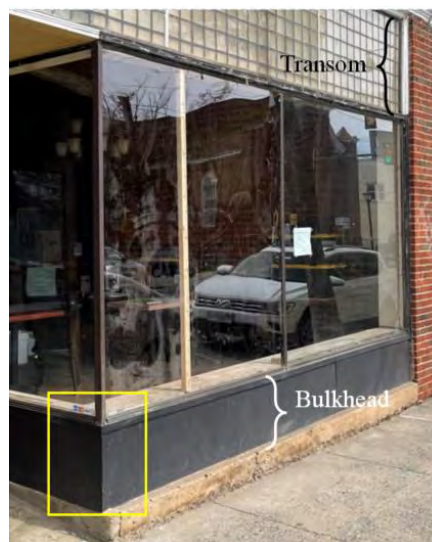
Refer to images below:

- The transom and bulkhead will not be altered.
- #1. Bronze trim will be retained.
- #2. Bronze glazing strips (top and bottom) will be removed.
- #3. Bronze corner post. Unclear if this will be retained or replaced.
- Vertical mull in center will be removed. (Uncertain if this is original to bronze components; however, it matches similar mull in adjacent storefront.)
- Glass is not historic

The submittal does not indicate if the bronze corner post will be retained or replaced. (See component #3 in the photographs below, under *Facades & Storefronts*, item 4.) BAR should discuss this detail. For example, if replaced, with what and what are the dimensions. Note: It is uncertain if this a structural component—supporting the transom above—or only a glazing component.

- Glass have VLT of not less than 70%.
- Any original, metal components that are removed will be retained on-site and labeled, should a future restoration be considered. (Refer to comments under *Facades & Storefronts*, item 4.)

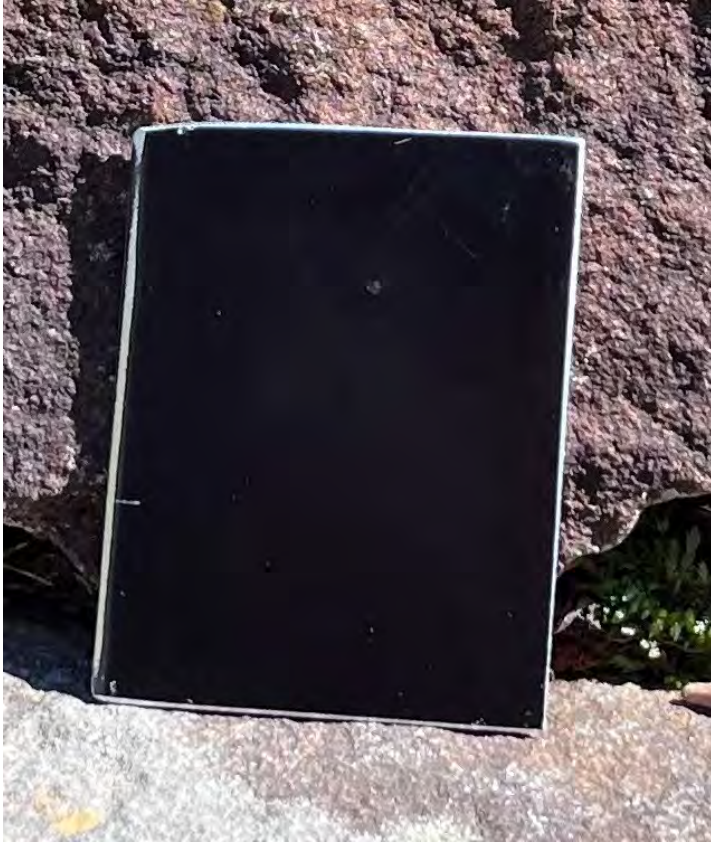
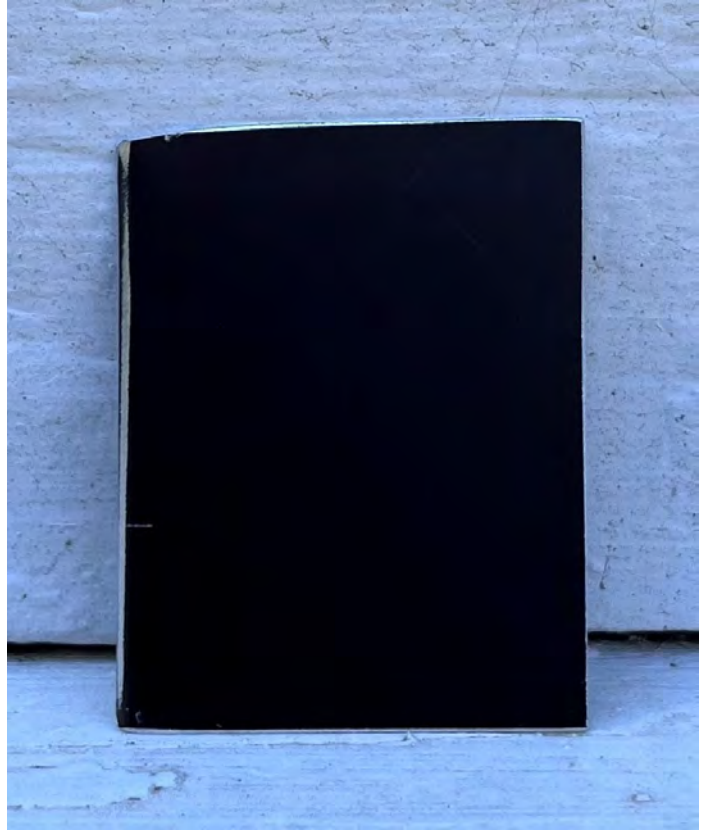
707 West Main - storefront alterations. April 2022. Color sample for metal frame

In sun

In shade\
