**City of Charlottesville  
Board of Architectural Review  
Staff Report  
December 20, 2022**

BAR 22-12-02

116 West Jefferson Street, TMP 330183000

Project: Front porch reconstruction, alterations at rear elevation

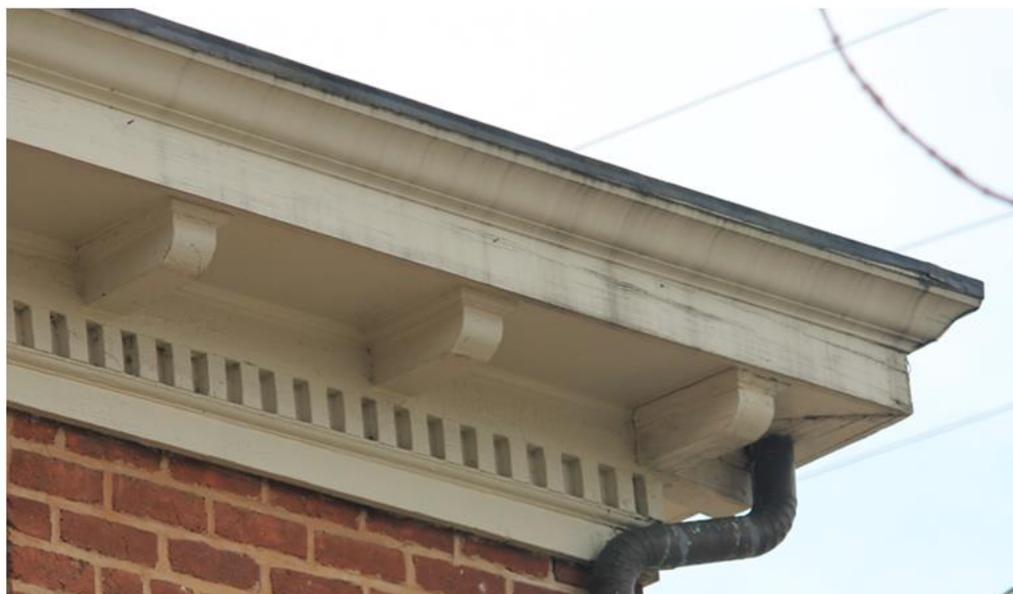
Existing cornice at 116 West Jefferson Street. New porch cornice to match.

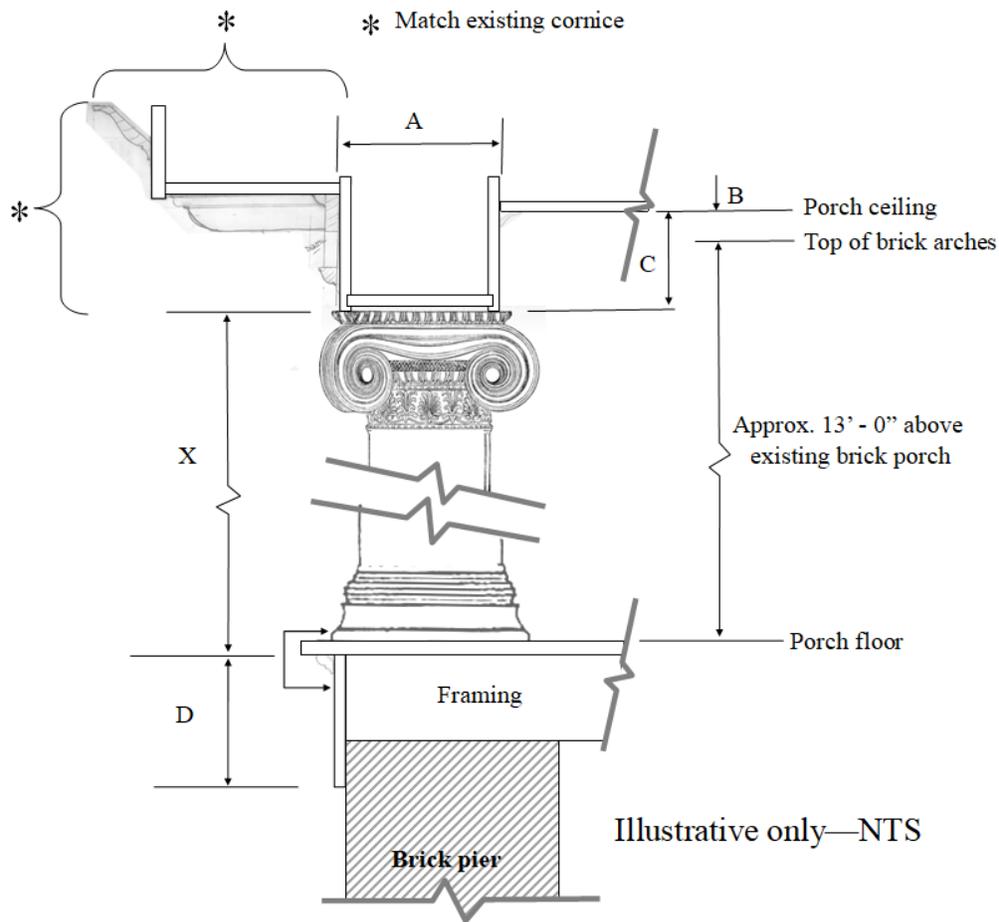
Illustrative porch detail for 116 West Jefferson Street: Dimensions and proportions should match or be similar to 406 Altamont Circle and/or appropriate to the period. The BAR should discuss specific dimensions, if necessary.

- Columns: (Similar to the columns at 406 Altamont Circle.) \*
  - Capital: Photos indicate Angular (*Scamozzi*) Ionic.
  - Shaft: Smooth. Round columns at the front. Square, engaged columns at the walls.

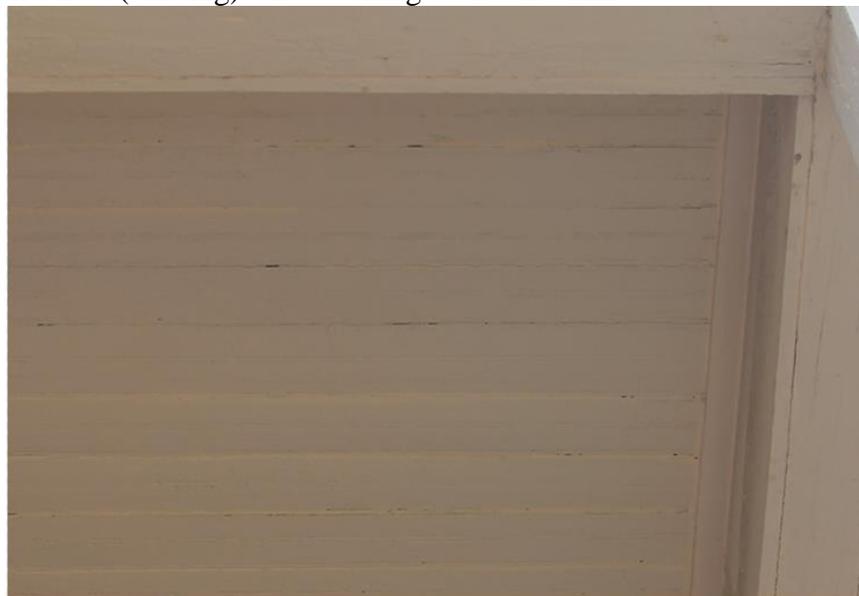
116 West Jefferson Street (existing) – note ceiling board and trim

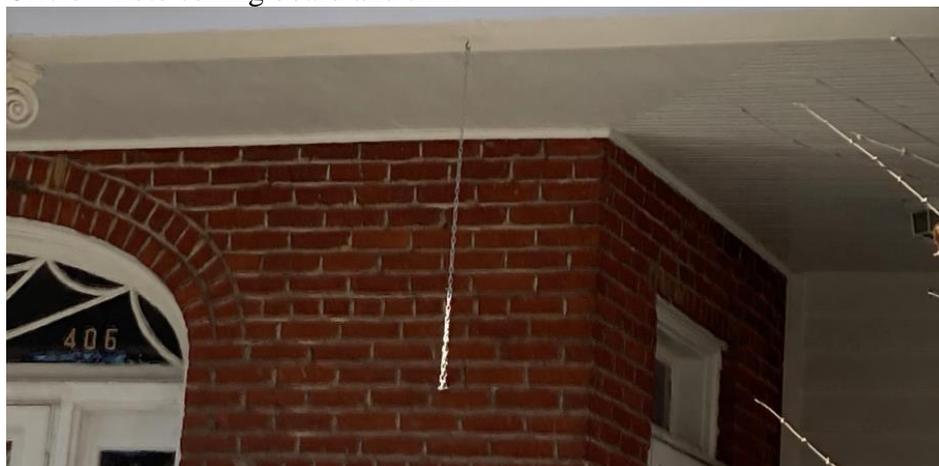
406 Altamont Circle – note ceiling board and trim

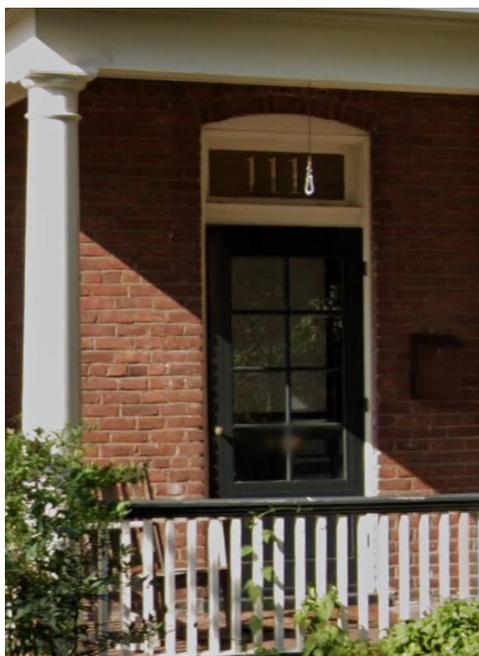
New French door at rear porch to be similar to existing door at 111 Altamont Circle:

New French door at rear porch (1<sup>st</sup> floor) and new six-panel door at the east elevation (basement) of 1913 house: Staff recommends approval with the following condition of approval:

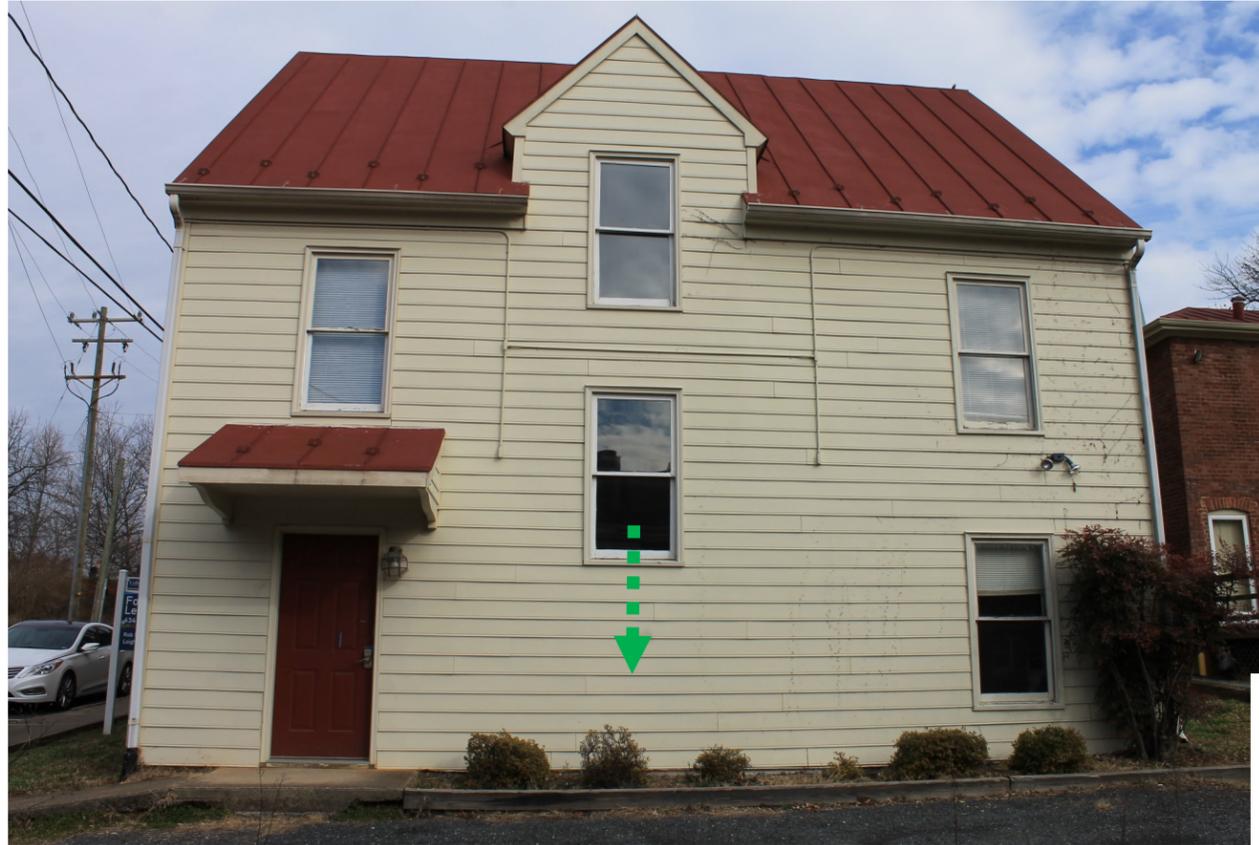
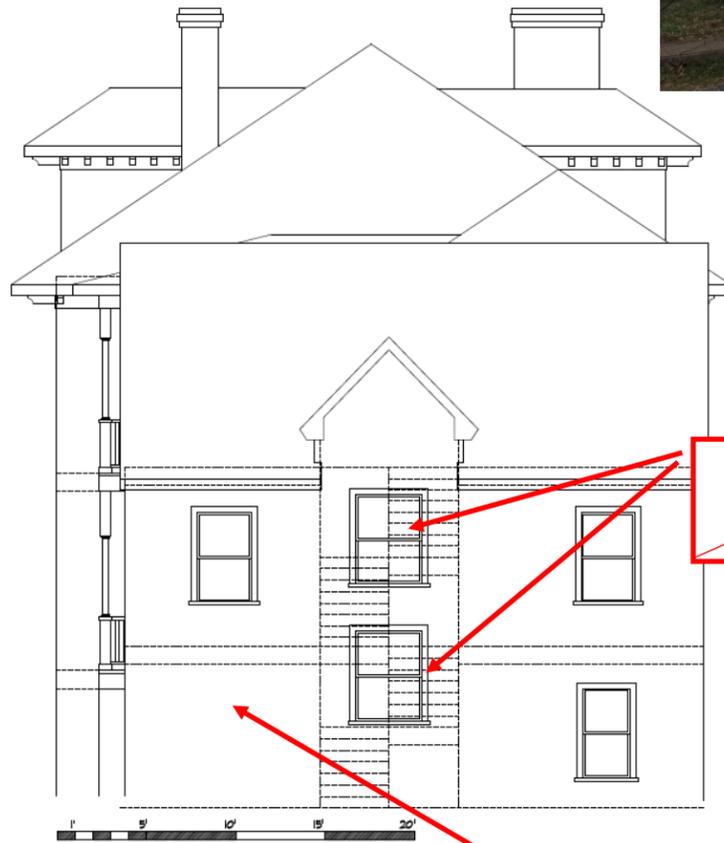
**South Elevation—Contemporary Addition**

**Install larger windows**

Move window down.  
Repair wall to match.

- South Elevation: Remove two windows, existing door, and canopy. Install two larger windows.
- North Elevation: Remove window and wall section. Install double doors and window.
- West Elevation: Remove one window. Install new door in opening.

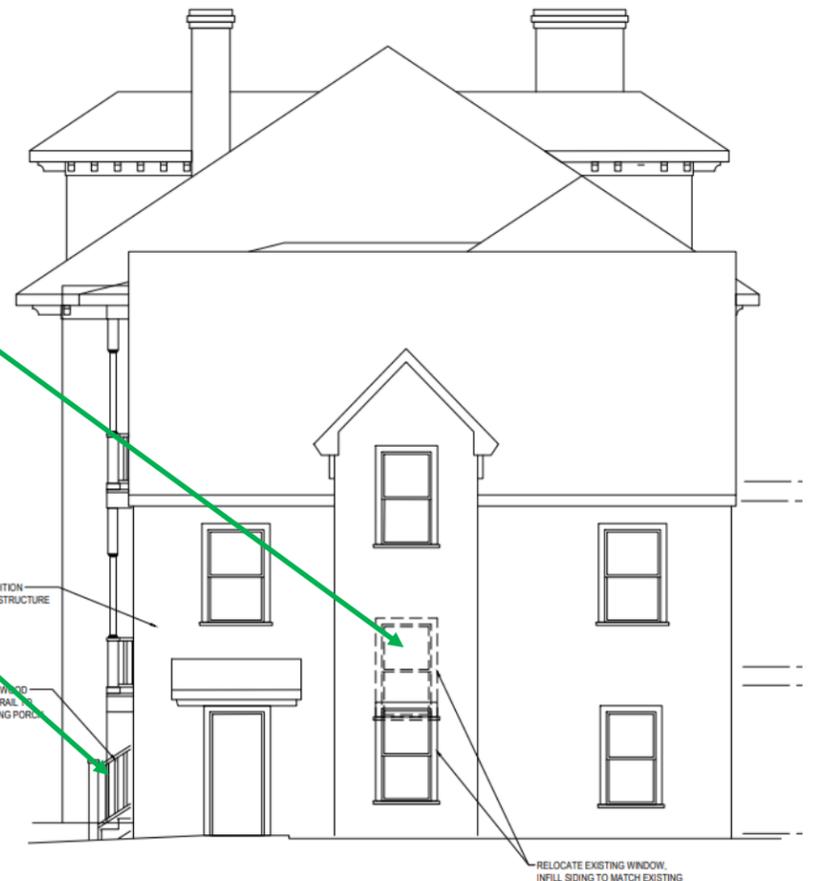
EXISTING ADDITION TO HISTORIC STRUCTURE  
NEW PAINTED WOOD STAIR, GUARDRAIL TO MATCH EXISTING PORCH

RELOCATE EXISTING WINDOW, INFILL SIDING TO MATCH EXISTING

Construct painted wood stairs and install new door at west elevation. Railing detail to match rear porch.
