From: [Werner, Jeffrey B](#)
To: [William \(Bill\) L. Owens, AIA](#)
Cc: [Murphy, Mollie](#)
Subject: BAR action - FUMC solar panels
Date: Thursday, January 19, 2023 6:18:17 PM

Certificate of Appropriateness

BAR # 22-10-02

Project: FUMC solar panels

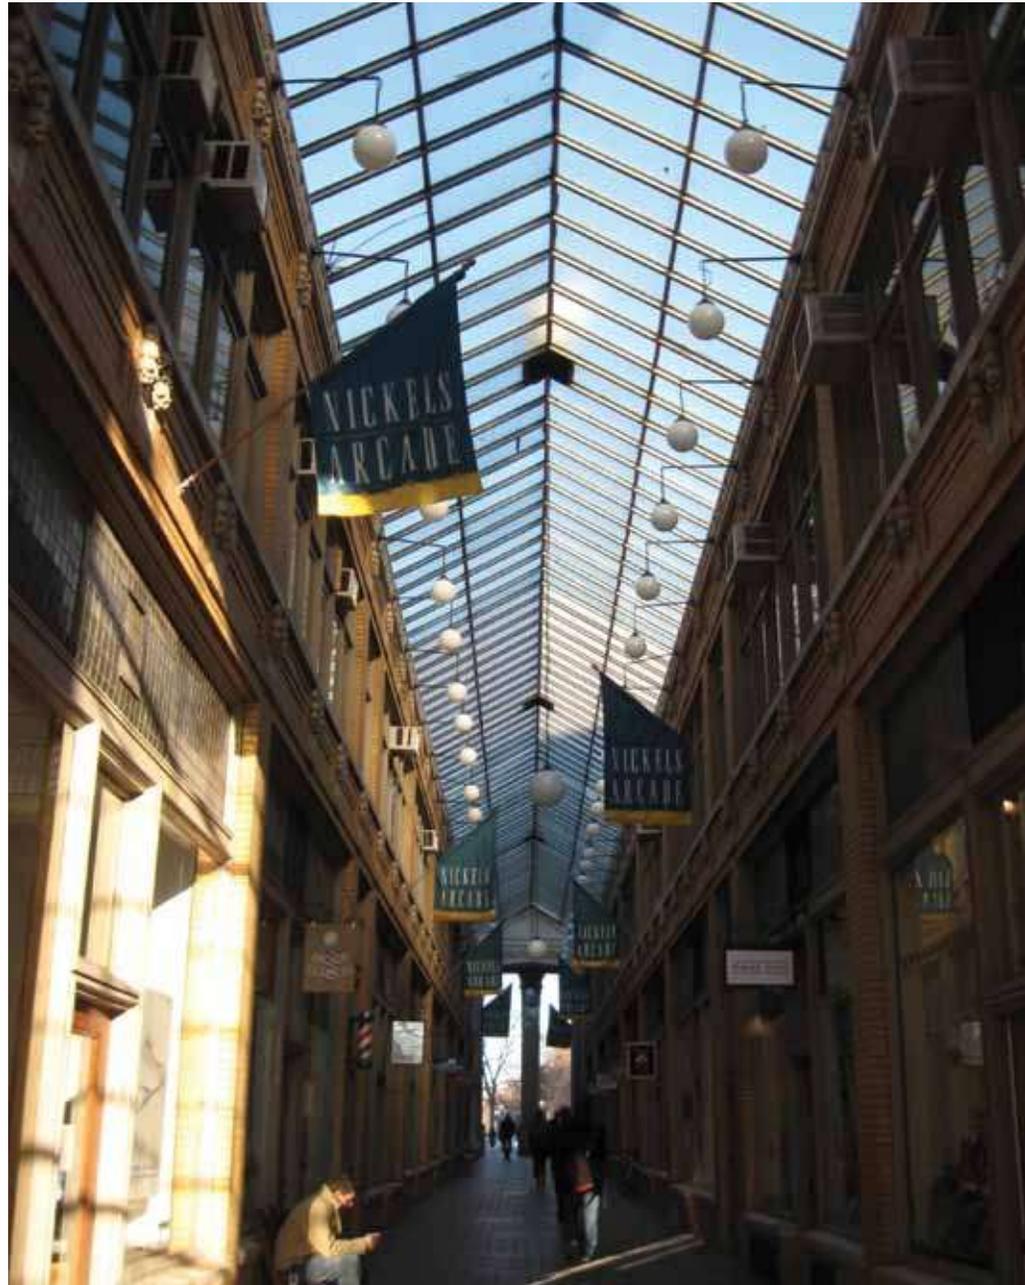
[15] Glass skylight illuminates historic shopping arcade.

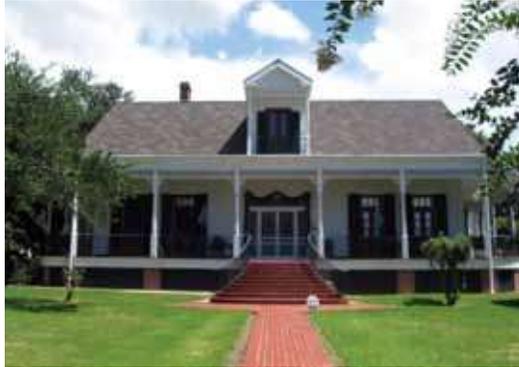
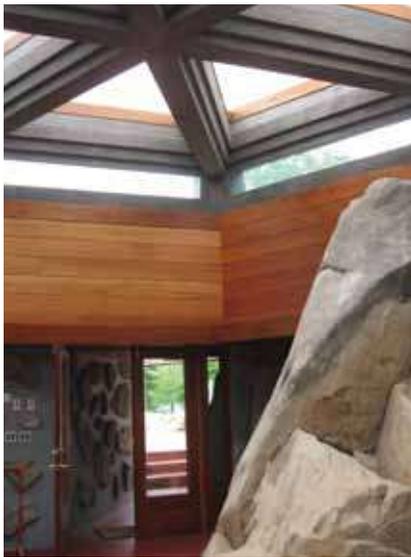
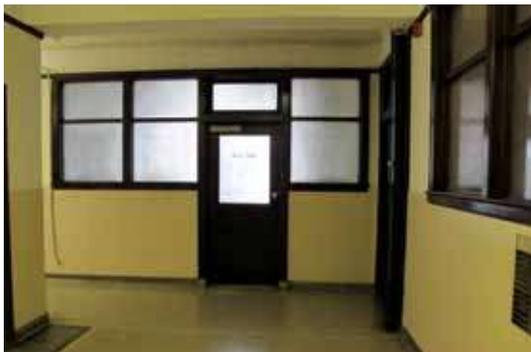
[16-18] Inherently sustainable features of historic buildings: Shutters and a deep porch keep the interior cool in a historic house in a warm climate (top); a skylight provides natural light to the interior of this mid-20th century house (center); partially glazed partitions and doors allow natural light into the corridor of a historic office building (bottom).

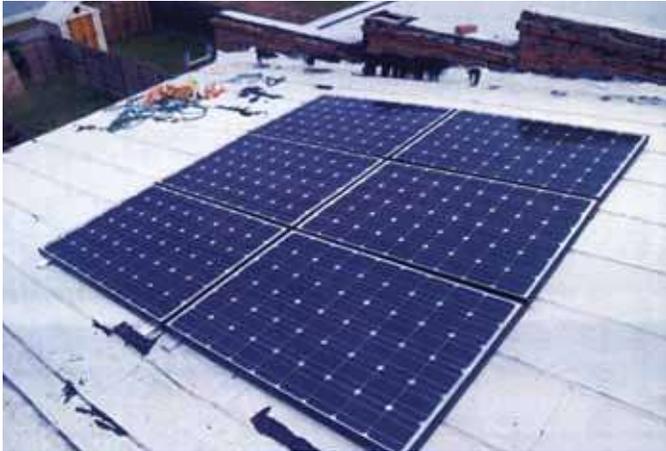
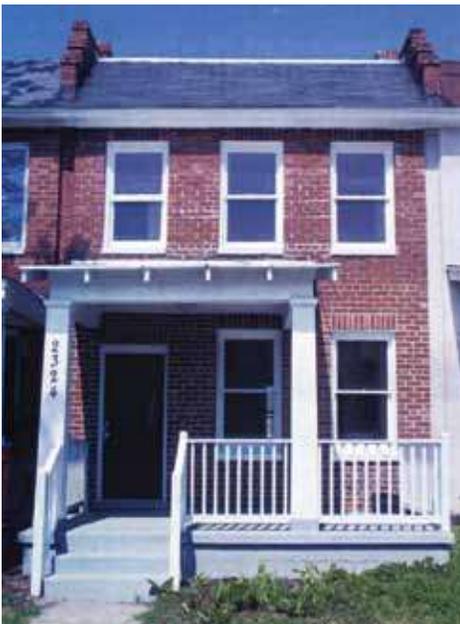
Recommended: [72-73] Solar panels were installed appropriately on the rear portion of the roof on this historic row house that are not visible from the primary elevation.

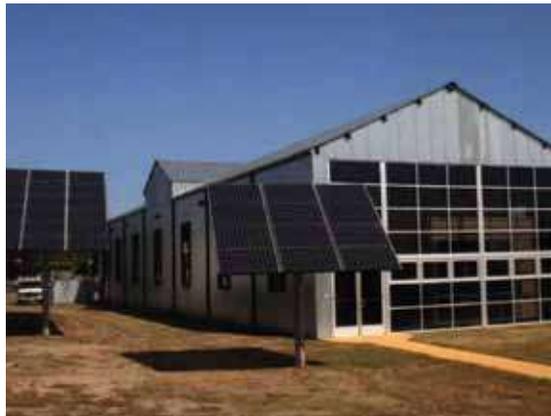
74

Recommended: [74] Free-standing solar panels have been installed here that are visible but appropriately located at the rear of the property and compatible with the character of this industrial site.

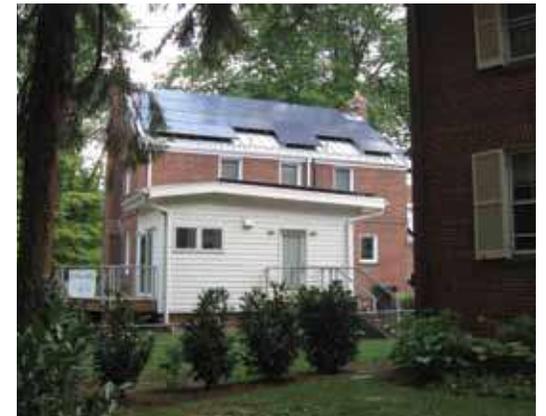
75

Not Recommended: [75] Solar roof panels have been installed at the rear, but because the house is situated on a corner, they are highly visible and negatively impact the character of the historic property.

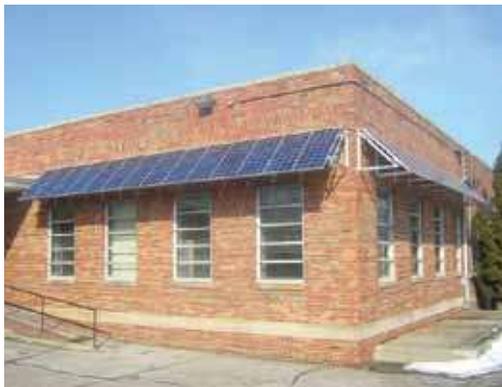
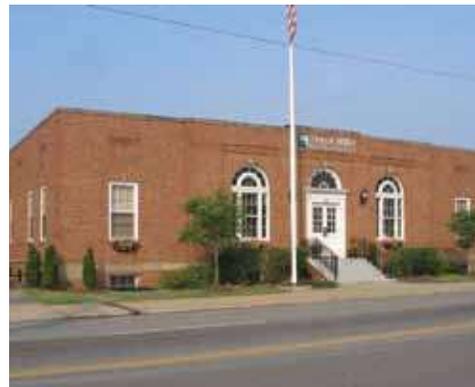
Recommended: [76-77] Solar panels, which also serve as awnings, were installed in secondary locations on the side and rear of this historic post office and cannot be seen from the front of the building. [78] Solar panels placed horizontally on the roof of this historic building are not visible from below.

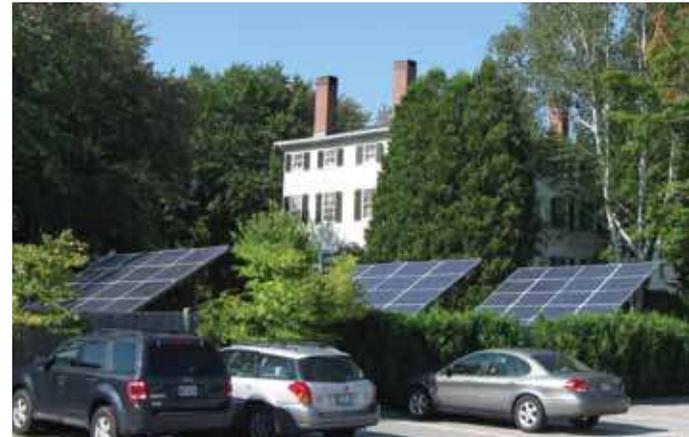
79

Not Recommended: [79] Although installing solar panels behind a rear parking lot might be a suitable location in many cases, here the panels negatively impact the historic property on which they are located.

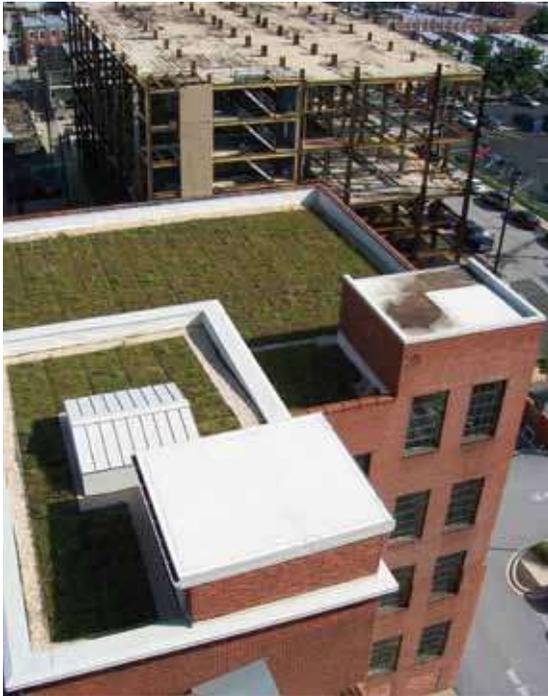
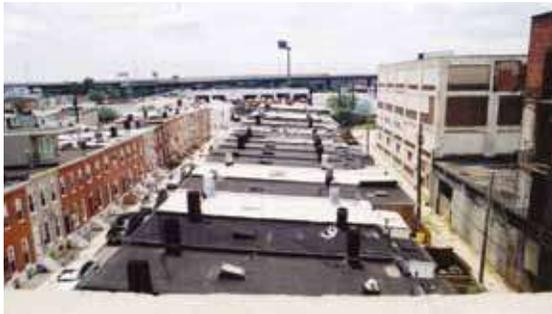
Recommended: [85-86] A cool or green roof is best installed on a flat roof where it cannot be seen from the public right of way and will not negatively impact the character of the historic building.

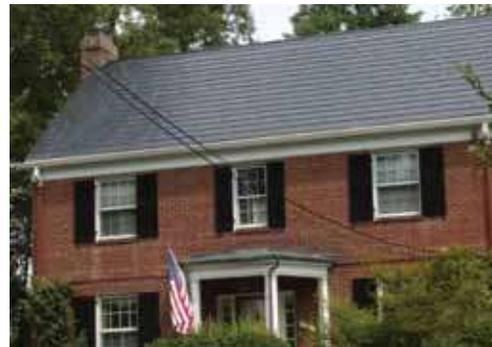
87

Not Recommended: [87] Historic roofing materials in good condition should be retained rather than replaced with another material perceived as more sustainable, such as, in this case, solar roofing shingles.

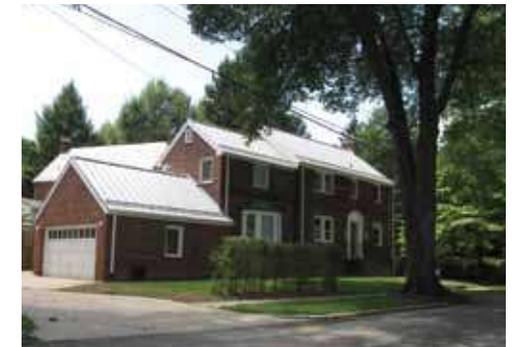
88

Not Recommended: [88] This new, cool white metal roof is not an appropriate material or color for this historic mid-20th century house.

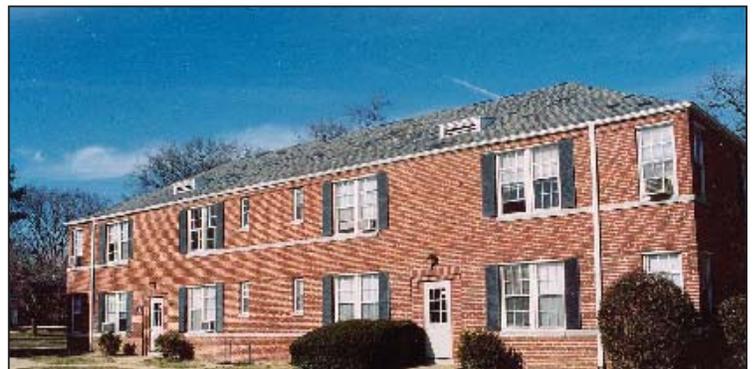
Typical view of Colonial-Revival apartment building in complex before rehabilitation. Note the mottled appearance of original slate due to numerous past repairs.

Application 1 (Compatible Treatment): After surveying approximately fifty buildings in this Colonial Revival-Style apartment complex, it was determined that the 80-year old slate roofing was in poor condition. As a result, the owner proposed that all the slate be removed and replaced with a polymer-based substitute. The most distinctive features of these simple 2-1/2 story brick garden apartments are their hipped and gabled slate roofs, which are very visible within the complex. Therefore, replacement with a substitute material was deemed incompatible and the owner agreed to use new slate from the original quarry. The new slate roofs, which require only seasonal maintenance, are a sound investment and historically appropriate.

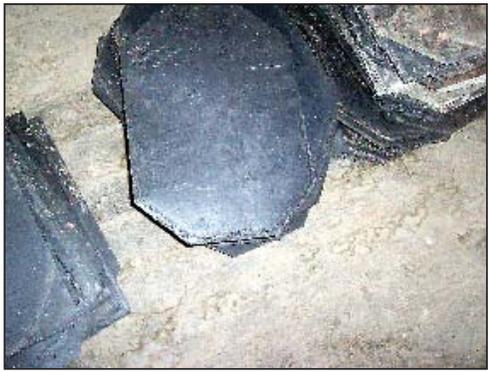
Right: New rubber slate (center; left) next to historic slate (right).

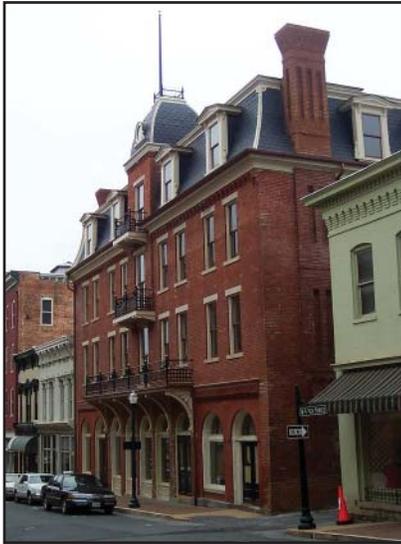
Left: Second Empire former hotel, built in 1894.

Application 2 (Compatible Treatment): This 1894 example of Second Empire architecture is “high style” with pedimented dormers, balconies, corbelled cornices, a dominant central tower, and a small mansard roof covered in slate. Prior to rehabilitation the property was in extremely deteriorated condition and although some of the slate on the mansard was still there, it was delaminating, fractured, and partially painted. Since the roof is only one of many decorative elements making up the primary façade and not the sole defining feature of the building, replacing the slate with a polymer-based substitute slate was an acceptable alternative. Although the replacement slate is visible,

it replicates the decorative fish-scale pattern of the historic slate and, thus, has the same appearance as the original roof. Because the building is on a narrow street and is generally viewed at an angle rather than head on, the mansard roof is not the major focal point.

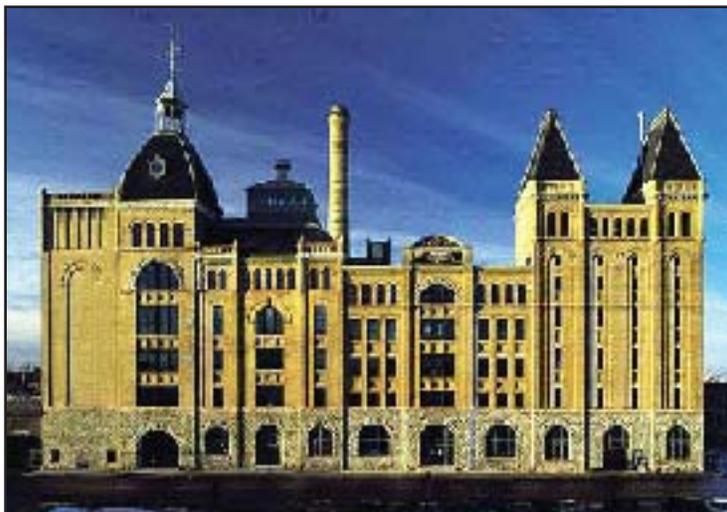
Above: Close up of the replacement roof after installation.

Application 3: (Compatible Treatment): After careful inspection, the slate roof of this circa 1895 former brewery was determined to be beyond repair and during rehabilitation was replaced with high quality asphalt-based fiberglass shingles. The new asphalt shingles are the same size and color as the original slate and have similar shadow lines. The roof, with its many towers, turrets and monitors, is clearly a distinctive and prominent feature, but because of the massive scale and height of the building, it can only be viewed at a considerable distance. For this reason, a substitute roofing material was acceptable in this instance.

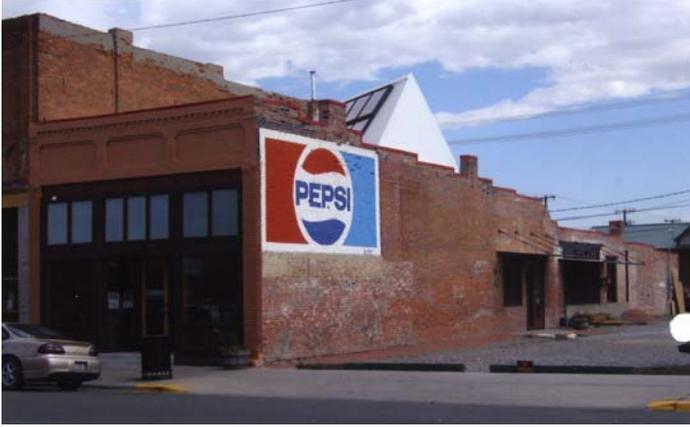
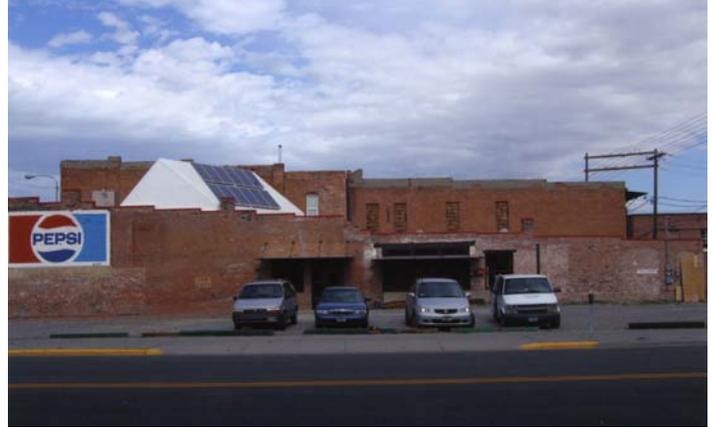
The addition of a large rooftop monitor featuring skylights on the front slope and solar panels on the rear slope is not compatible with the historic character of this small, one-story commercial building.

Application 2 (*Incompatible treatment*): During the rehabilitation of this late-nineteenth century commercial building, a conspicuous rooftop monitor with prominent solar panels and skylights was constructed on the one-story structure. The size and finish of this rooftop addition are incompatible with the historic character of the building. However, the building could have accommodated both skylights and solar panels if they had been installed differently. An alternative design that could have met the Standards would have included low-profile skylights and solar panels concealed behind the parapet wall.

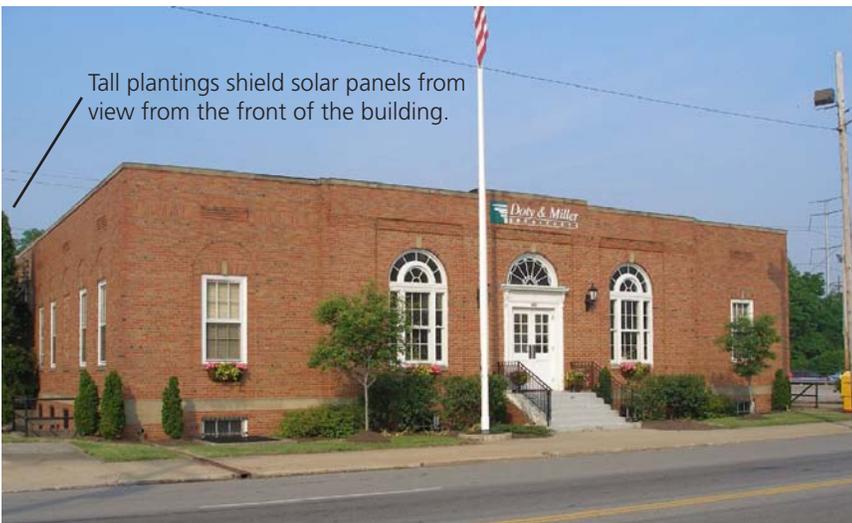
Tall plantings shield solar panels from view from the front of the building.

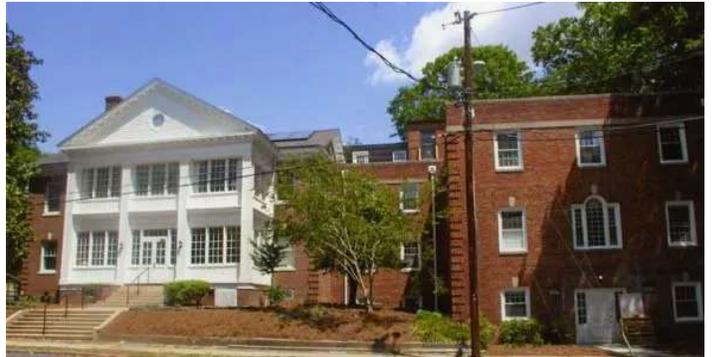
The visual prominence of the two solar collectors installed on this cross gable is further minimized by the complexity of this elevation.

Several specific circumstances made it possible to install solar collectors on a street-facing slope of this gable roof. The panels were flush-mounted on a low-pitch roof, and only two were required. They were installed on a portion of the roof that is set back from the face of the building behind a prominent pediment. Thus, the solar collectors are visible but not conspicuous, and this installation meets the Standards in the context of the overall project.

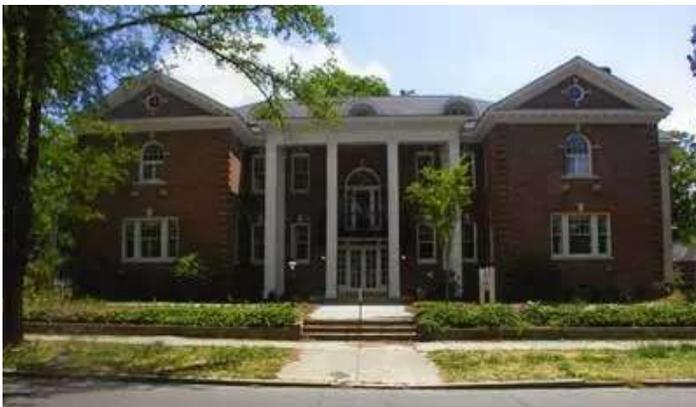
Front of the King's Daughters Home. The solar panels are installed on the facade that faces the street at the right edge of this photograph.

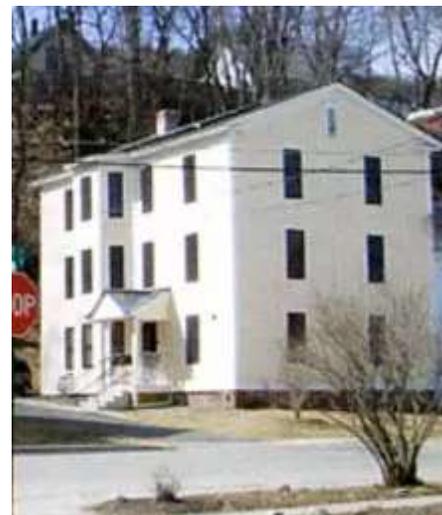
Low-profile solar collectors located on the south side of the gable roof are minimally visible.

The gable end of this historic apartment building faces the street. Low profile solar collectors for a water heating system were flush mounted on the sloped roof on the south side of the gable. Though visible, these few panels have relatively little impact on the historic character of the property. However, if the roof had been a more prominent feature of the property, this installation may not have been appropriate.

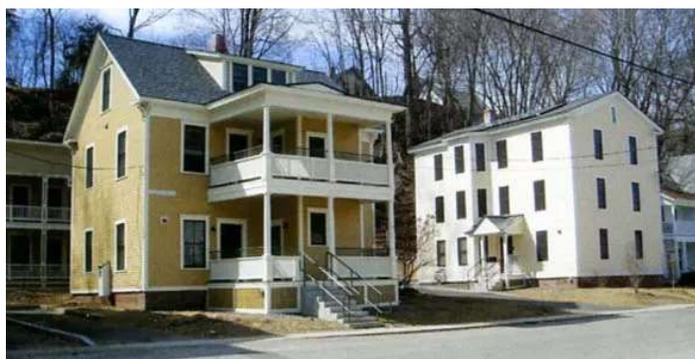
From this angle, the panels are more noticeable, yet the historic character of the building is not significantly diminished.
