Property Information

Name Explanation	Name
Function/Location	House, 504 12th Street NW

Current - 504 12th Street NW

January 2020: According to the Charlottesville City Property Records, this house was constructed in 1920 (City of Charlottesville GIS Viewer 2020). However, it is not depicted on the 1920 or 1929 Sanborn Maps. It does appear on the 1950 Sanborn Maps as a one-story, rectangular dwelling with a one-story, full-width, open front porch. These maps also list the address as either 508 or 412 12th Street NW. There is no listing for this property in the 1940 city directory, but by 1950 it was occupied by Rosa Price. Therefore, it was likely built c. 1945 (Sanborn Map Company 1920; Sanborn Map Company 1929; Sanborn Map Company 1950; Hill Directory Co. 1940; Hill Directory Co. 1950). By 1968, a rear vestibule was constructed in the center of the southeast elevation. Between 1994 and 2002, a rear, one-story addition was built on the northeast half of the southeast elevation, incorporating the earlier vestibule. Between 2006 and 2009, this addition was doubled in length. It is not known when the rear deck and vestibule were built, but they likely predate the larger rear additi

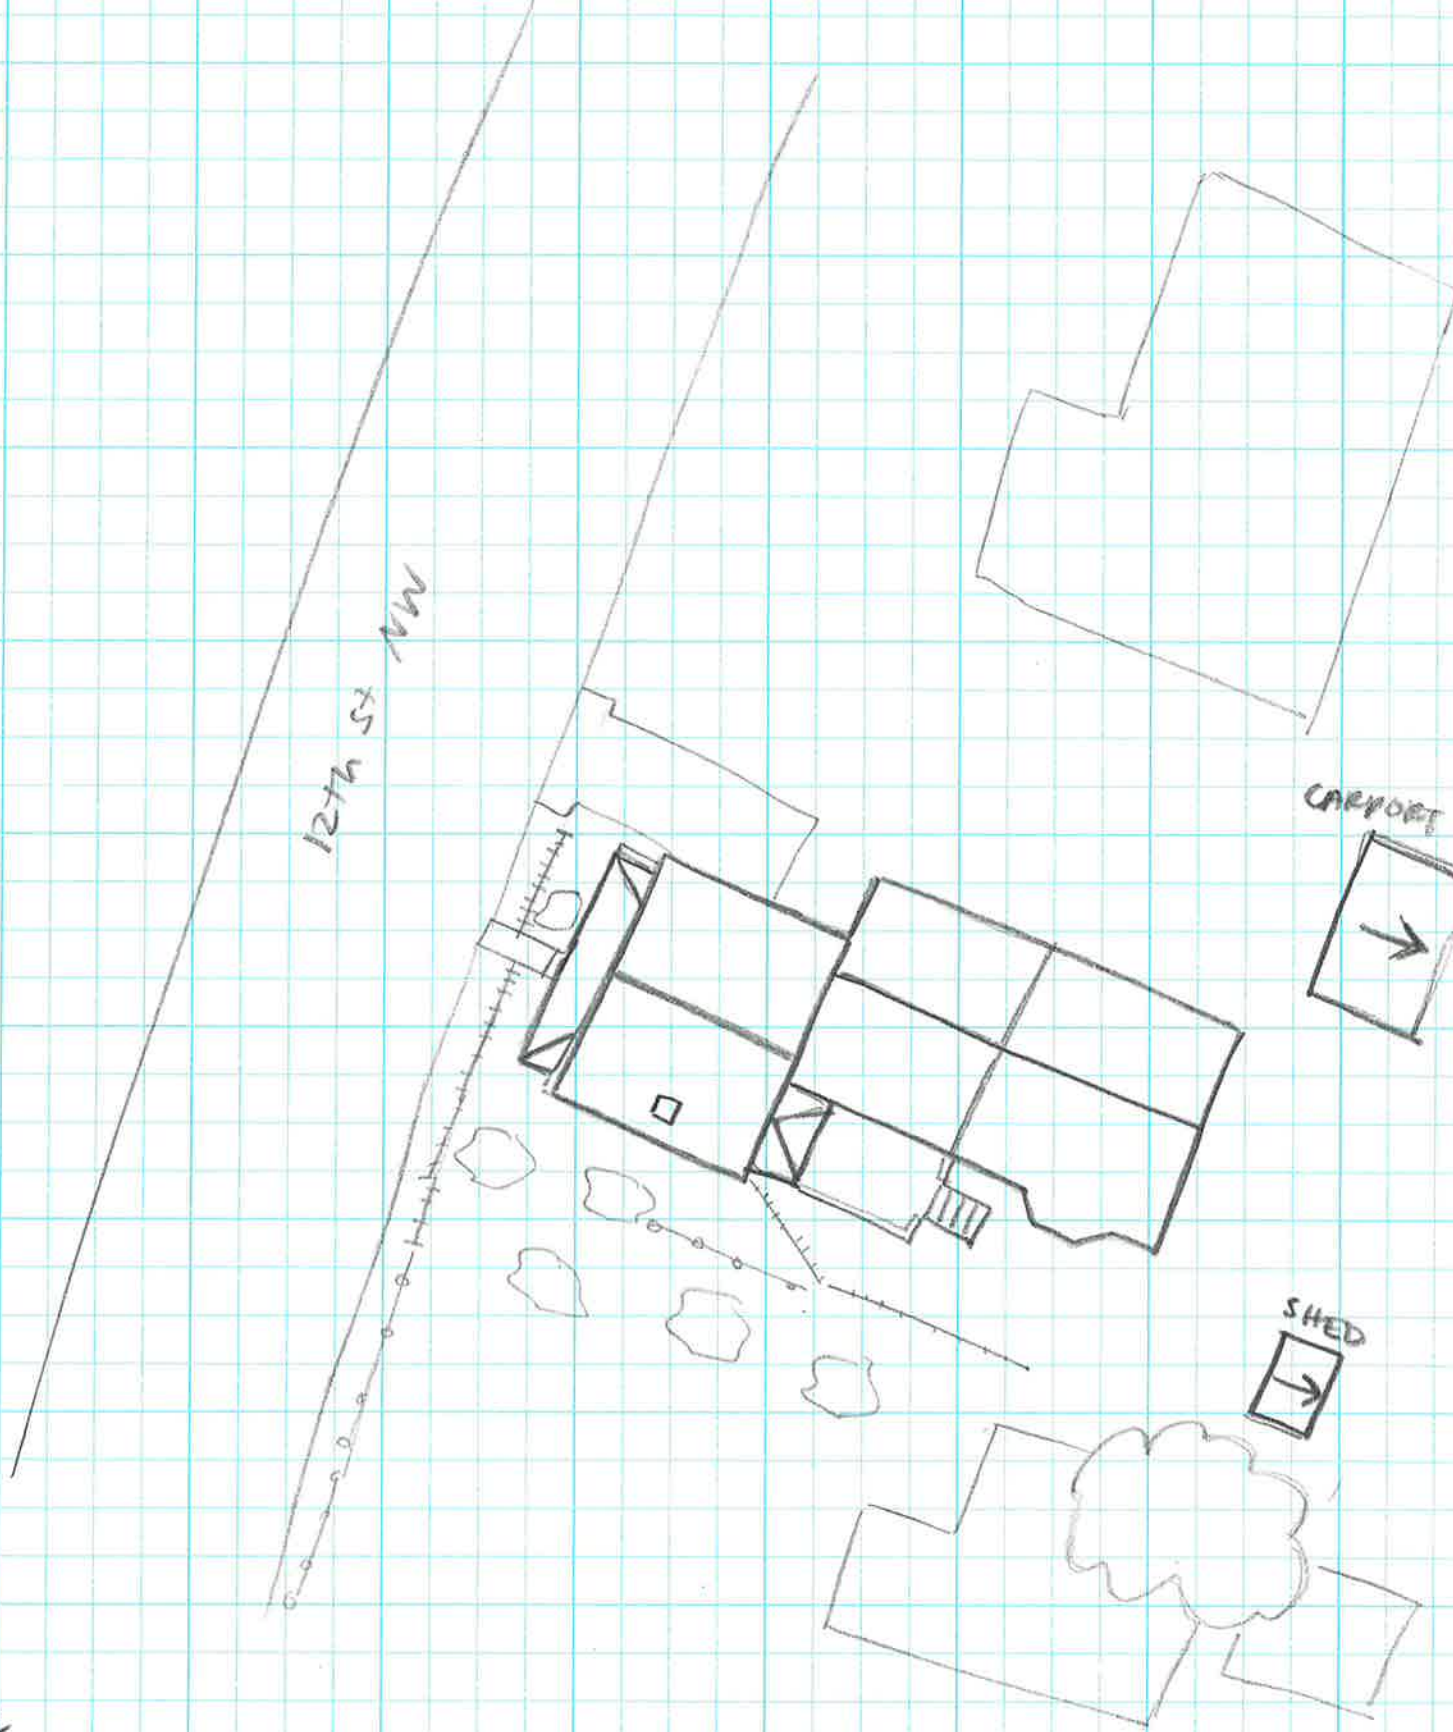
504 12th St NW
SURVEY DATE 1/28/2020
NOT TO SCALE

January 2020: This one-story house is located on the east side of 12th Street NW. There is a small tree in the front yard and a wood fence along the northwest side of the property. There is a partial-length chain link fence along the southwest and northeast property lines, along with several box hedges. A partial-length wood fence extends from the south corner of the house to the southeast. Near the north corner of the lot, there is an asphalt parking pad. Near the center of the northeast elevation of the house, there is a trampoline. In the east corner of the lot, there is a carport and near the south corner, there is a shed. This property consists of a house, a shed, and a carport.
