Certificate of Appropriateness
BAR # 24-05-02
130 Madison Lane, TMP 090138000
The Corner ADC District
Owner: St Elmo Club of UVA INC
Applicant: Kevin Schafer / Design Develop
Project: Install door at dormer window above west portico and install egress stairs at east elevation.

**City of Charlottesville
Board of Architectural Review
Staff Report
May 21, 2024**

Project: Alterations to the west [front] and east [rear] elevations.

- Applicant submittal: Design Develop drawings *St. Elmo's Hall Renovation*, dated April 30, 2024, 21 sheets.

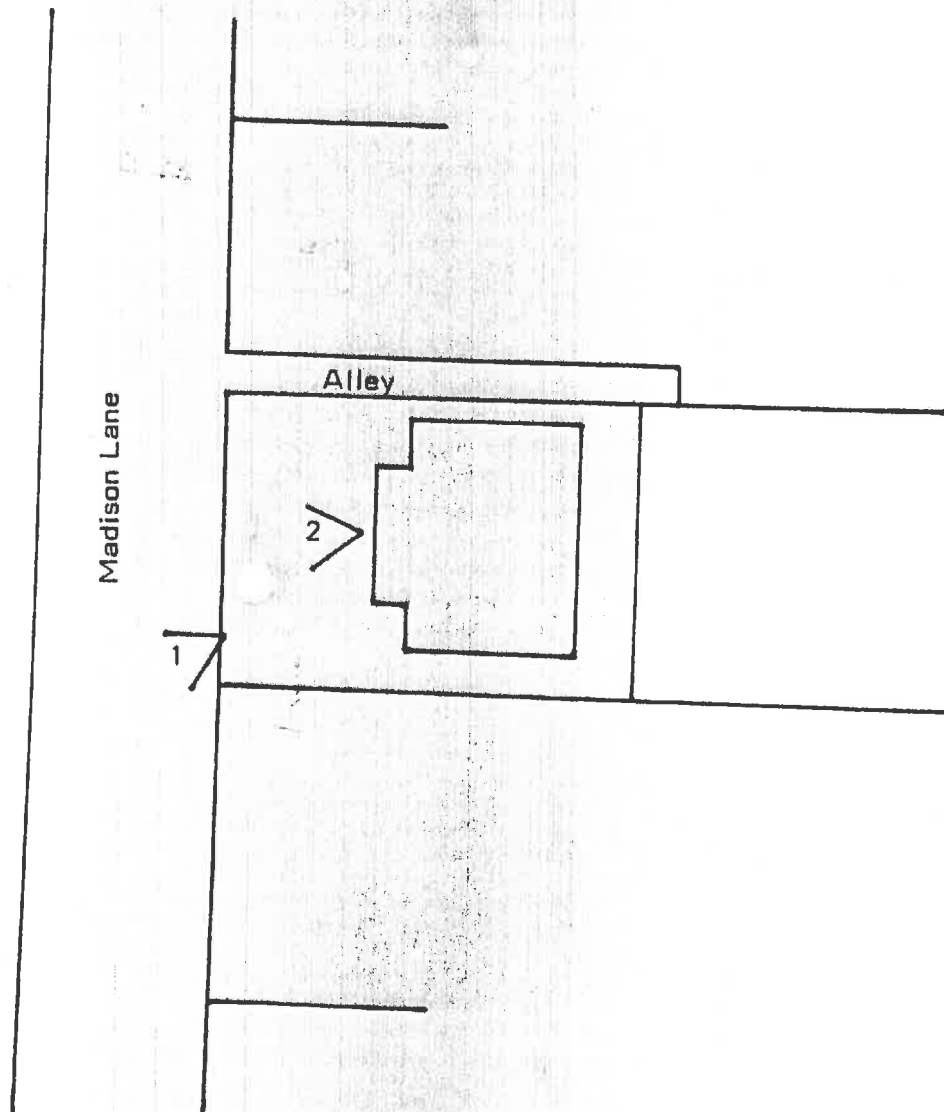
SAINT ELMO HALL
130 Madison Lane

Numbered arrows show locations
where photographs were taken

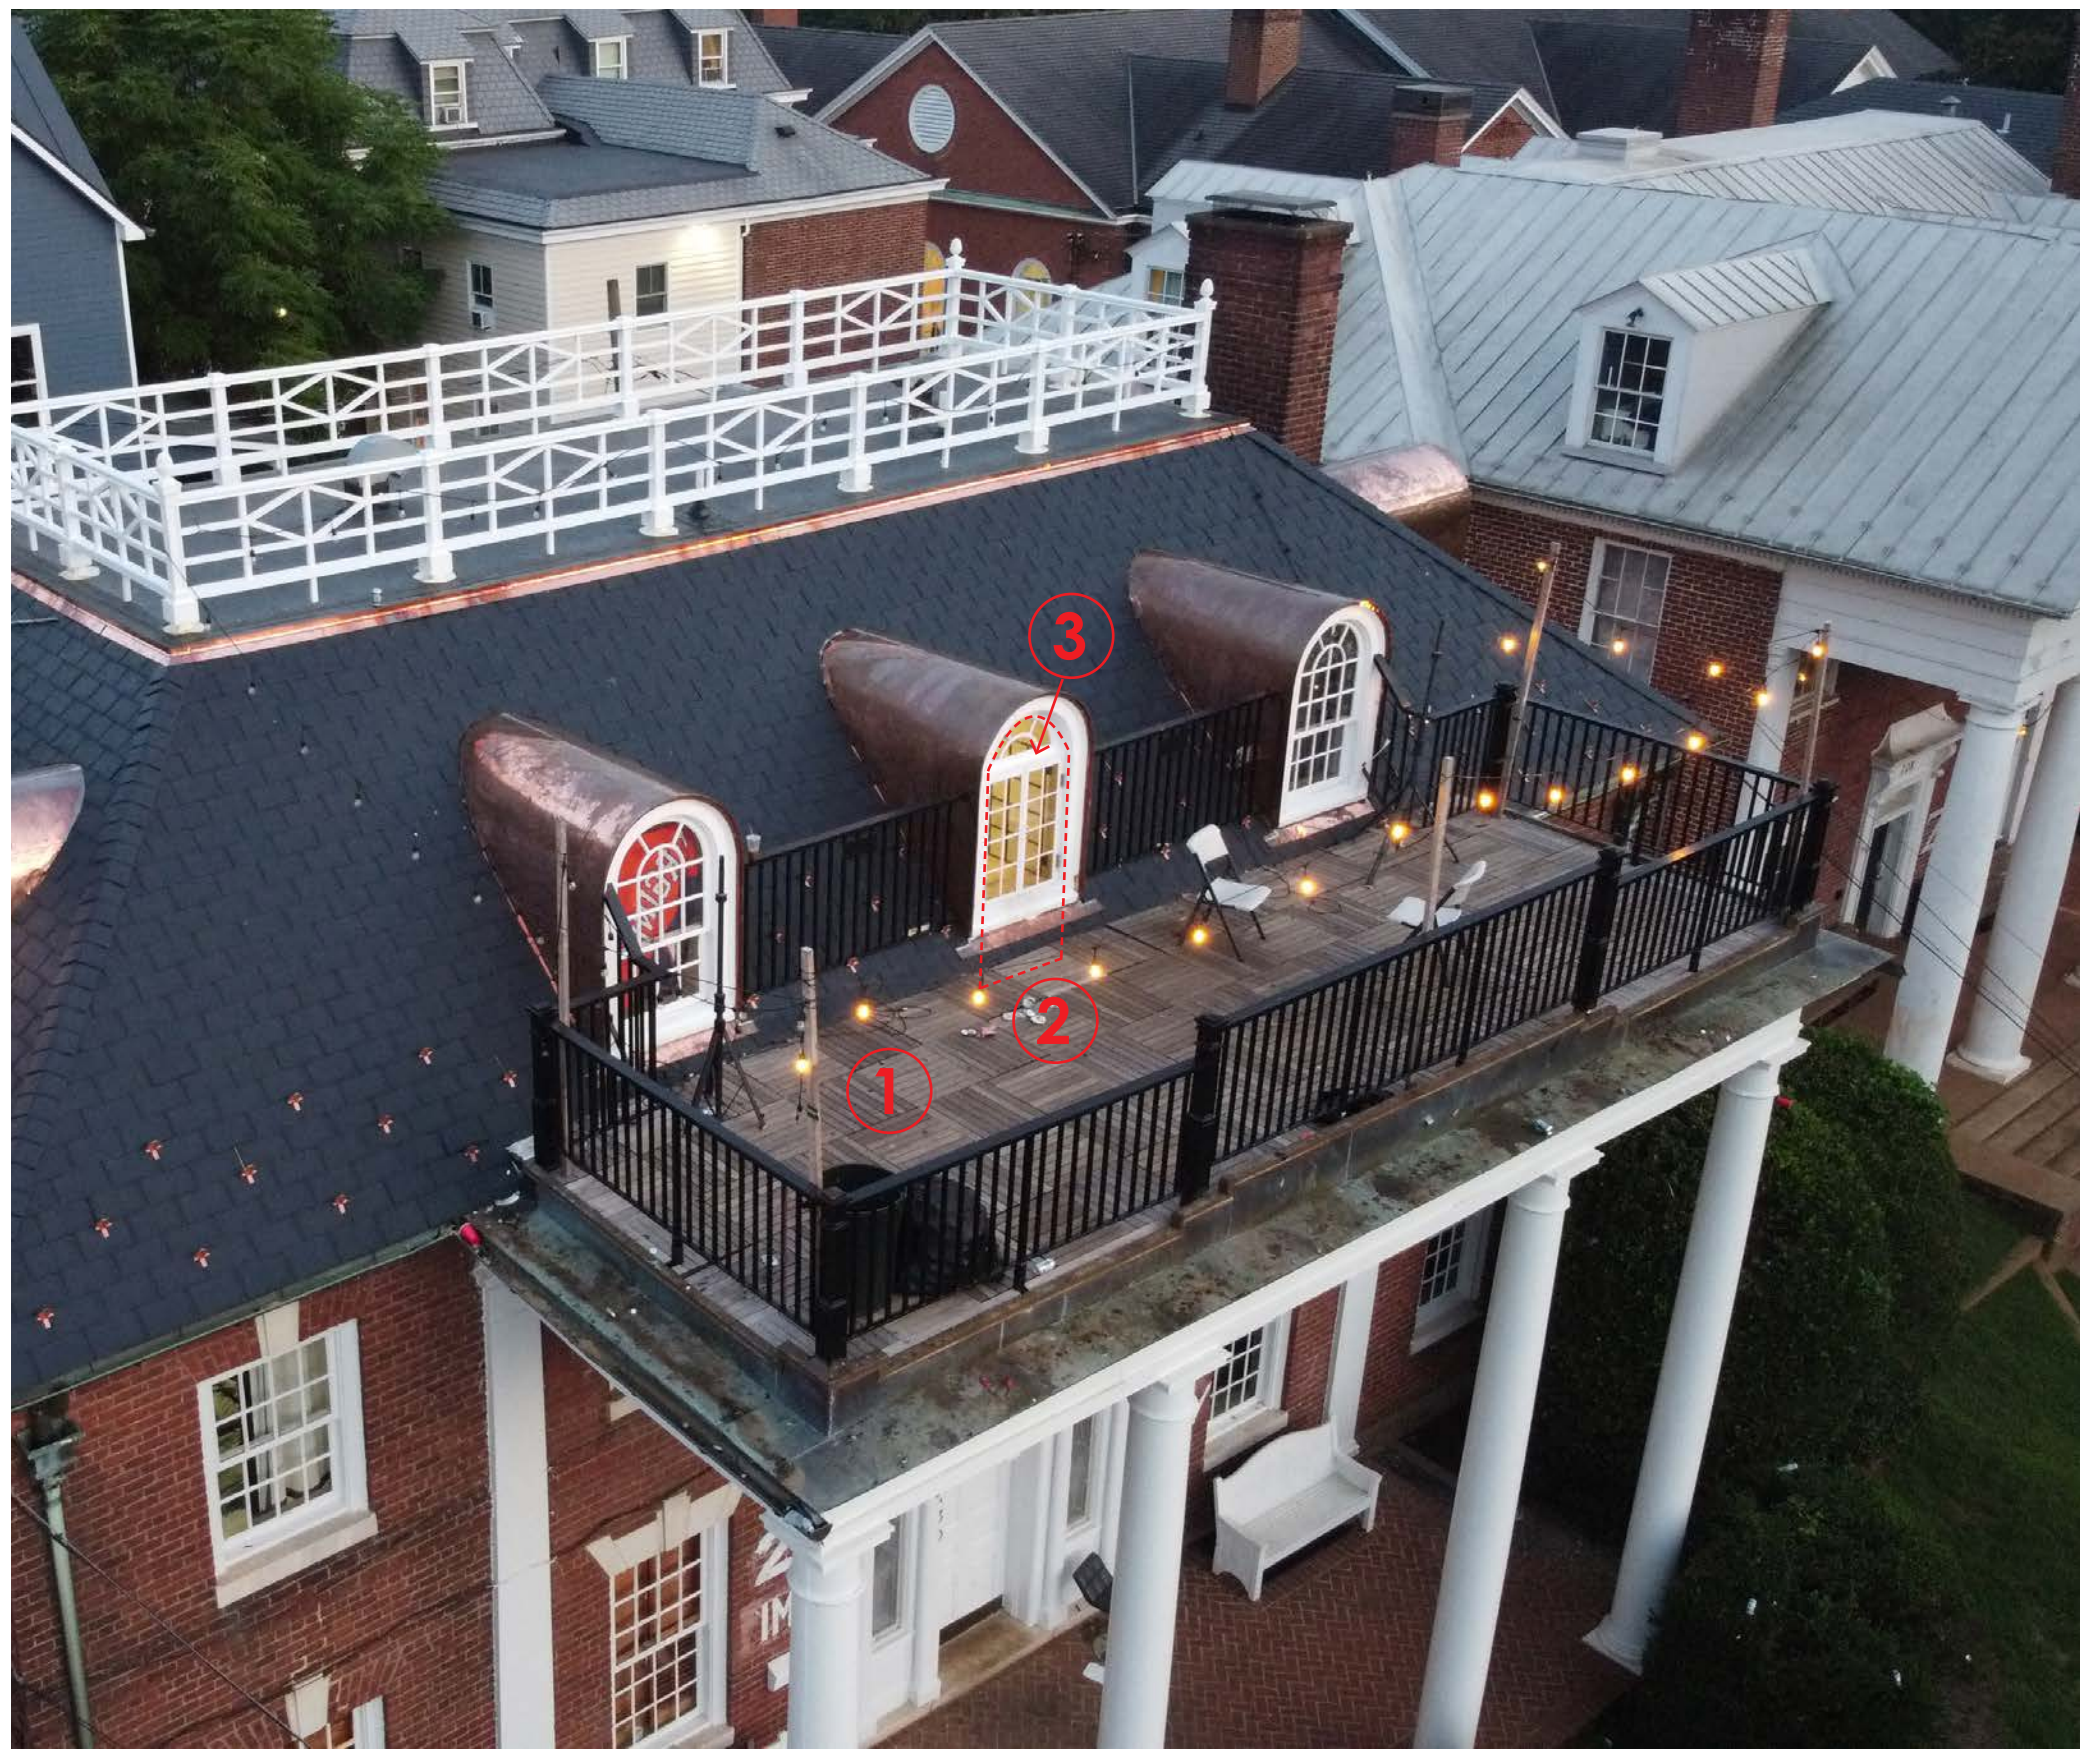
- SCOPE OF WORK:
- 1. REMOVE EXISTING DECK BOARDS / PEDESTALS, EXISTING RUBBER MEMBRANE ROOF AND BUILT-UP RIGID INSULATION TO LOWER THE ELEVATION OF THE EXISTING ROOF (~10" OF ROOF ASSEMBLY)
 - 2. EXPAND THE OPENING OF THE MIDDLE DOOR TO PROVIDE A MEANS OF EGRESS THAT MEETS CODE REQUIREMENTS
 - 3. REPLACE THE EXISTING (NON-HISTORIC WINDOW) WITH AN OPERABLE DOOR THAT REPLICATES THE LOOK / CONSTRUCTION OF THE ADJACENT ORIGINAL WINDOWS. THIS WINDOW WAS MODIFIED IN A 2008 RENOVATION.
 - 4. EXTERIOR EGRESS STAIR ON BACK OF BUILDING (NOT SHOWN ON THIS PAGE)

- Remove window sash in the center dormer and replace with a full height, operable door that will replicate the rails, stiles, and muntins of the window sash.

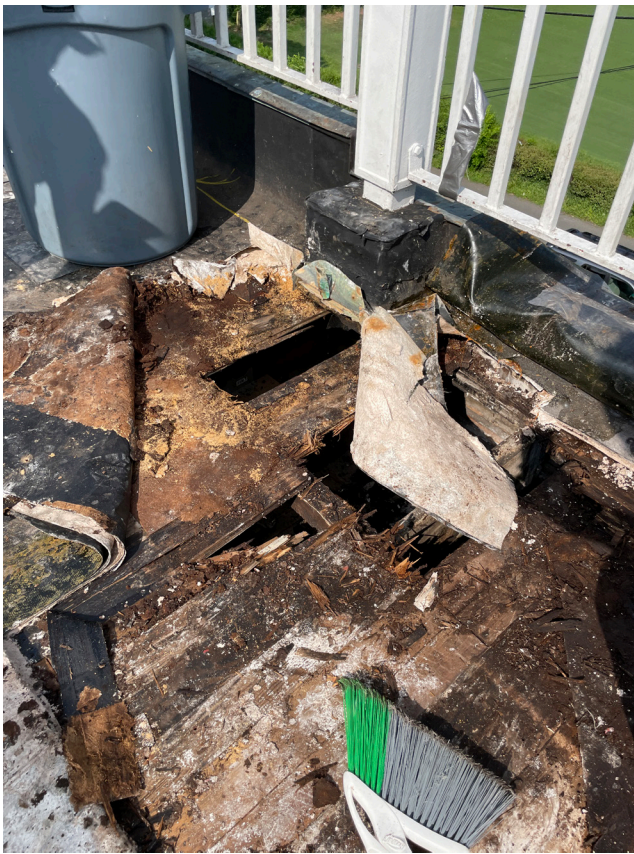
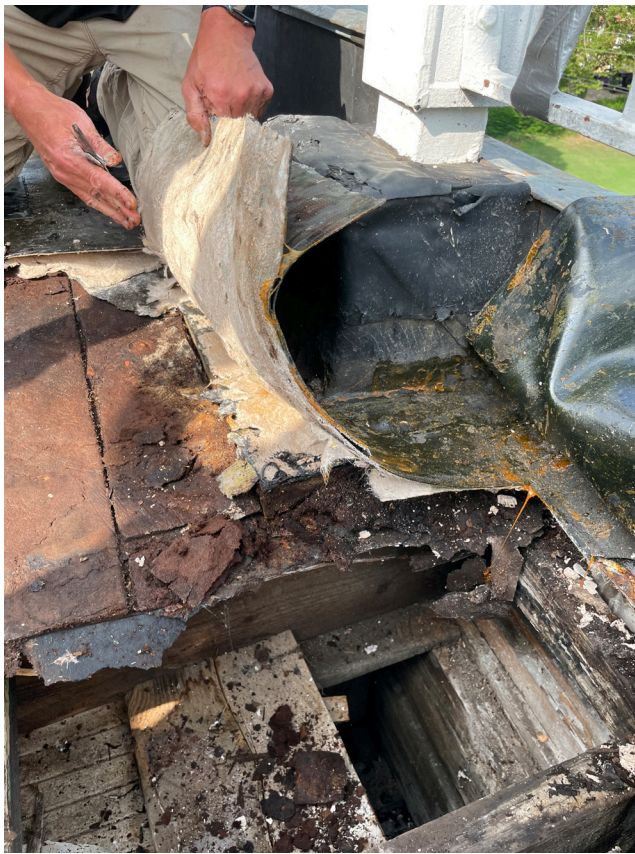
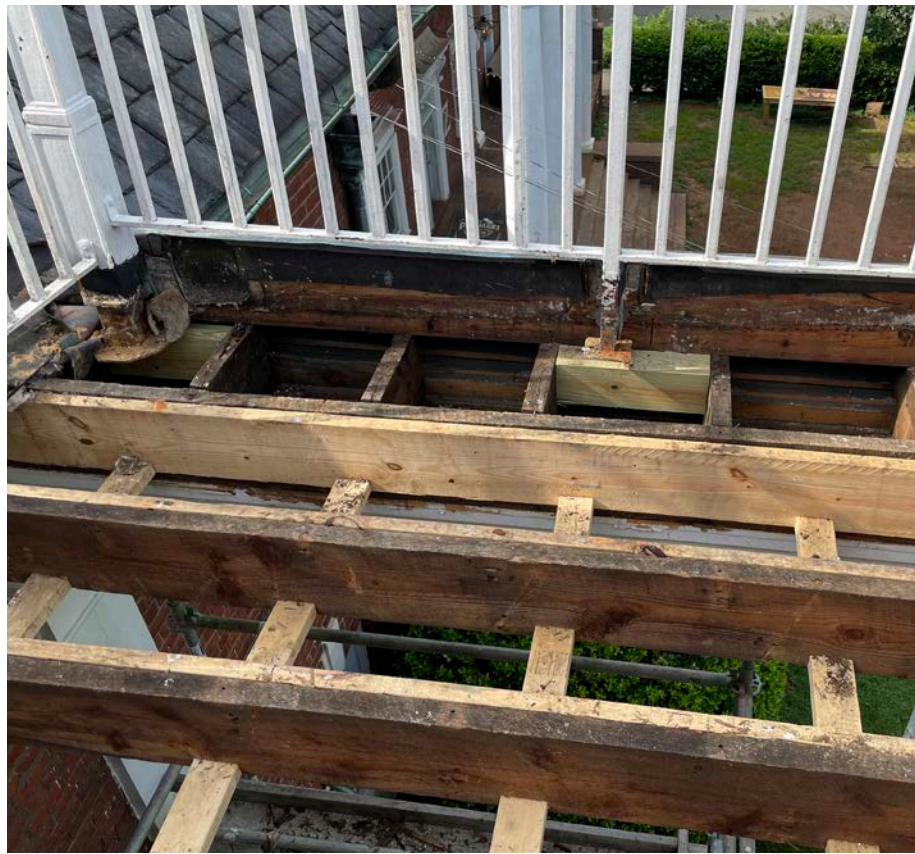
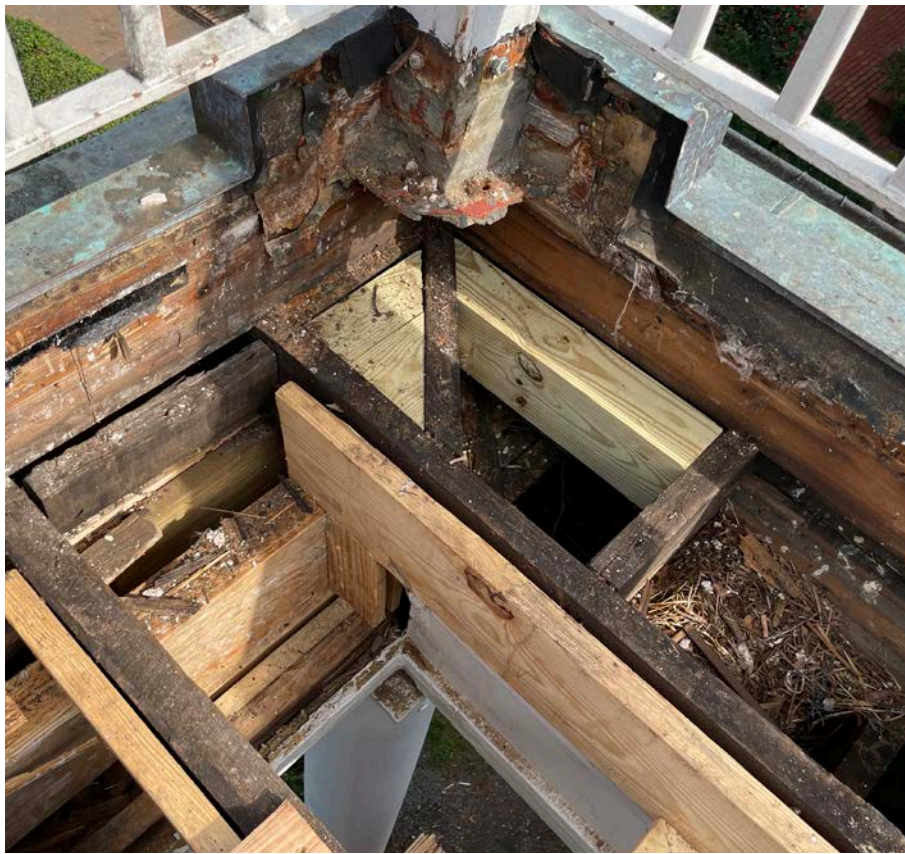
JULY 2022 - DESIGN DEVELOP ASKED TO EVALUATE EXISTING ROOF. DISCOVERED SEVERE DETERIORATION AND DAMAGE TO EXISTING HISTORIC PORTICO

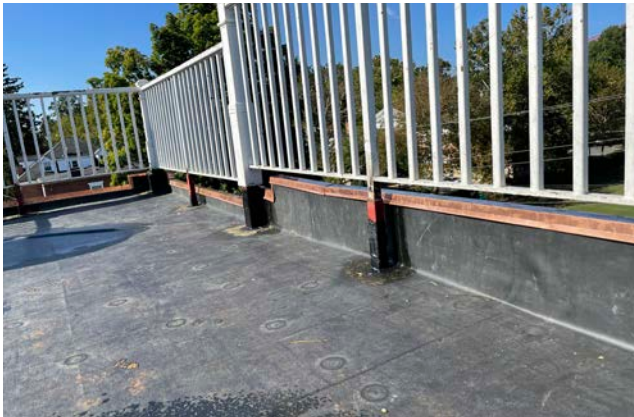
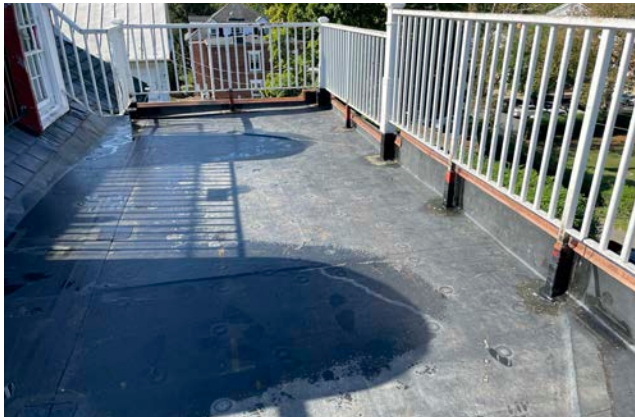
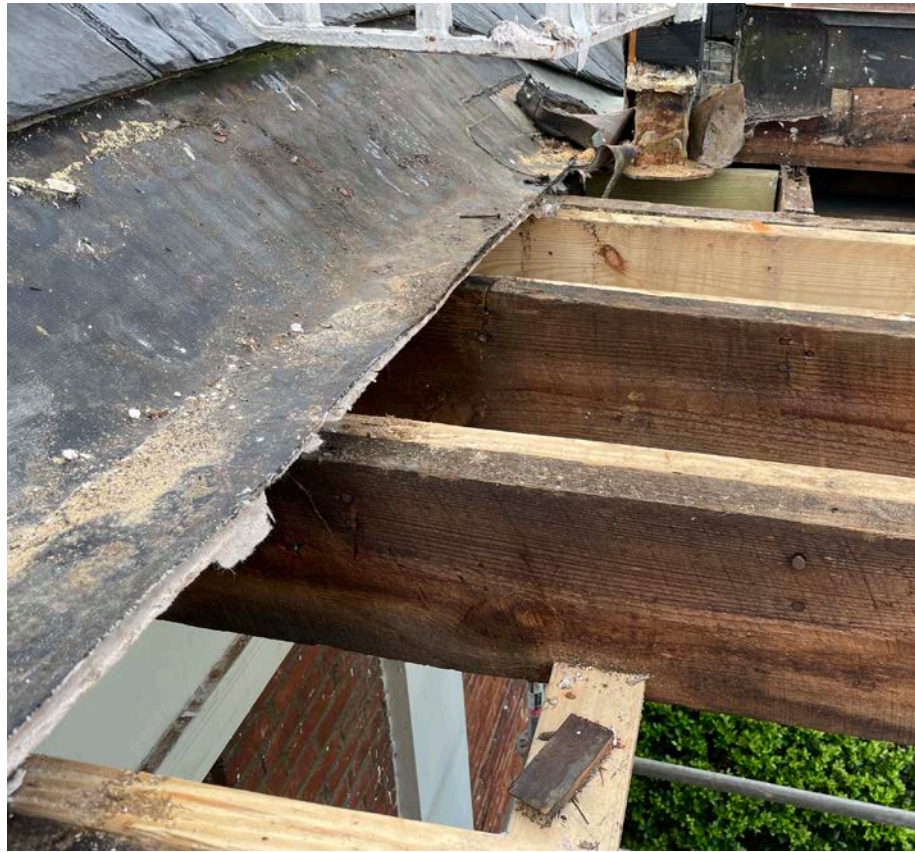
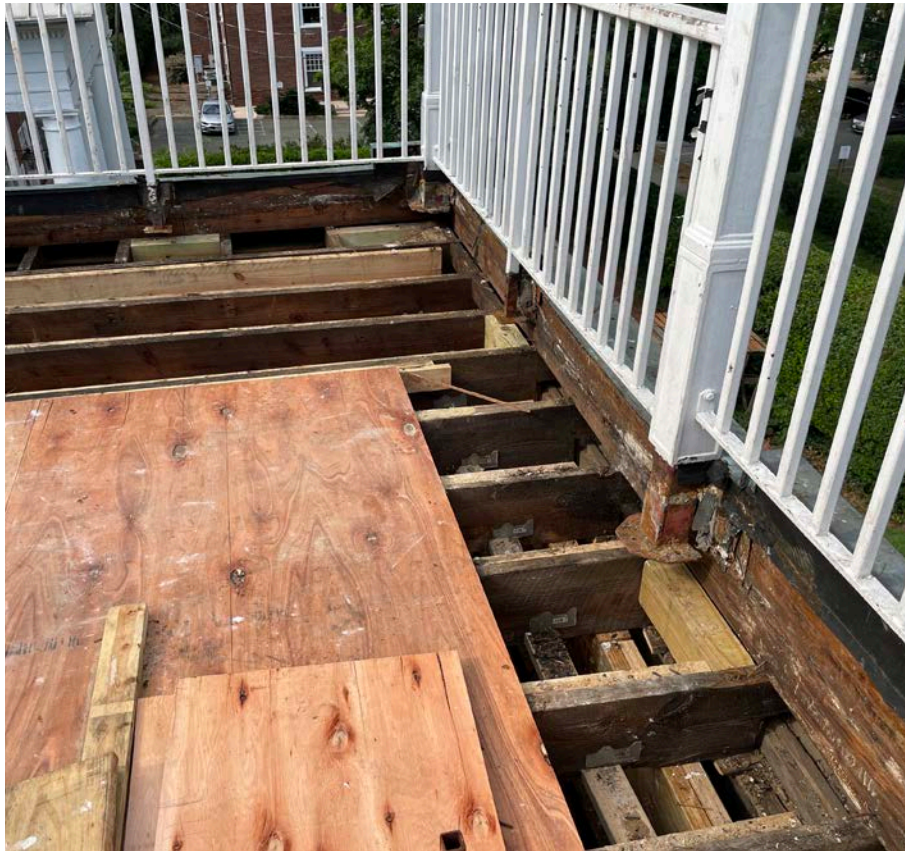
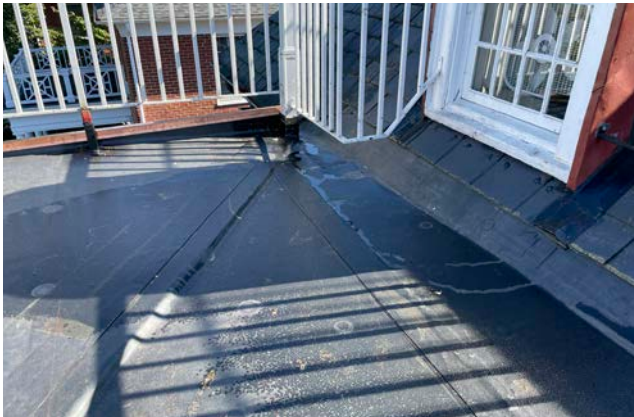
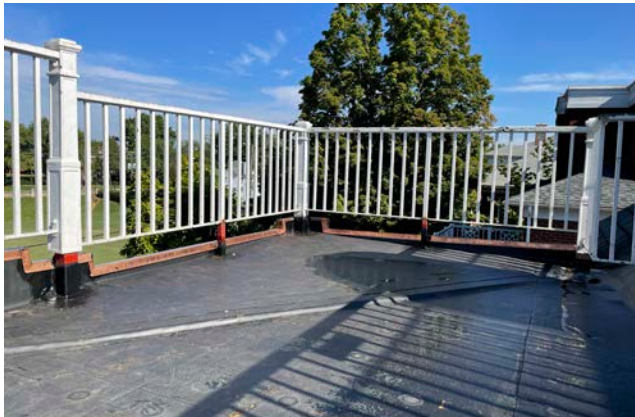
SEPTEMBER 2022 - NEW EPDM RUBBER ROOFING MEMBRANE OVER PITCHED RIGID INSULATION INSTALLED, NEW PITCH POCKETS / WATERPROOFING BOOTS INSTALLED AT RAILING POSTS.

AUGUST 2022 - DESIGN DEVELOP, IN PARTNERSHIP WITH DUNBAR STRUCTURAL ENGINEERING, PROVIDED A DESIGN TO STABILIZE, REINFORCE AND ENSURE THE LONGEVITY OF THE HISTORIC FRAMING, WHILE STRENGTHENING THE FAILING RAILING CONNECTIONS. EVALUATION OF THE HISTORIC COLUMNS WAS PERFORMED, AND THE FRONT PORCH BEAM WAS REINFORCED.

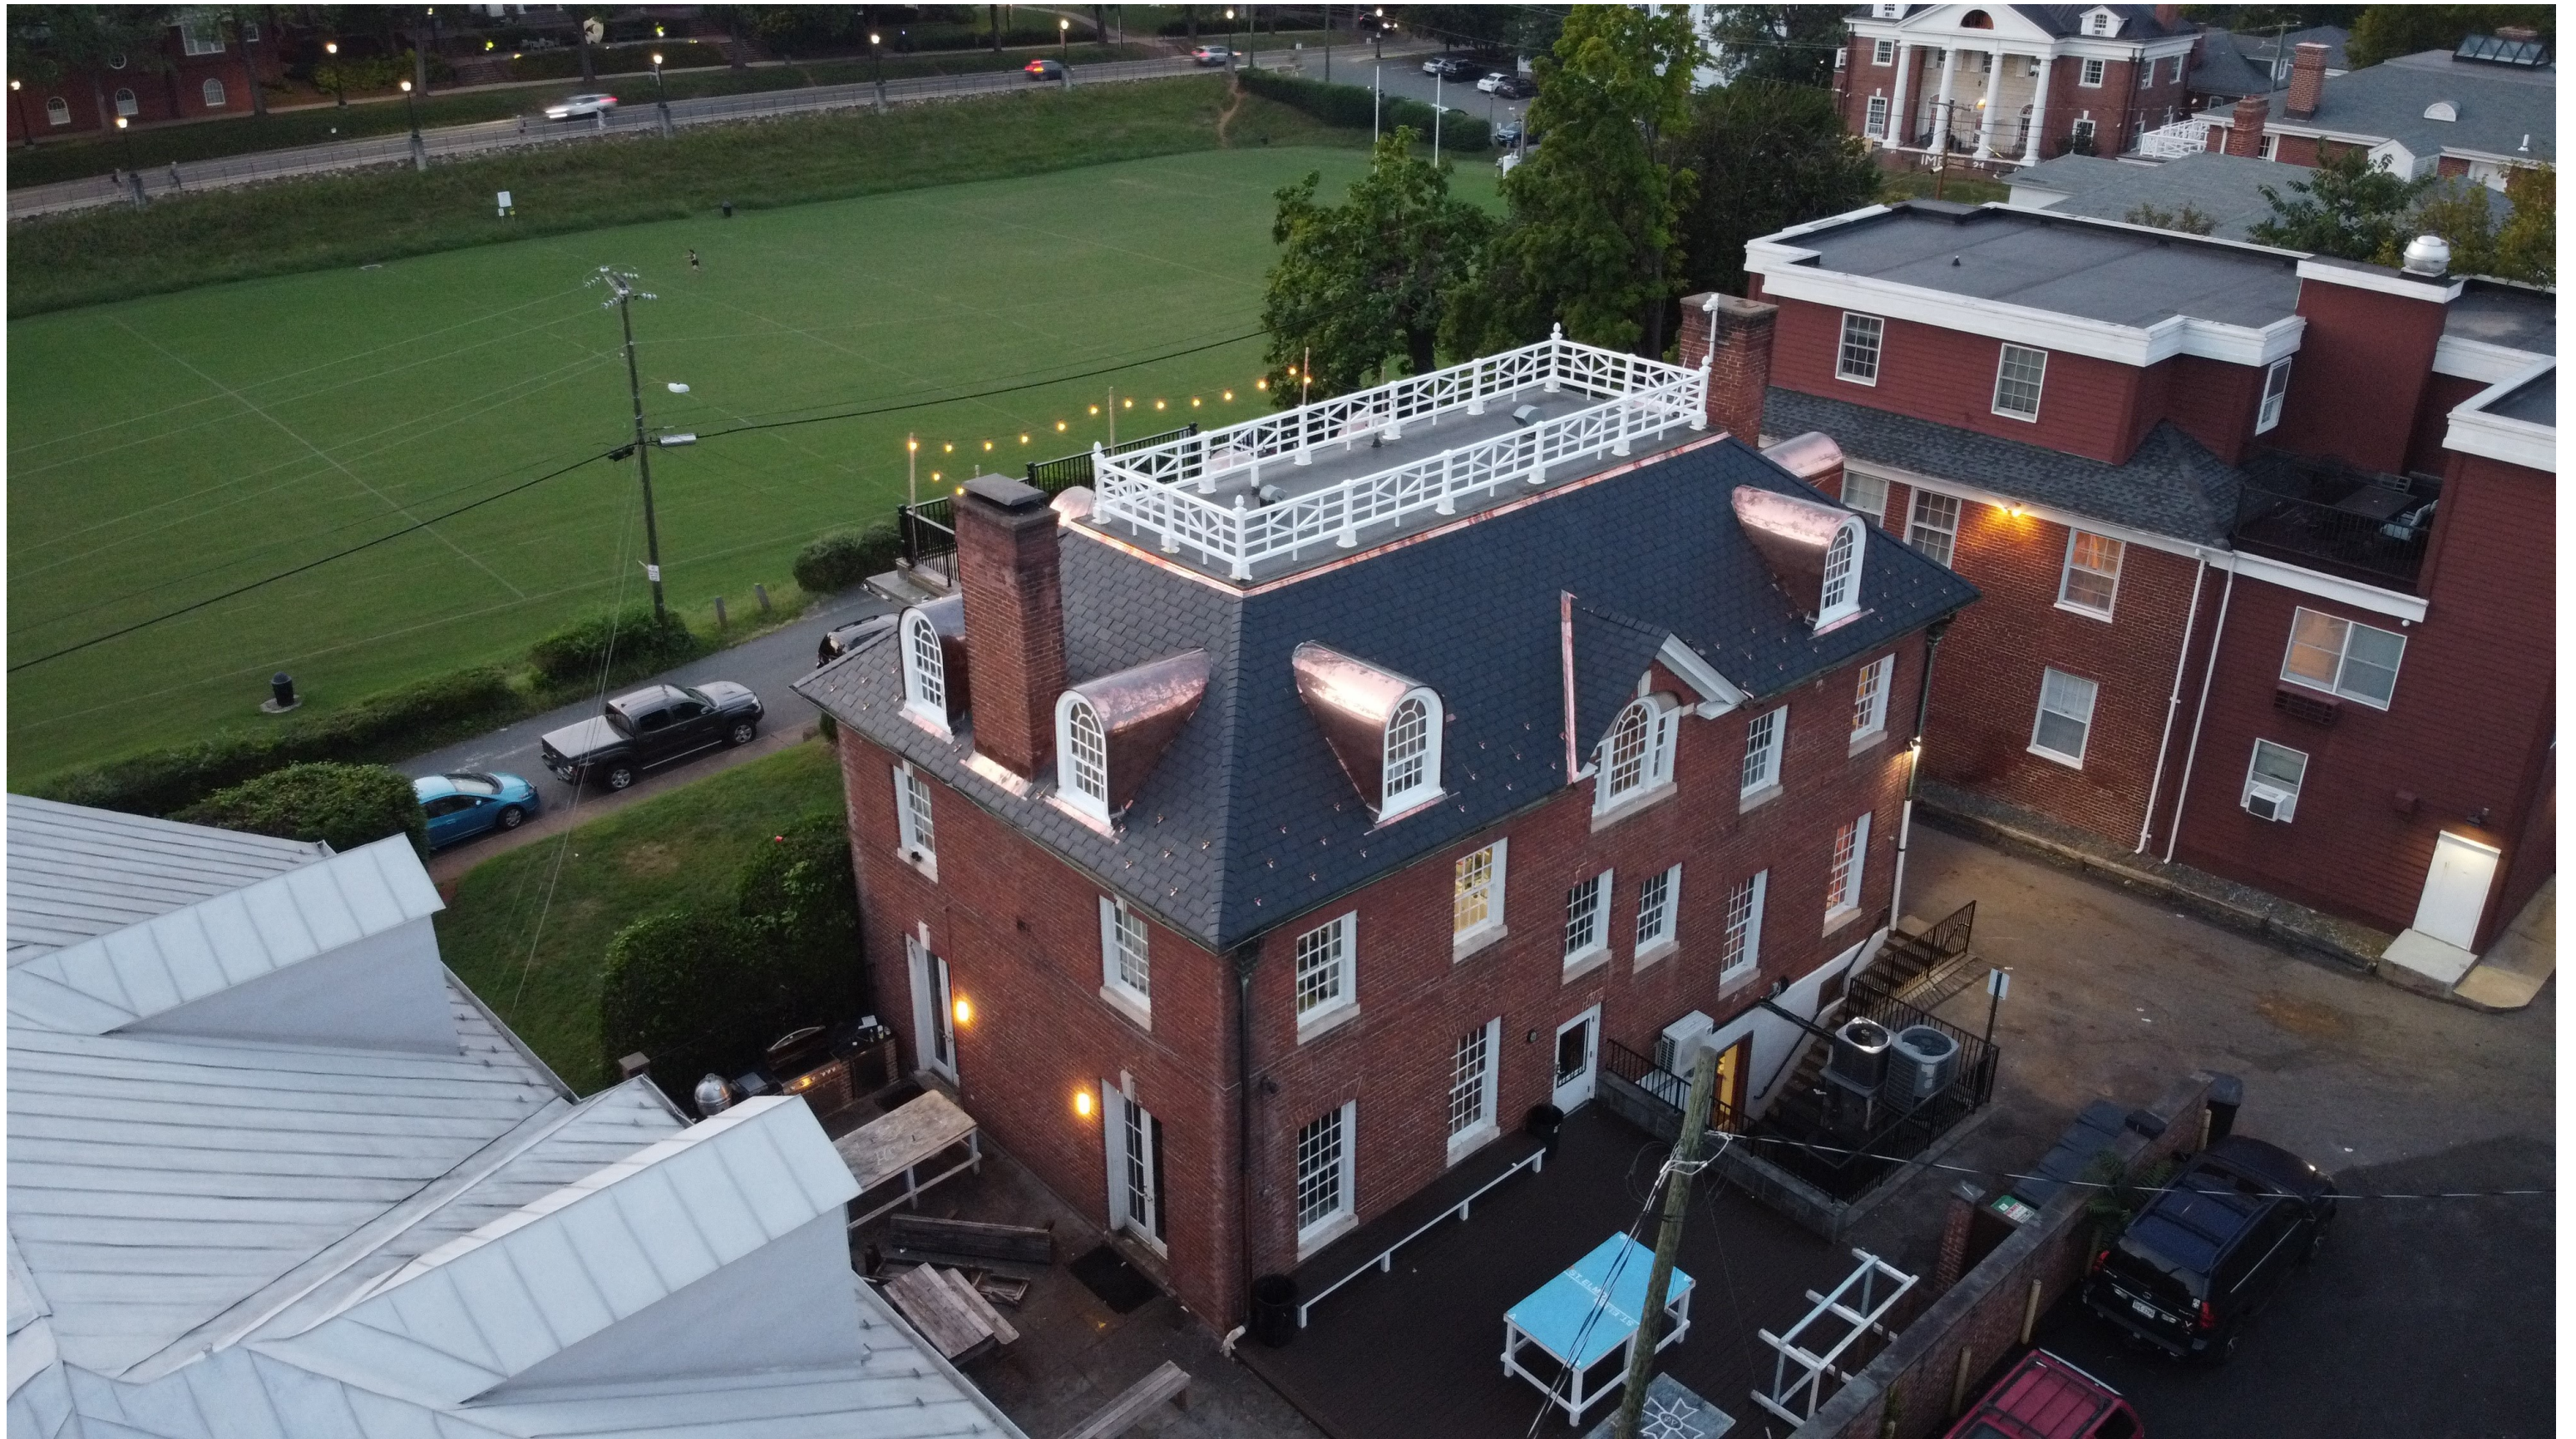
APPENDIX A: EXISTING REAR ELEVATION (2023)
20

1. PATCH & REPAIR ALL WOOD TRIM AS REQUIRED
2. PATCH & REPAIR WINDOW SASH AS REQUIRED
3. REPAIR METAL ROOFING @ DORMERS
4. PAINT ALL WOODWORK
5. REMOVE ALL GRAFFITI FROM MASONRY
