Certificate of Appropriateness
BAR # HST26-0007
707-709 West Main Street; TMP 320156000
West Main Street ADC District
Owner: Starr Hill Properties, LLC
Applicant: Cliff Fox
Project: Seasonal vestibule

**City of Charlottesville
Board of Architectural Review
Staff Report
March 17, 2026**

Certificate of Appropriateness Application

Project: Seasonal vestibule

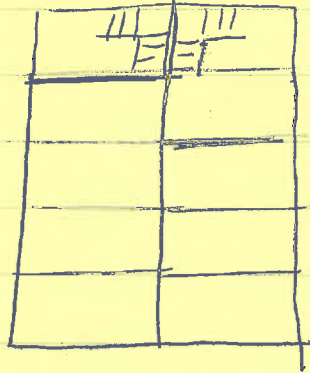
709 - mirror image of 707

stone facing below display window

705 - stone + copper
simpler stn seal, not 703

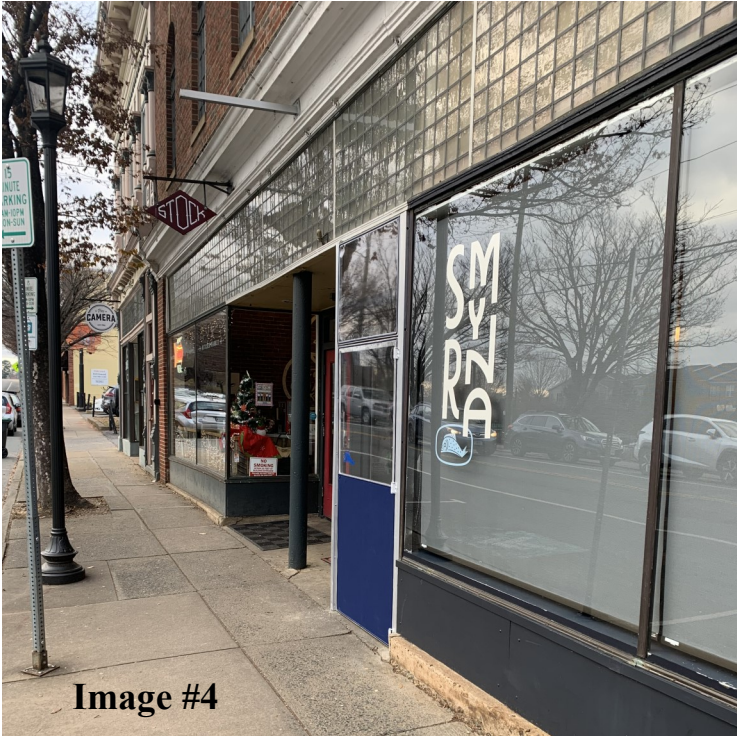
Image #4

December 2024: Staff was notified that a temporary, seasonal vestibule had been installed at the front entrance to the restaurant at 707 West Main Street. (See images 4 and 5.)

- BAR approve this CoA request with the condition that by April 1, 2026 the vestibule, in its entirety, be removed and impacts of its installation be repaired.
- BAR instruct staff to examine and submit a recommendation by September 1, 2026 regarding how similar and related temporary, weather proofing components should be evaluated and considered, consistent with the BAR review criteria. The recommendations should include possible conditions of approval, including suggested time periods when temporary

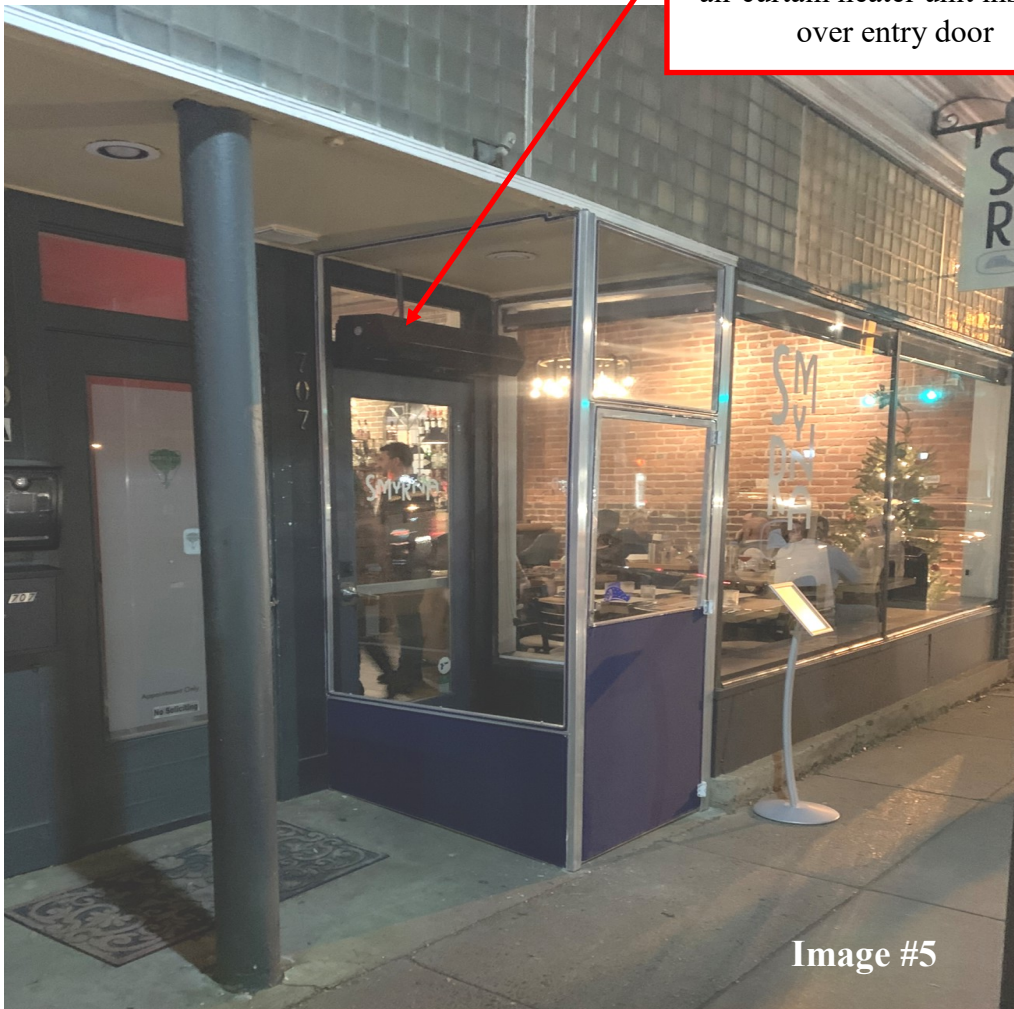
Image #5

Regarding the air current heater above the entry door. While visible in the applicant's photos, the heater was not identified as part of this CoA request, nor was it the subject of any prior CoA request. Furthermore, the installation of a temporary vestibule does not result in that area becoming an interior space: the heater is an exterior alteration that requires a CoA. Additionally, staff is not aware if the installation was completed under an appropriate building permit. Staff will consult with Building Code Official and Zoning, and advise the BAR accordingly at a later date.

air curtain heater unit installed over entry door

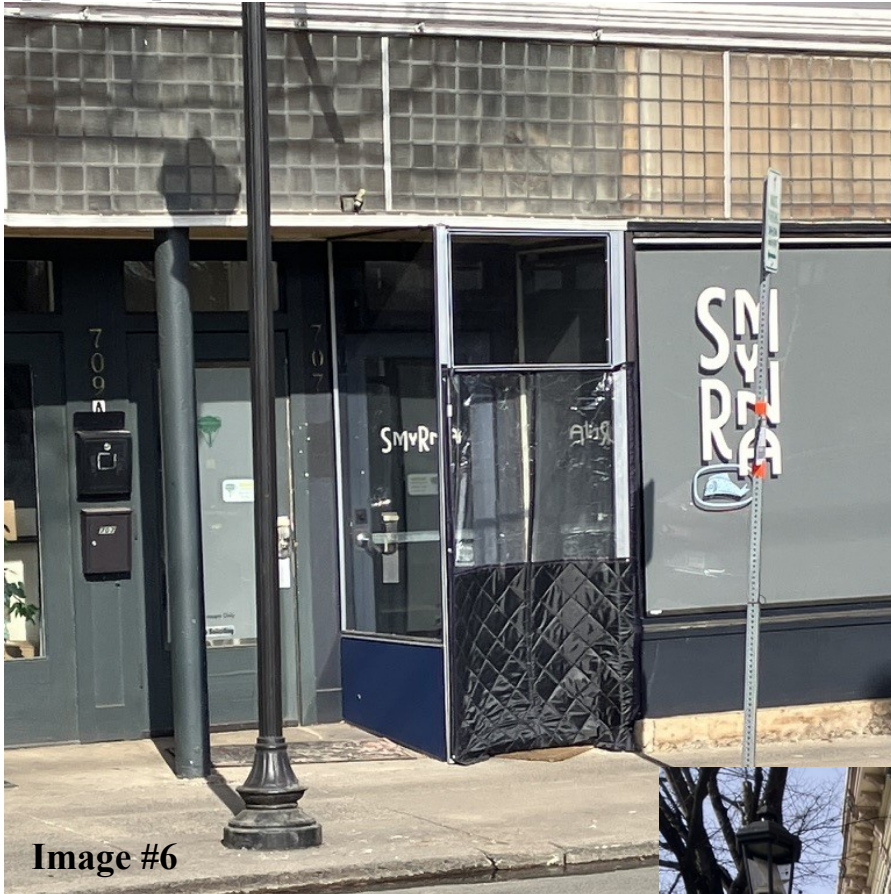
Image #6

In February 2026, the vestibule the door had been removed and replaced with a cloth and clear-vinyl curtain. (See images 6 through 12.) The applicant was notified and issued a zoning violation. [Staff cannot determine if the vestibule remained in place throughout 2025. There is evidence to suggest it was; however, that is moot at this point.]

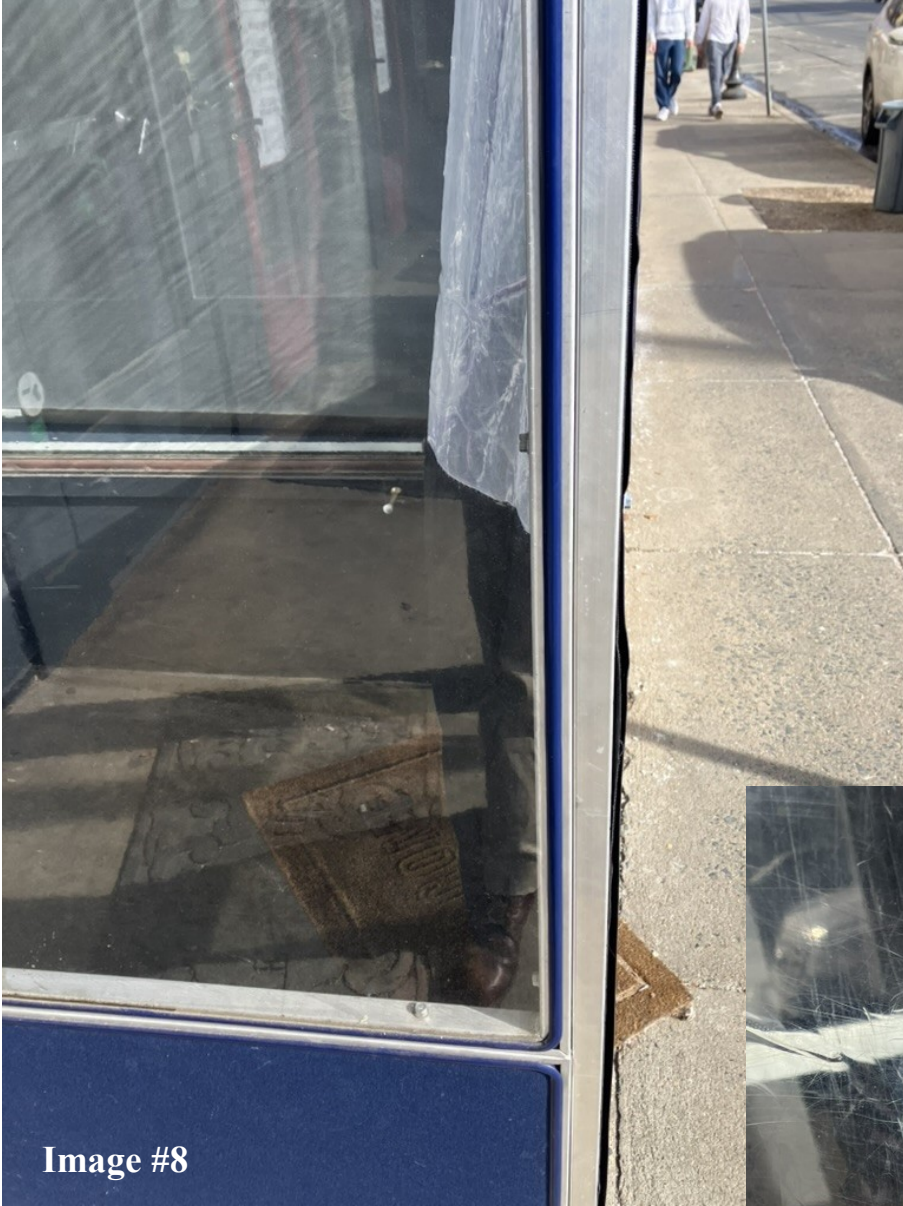
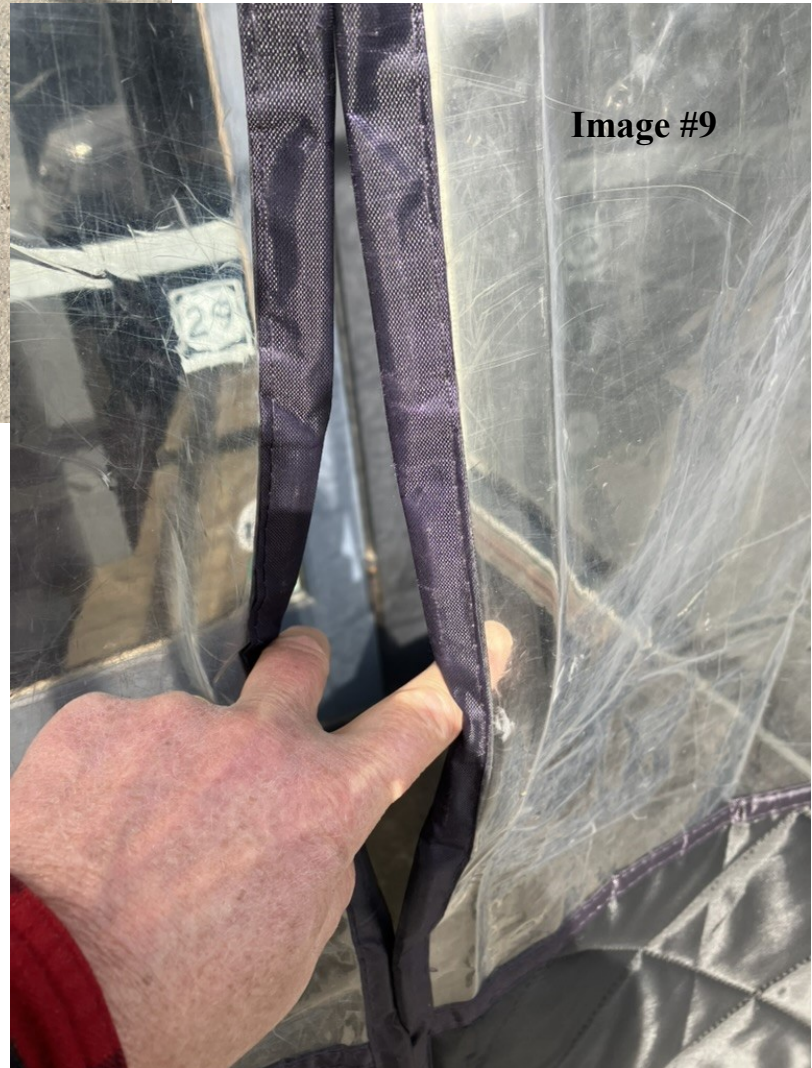
March 3, 2026 - Vestibule with weather flaps and air curtain heater unit; photo by NDS

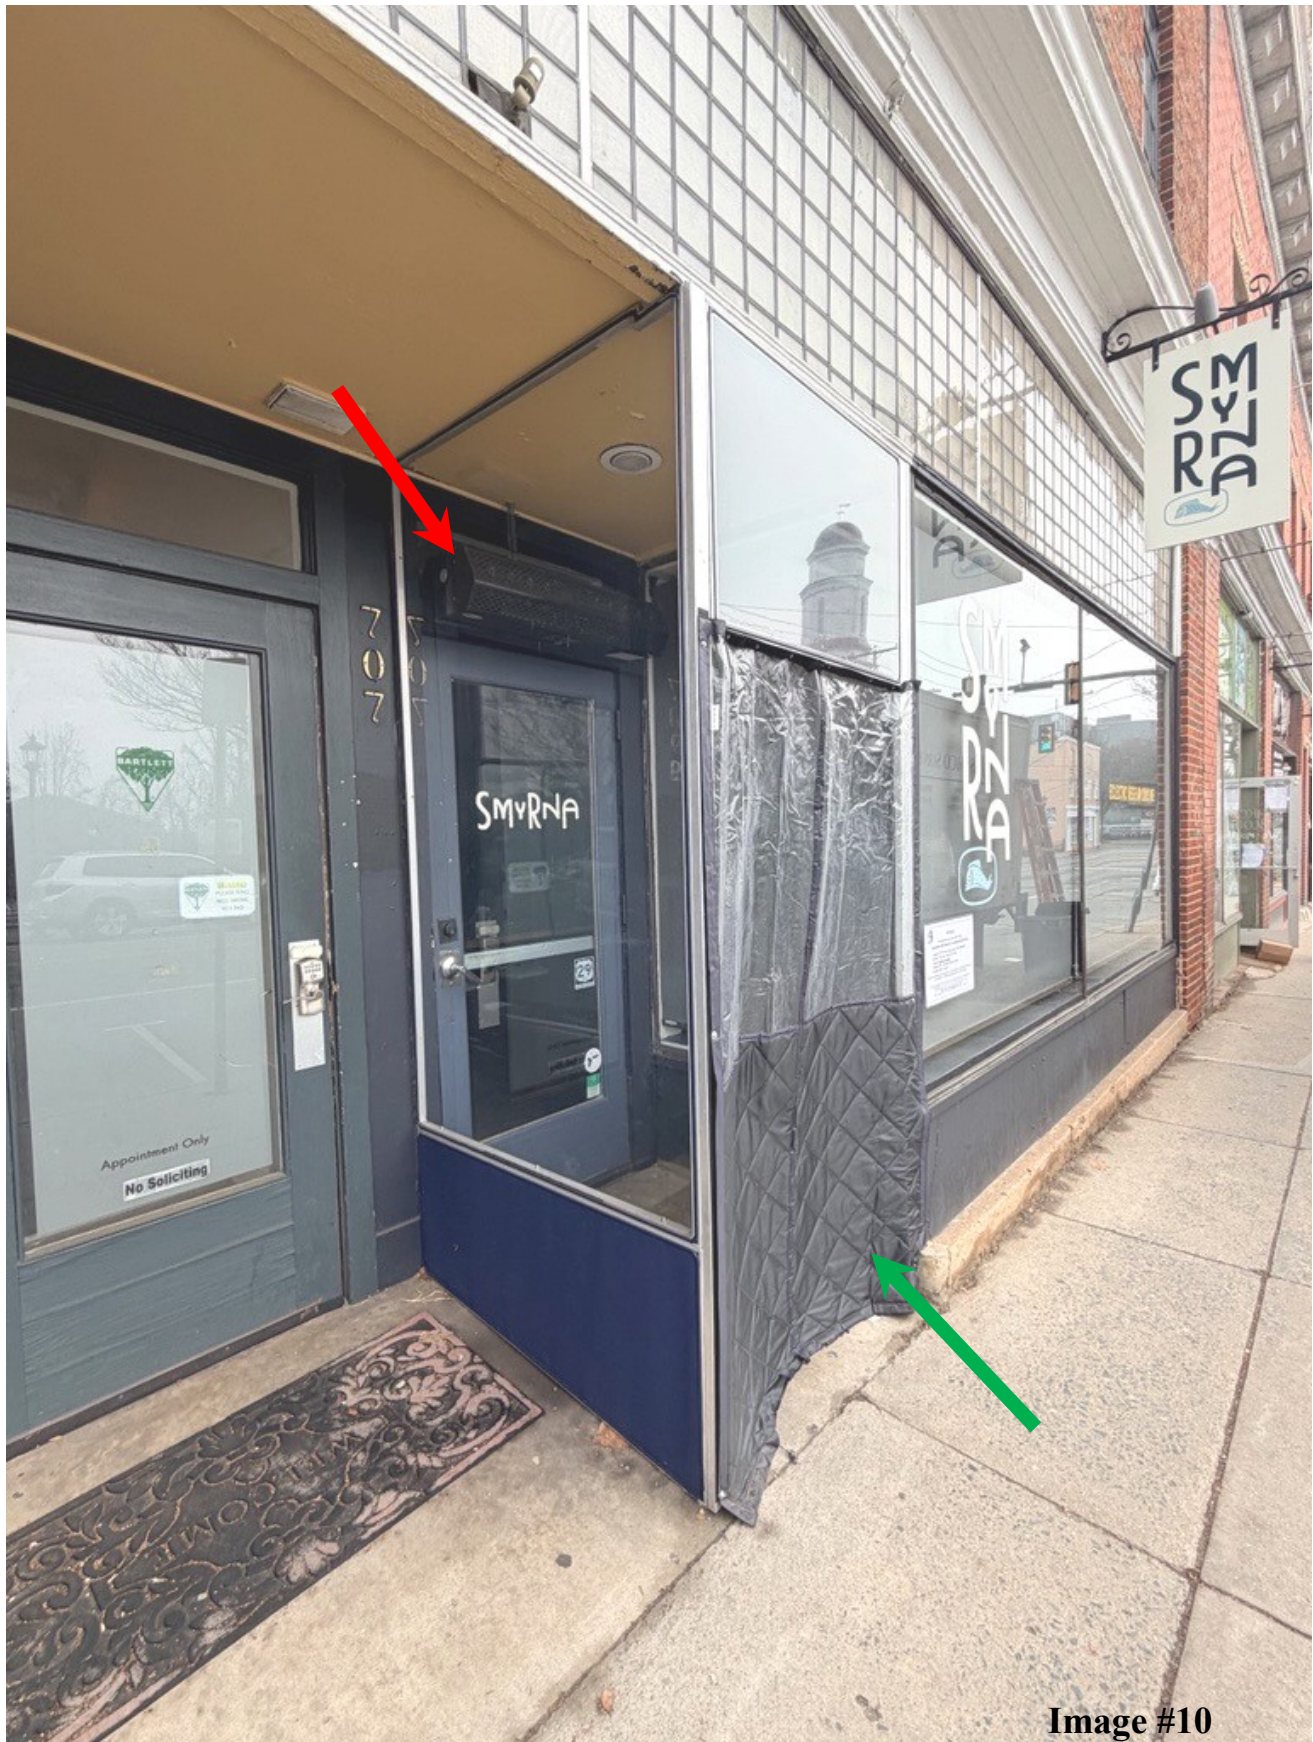
Image #10

March 3, 2026—Photos by NDS
