**From:** Scala, Mary Joy  
**Sent:** Thursday, February 19, 2015 3:03 PM  
**To:** Scott Colley (scottcolley@hughes.net)  
**Subject:** BAR Action Feb 17, 2015 – 611 Preston Place

**Certificate of Appropriateness Application**

BAR 15-02-02  
611 Preston Place  
Tax Parcel 050112000  
Scott and Christine Colley, Owner  
Exterior changes

## **Application for Charlottesville Board of Architectural Review Certification, Part I:**

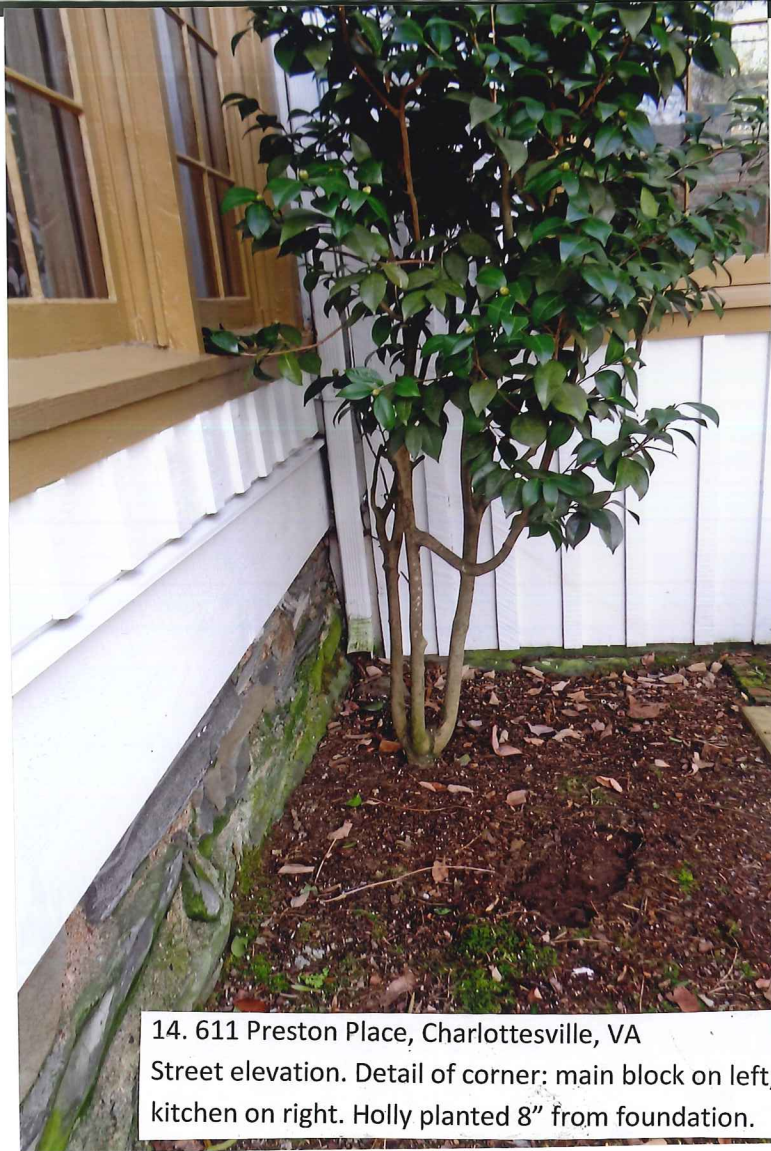
**15. Shrubs placed too close to foundation.** All around the house, shrubs are placed within a foot of the foundation. Most are small, and do not threaten the foundation now, but some of the hollies are six feet tall, and all of these shrubs will continue to grow. (Photos 14, 15, 16, 17, 21)

14. 611 Preston Place, Charlottesville, VA  
Street elevation. Detail of corner: main block on left, kitchen on right. Holly planted 8" from foundation.

Proposed Changes: Remove shrubs within 2' of the foundation and replant/replace at 3' out. Widen foundation planting beds, and fill in with shade perennials such as hostas, solomon's seal, hellebores, and bleeding hearts.

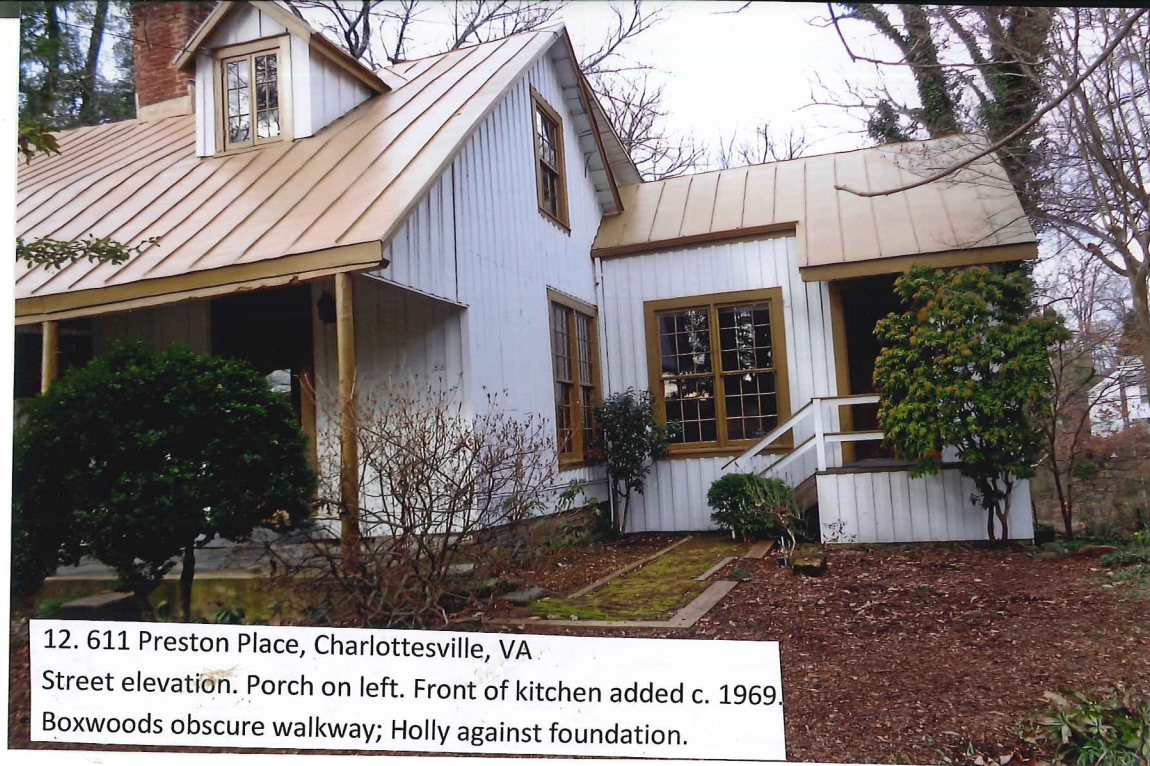
12. 611 Preston Place, Charlottesville, VA  
Street elevation. Porch on left. Front of kitchen added c. 1969.  
Boxwoods obscure walkway; Holly against foundation.

**14. Walkway from kitchen door.** (photos 12, 15) The door in the SE wall of the kitchen opens to a tiny landing, steps along the kitchen foundation leading down to the ground, and a 90 degree turn away from the house onto a brick walkway bordered with treated lumber. A boxwood planted at the bottom of the steps encroaches half the width of the brick walk.

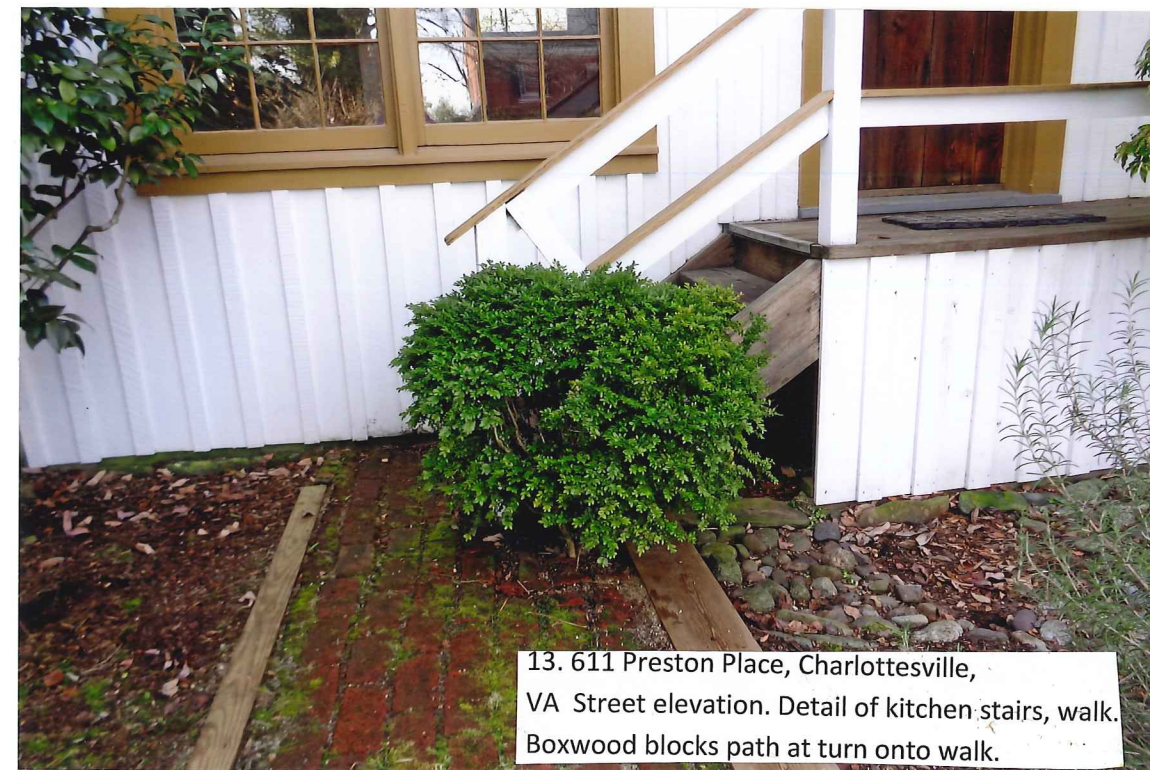
13. 611 Preston Place, Charlottesville, VA  
Street elevation. Detail of kitchen stairs, walk.  
Boxwood blocks path at turn onto walk.

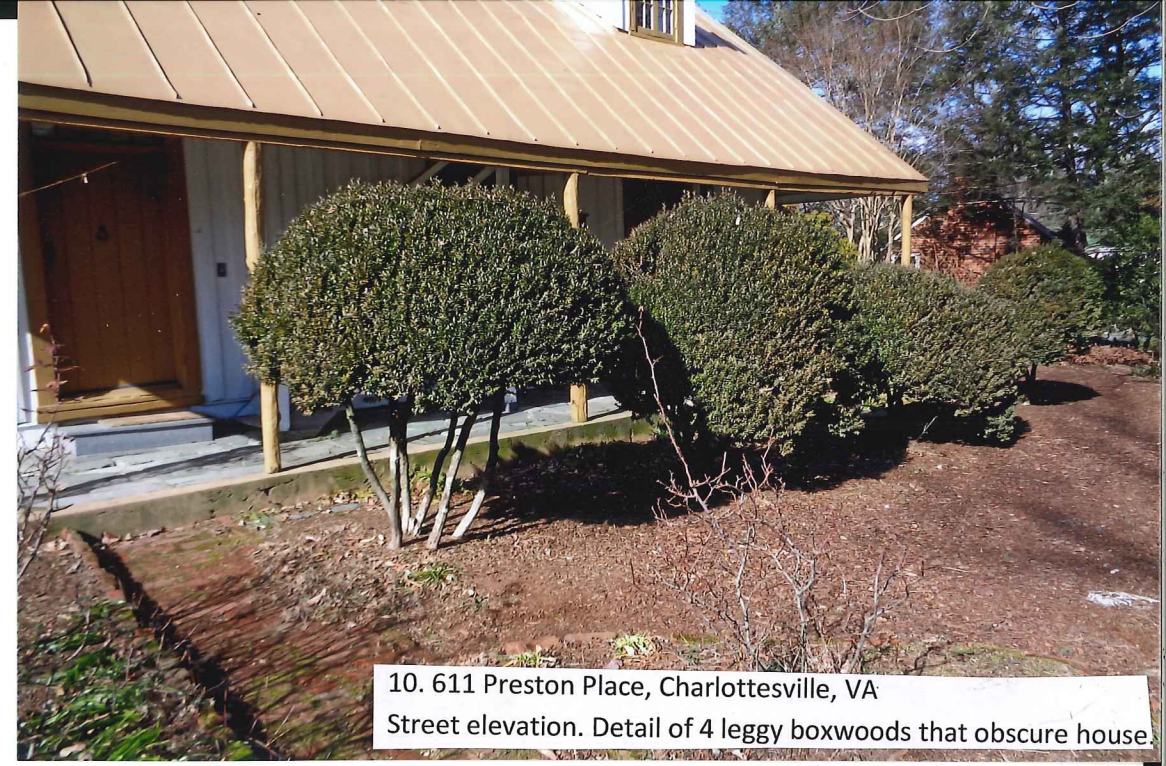
10. 611 Preston Place, Charlottesville, VA  
Street elevation. Detail of 4 leggy boxwoods that obscure house.

Proposed changes. Remove old boxwoods, amend soil, and replace with smaller dwarf form boxwoods and perennials. Some of the old boxwoods might be re-used to soften privacy fences at the rear of the property.

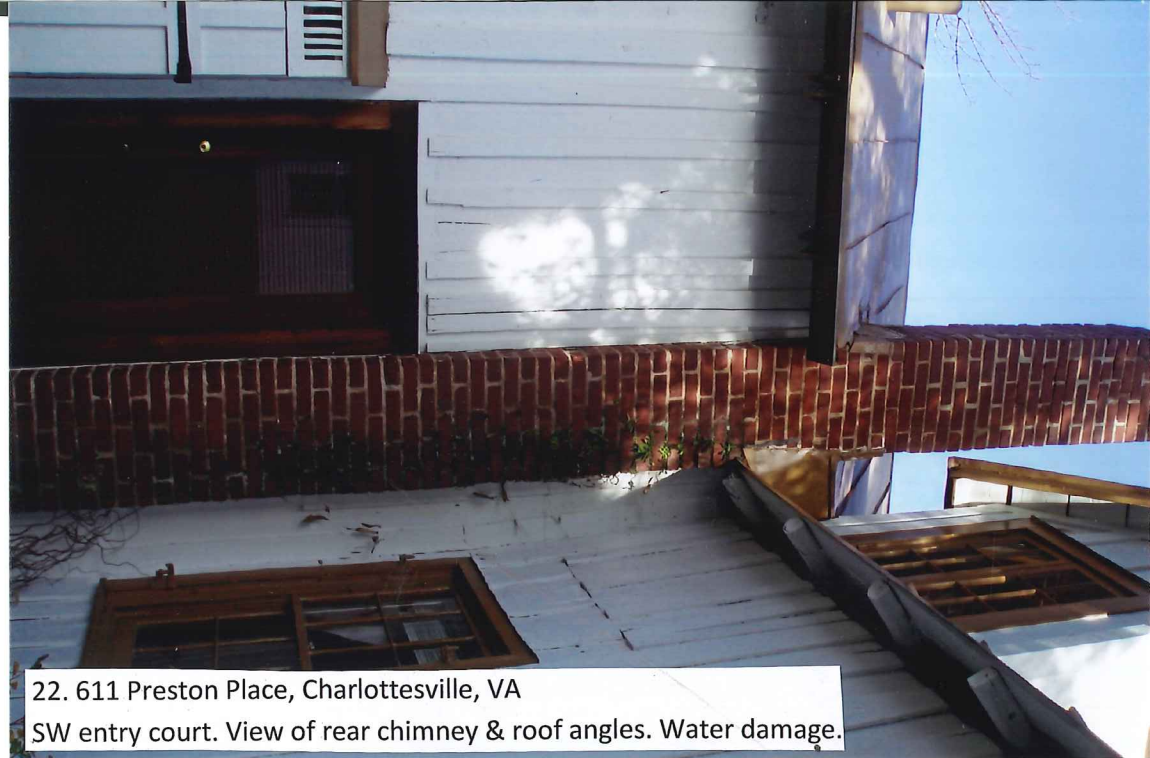
22. 611 Preston Place, Charlottesville, VA  
SW entry court. View of rear chimney & roof angles. Water damage.

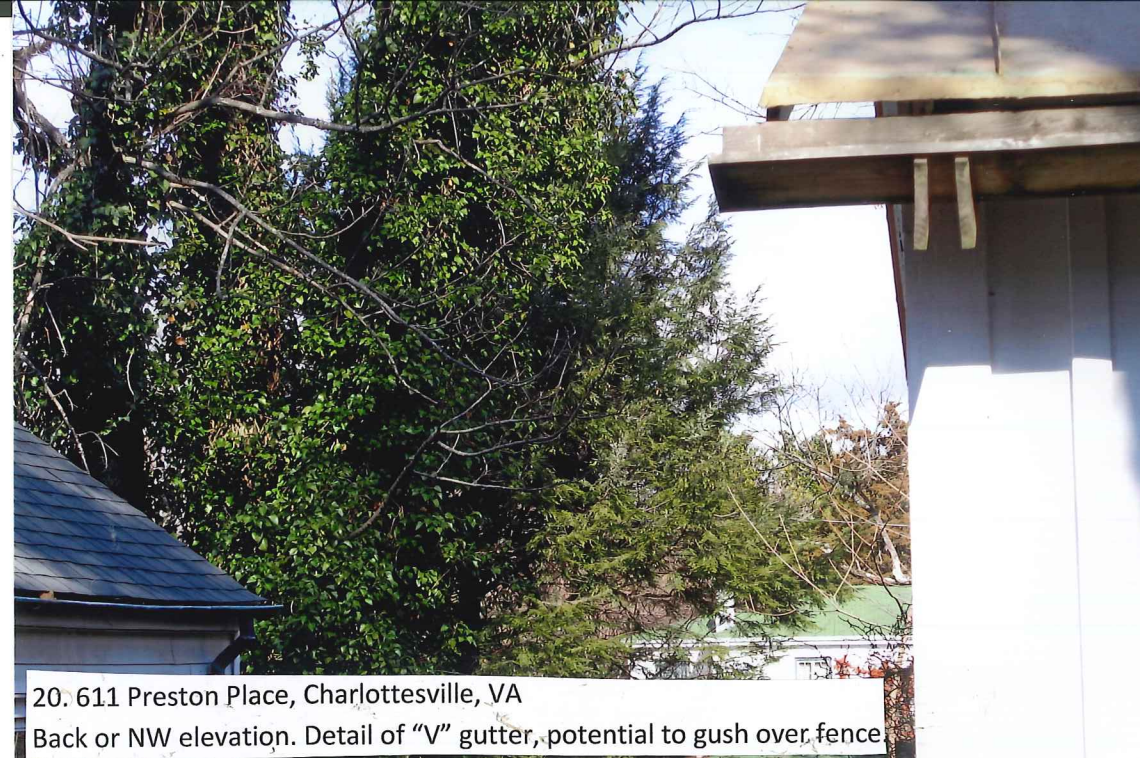
20. 611 Preston Place, Charlottesville, VA  
Back or NW elevation. Detail of "V" gutter, potential to gush over fence

2. Re-grade driveway to direct drainage away from the foundation. Replave "V" wooden gutters over the side entrance with ½ round white metal gutters;
3. Repair water-damaged batten area and add rodent screening;

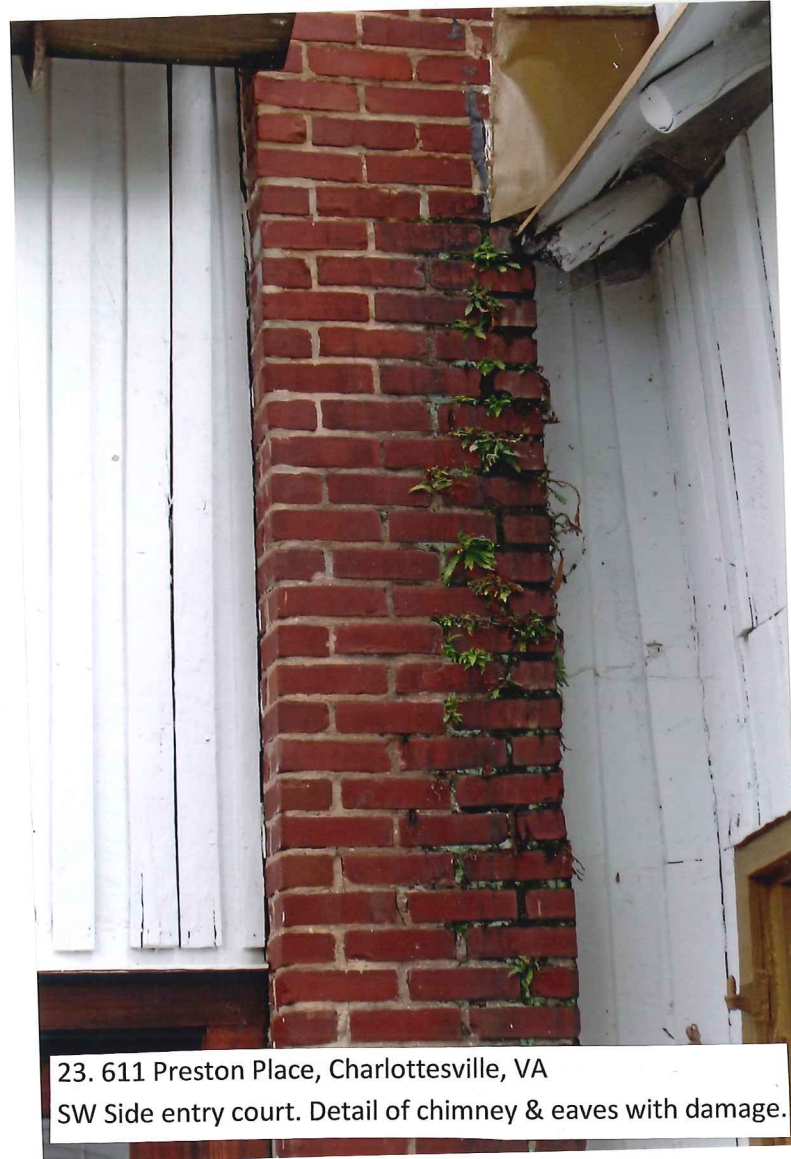
23. 611 Preston Place, Charlottesville, VA  
SW Side entry court. Detail of chimney & eaves with damage.

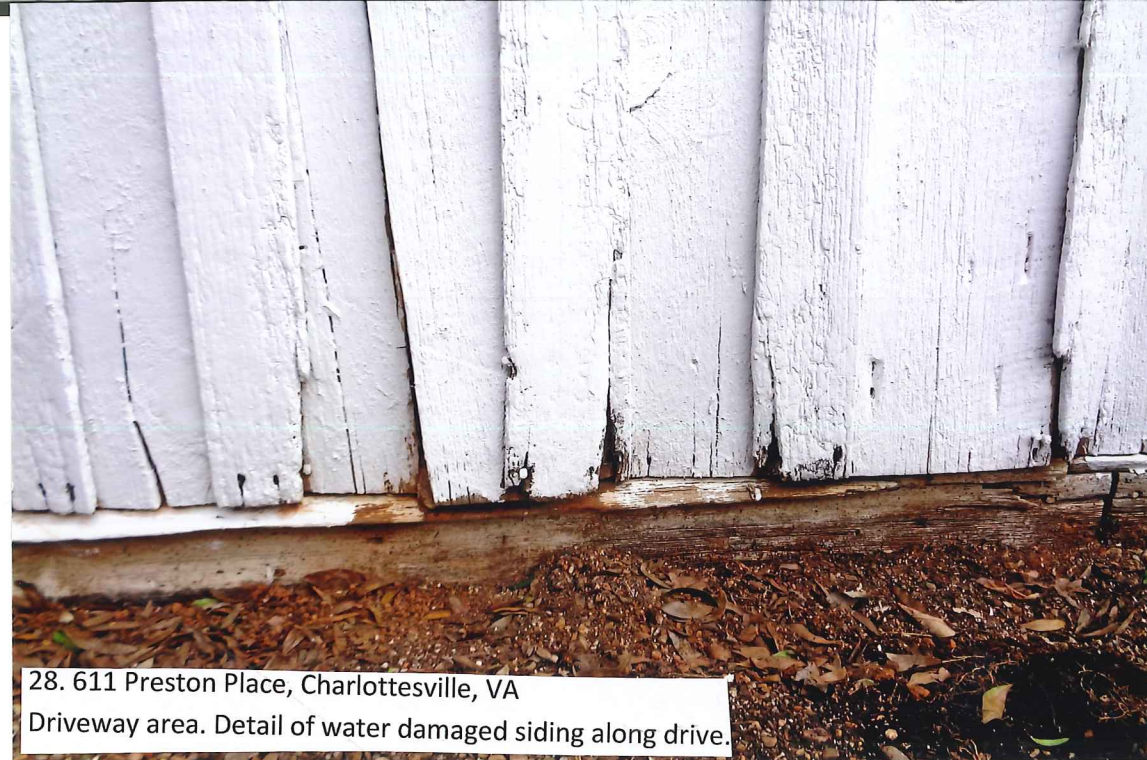
**3. Siding.** The board and batten siding is badly deteriorated at the base (photos 26, 28, 29), especially along the driveway on the uphill side of the core of the house. Battens have pushed away from the house an inch in places, leaving gaps that admit water flowing down the siding, and at the bottom, holes for entry of insects and possibly other small creatures.

28. 611 Preston Place, Charlottesville, VA  
Driveway area. Detail of water damaged siding along drive.

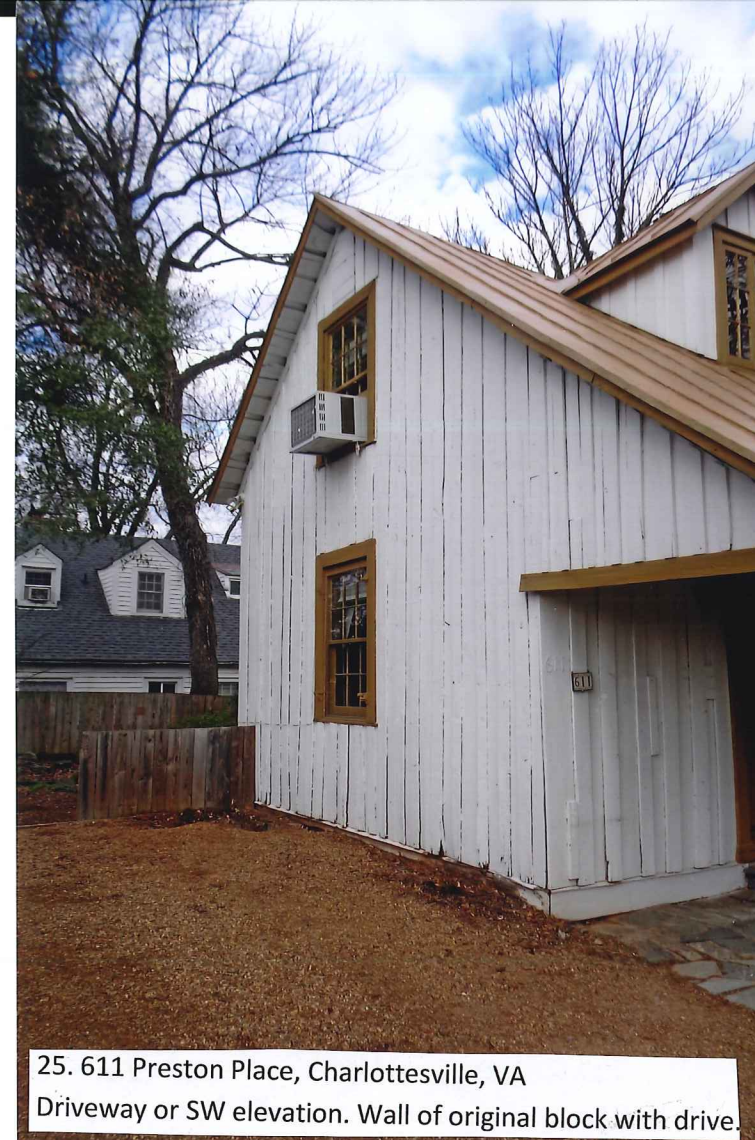
**2. Drainage.** On the uphill (Southwest) side of the house, the siding comes nearly to grade (photos 25, 26, 27, 28). The grade drops substantially, and on the downhill side, about 3' of foundation is visible. Repeated additions of mulch and gravel have raised the grade along the present driveway, and water flows toward the house. There are few gutters, and only two downspouts, so rain water soaks the ground at the foundation. As a result, the lower parts of the siding boards are exposed to considerable water, and parts are rotted away.

25. 611 Preston Place, Charlottesville, VA  
Driveway or SW elevation. Wall of original block with drive.

Proposed changes: Re-grade the driveway after geothermal drilling, lowering the grade by about eight inches so that water can flow downhill from the siding away from the foundation. Reshape existing flower border along the SW wall of the rear addition to the house to slope away from the house. Install a French drain just outside the bed to convey water around the back of the house where it can flow downhill and naturally disperse in the vinca bed on the downhill side of the house. Replace "V" wooden gutters over the side entrance (photo 19, 20) with half round white metal guttering connected to a downspout on the back corner of the house, and connect to the underground drains. The goal is to protect the brickwork where water now drains freely (photos 21, 22, 23, 24), prevent dripping on the entry route, and to carry water away from the house. The only elements that will show are the gutters and downspout, both in the entry courtyard and behind the older front block of the house.

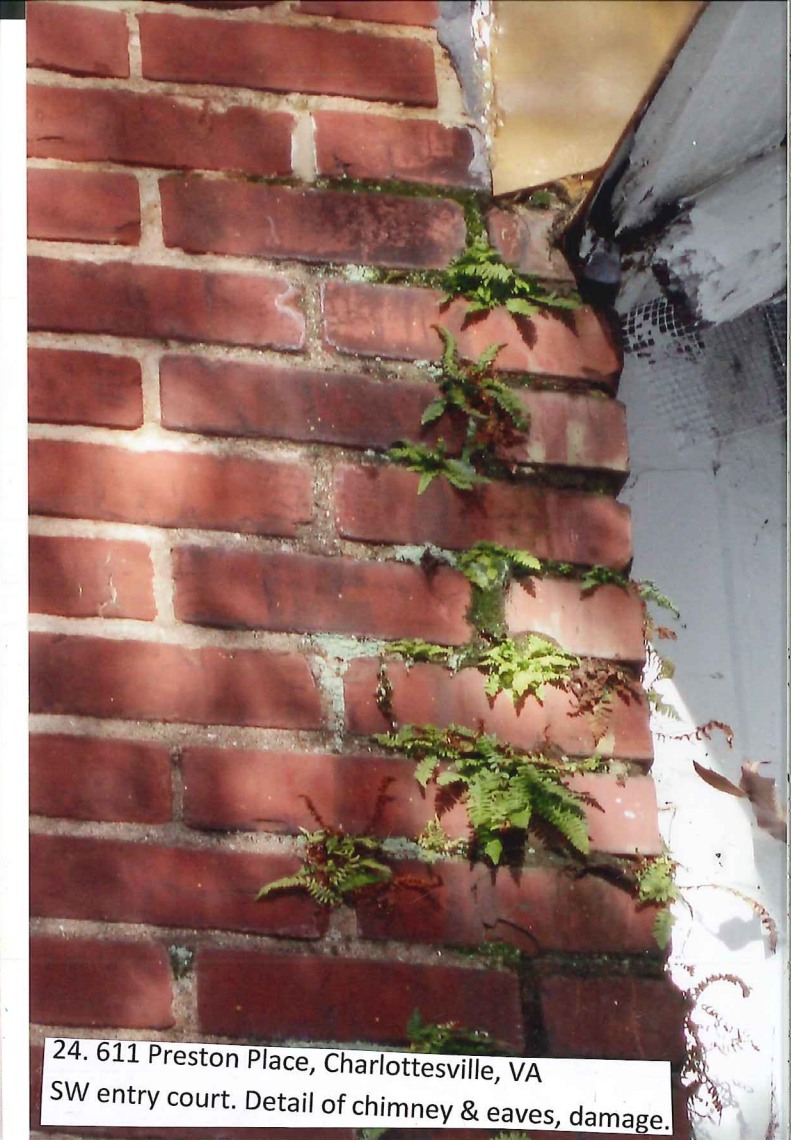
24. 611 Preston Place, Charlottesville, VA  
SW entry court. Detail of chimney & eaves, damage.

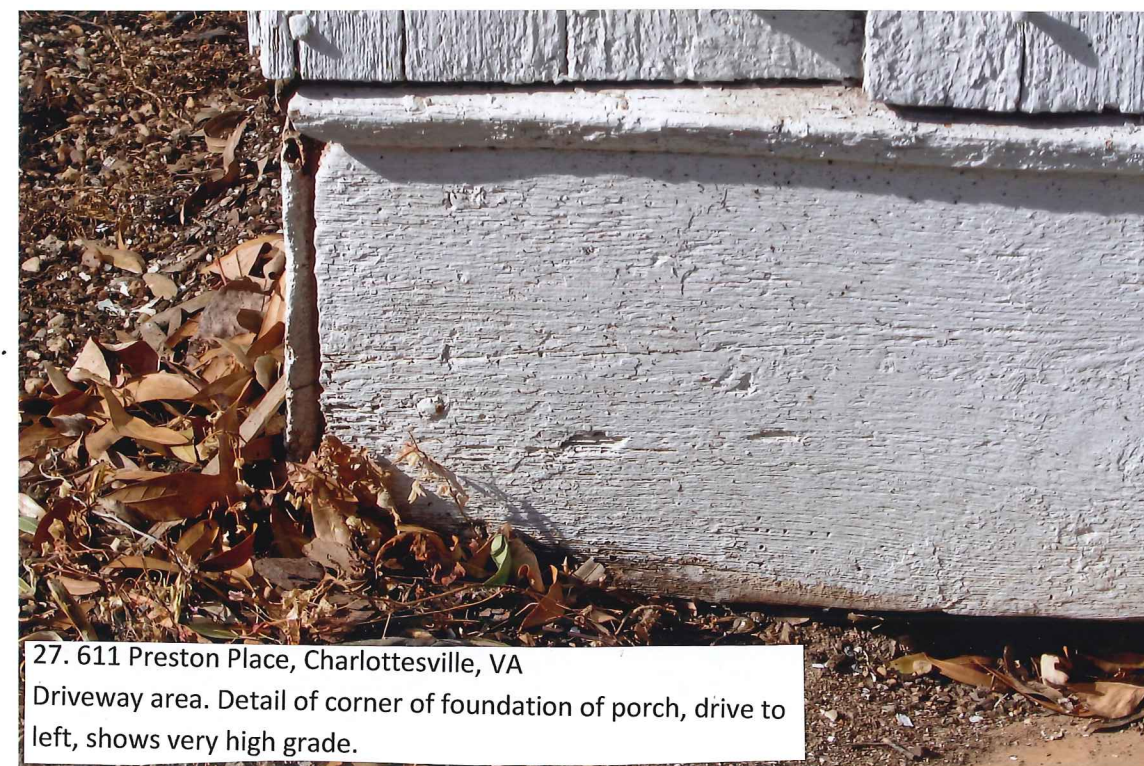
27. 611 Preston Place, Charlottesville, VA  
Driveway area. Detail of corner of foundation of porch, drive to left, shows very high grade.

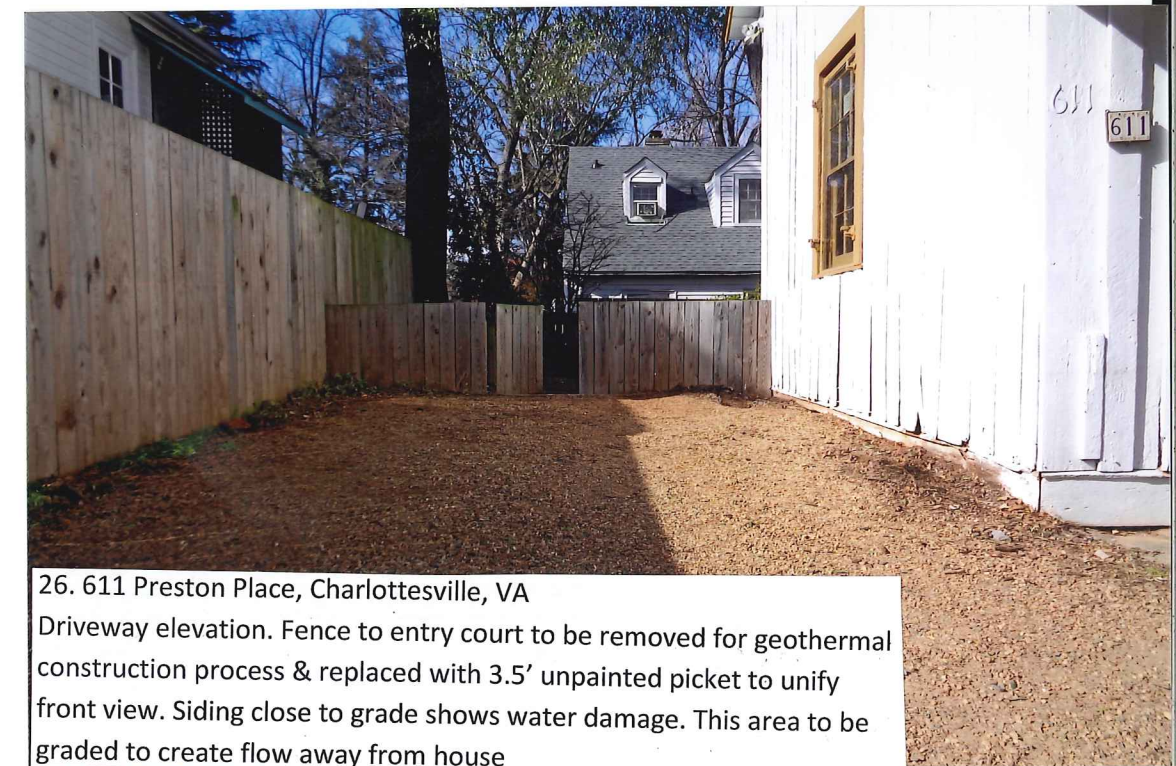
26. 611 Preston Place, Charlottesville, VA  
Driveway elevation. Fence to entry court to be removed for geothermal construction process & replaced with 3.5' unpainted picket to unify front view. Siding close to grade shows water damage. This area to be graded to create flow away from house

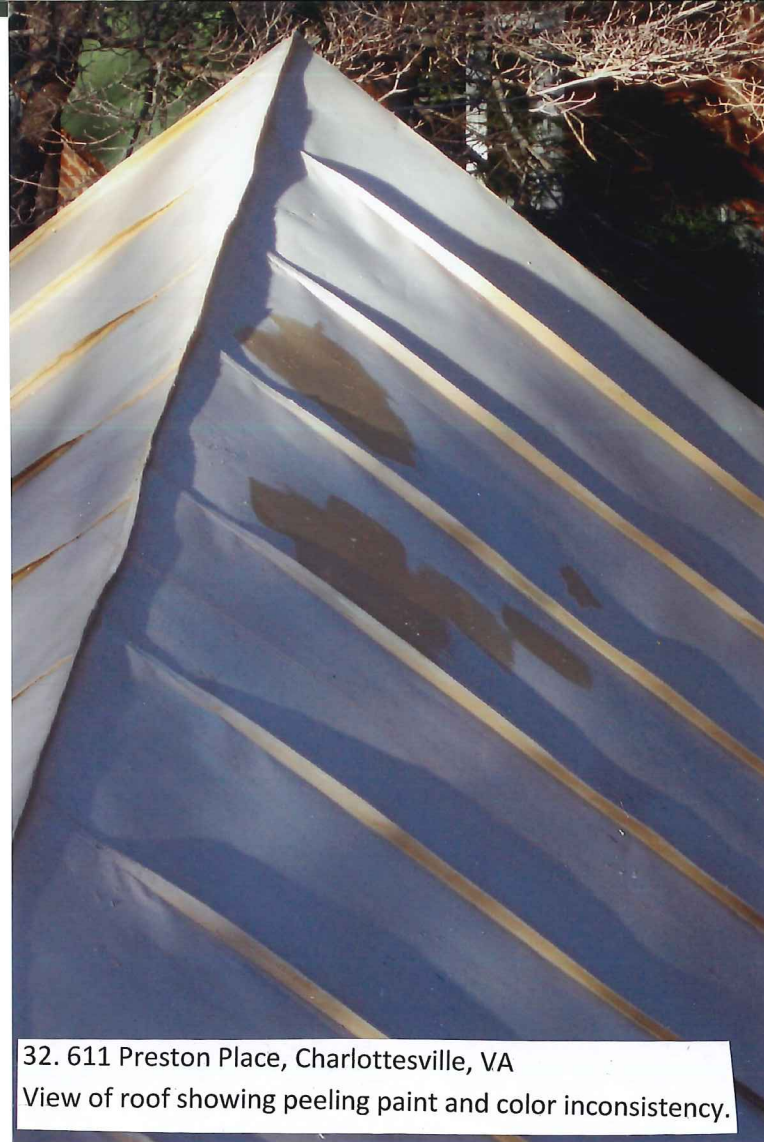
**9. Roof and Flashing.** The existing standing seam roof has deteriorated. Parts are cracked, bent, and thinning. Paint is peeling, and colors from serial painting projects do not match.

**10. Chimney and flues.** The central chimney has suffered considerable mortar loss (photo 32), and the mortar cap (photo 36, 35) is broken and decayed. There are four flues, three of which have been fitted with protective sleeves and dampers. The chimney is open to the elements, allowing entry of birds and animals and exposing the interior masonry to rain and snow.

32. 611 Preston Place, Charlottesville, VA  
View of roof showing peeling paint and color inconsistency.

Proposed changes: Remove the existing roof and flashing. Replace with a pre-painted black steel standing seam roof, retaining the materials and configuration of the present roof. Roof to be installed by Blue Ridge Roofing, which has experience with historic buildings. Material used is Englent and Sheffield coil stock, pre-finished with low glass 35-year guaranteed gavalumium. Intervals between seams custom set to match existing roof. 1" double lock standing seams are hand crimped. (Blue Ridge Roofing can address technical questions: 434-979-0501.) Color will be low gloss black. The goal is to replace a roof in need of painting and repair with a new one with improved paint durability. Replace flashing with new material in same pattern as the existing roof. No changes to configuration of the roof.

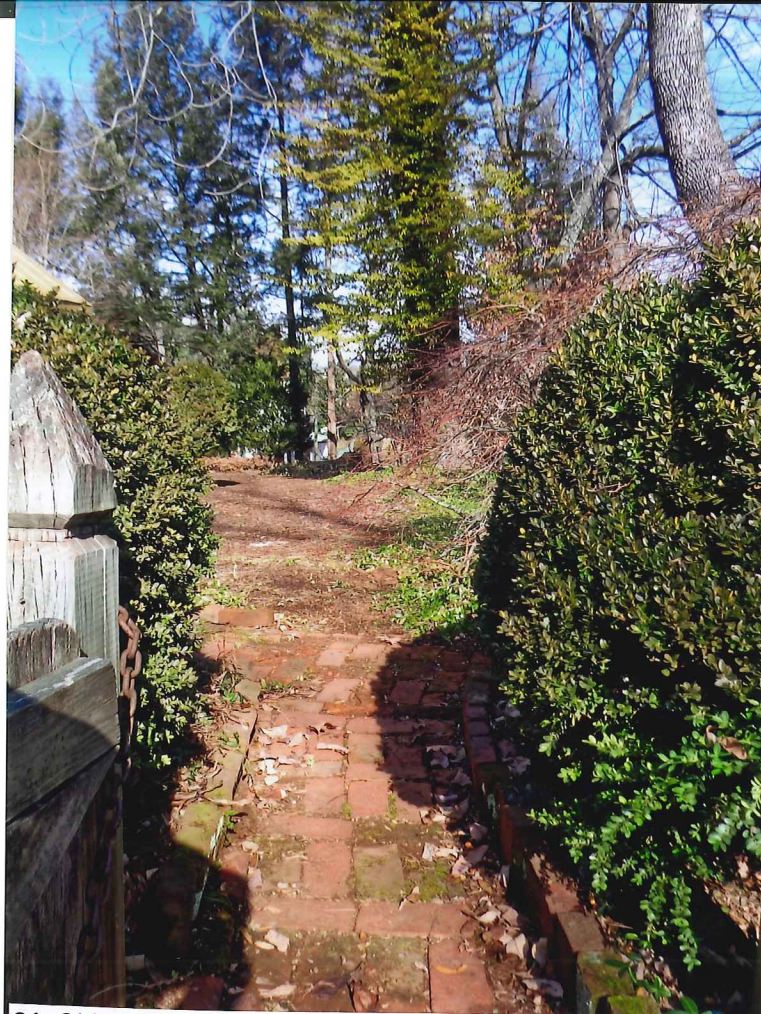
31. 611 Preston Place, Charlottesville, VA  
Driveway. Detail of gate & walkway leading into front yard.  
Walk is too narrow for safety, & soldier courses are a trip hazard

Proposed changes: replace the deteriorated rail fence with the same 3.5' unpainted picket fencing proposed for the street frontage and the head of driveway. Install a matching gate 34" wide. Prune the boxwoods to reduce incursion into walk. Remove the brick walkway, refurbish sand base, and rebuild with the soldier bricks horizontal and flush with the walkway. The resulting walk would be a comfortable 37" wide, with no high border to trip over.

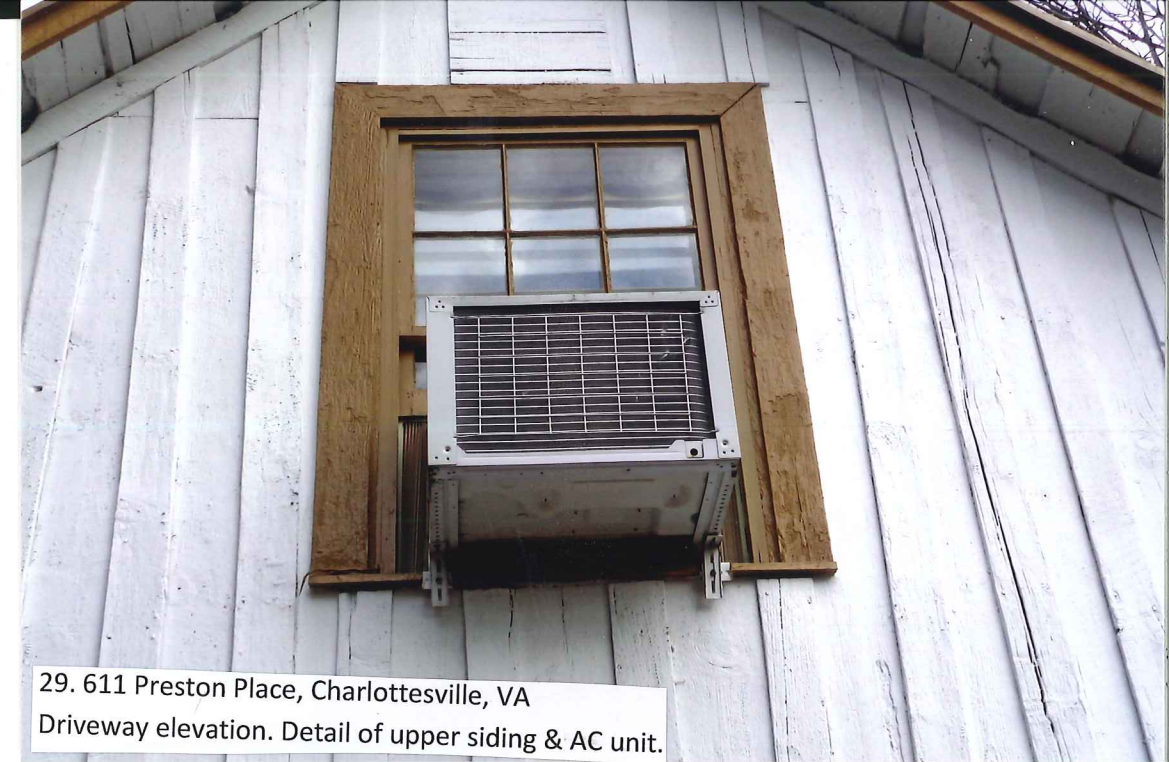
29. 611 Preston Place, Charlottesville, VA  
Driveway elevation. Detail of upper siding & AC unit.

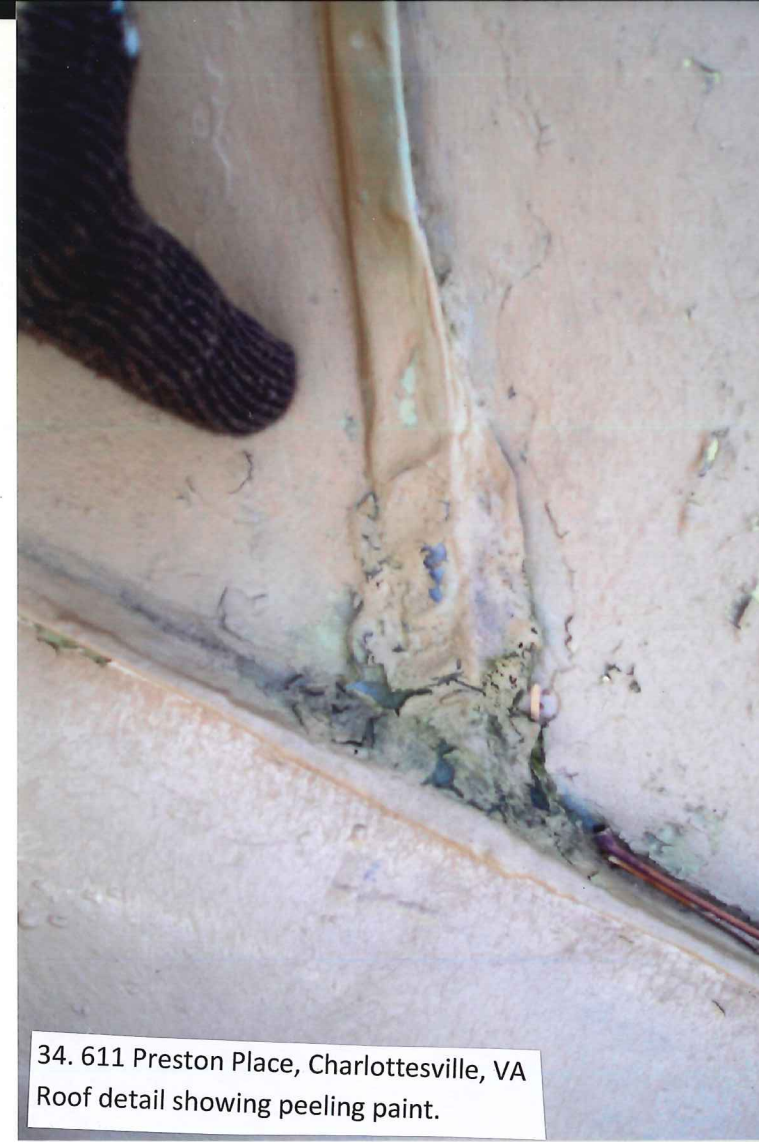
34. 611 Preston Place, Charlottesville, VA  
Roof detail showing peeling paint.

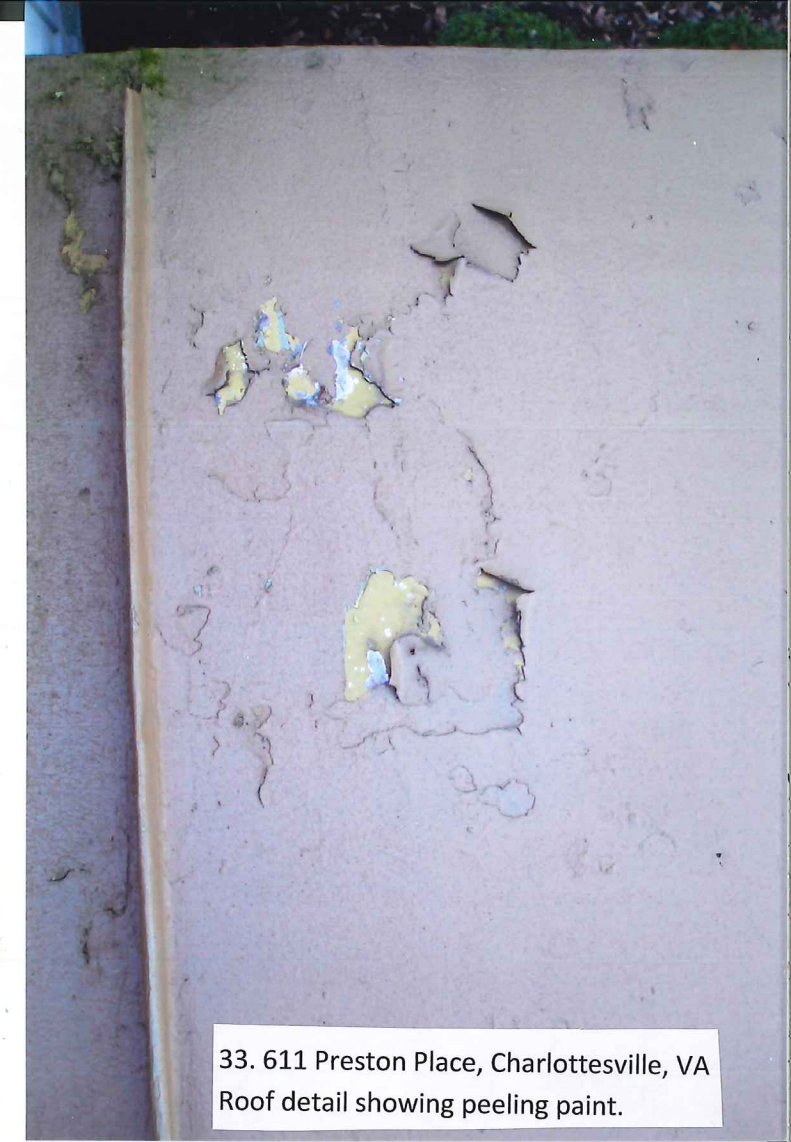
33. 611 Preston Place, Charlottesville, VA  
Roof detail showing peeling paint.

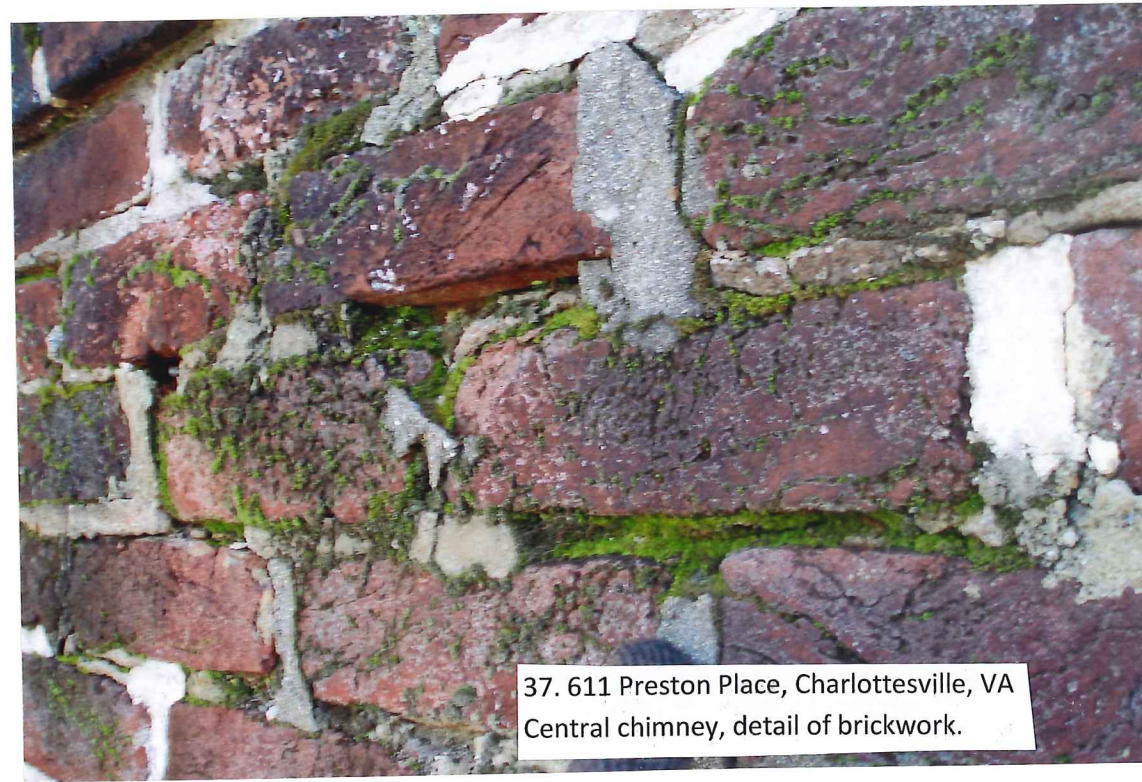
37. 611 Preston Place, Charlottesville, VA  
Central chimney, detail of brickwork.

Proposed changes: Point the brickwork following the existing pattern, and repair the masonry to match the existing work. Add a metal screen to prevent entry of birds and animals. Add a damper to the fourth flue, and add a black metal roof or cap to limit water damage to the chimney interior. Cap to be crafted to custom dimensions from galvanized stock and painted black to match the roof. Only the protective metal cap will be visible and different from the existing appearance.

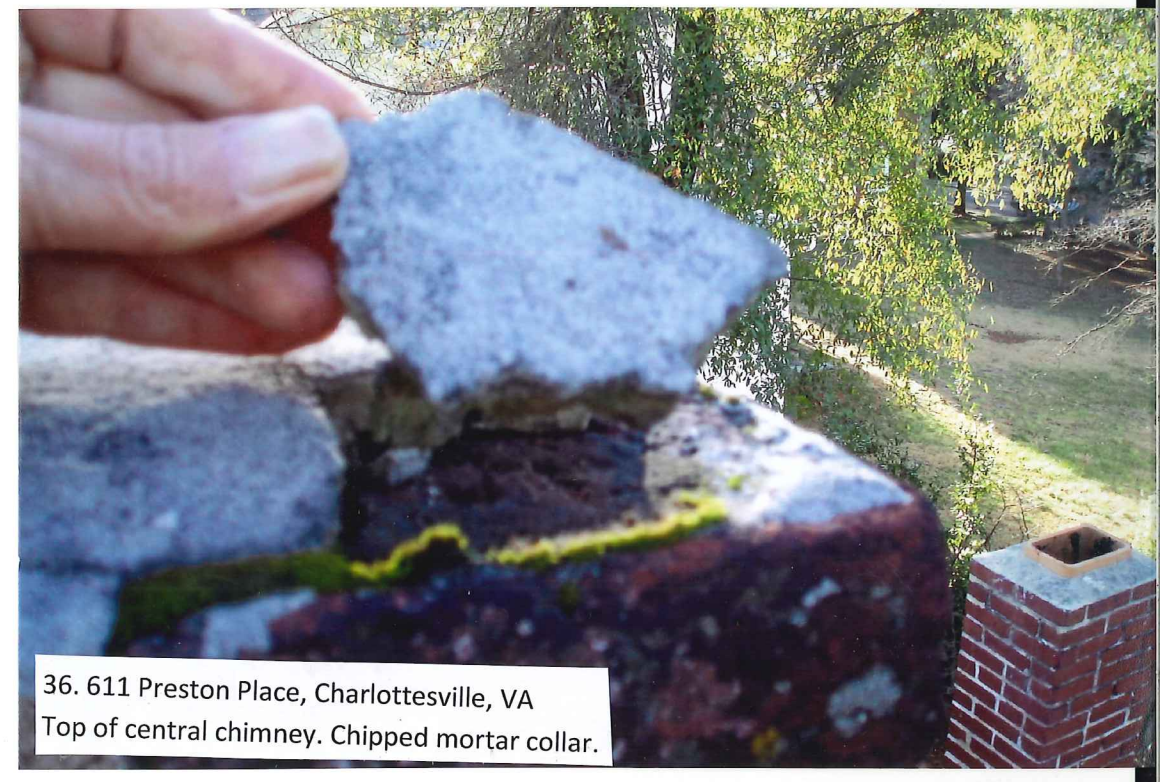
36. 611 Preston Place, Charlottesville, VA  
Top of central chimney. Chipped mortar collar.

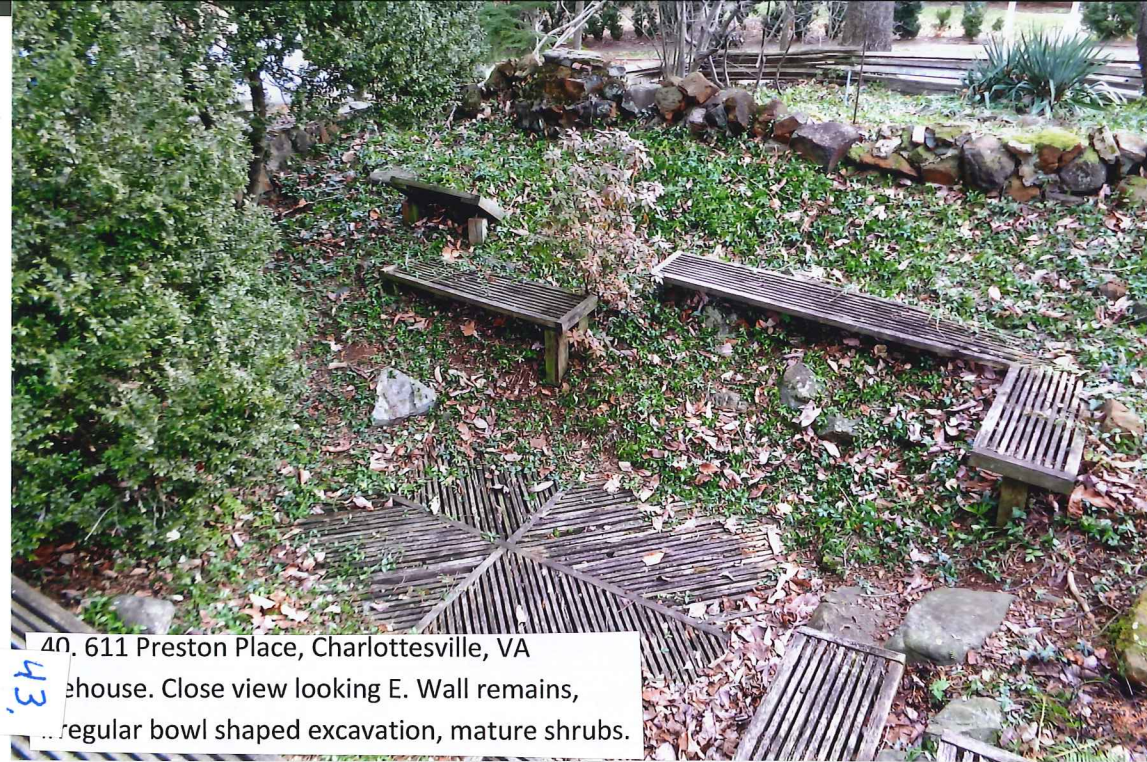
**11. Foundations and partially excavated remains of old ice house.** (photos 38, 39, 40, 41) To the right of the porch, as viewed from the street, are the remains of an old outbuilding. We understand these remains are not listed on the original protection of the house. On the plat we have (see attached copies) there is a "wood patio" in this position. It appears that the most recent owners, in residence from the late 1960's, dug out the entry steps and a bowl-shaped part of the below-grade interior of what appears to be an ice house. Found masonry fragments were piled along probable wall lines, and latticed benches were installed in the excavation, apparently for seating. The result is a four-foot-deep cavity with loose, rough stone steps, partly filled by dirt, and over-grown by vinca ground cover and mature shrubs. The ruin is not visible from the street, since the level of the yard is 2-3' above street level. As is, the cavity presents a significant falling hazard, and probably meets the insurance definition of an "attractive nuisance." The old seats inserted at the base of the cavity are deteriorated, and the steps uneven, loose, and treacherous. The cavity offers a possible habitat to nuisance reptiles and animals. It occupies a significant portion of a very small yard, significantly restricting landscaping and use of the front yard.

40. 611 Preston Place, Charlottesville, VA  
Icehouse. Close view looking E. Wall remains,  
regular bowl shaped excavation, mature shrubs.

10. Repair and re-point the brick chimney; add black metal cap;
11. Fill in excavated old ice house;
12. Remove old boxwoods and replace with smaller dwarf form;

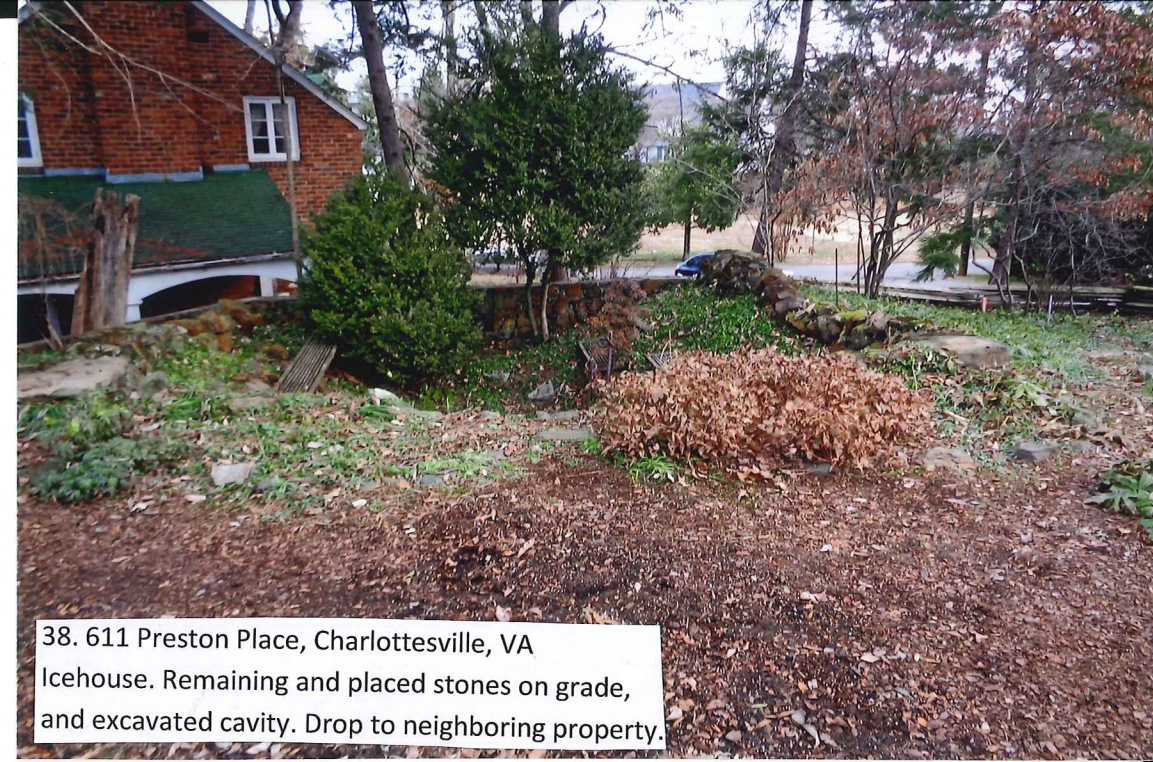
38. 611 Preston Place, Charlottesville, VA  
Icehouse. Remaining and placed stones on grade,  
and excavated cavity. Drop to neighboring property.

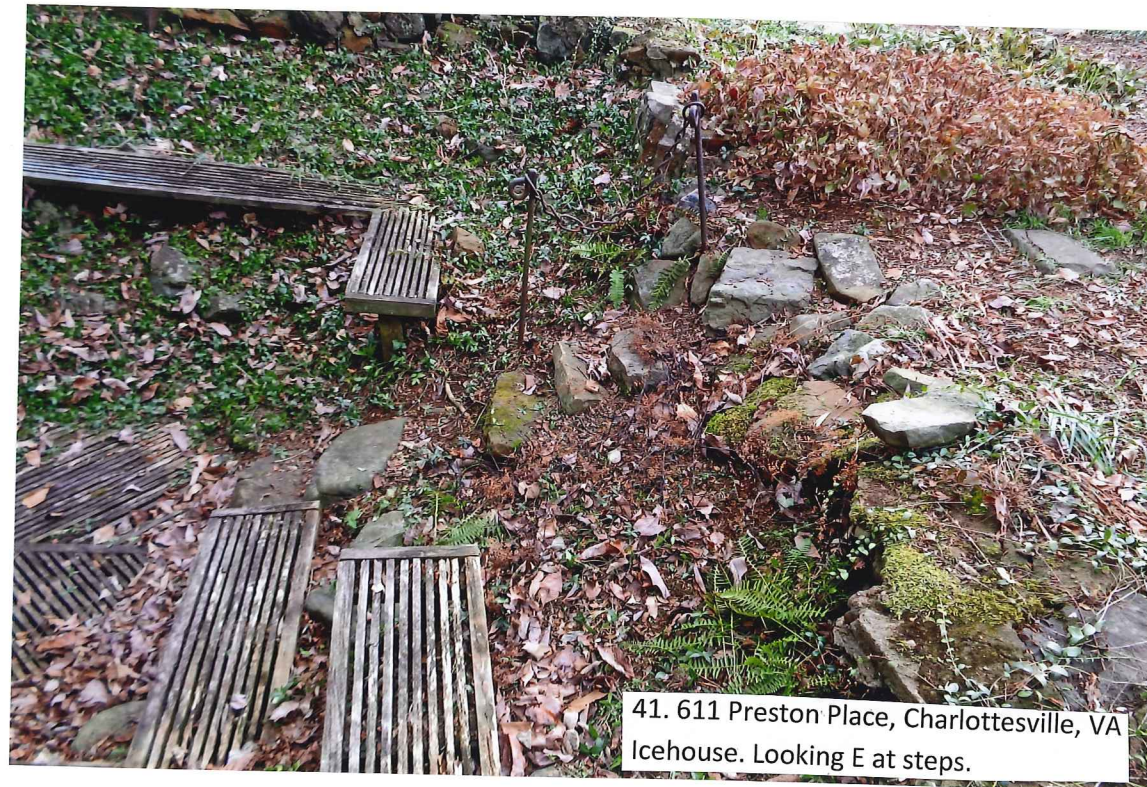
41. 611 Preston Place, Charlottesville, VA  
Icehouse. Looking E at steps.
