**From:** Scala, Mary Joy  
**Sent:** Thursday, February 19, 2015 3:03 PM  
**To:** Scott Colley (scottcolley@hughes.net)  
**Subject:** BAR Action Feb 17, 2015 – 611 Preston Place

**Certificate of Appropriateness Application**

BAR 15-02-02  
611 Preston Place  
Tax Parcel 050112000  
Scott and Christine Colley, Owner  
Exterior changes

## **Application for Charlottesville Board of Architectural Review Certification, Part I:**

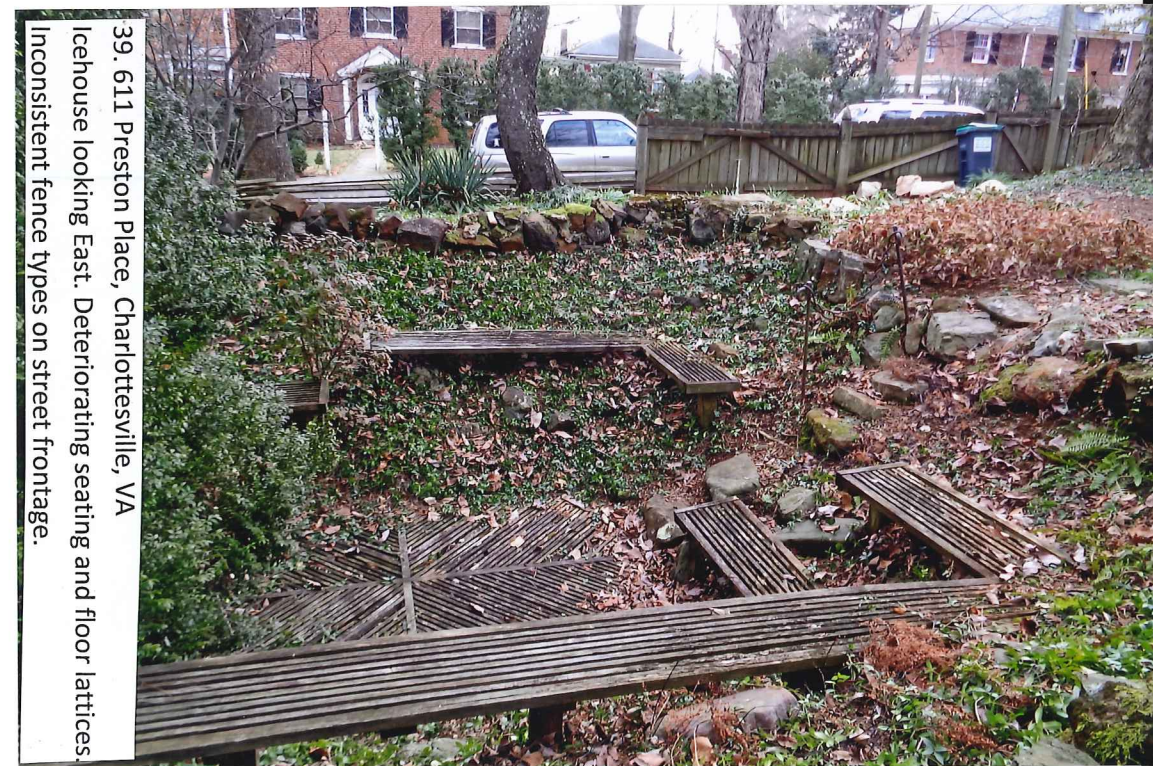
**11. Foundations and partially excavated remains of old ice house.** (photos 38, 39, 40, 41) To the right of the porch, as viewed from the street, are the remains of an old outbuilding. We understand these remains are not listed on the original protection of the house. On the plat we have (see attached copies) there is a "wood patio" in this position. It appears that the most recent owners, in residence from the late 1960's, dug out the entry steps and a bowl-shaped part of the below-grade interior of what appears to be an ice house. Found masonry fragments were piled along probable wall lines, and latticed benches were installed in the excavation, apparently for seating. The result is a four-foot-deep cavity with loose, rough stone steps, partly filled by dirt, and over-grown by vinca ground cover and mature shrubs. The ruin is not visible from the street, since the level of the yard is 2-3' above street level. As is, the cavity presents a significant falling hazard, and probably meets the insurance definition of an "attractive nuisance." The old seats inserted at the base of the cavity are deteriorated, and the steps uneven, loose, and treacherous. The cavity offers a possible habitat to nuisance reptiles and animals. It occupies a significant portion of a very small yard, significantly restricting landscaping and use of the front yard.

39. 611 Preston Place, Charlottesville, VA  
Icehouse looking East. Deteriorating seating and floor lattices.  
Inconsistent fence types on street frontage.

10. Repair and re-point the brick chimney; add black metal cap;
11. Fill in excavated old ice house;
12. Remove old boxwoods and replace with smaller dwarf form;

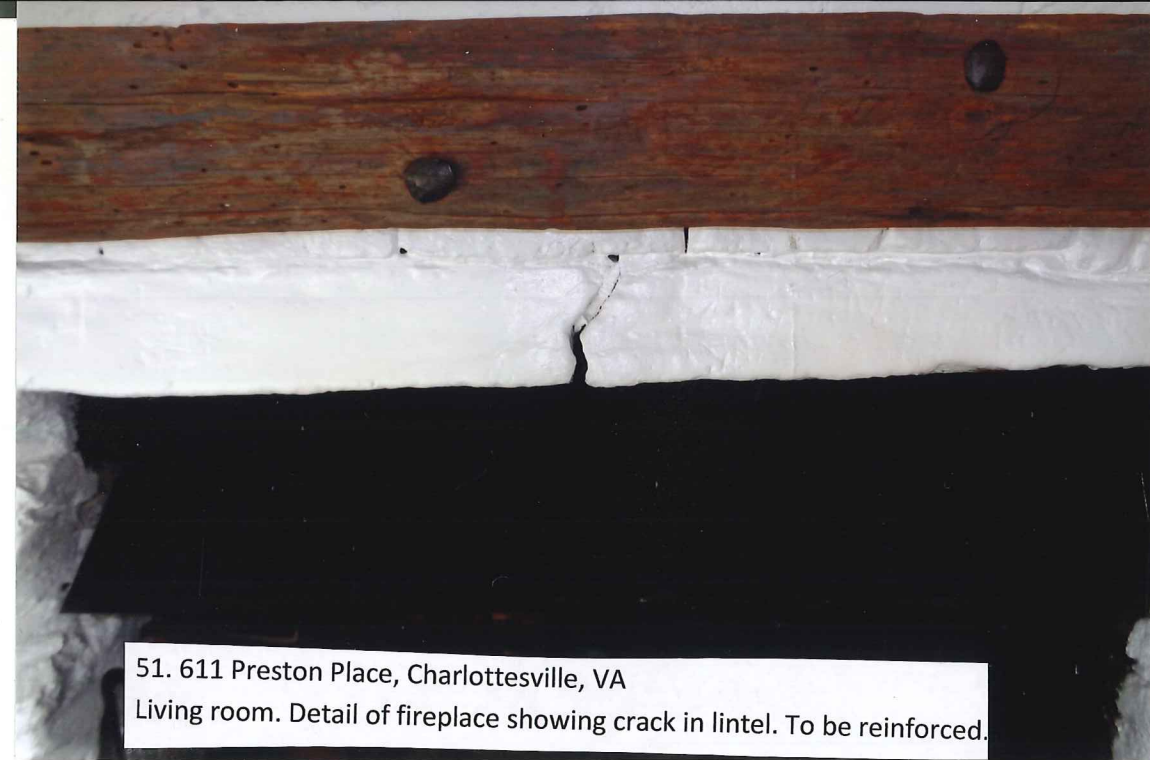
51. 611 Preston Place, Charlottesville, VA  
Living room. Detail of fireplace showing crack in lintel. To be reinforced.

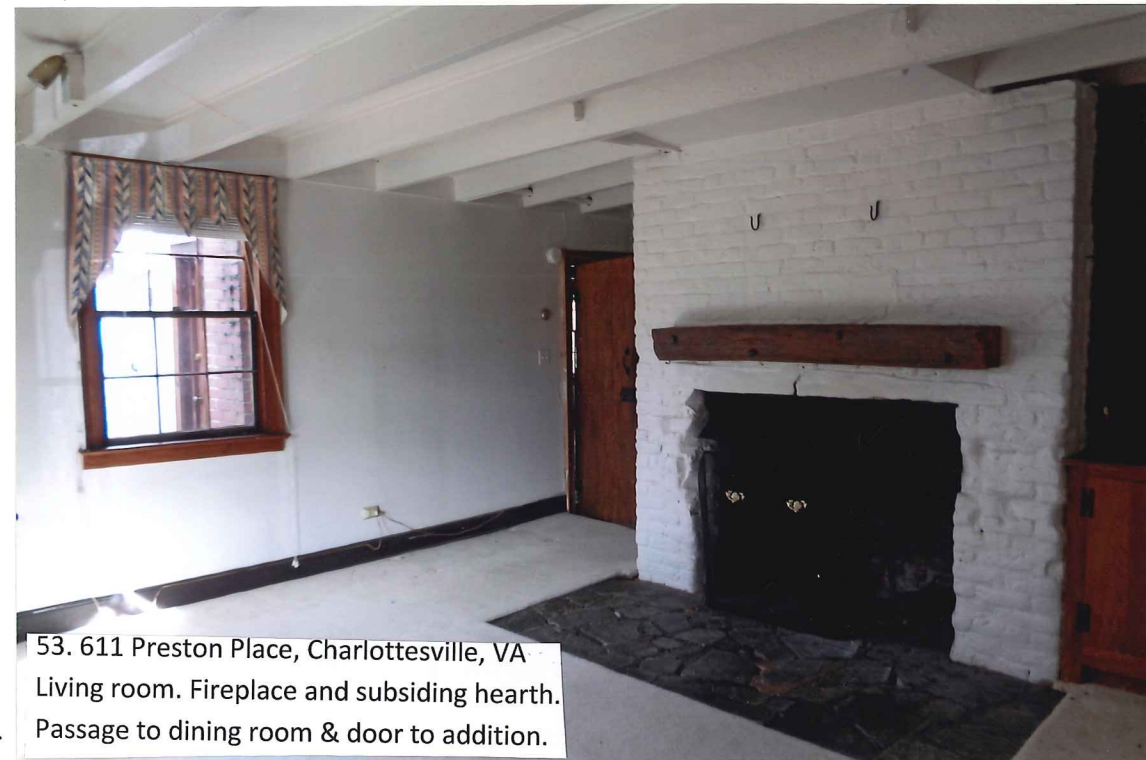
53. 611 Preston Place, Charlottesville, VA  
Living room. Fireplace and subsiding hearth.  
Passage to dining room & door to addition.
