**VIRGINIA**  
**HISTORIC LANDMARKS COMMISSION**  
 SURVEY FORM

## HISTORIC DISTRICT SURVEY FORM

Street address 164 Rugby Road  
Town/City Charlottesville

Historic name Peyton House

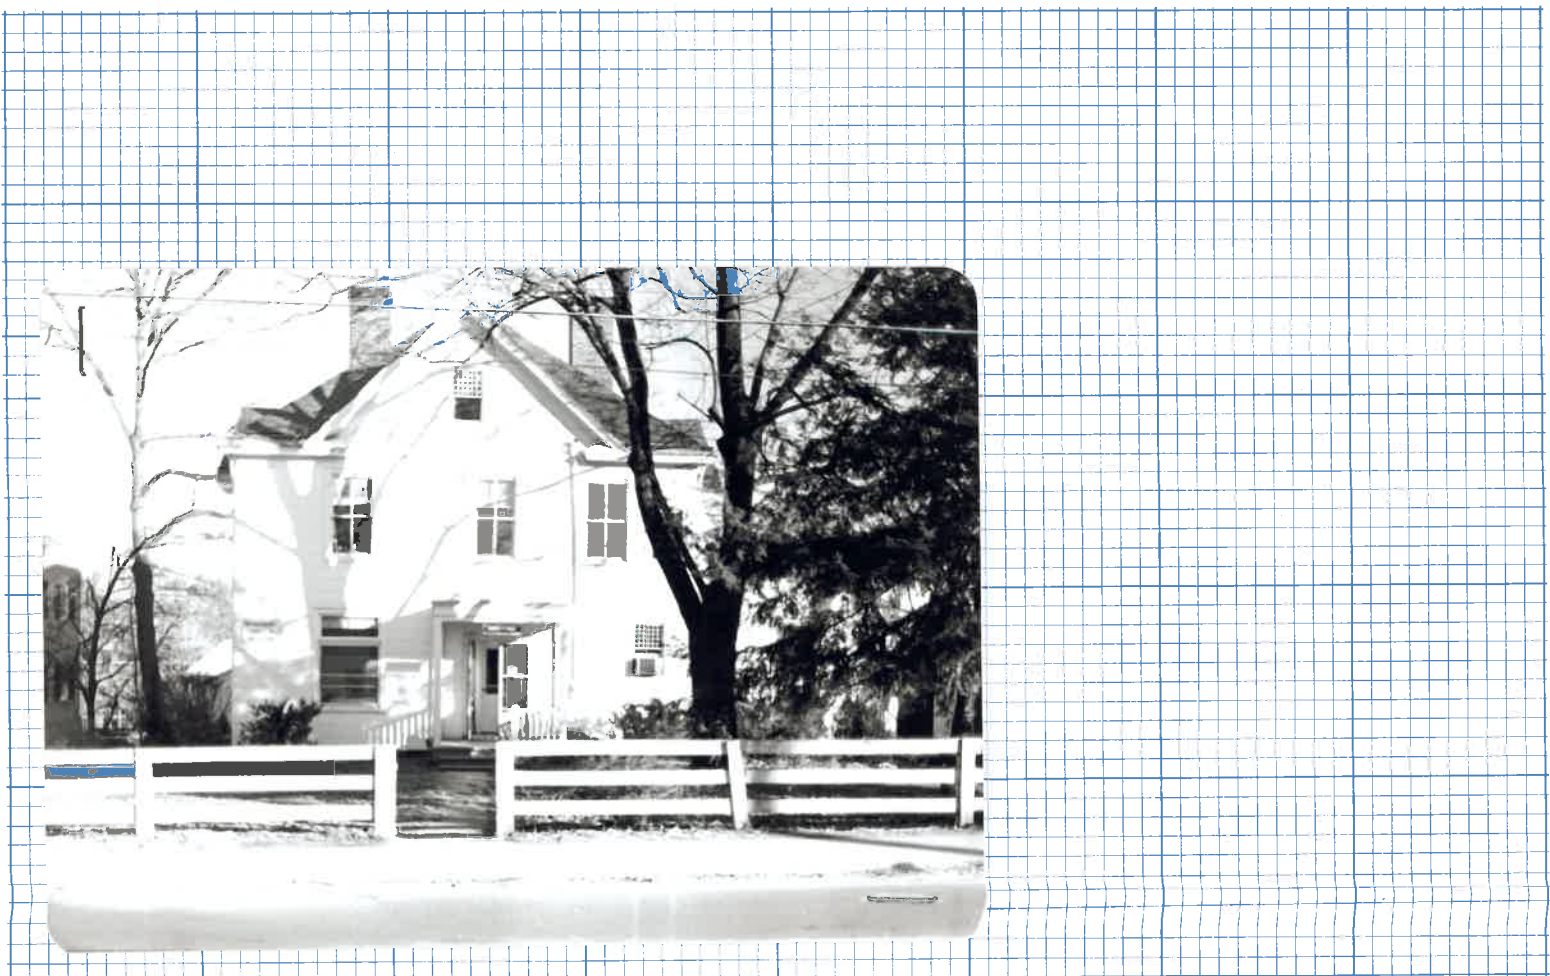
Site plan (Locate and identify outbuildings, dependencies and significant topographical features.)

garage in rear

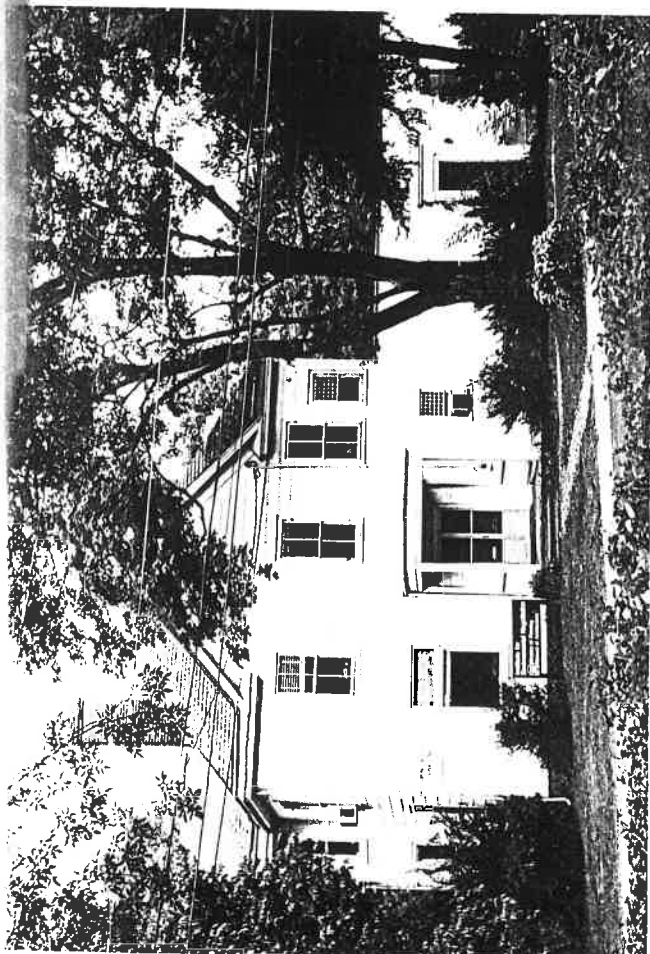
Note: Two mid-20th-century outbuildings stand on the property; neither contribute to the Historic District

This eclectic house—one of the few frame dwellings along Rugby Road—combines elements of the Colonial Revival and Queen Anne styles. The house achieves visual interest from its complex massing, with front cross-gable <sup>and</sup> two-story polygonal side bay; and <sup>from its</sup> varied-size front windows. Except for a side extension and recent asbestos-shingle cladding, the house remains largely in its original state.

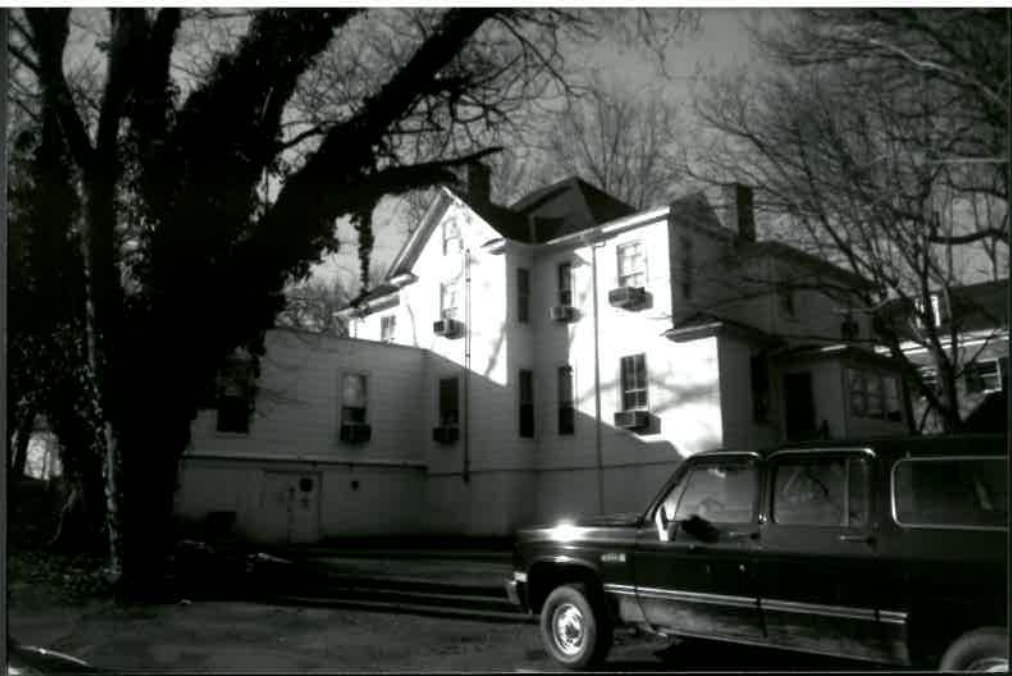
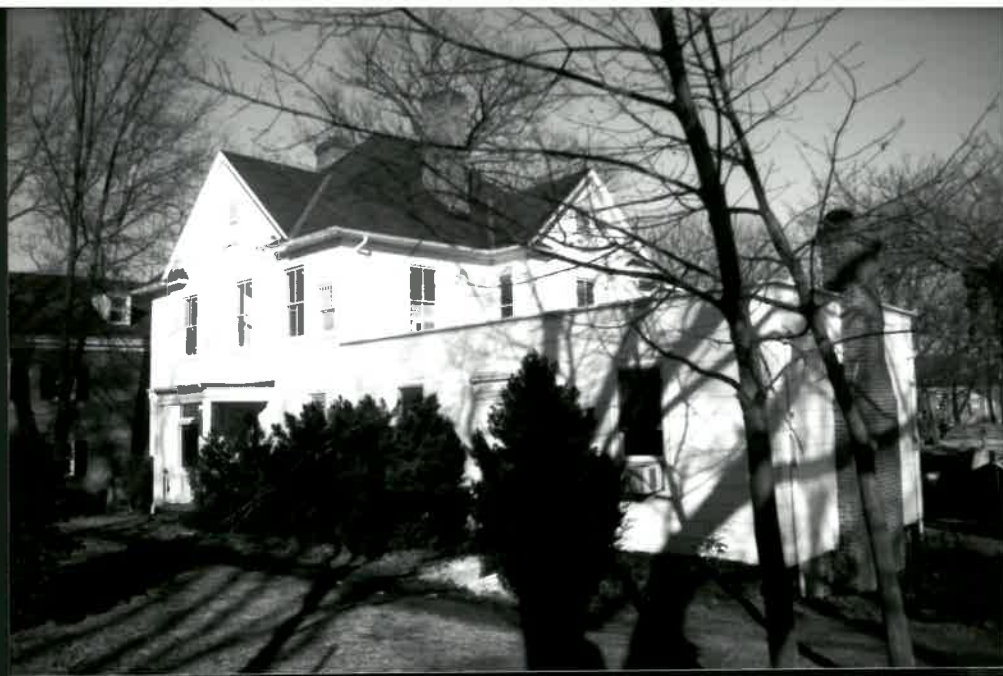
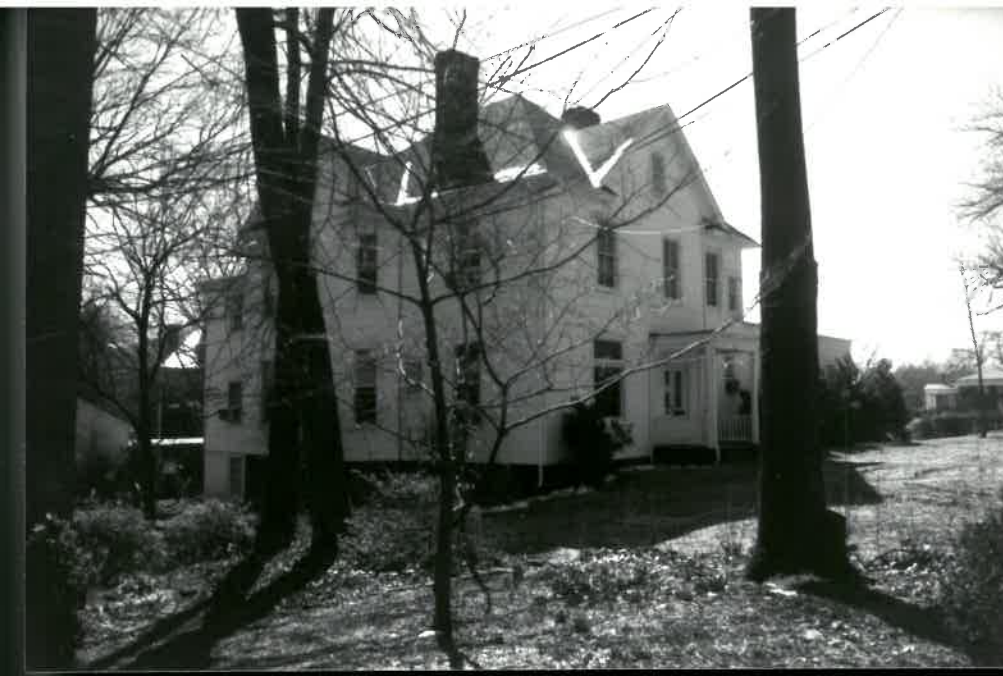
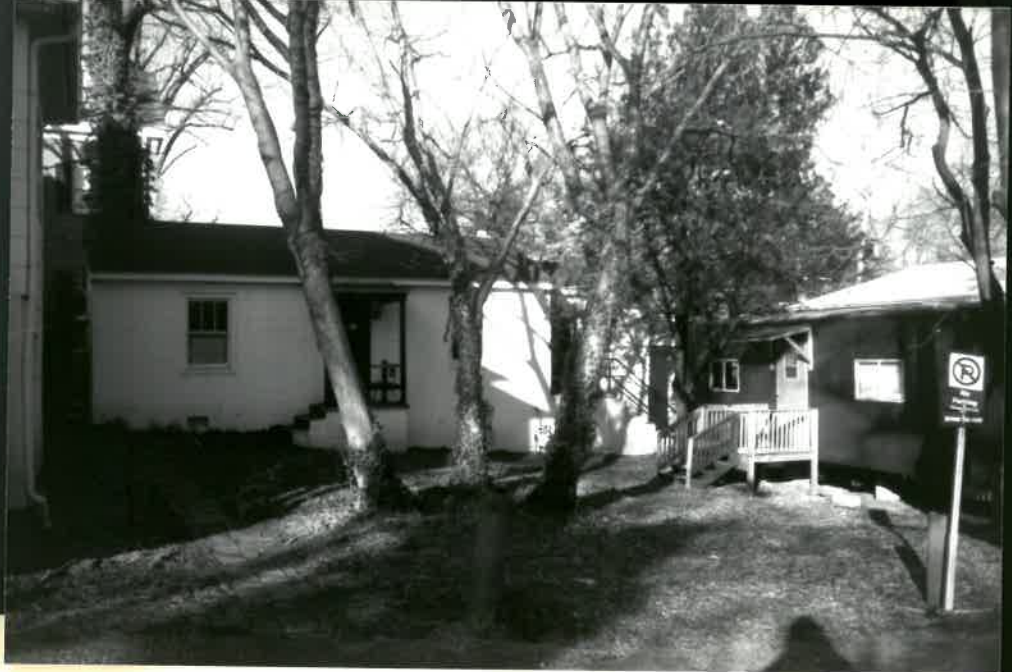
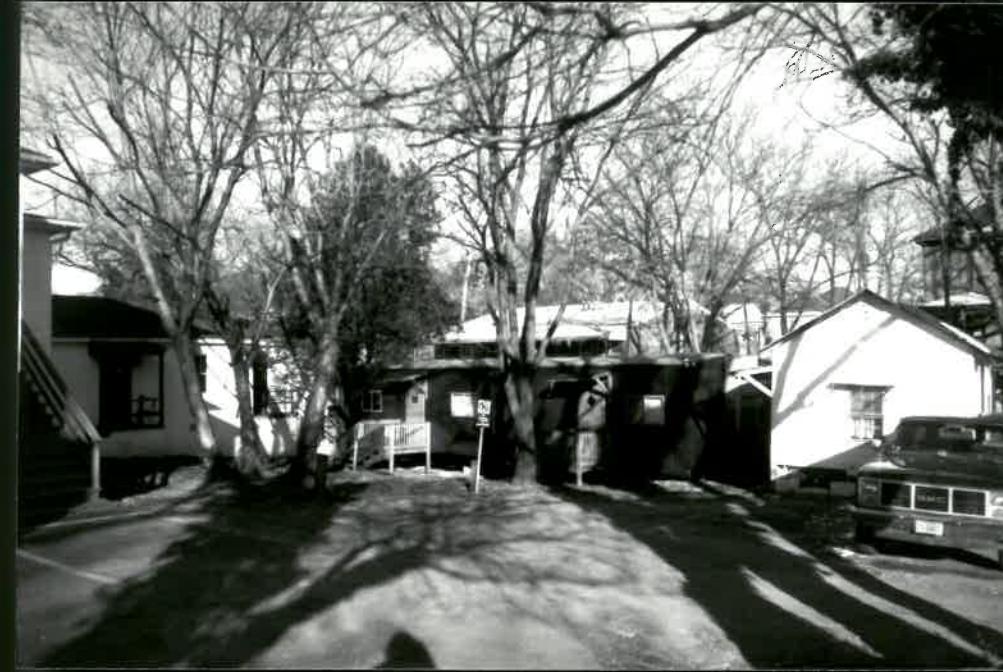
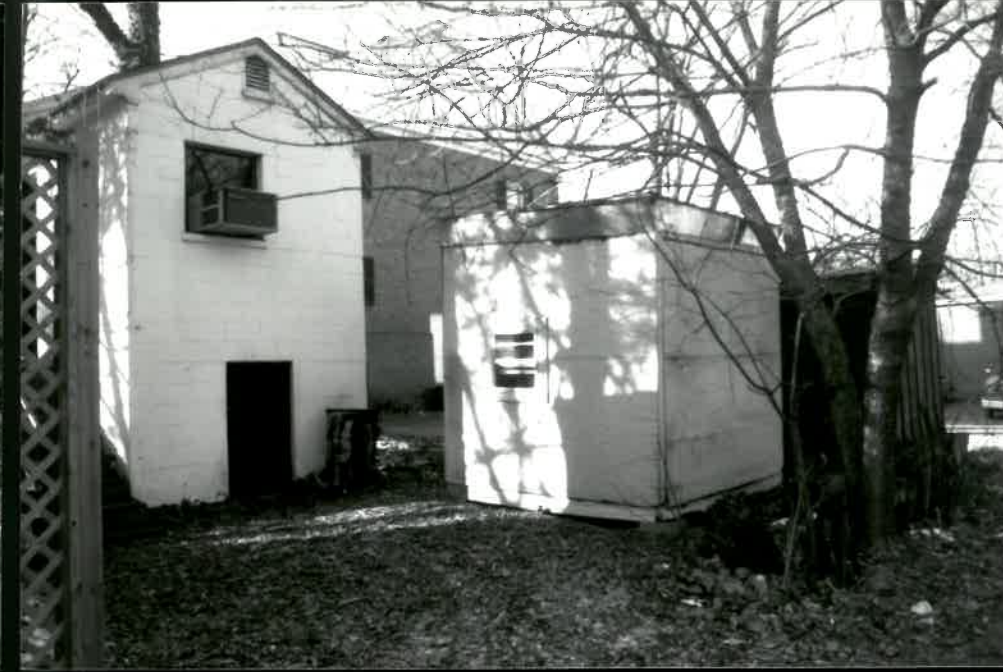
Date 3/9/96 File No. 104-133-4  
 Name Peyton House, 164 Rugby Rd.  
 Town Charlottesville  
 County \_\_\_\_\_  
 Photographer S.E. Smead  
 Contents 8 exterior views (3 house,  
5 outbuildings)

Rectangular block of frame construction, with hipped roof, a one-bay deep two-story extension to the rear, and a one-story side wing to southwest; main block has three-bay front facade, with entrance containing paired wood doors with glazing, sheltered by one-bay, one-story entrance porch with Doric columns and wood rails. Immediately northeast of entrance is a picture window with a transom; multi-light windows are at the southwest end of the front facade's first and second floors. There is a large gabled wall dormer in the center of the front facade, containing multi-light window; full-height projecting sections, one bay deep, on each of the side walls are also topped with gables containing multi-light windows. The cornice is boxed, with returns in the gables. The southwest side wing appears to have a flat roof; its entrance has a Classical Revival door surround with fluted pilasters and a cornice with tryglyphs and metopes.

Southwest side addition built between 1929 and 1941. House has been clad with asbestos shingles; a one-story front porch extended across the front of the main block, and has been removed since 1969. There is evidence that the house had window blinds.

with a trailer and a small storage building. The outbuilding on the northeast side of the property is of concrete block, and apparently replaces a two-story dwelling built on the same site between 1920 and 1929; the concrete block building was constructed by 1941. The smaller frame shed on the southwest side of the property was also built by 1941, and was in use as a dwelling in that year and in 1969. These two buildings now appear to serve as auxiliary office space. The trailer, apparently also used for offices, and storage structure added to the property since 1969.
