**City of Charlottesville**  
**Board of Architectural Review**  
**Staff Memo**  
September 15, 2020

**Preliminary Discussion**

Barksdale-Coles House  
217 5<sup>th</sup> Street SW, TMP 290066000  
Individually Protected Property  
Applicant: Mitch Willey  
Rehabilitation/Restoration of historic house; raze outbuildings and construct new.

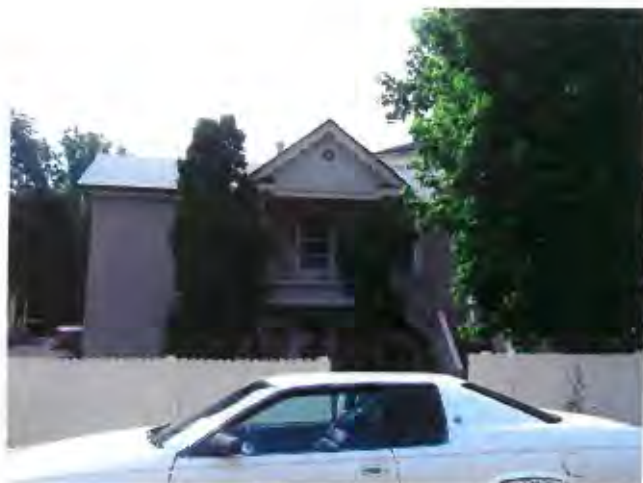
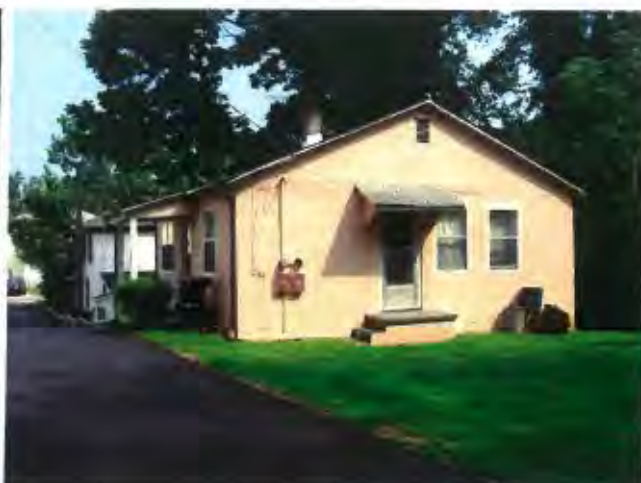
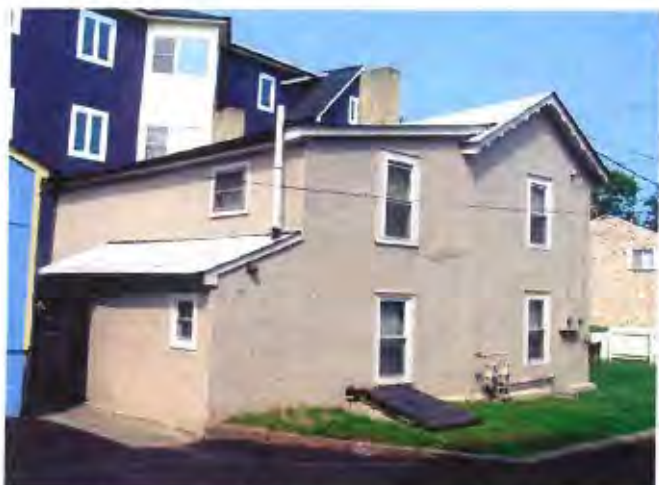
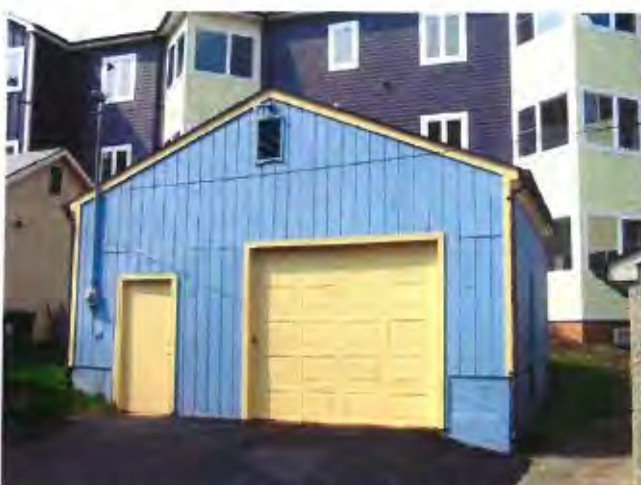
217 5<sup>th</sup> Street SW 104-0213-0159

*Primary Resource Information:* **Single Dwelling, Stories 2.00, Style: Other, ca 1860**  
July 2006: This 2-story, 3-bay, gable-roofed, stuccoed vernacular dwelling features a 2-story, bi-level, pedimented entrance porch with decorative vergeboard. Believed to have been constructed ca. 1854-1864 by John T. Barksdale the single-pile symmetrical dwelling rests on a low foundation and has an asphalt shingled roof. The deeply overhanging eaves have a scalloped vergeboard on all sides. To the rear are a 2-story shed-roofed wing with a central brick flue and a rear 1-story shed-roofed wing. The 2-story, 1-bay front porch has square supports and a modern exterior stair allowing for access to the second-floor central door and porch. All the 2/2-sash windows have been replaced with modern 1/1-sash.

<i>Individual Resource Status:</i>	<b>Single Dwelling</b> Contributing	<i>Total:</i> 1
<i>Individual Resource Status:</i>	<b>Garage</b> Non-Contributing	<i>Total:</i> 1
<i>Individual Resource Status:</i>	<b>Single Dwelling</b> Contributing	<i>Total:</i> 1
<i>Individual Resource Status:</i>	<b>Single Dwelling</b> Contributing	<i>Total:</i> 1

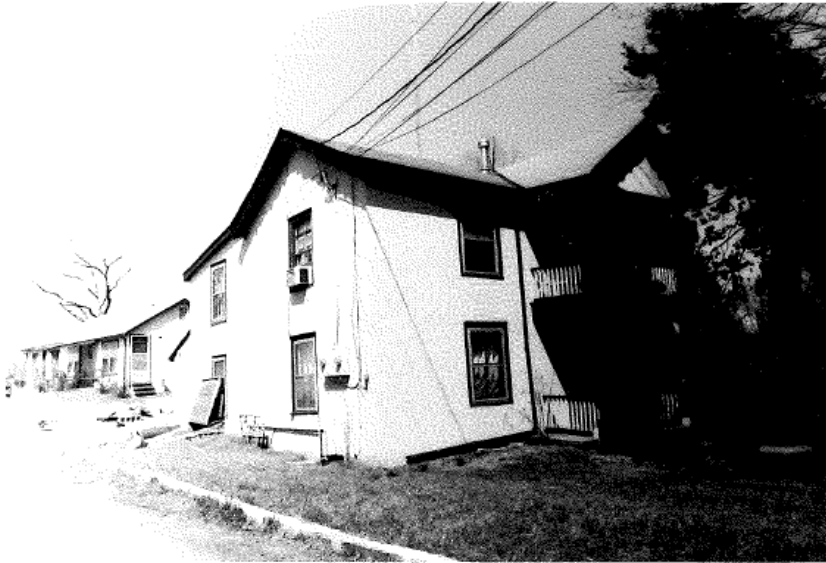
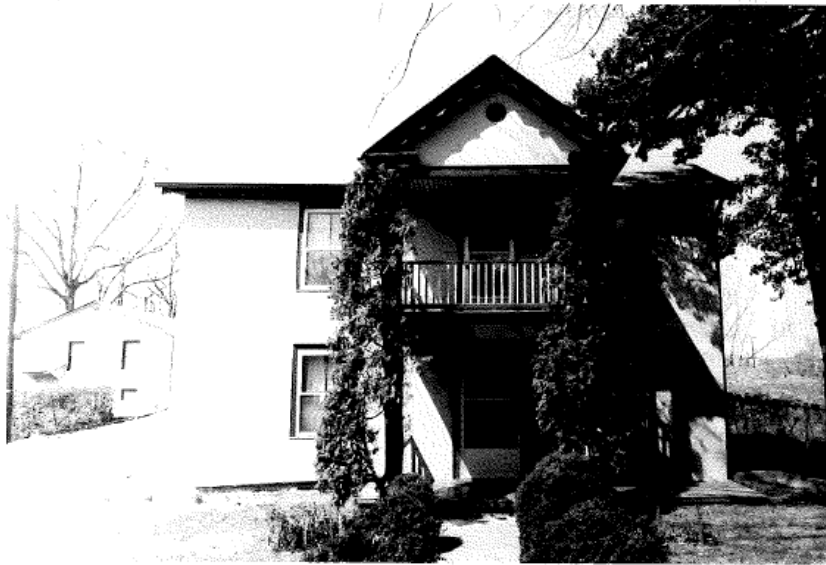
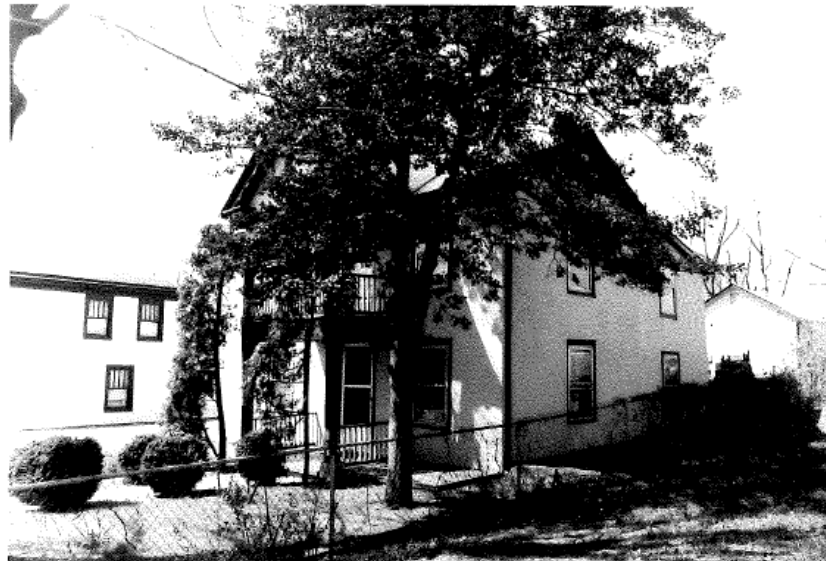
This house is distinguished by a small two-storey pedimented entrance porch. It is a 2-storey, 3-bay single-pile house with a 2-storey rear wing making it double pile. It is set on a low foundation and has a partial basement. The weatherboarded walls have been faced with stucco, and composition shingles have replaced the metal on the medium pitched gable roof. The roof has projecting eaves and verges, a boxed cornice, and sawn bargeboard and eaves trim. Two exterior chimneys located at the rear of the original section were made central chimneys by the rear addition. The wide double-sash windows are 2-over-2 light with architrave trim, the same height at both levels. The 2 storey entrance porch centered on the facade has a steep gable roof with cornice returns. Each level has square posts and a simple balustrade. The first level has a tile floor. The door have plain trim. The rear elevation of the house is covered by a 2-storey addition with a shed roof only slightly lower pitched than the gable roof of the main block. The eaves and verges do not project as far and they lack the sawn trim. Side windows are 2-over-2 light with plain trim. Because of the low roofline on the rear elevation, windows at the second level are half-sized casement. A one-storey shed-roofed porch across the rear elevation has been enclosed.

John T. Barksdale bought this lot in 1854 (ACDB 53-478) and built the house by 1865 according to tax records. John C. Coles contracted to buy it in 1867 and received a deed in 1870 (ACDB 65-496). His family owned it for over half a century. Increases in the tax appraisal in the 1890's may be due to the rear addition. It is shown on the 1907 Sanborn Map. The Rev. R. H. Hailstock bought the house from the Coles family in 1928 (City DB 64-194) and lived there until his death in 1983 (WB 27-182). He may have faced the walls with stucco soon after buying the house. The two cottages in the back yard were built sometime after 1920.

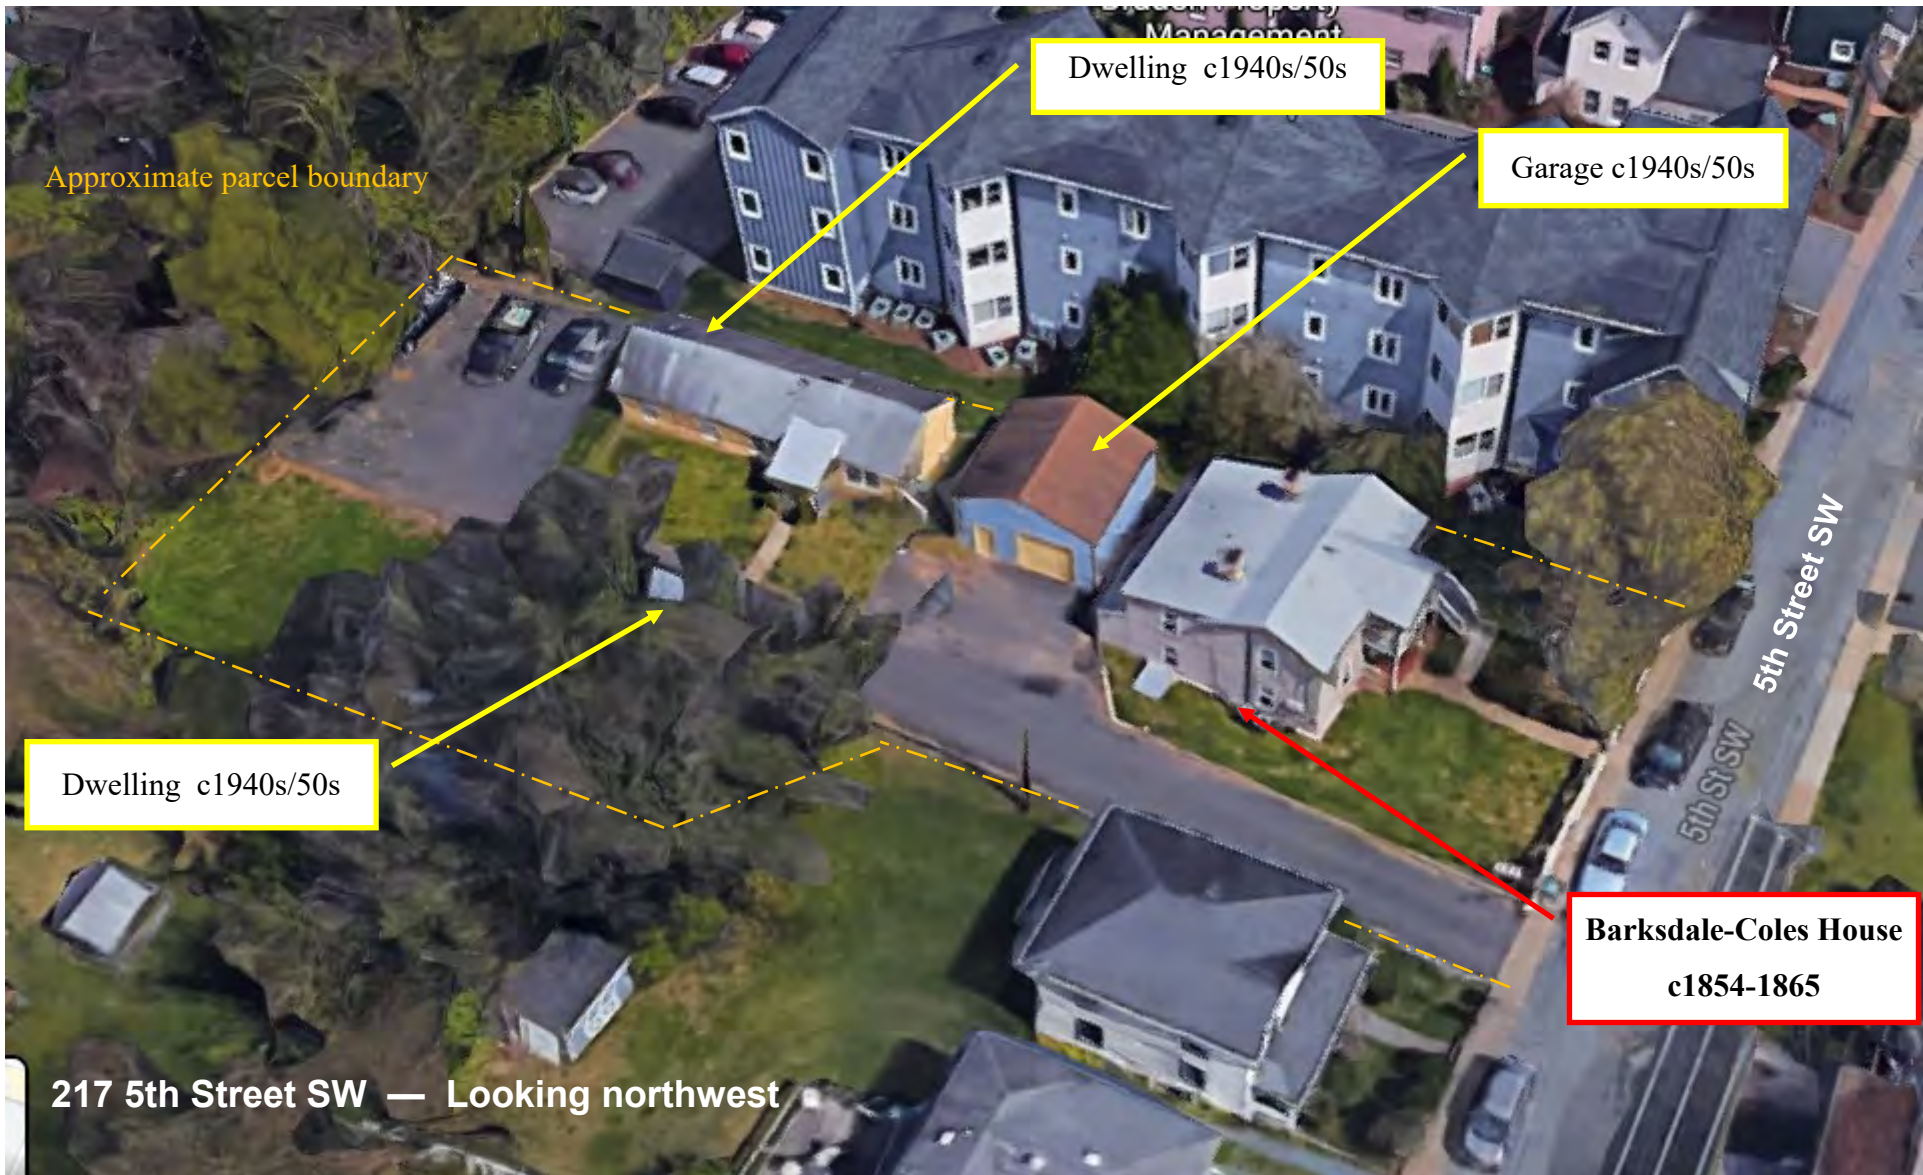
217 5th Street SW — Looking northwest

Dwelling c1940s/50s

Garage c1940s/50s

Approximate parcel boundary

**Barksdale-Coles House**  
c1854-1865

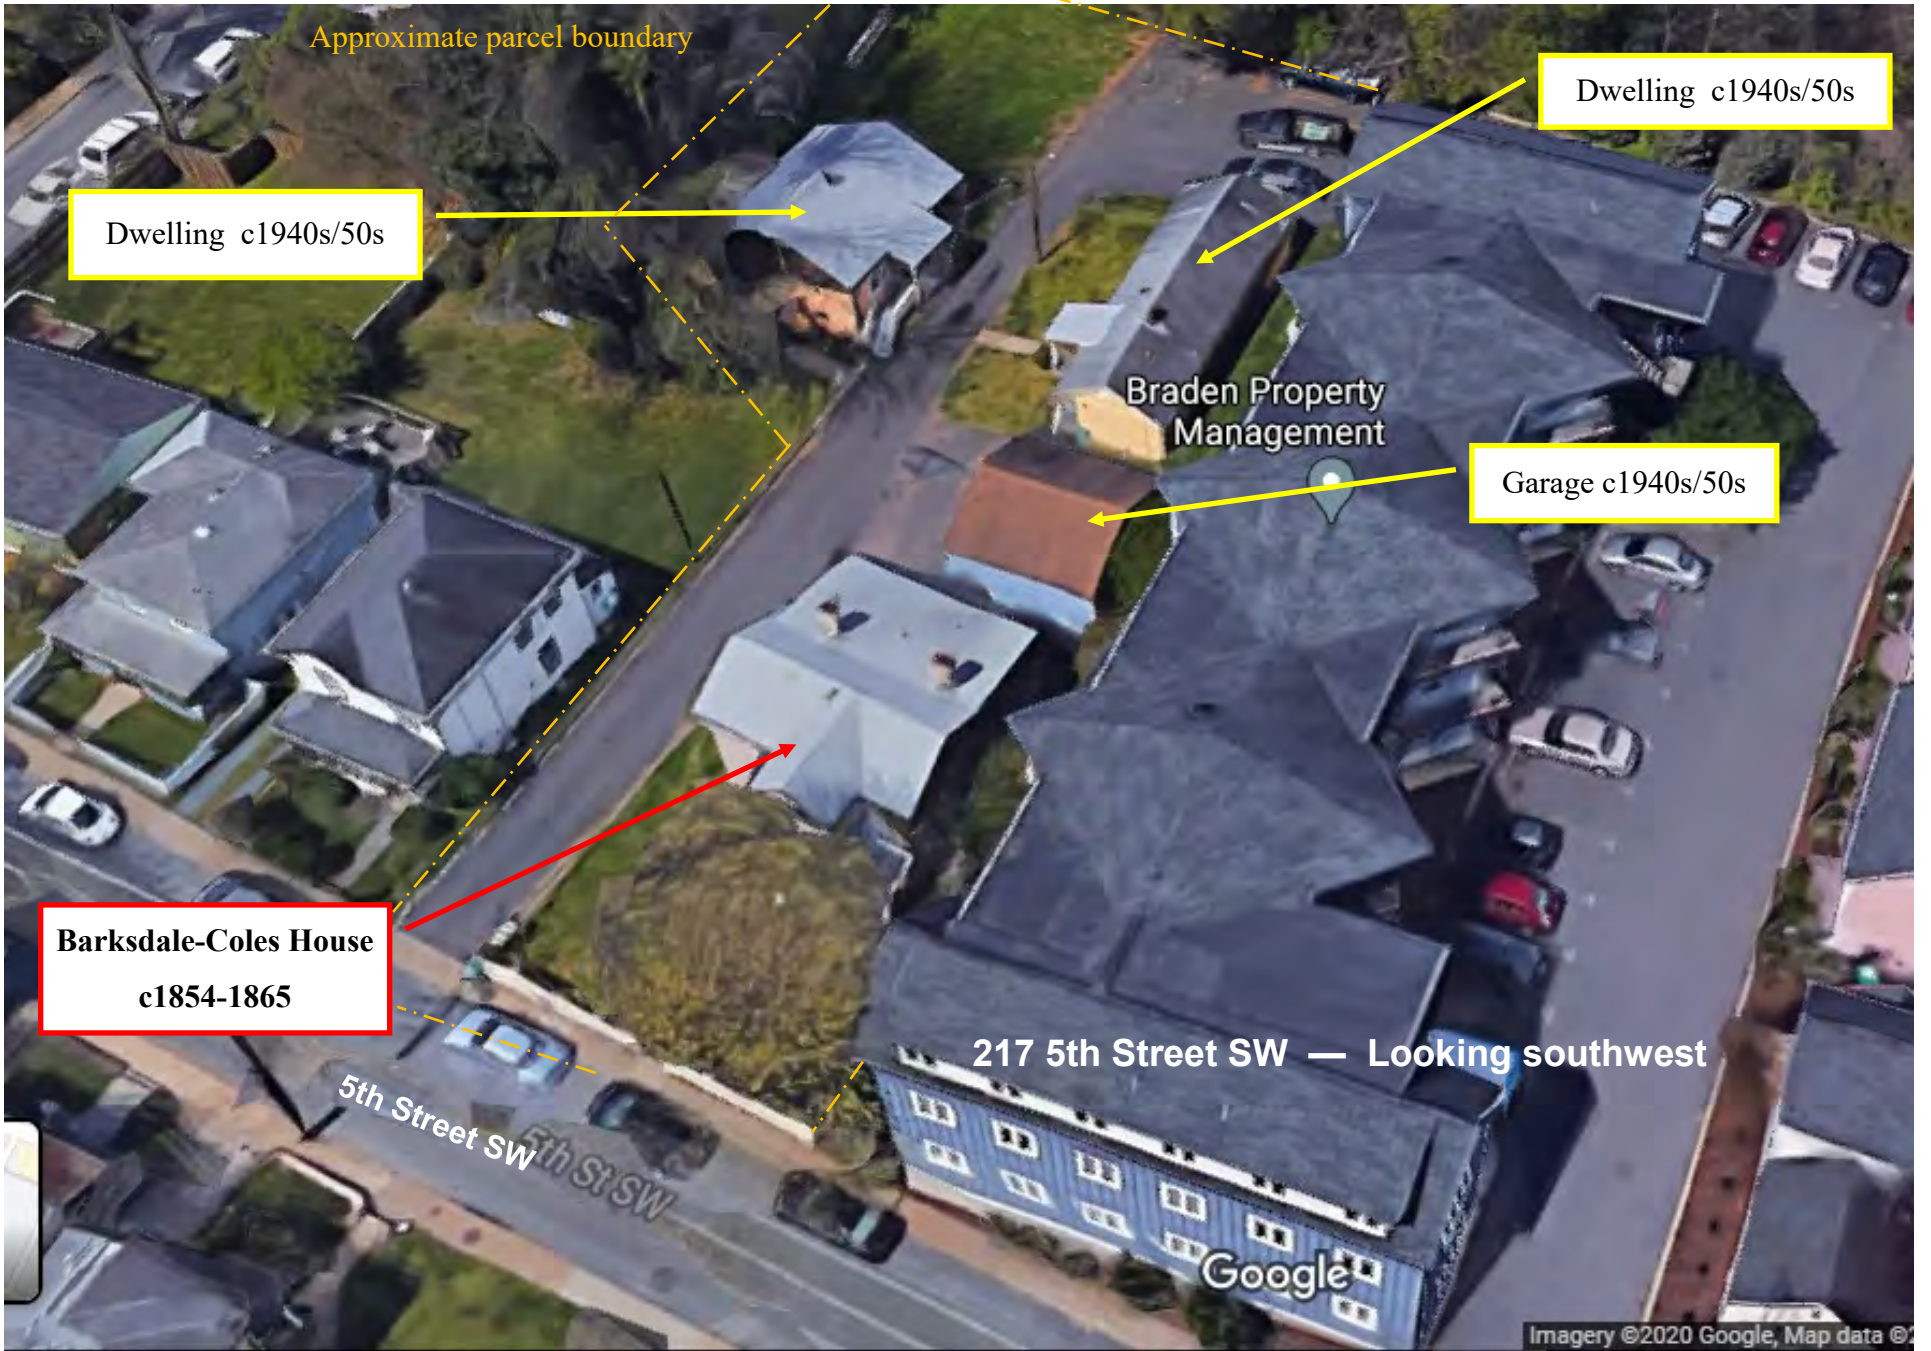
217 5th Street SW — Looking southwest

Approximate parcel boundary

Dwelling c1940s/50s

Garage c1940s/50s

**Barksdale-Coles House**  
c1854-1865

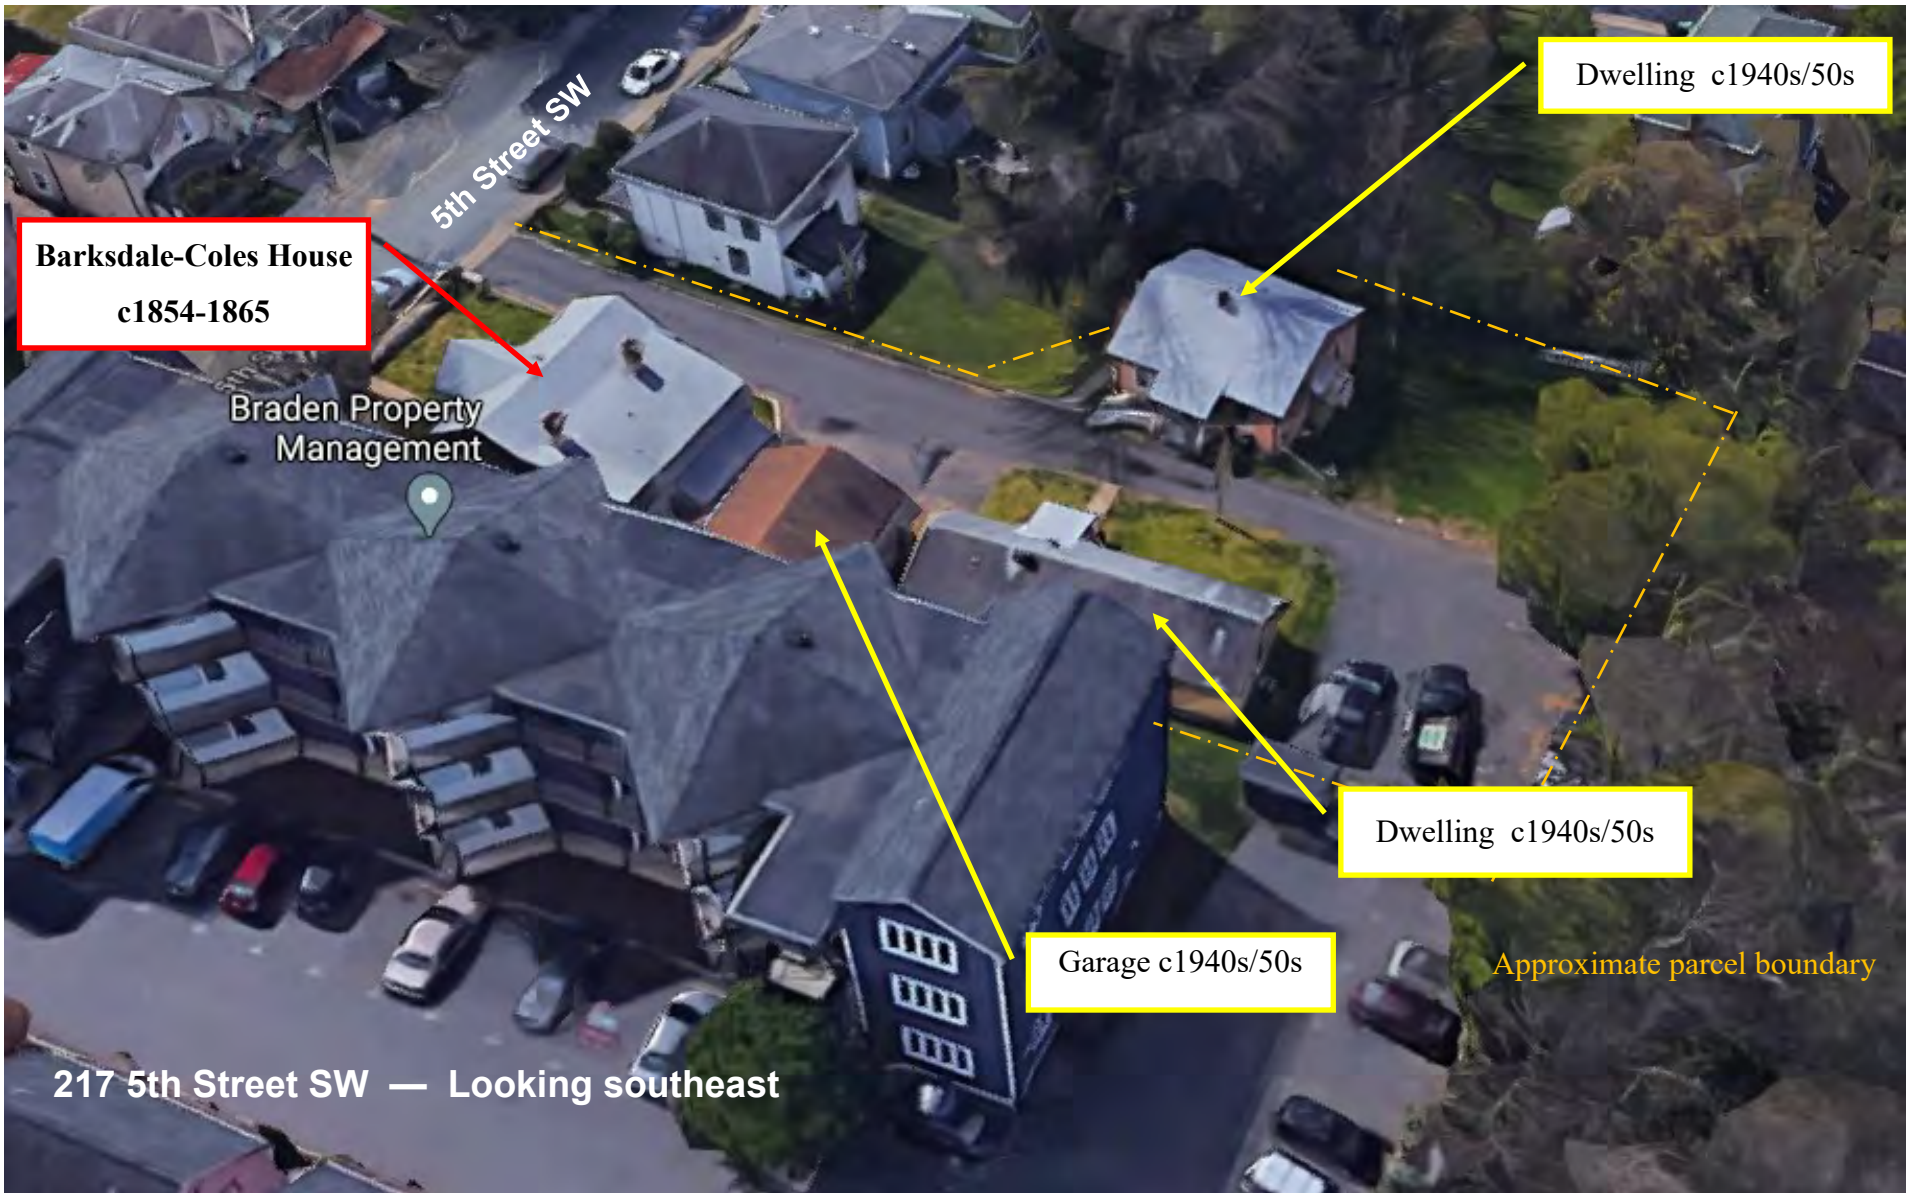
217 5th Street SW — Looking southeast

**Barksdale-Coles House**  
c1854-1865

Dwelling c1940s/50s

Garage c1940s/50s

Approximate parcel boundary
