**City of Charlottesville
Board of Architectural Review
Staff Report
November 16, 2021**

BAR 10-11-04

123 Bollingwood Road, TMP 070022000

Project: Modifications to the west elevation

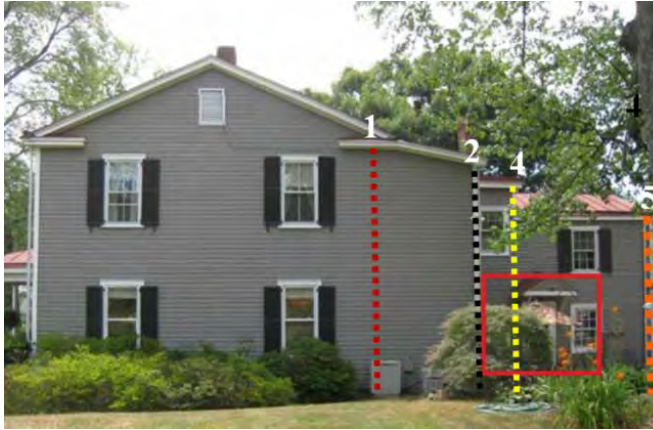
Current

Modifications to the west elevation: The existing door and window to the left (in the photos and elevations) are not in the historic photos and were added after/during construction of the small addition to the SW corner of the main house. (See the comparison photos in the Appendix.)

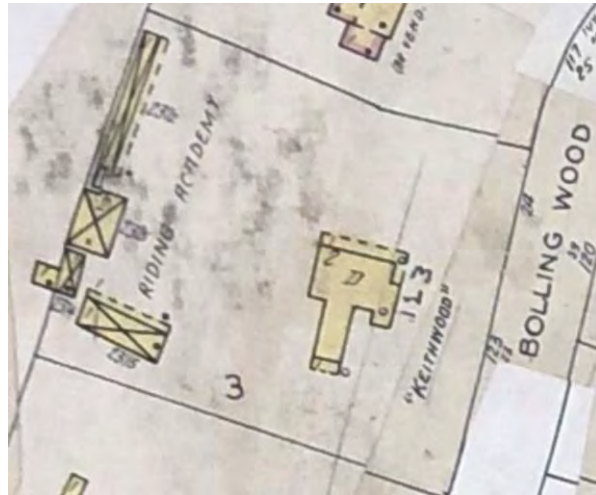
c1965 Sanborn Map

Disney-Keith House, a vernacular farmhouse. Between 1923 and the mid-20th century, Arthur Keith's wife, Ellie Wood Keith, operated a riding academy here.* A barn, outbuildings, and stables immediately west of the house are no longer standing, but can be seen on the c1965 Sanborn Maps and 1966 aerial photo--see the Appendix. The existing garage south of the house was constructed in 1988. (*It is said that *Elliewood Avenue* was named for Mrs. Keith, but we cannot be certain.)

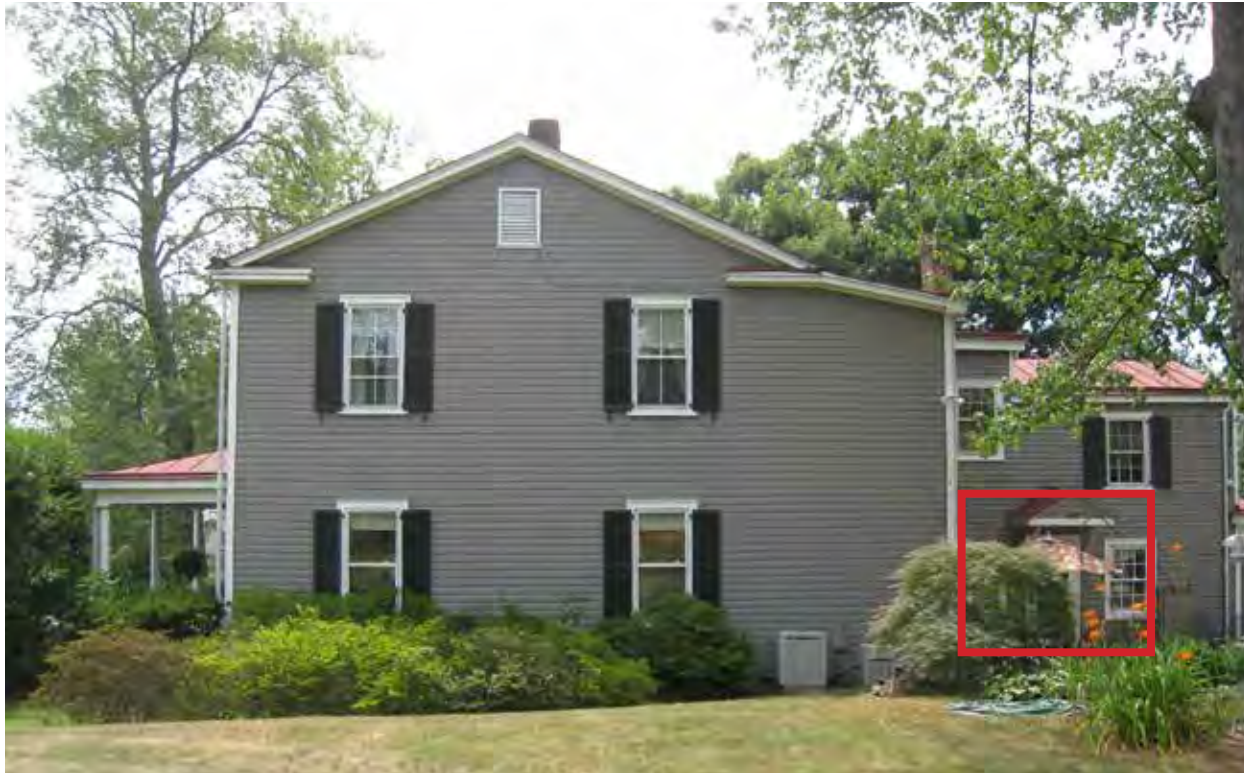
Site Concept Plan

Limit of work outlined in red

Request CoA to modify the west elevation of the rear addition: remove the small roof over the door and replace the door and two adjacent windows with a three-panel sliding door. (The landscape plan, including other work on the property, is aspirational and included in the submittal for context only.)

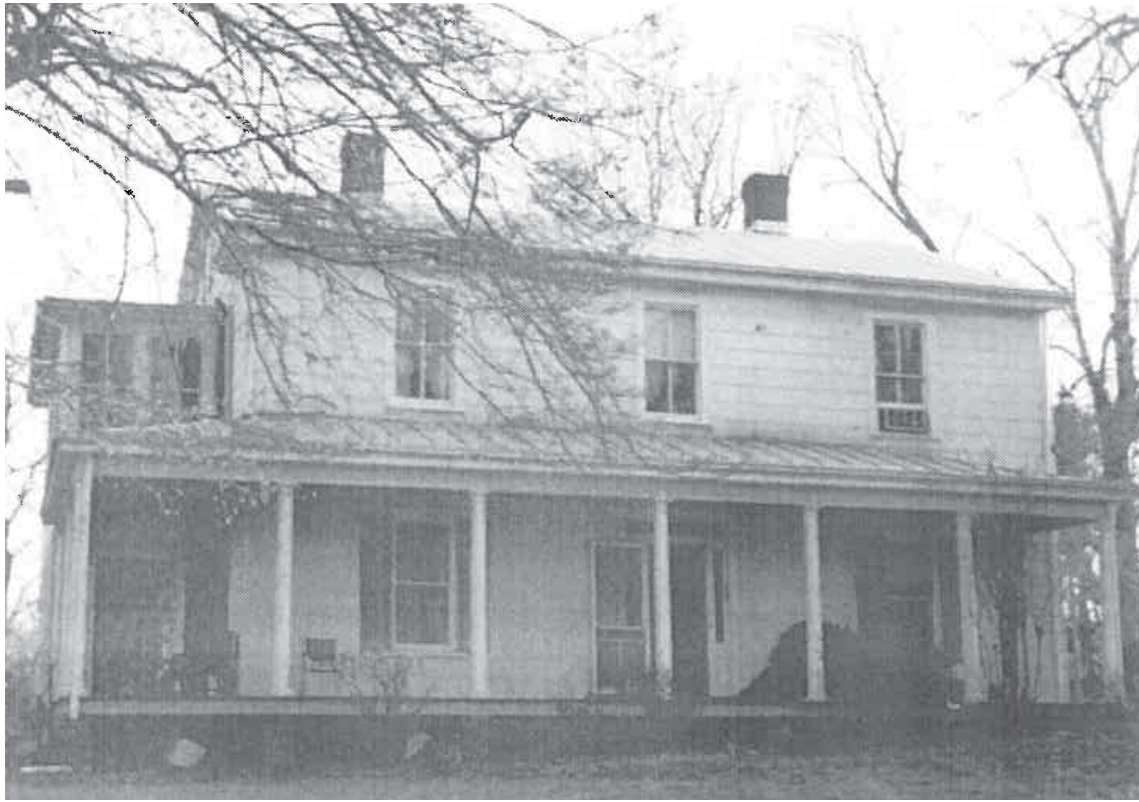
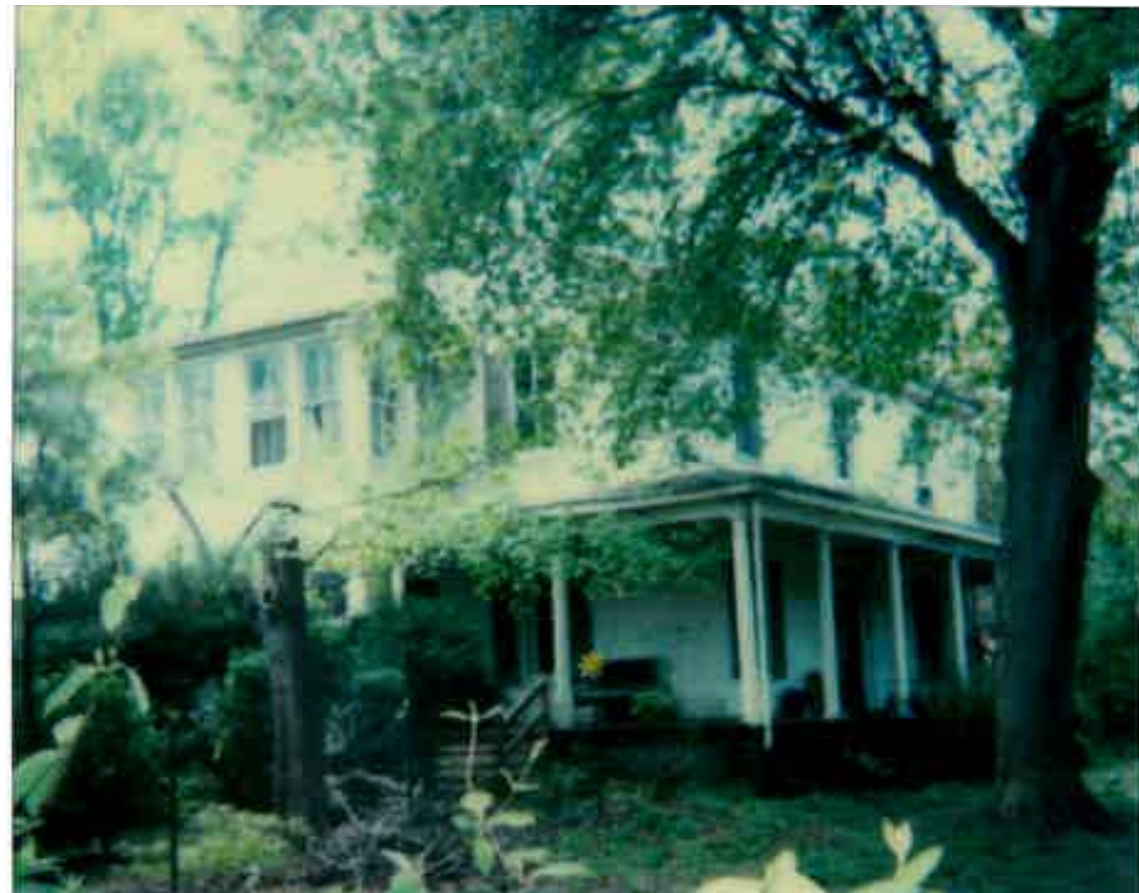
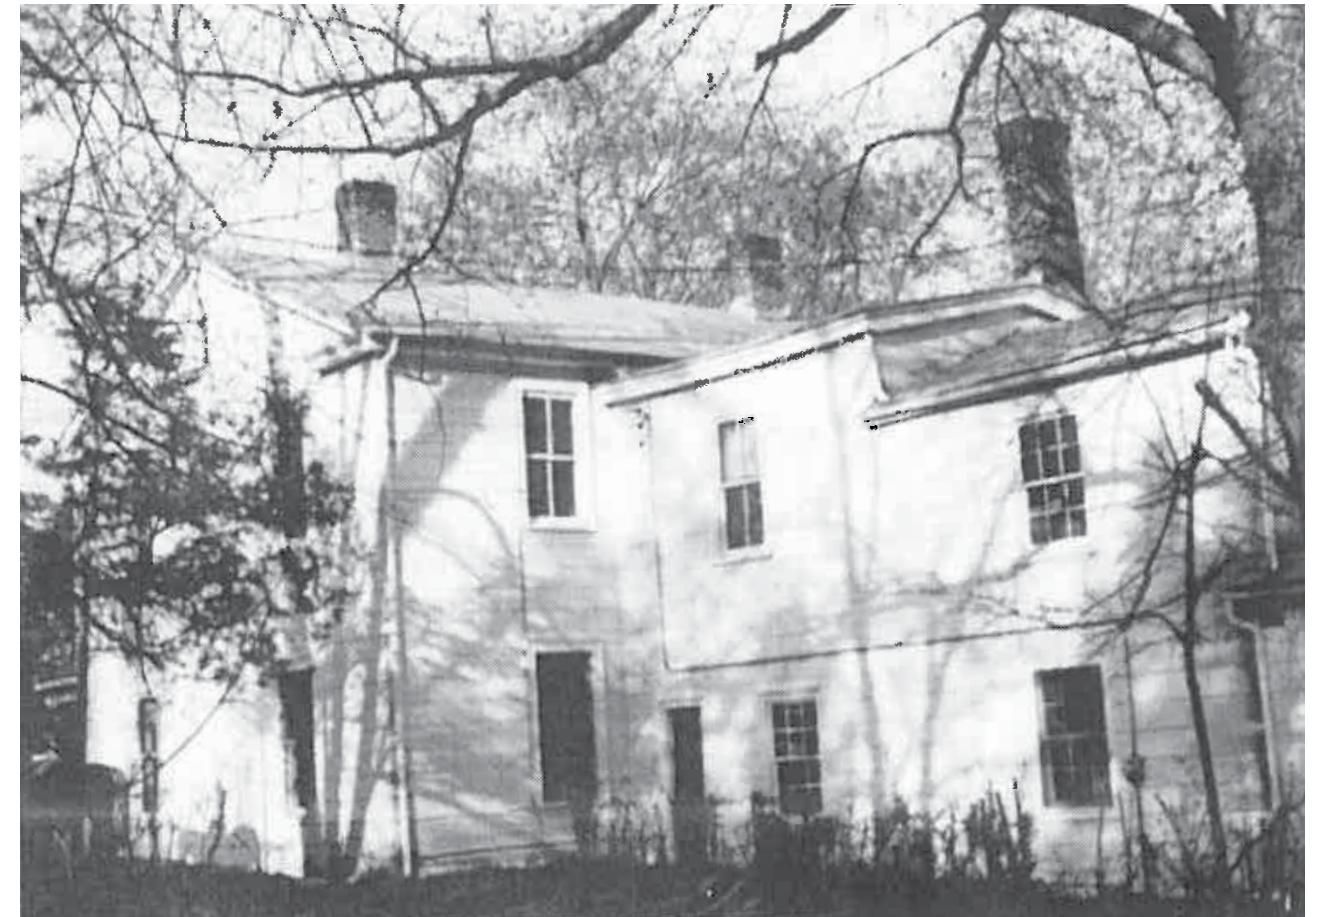
Existing Conditions

The property has been substantially altered over time. The enclosed sleeping porch on the left in these 2 images has been completely removed.

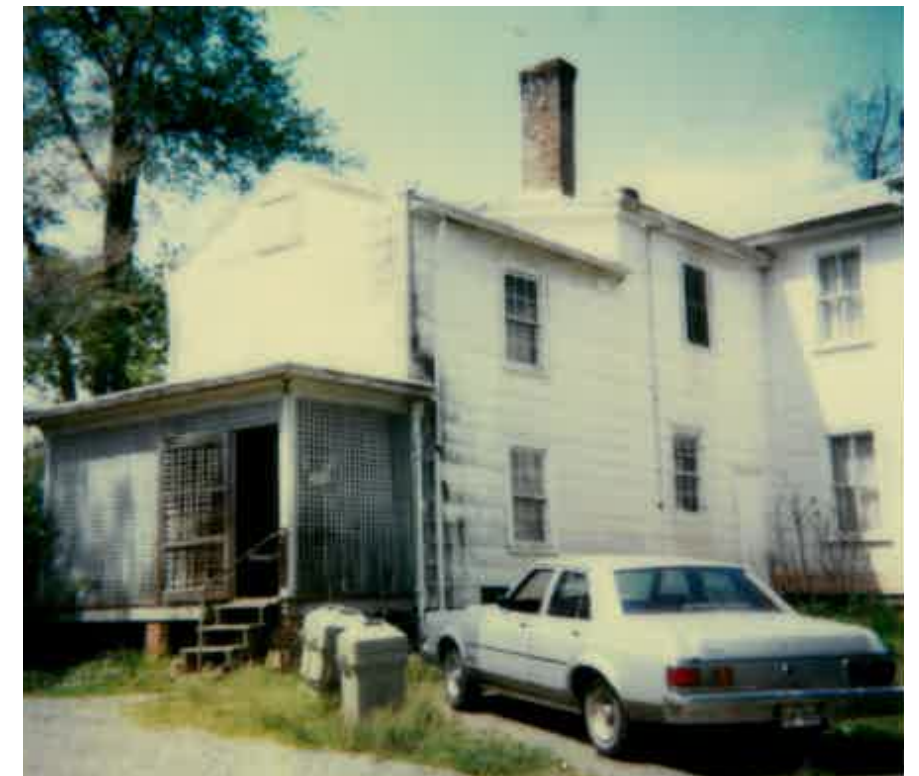
The rear additions have also been altered over time.

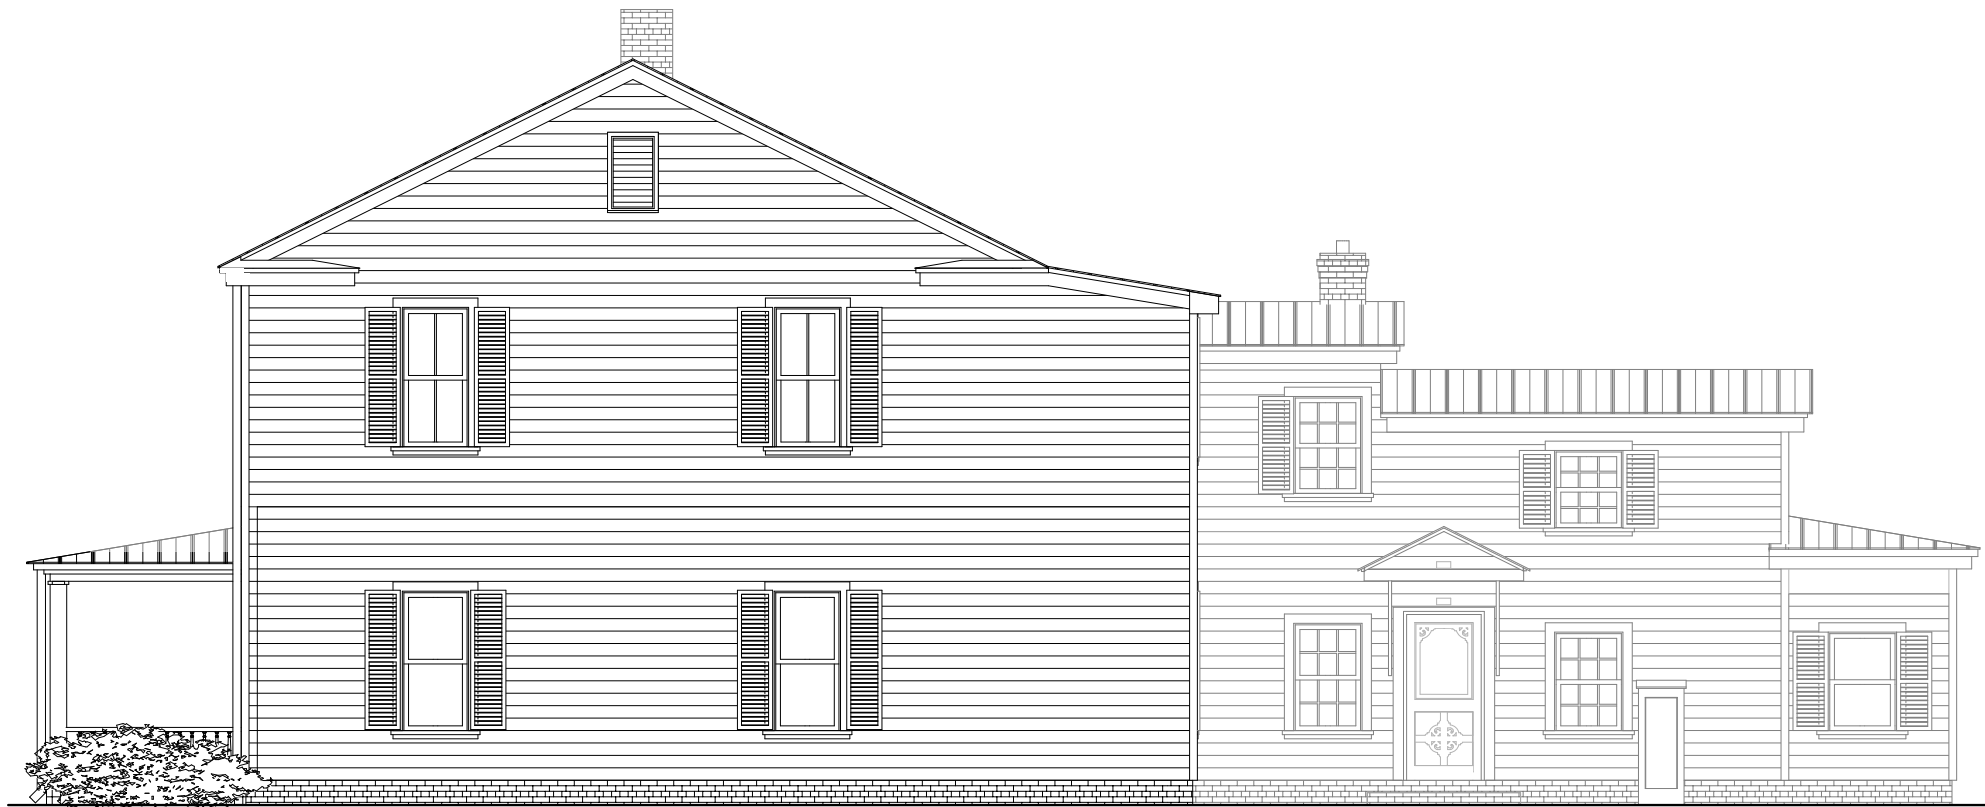
EXISTING ELEVATION

Exterior renovation would be limited to the southwest facade of the structure - a series of later additions to the original farm house, not visible from Bollingwood Road. The interior space at this location is the kitchen and family dining area, and the goal of the project is to connect the interior and exterior with better views and accessibility to the entertainment terrace. The design is intended to emphasize a distinction between the older building fabric and the modern renovation, not to pretend that this work was part of the historic fabric. Modifications would include:

- Removal of small roof over door.
- Replace door and 2 windows with single, three-panel sliding door with minimal frame and with metal surround encasing sliding door.
- Repair and replace all wood siding effected by the modification.

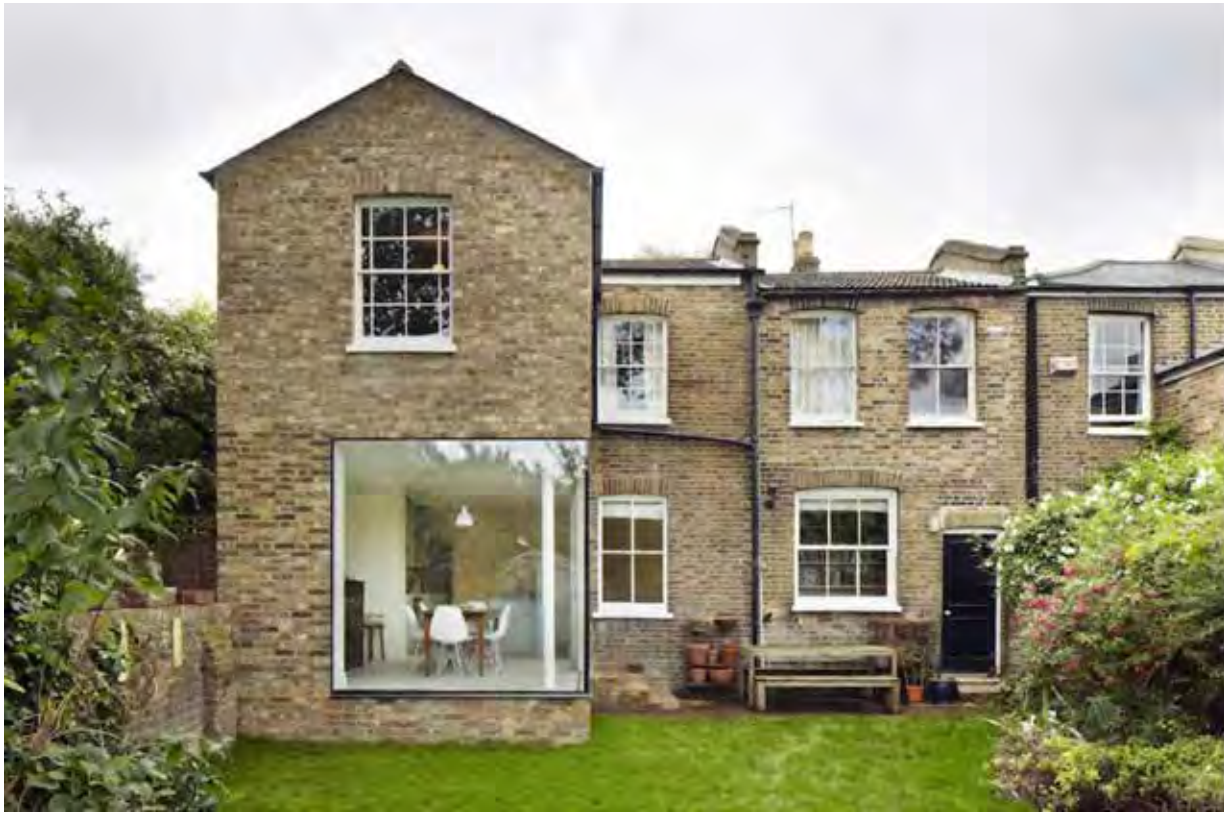
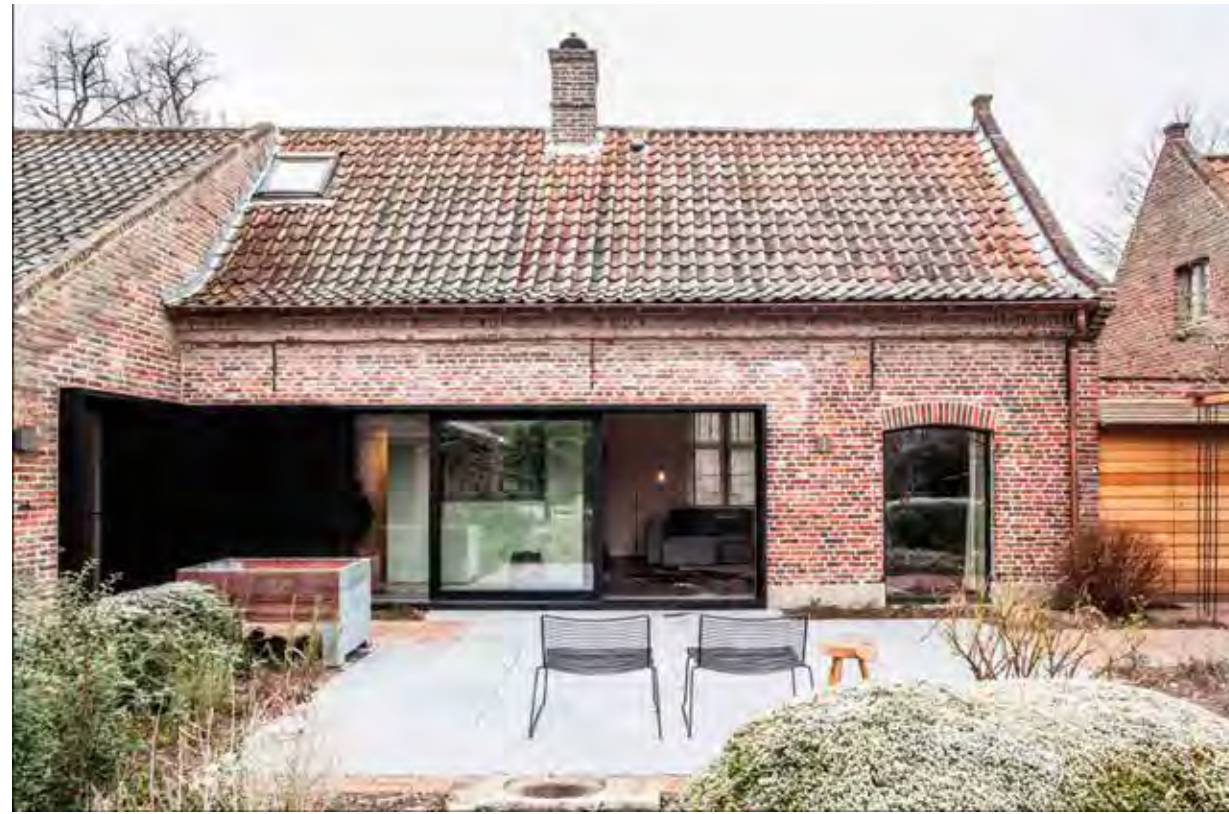
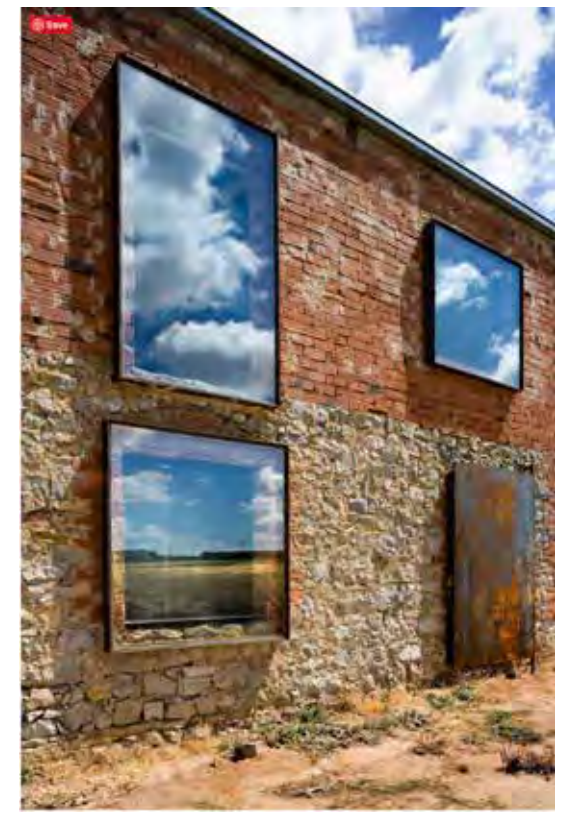
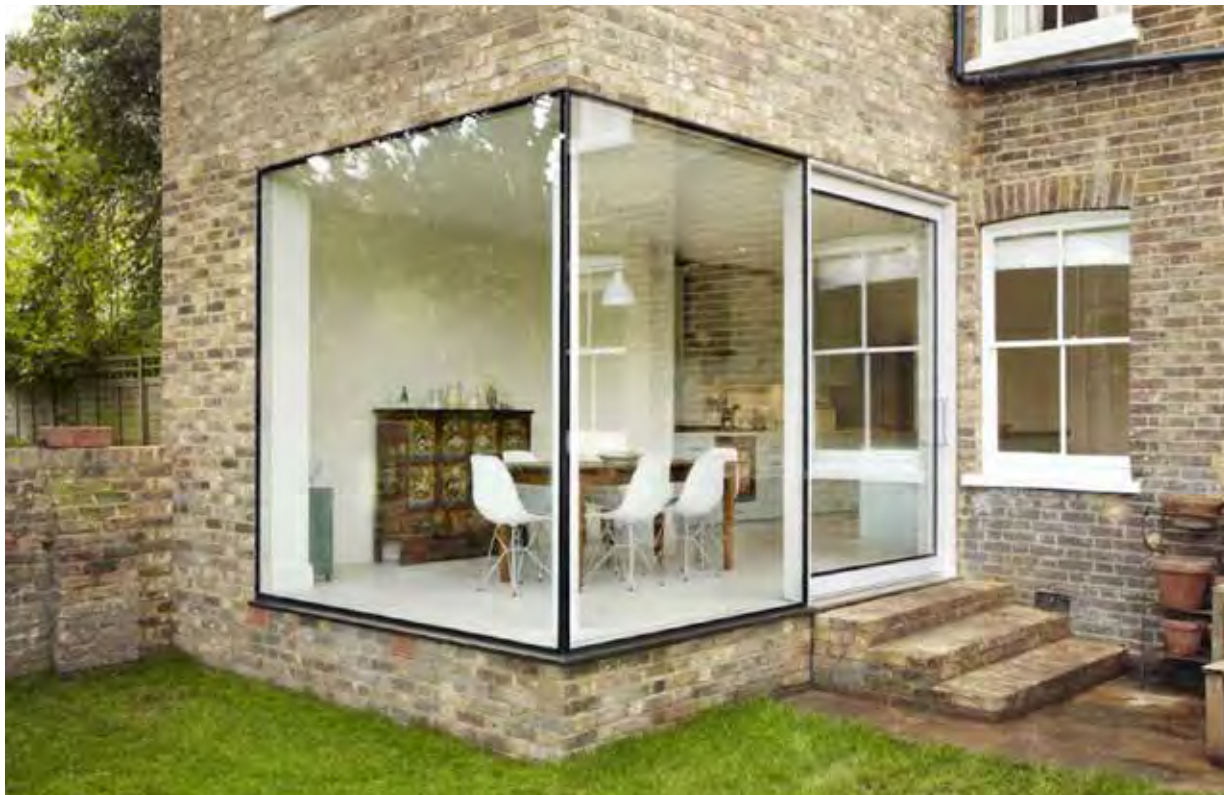
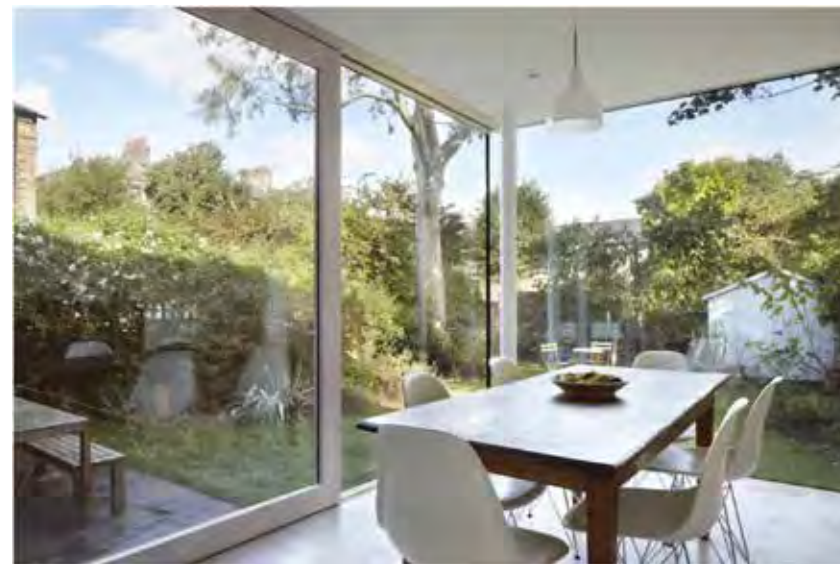
Elevation Concept

Older, historic fabric with modern interventions
