Certificate of Appropriateness  
BAR # 25-0068  
1301 Wertland Street, TMP 040303000  
Wertland Street ADC District  
Owner: 1301 Wertland LLC JSB  
Applicant: Edward Carrington, Seven Development  
Project: Demolition of contributing structure

**City of Charlottesville  
Board of Architectural Review  
Staff Report  
May 20, 2025**

Project: Demolition of structure

RE: 1301 Wertland, Charlottesville VA  
Structural Condition Assessment  
Dunbar Project 2504-33

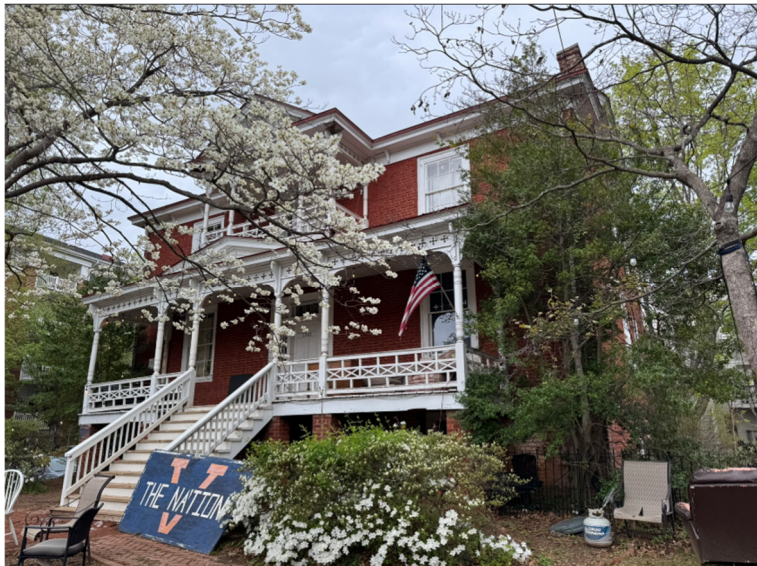
*Photo 1: Front of the building*

Overall, the building appears to be in generally adequate condition. However, several areas require maintenance and localized repairs. These items are detailed in the Recommendations section.

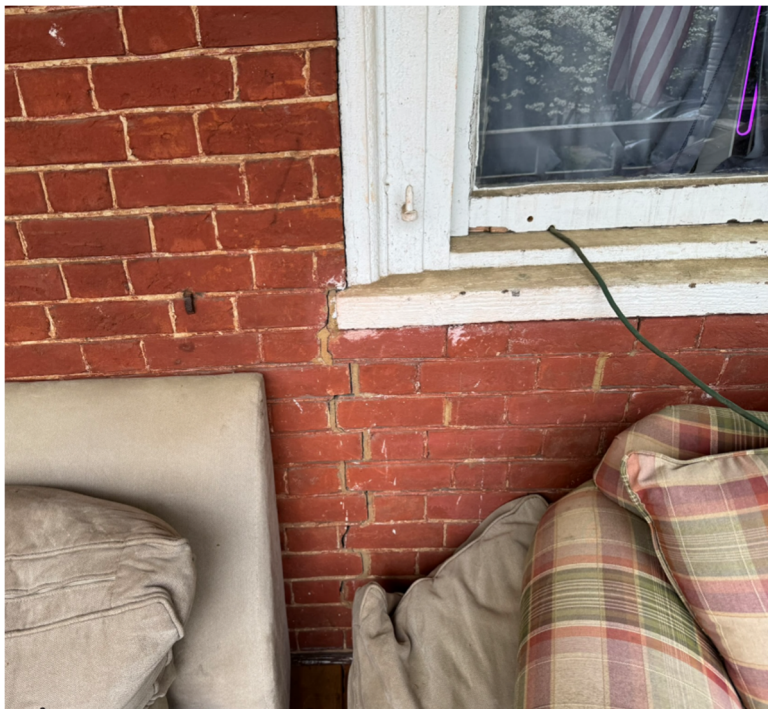
- The **brick exterior** is in fair condition. There is a vertical crack on the front wall running from ground floor to the right window (South East Corner). Also, Along the East side of the building, several window openings show signs of the brick warping indicating the East corner of the building might have settled more relative to the rest of the building. All visible repairs appear to be old so it is not apparent that any movement is a recent event.

*Photo 2: South East side window with vertical crack in brick. Signs of a previous older repair in the crack.*

- Patch all holes in the soffit and repair areas of rot and insect damage. Replace rotted fascia where necessary.
  - Reinstall loose bricks in deteriorated piers.
  - Replace all inadequately supported posts with new footings extending below frost depth (minimum 18").
  - Permanently patch holes in bathroom floors.
-

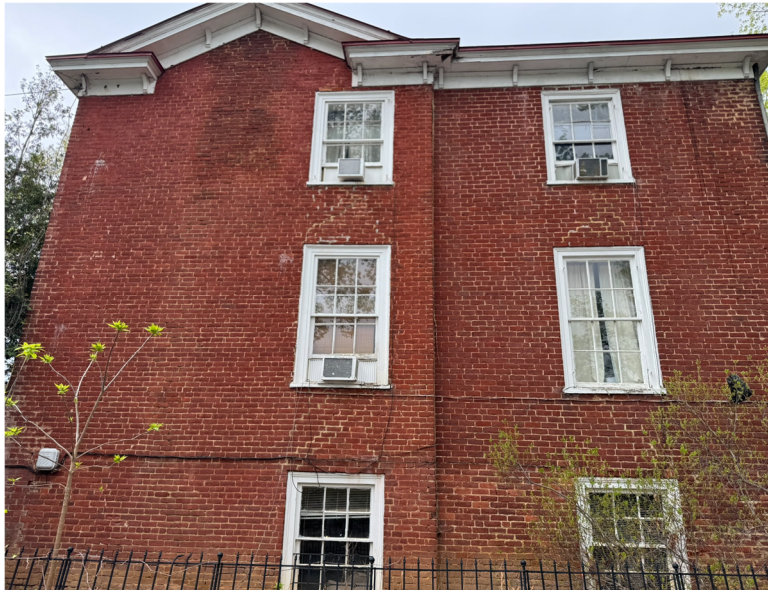
*Photo 3: East side of the building with some warping of the window frame and evidence of previously older repair to the brick under the windows.*

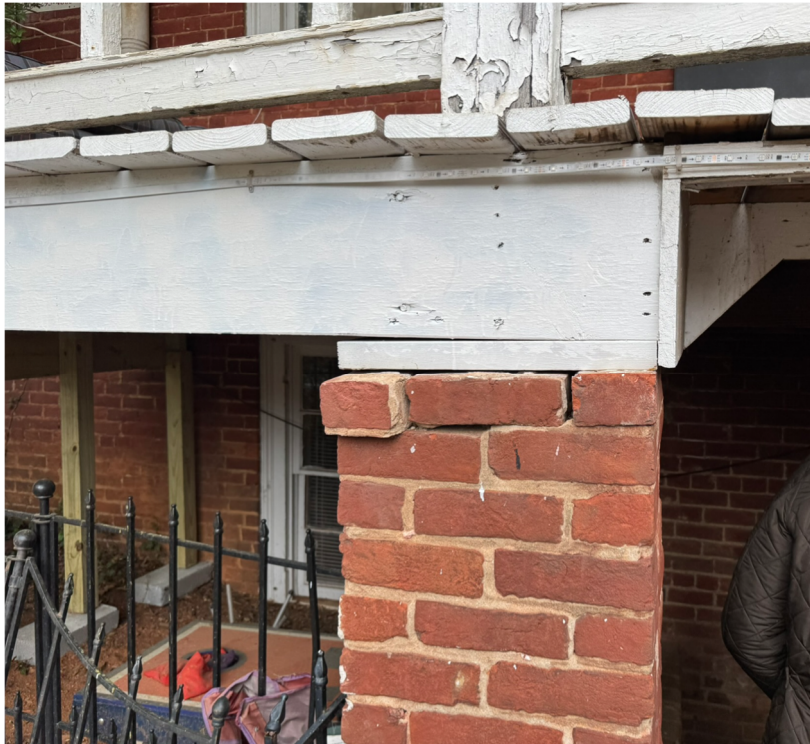
- The **front porch** is in fair condition. The brick pier to the left of the porch stairs (West of the stairs) has some of the bricks loose at the top of pier. There are several pressure treated posts added to the deck in a ad hoc manner. Some posts are sitting on the brick wall. Others are sitting on solid CMU blocks. The piers on CMU block foundations are not set below the frost line and are prone to frost heave. The posts should be set on solid blocks extending below the frost depth of 18" minimum.
  - The **porch floor framing** generally appears adequate except for areas of water and weather deterioration. The fascia board is rotten and insect damaged and should be replaced.
-

*Photo 4: Brick Pier with loose brick.*

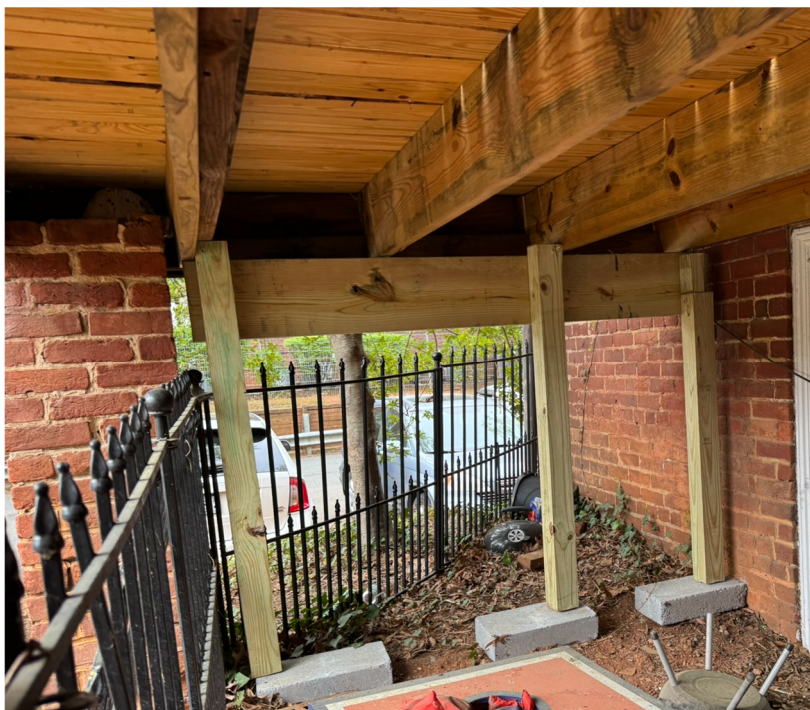
*Photo 5: Front porch with wood posts and CMU foundations.*

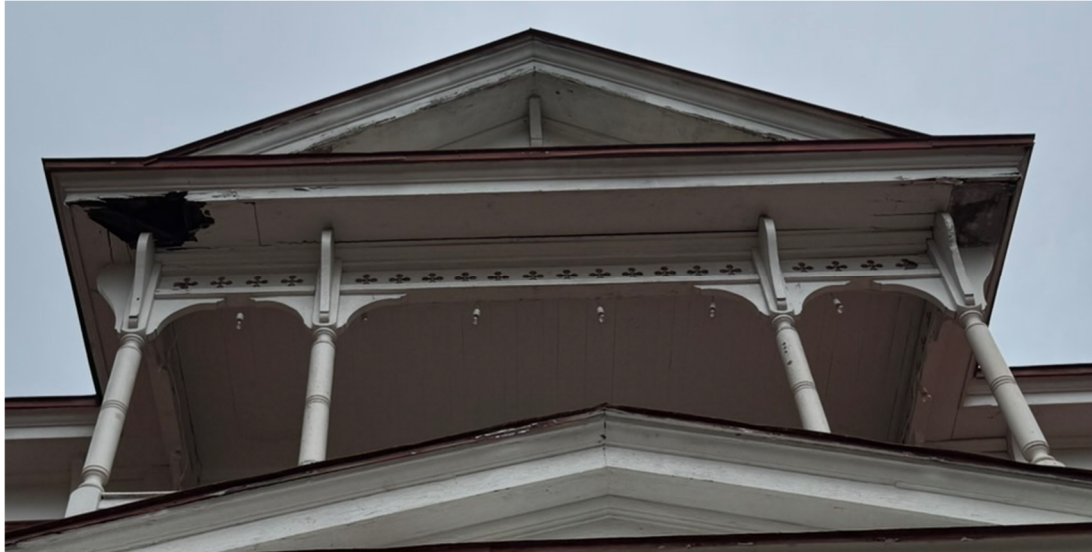
- The **roof overhangs** show significant rot and damage with several holes in the ceiling overhang that allow animal intrusion. These should be sealed up or repaired.

*Photo 6: Front balcony with damaged soffit.*

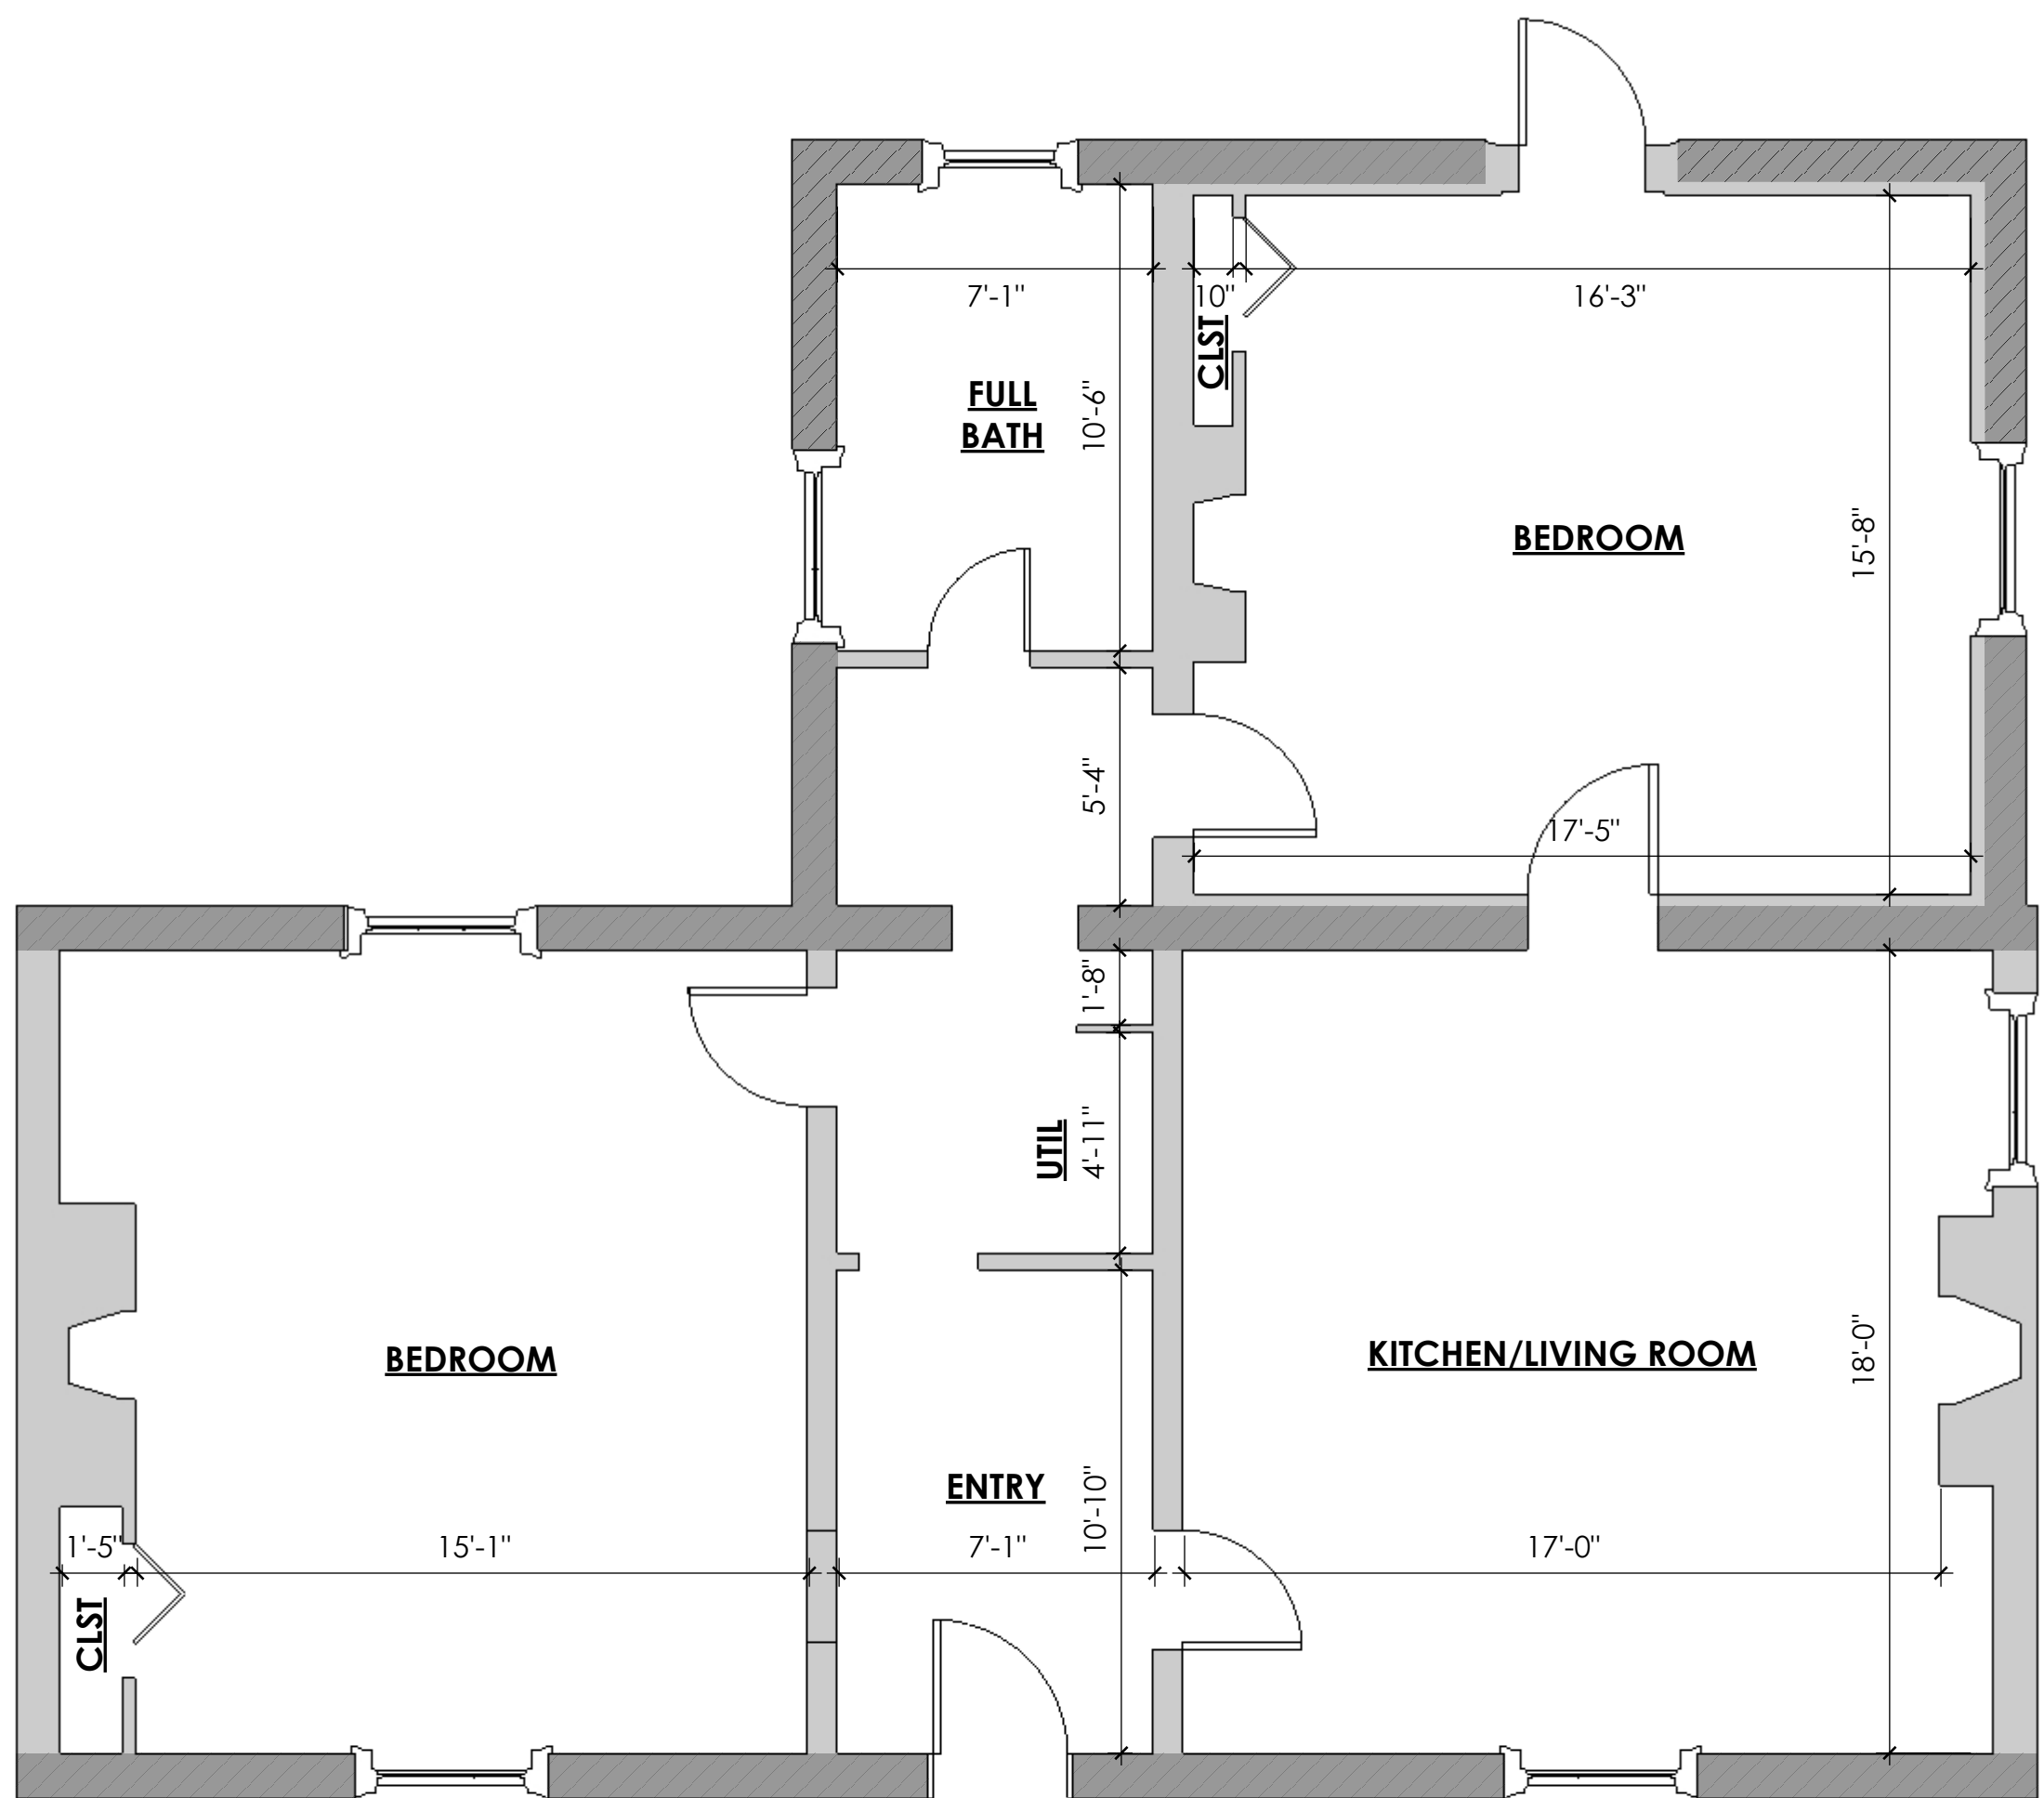
1  
SK1

EXISTING - LOWER FLOOR

1/4" = 1'-0"

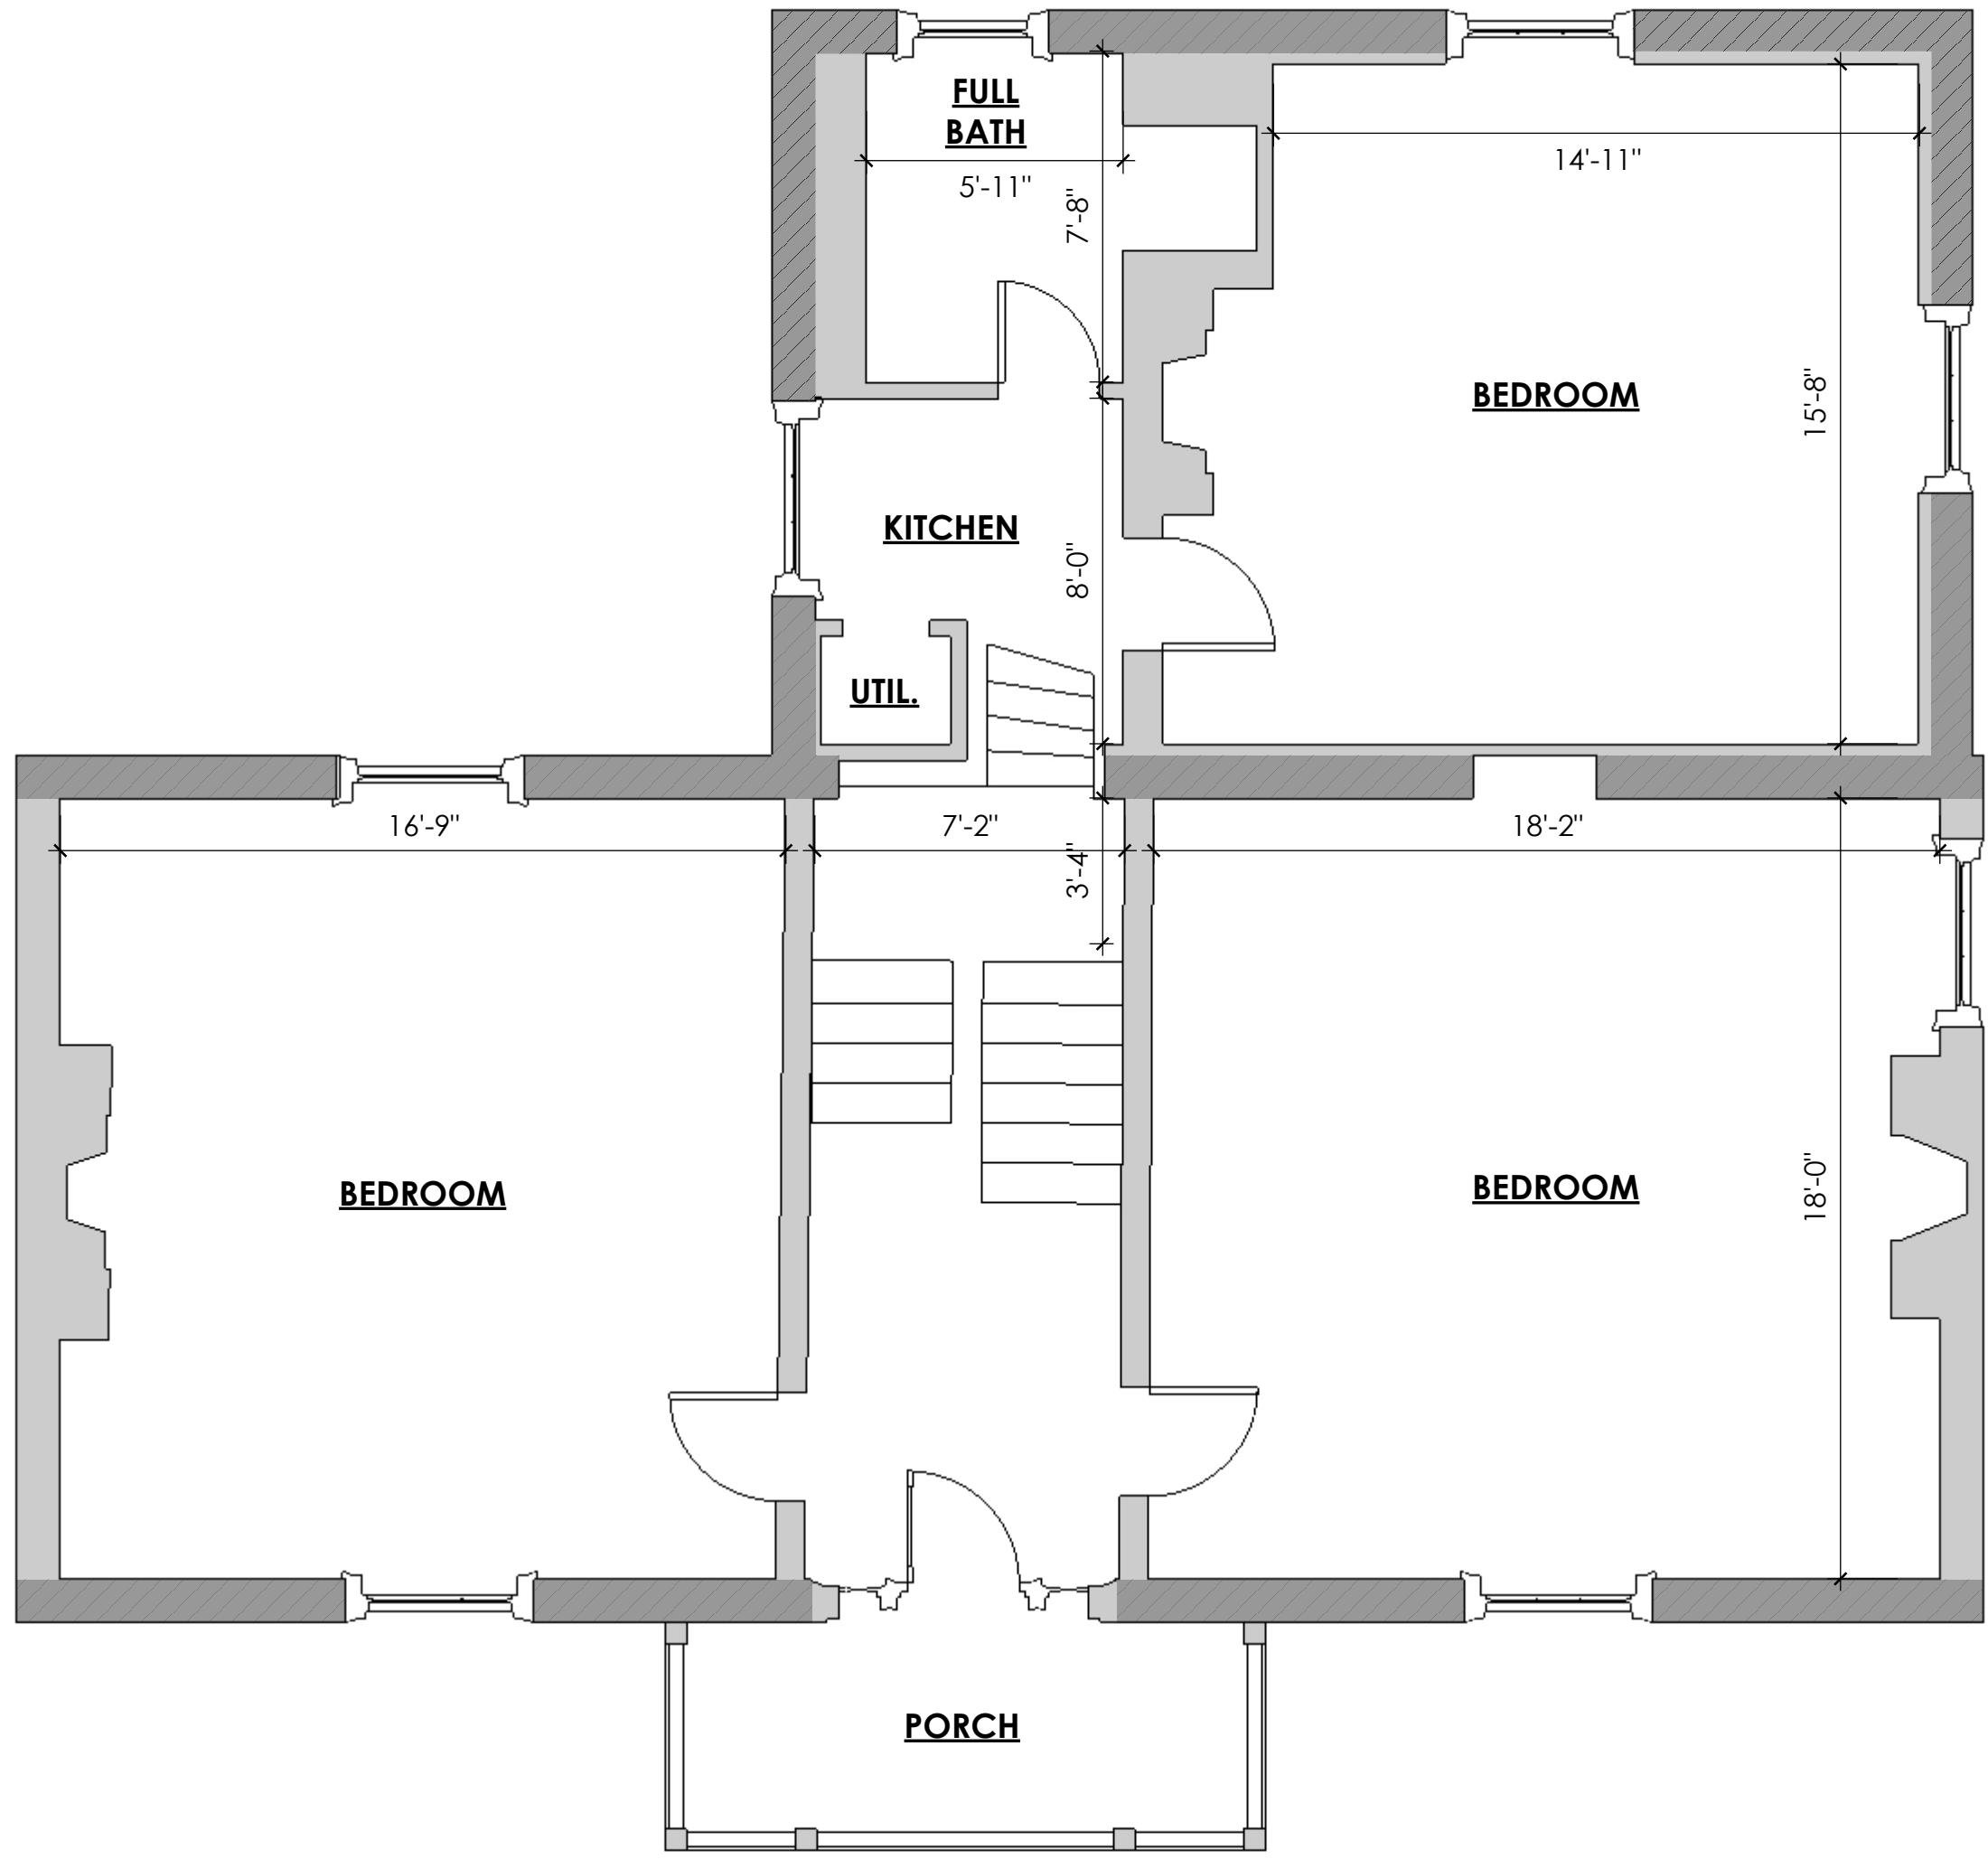
1  
SK3

EXISTING - UPPER FLOOR
