**OLD ALBEMARLE COUNTY JAIL  
PERIMETER WALL STUDY**

**4<sup>th</sup> Street NE  
Charlottesville, Virginia**

Prepared May 28, 2014  
for  
Albemarle County Public Services  
401 McIntire Road  
Charlottesville, Virginia 22902-4596

**Daniel S. Suggs Engineering**  
*Consulting Engineers*

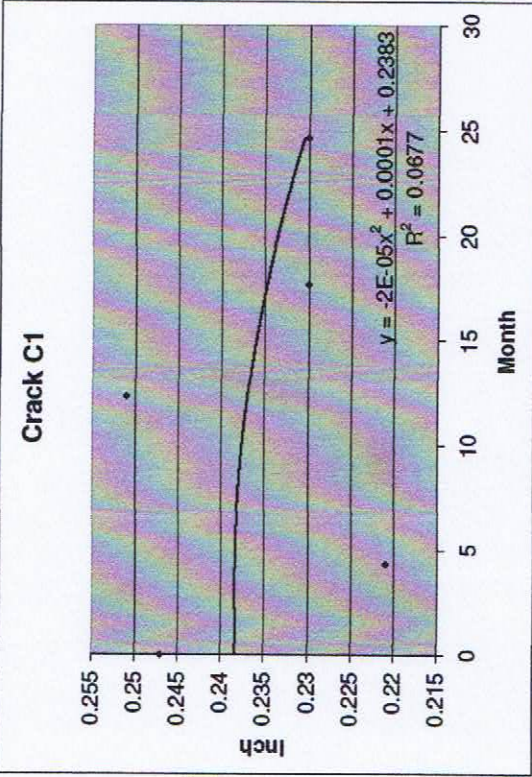
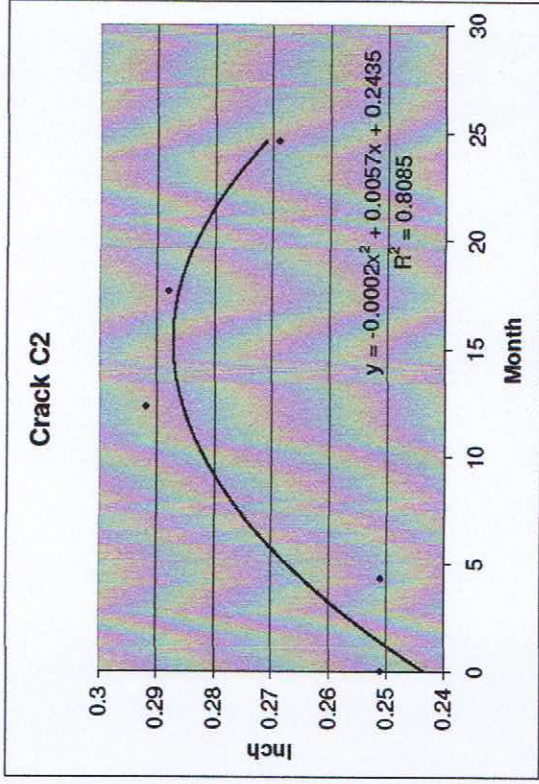
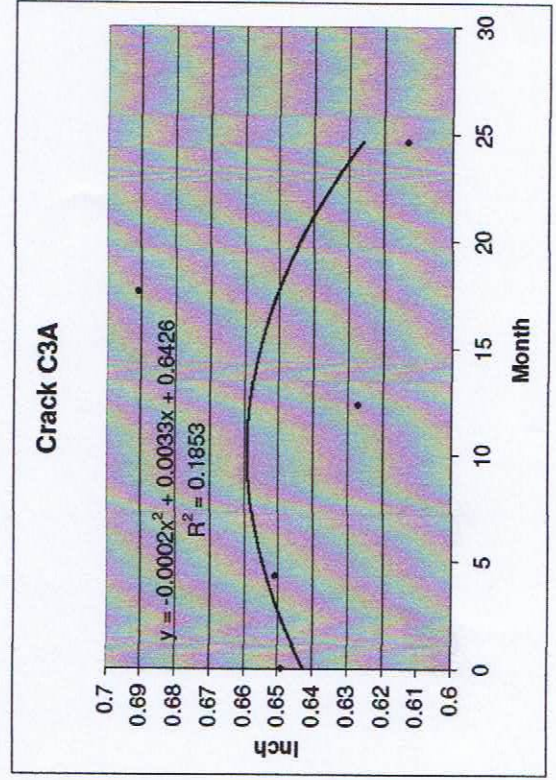
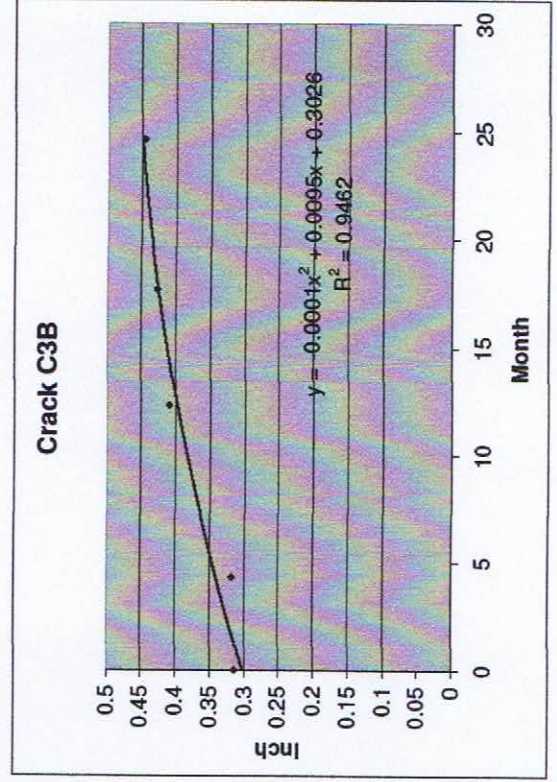
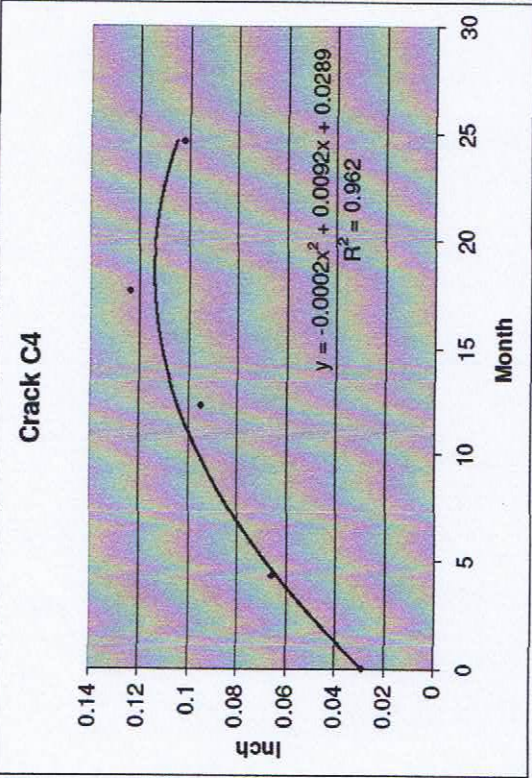
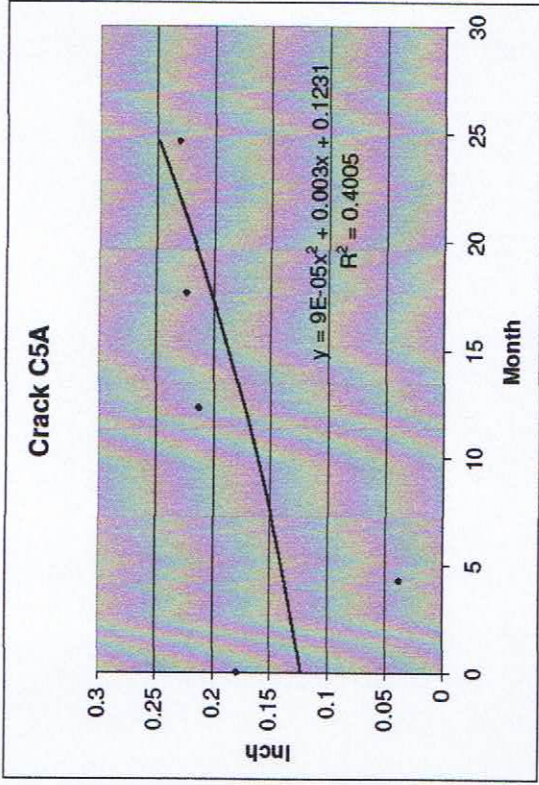
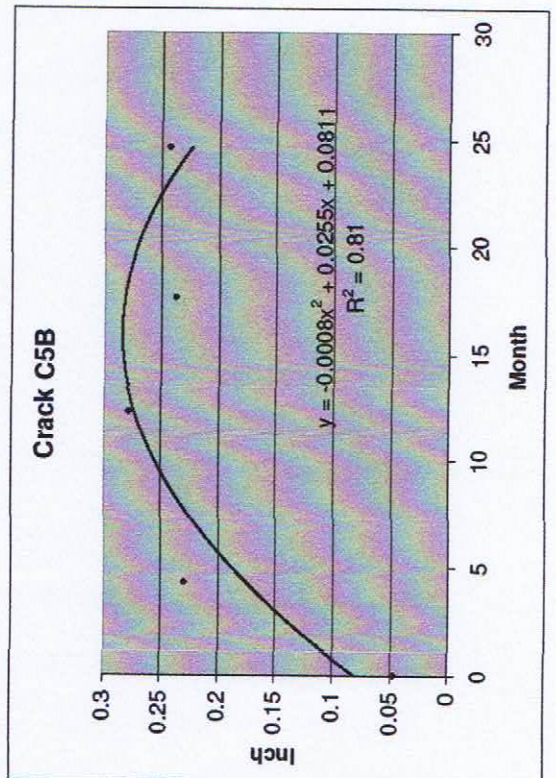
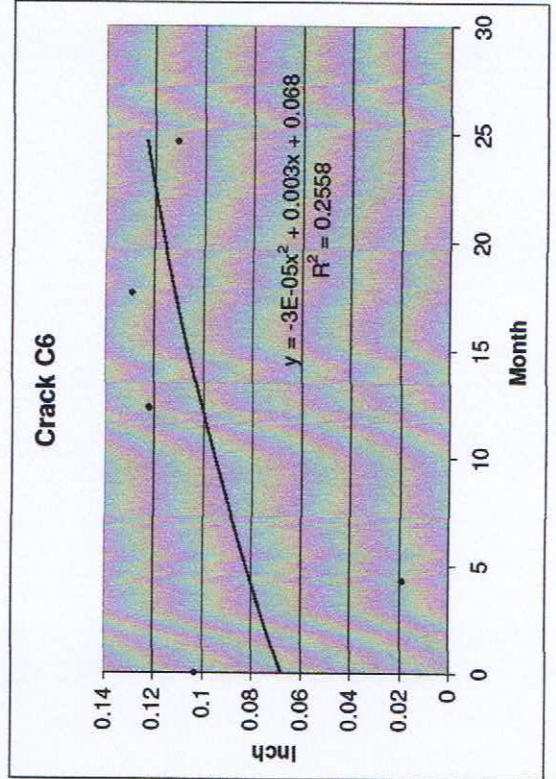
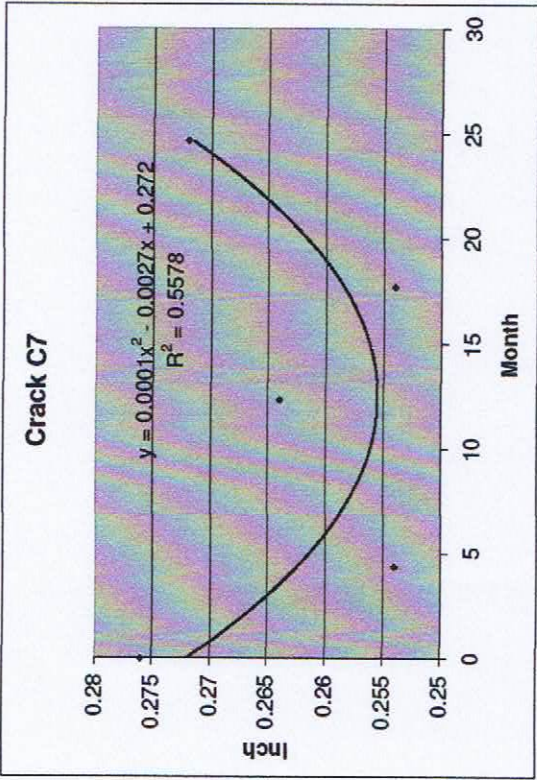
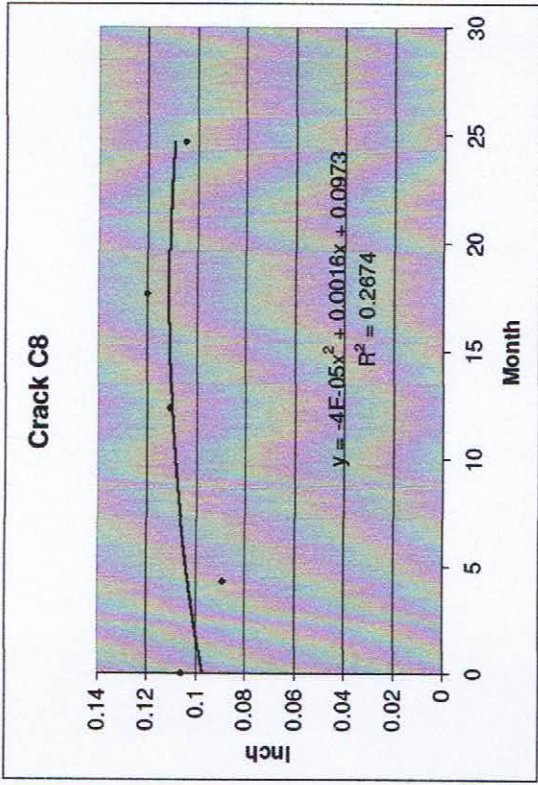
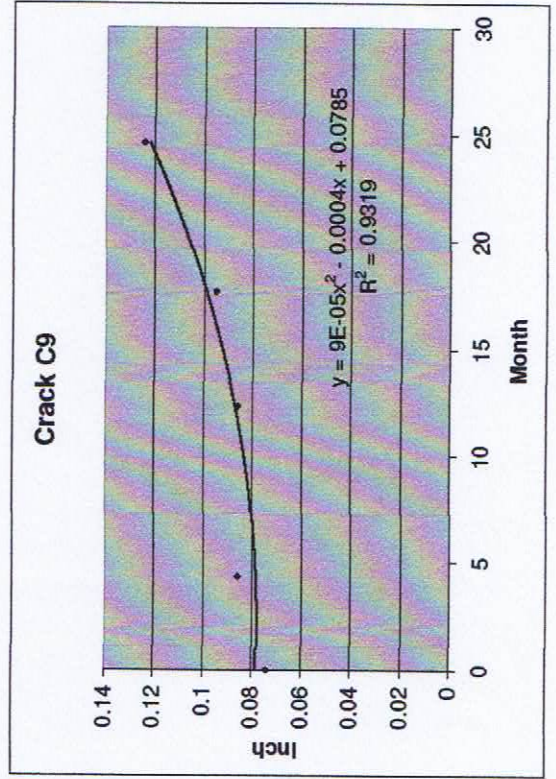
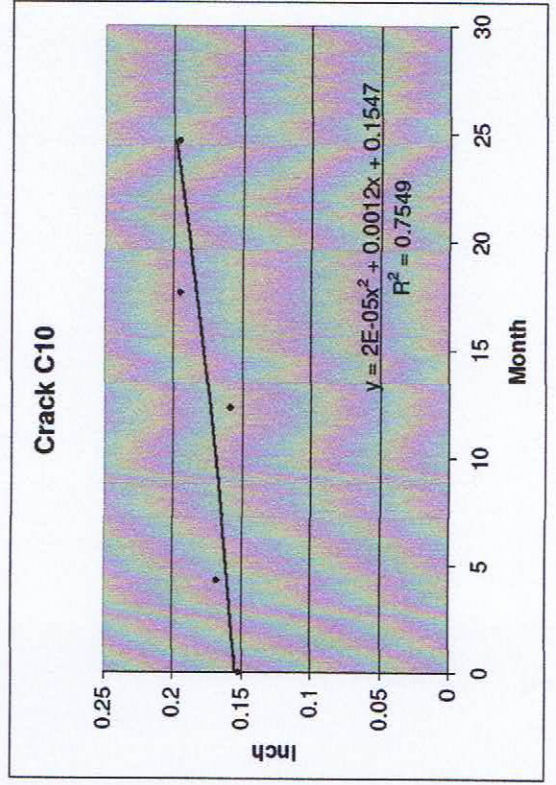
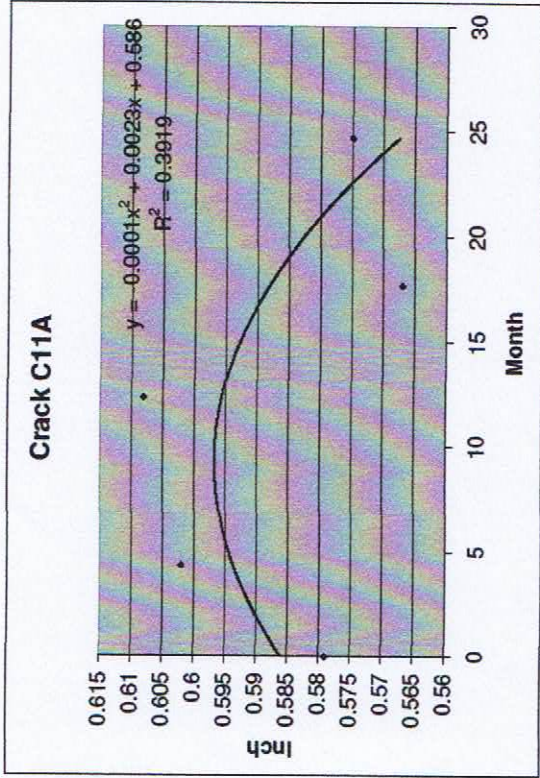
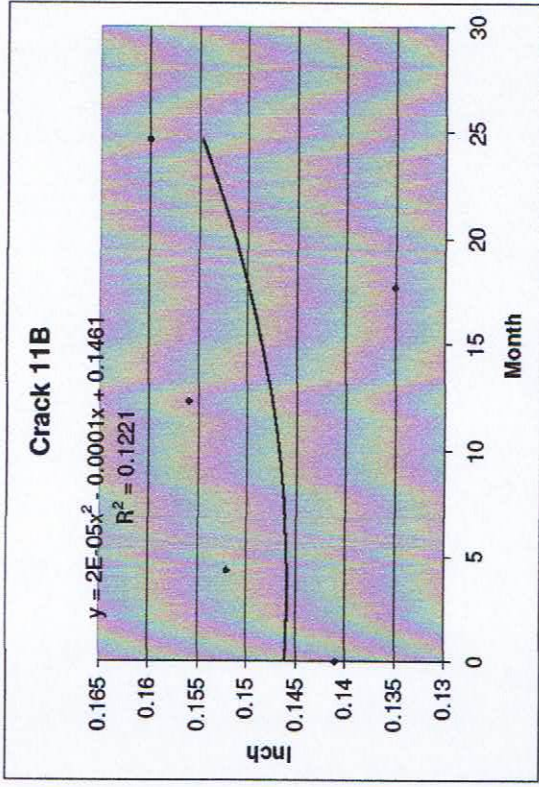
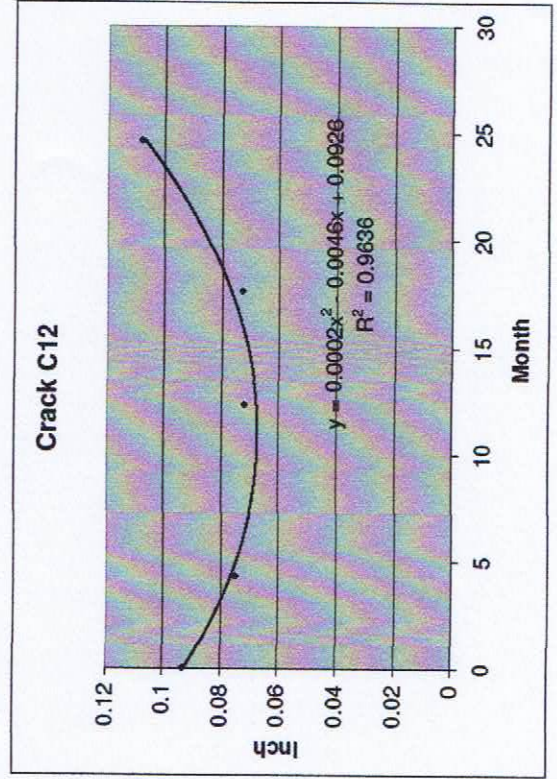
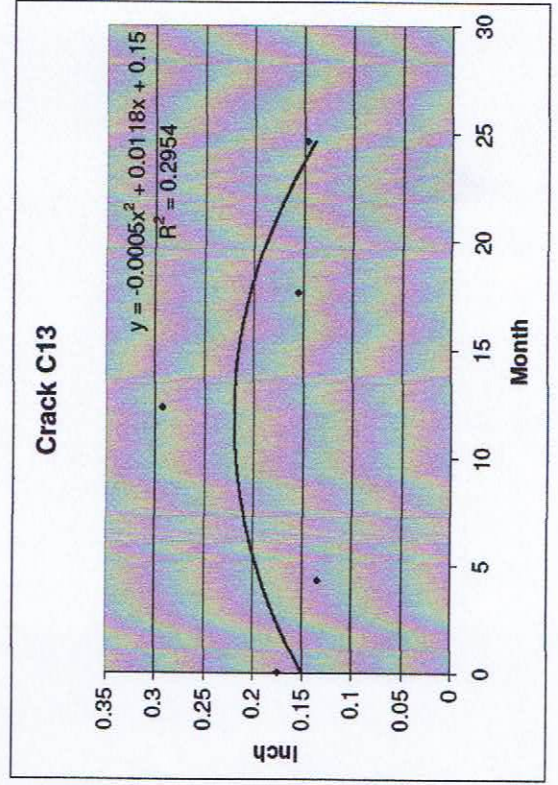
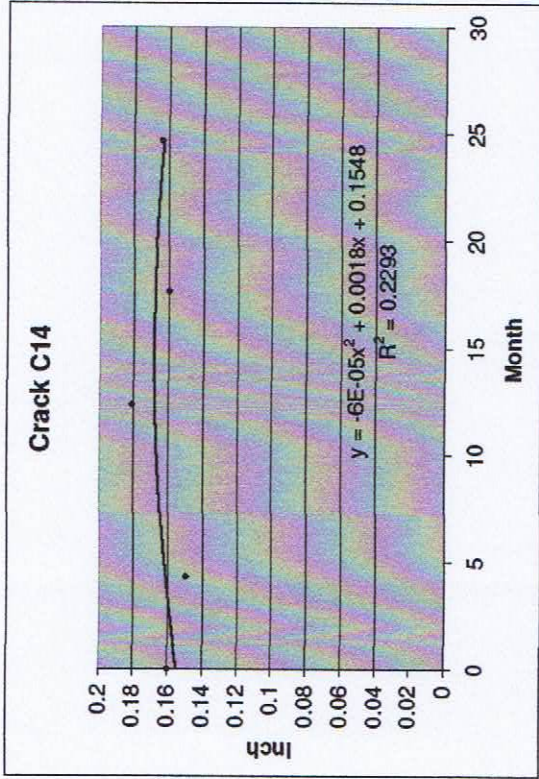
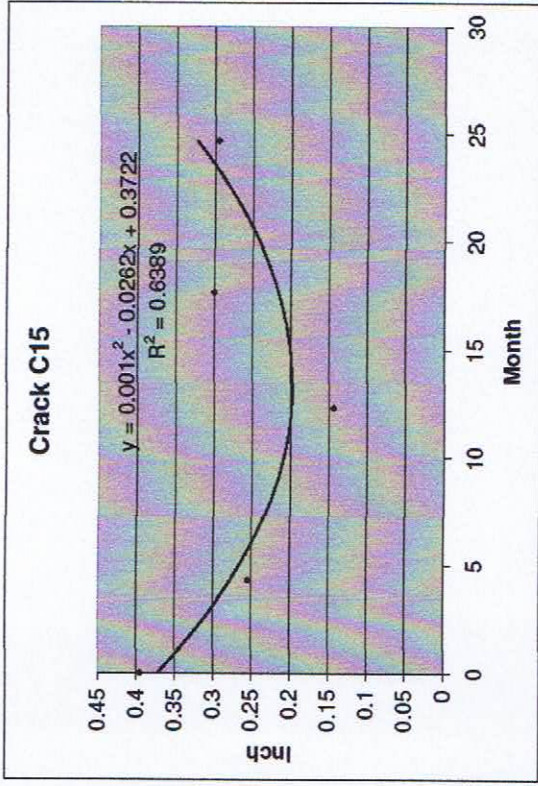
# Cracks

Wall Crack ID	Crack Location	Crack Width Projection Equation	Curve Fit to Data	Comments
C1	South wall, outer wythe, at sally port entrance	$Y = -0.00002 x^2 + 0.0001 x + 0.2383$	Poor	Crack likely caused by stresses resulting from settlement of the west corner of the sally port, and mortar and brick loss each side of the sally port entrance.
C2	West wall, outer wythe	$Y = -0.0002 x^2 + 0.0057 x + 0.2435$	Good	Nonlinear movement most likely caused by settlement of southwest corner pilaster.
C3A	West wall, outer wythe, at northeast pilaster	$Y = -0.0002 x^2 + 0.0033 x + 0.6426$	Poor	Likely cause of crack is previously removed large tree.
C3B	West wall, outer wythe, at northwest pilaster	$Y = -0.0001 x^2 + 0.0095 x + 0.3026$	Very Good	Crack likely started by previously removed large tree. Active crack width has been increasing over time. May be linked to settlement of northwest pilaster or rotting root system of removed tree.

C4	North wall, outer wythe, at location of removed slab	$Y = -0.0002 x^2 + 0.0092 x + 0.0289$	Very Good	Crack likely due to foundation settlement and/or mortar deterioration. Possibly stabilizing.
C5A	North wall, outer wythe, at pilaster near coal shoot gate	$Y = 0.00009 x^2 + 0.003 x + 0.1231$	Fair	Latter data indicates stabilizing. Crack likely caused by wall foundation settlement near northeast corner.
C5B	North wall, outer wythe, at pilaster near coal shoot gate	$Y = -0.0008 x^2 + 0.0255 x + 0.0811$	Good	Crack stabilizing. Crack is continuation of C5A. Crack likely caused by foundation settlement near northeast corner.
C6	North wall, outer wythe, at northeast pilaster	$Y = -0.00003 x^2 + 0.003 x + 0.068$	Poor	Latter data indicates stabilizing. Crack likely caused by foundation settlement at northeast corner.
C7	East wall, outer wythe, at northeast pilaster	$Y = 0.0001 x^2 - 0.0027 x + 0.272$	Fair	Active crack. Crack due to settling of northeast pilaster.

C8	South wall, inner wythe, at interior entrance to sally port	$Y = -0.00004 x^2 + 0.0016 x + 0.0973$	Poor	Data limited to a very narrow range. Crack is fairly stable.
C9	South wall, inner wythe, near southeast corner	$Y = 0.00009 x^2 - 0.0004 x + 0.0785$	Very Good	Crack is active with constantly increasing width. Crack is increasing in length. Crack caused by settling of southwest pilaster.
C10	South wall, inner wythe, at base of southwest pilaster	$Y = 0.00002 x^2 + 0.0012 x + 0.1547$	Good	Crack active with increasing width. Crack likely caused by settlement of southwest pilaster.
C11A	West wall, inner wythe, at northwest pilaster	$Y = -0.0001 x^2 + 0.0023 x + 0.586$	Poor	Data may suggest shift in northwest pilaster. Active crack caused by tree, since removed.
C11B	West wall, inner wythe, at northwest pilaster	$Y = 0.00002 x^2 - 0.0001 x + 0.1461$	Poor	Data may suggest shift in northwest pilaster. Active crack caused by tree, since removed. Crack width increasing.

C12	West wall, foundation overlay, near northwest pilaster	$Y = 0.0002 x^2 - 0.0046 x + 0.0926$	Very Good	Crack width increasing. Crack likely due to rotting of tree roots and settling of foundation at same location—possibly due to rotting roots.
C13	North wall, inner wythe, northeast corner	$Y = -0.0005 x^2 + 0.0118 x + 0.15$	Poor	Active crack. May be stabilizing. Crack likely caused by settlement of northeast corner.
C14	North wall, inner wythe, northeast corner	$Y = -0.00006 x^2 + 0.0018 x + 0.1548$	Fair	Crack appears stable. Crack likely due to settling of northeast corner. Excessive mortar loss below crack is influencing this crack.
C15	North wall, inner wythe, at northeast pilaster	$Y = 0.001 x^2 - 0.0262 x + 0.3722$	Good	Crack is active. Crack likely caused by foundation settling of northeast corner.

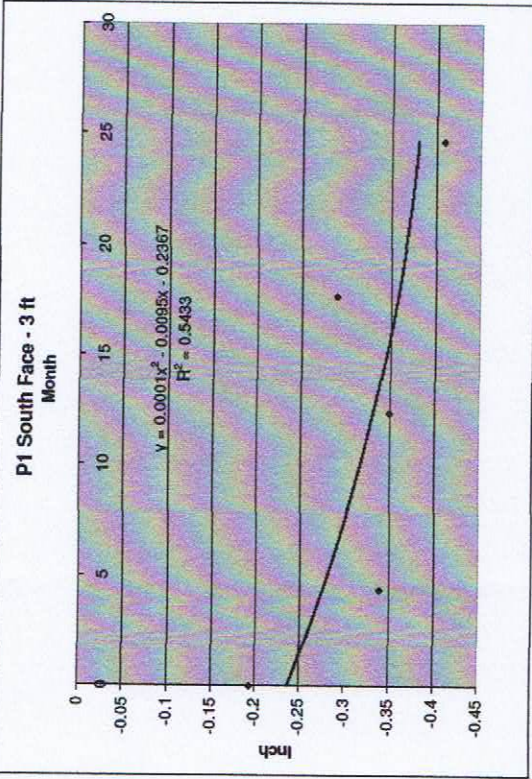
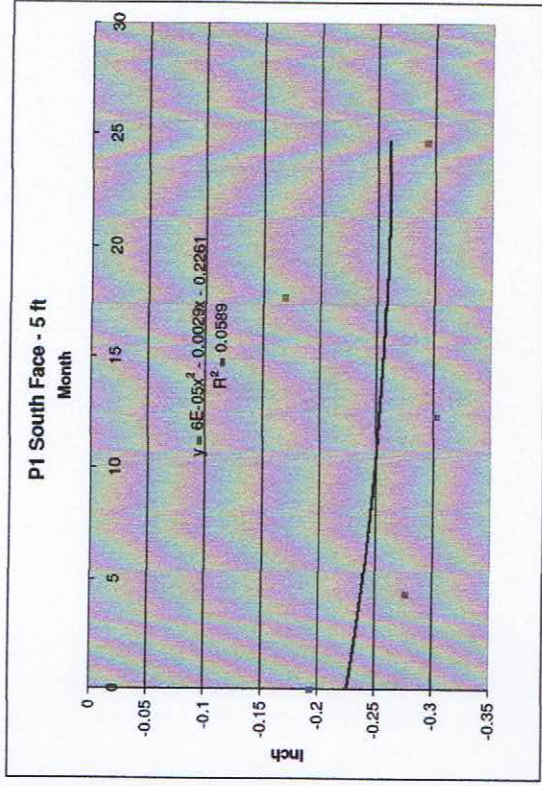
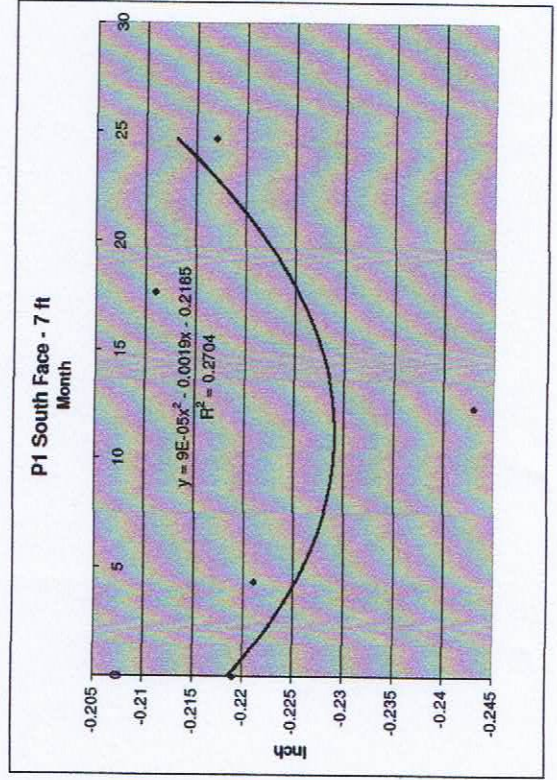
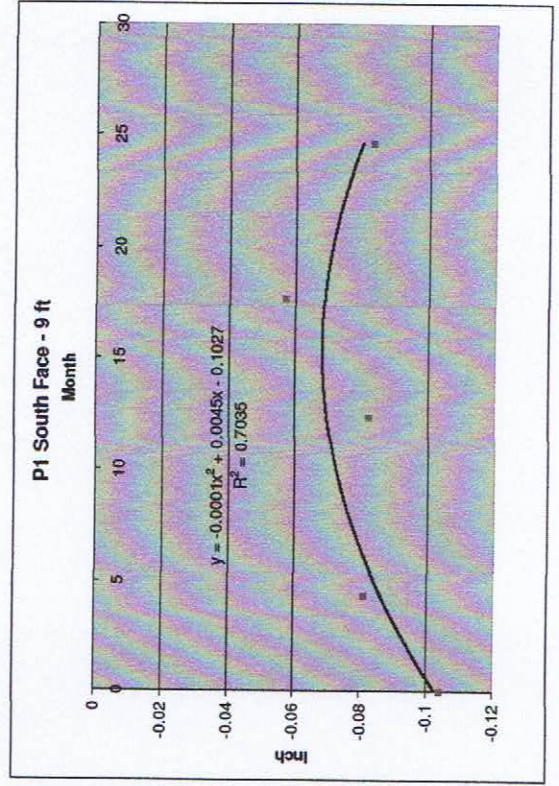
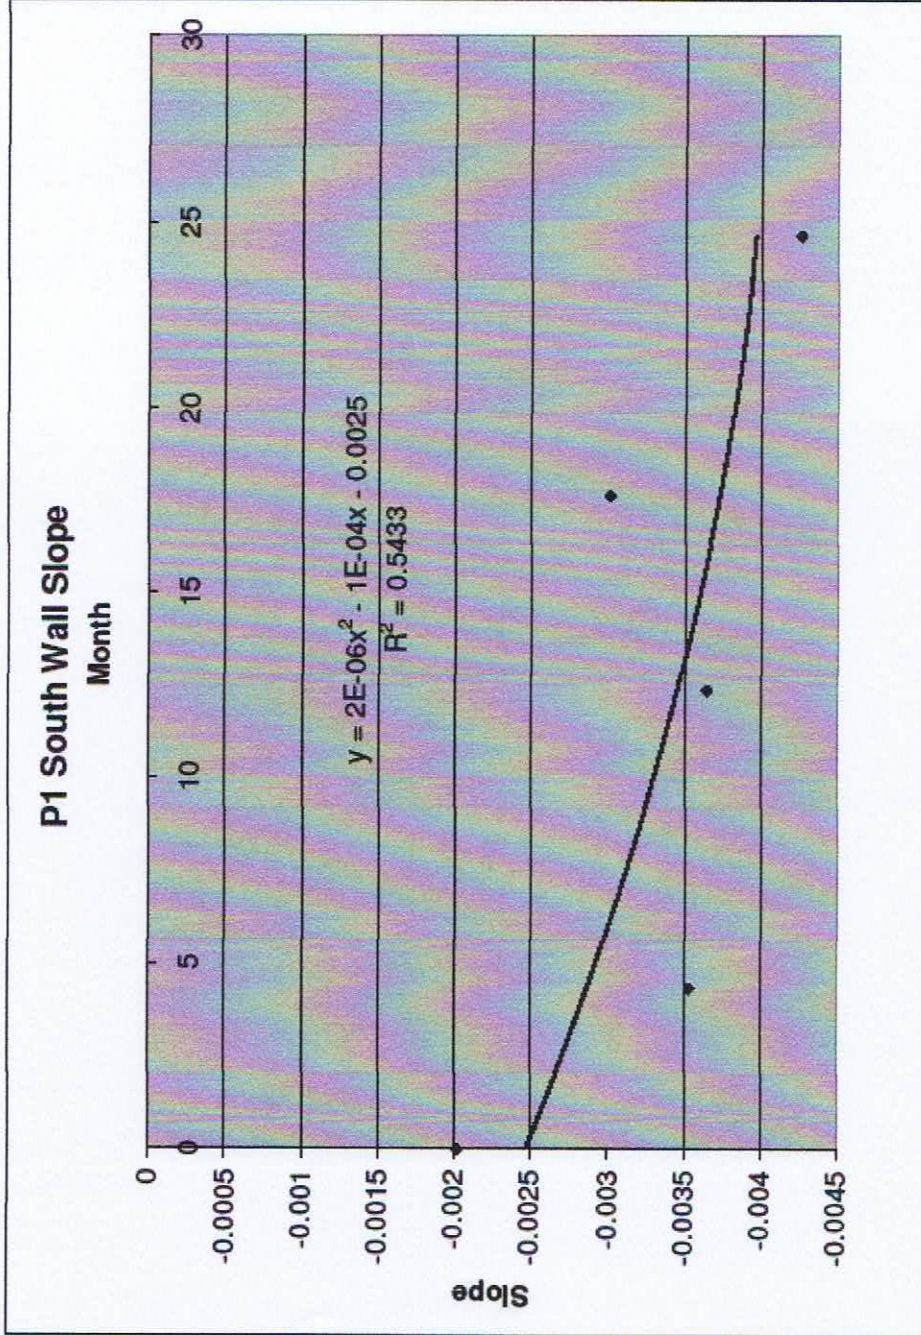
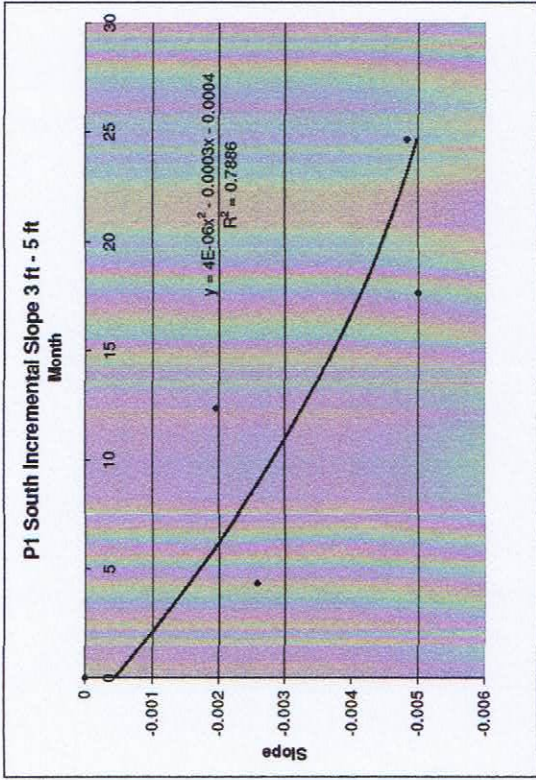
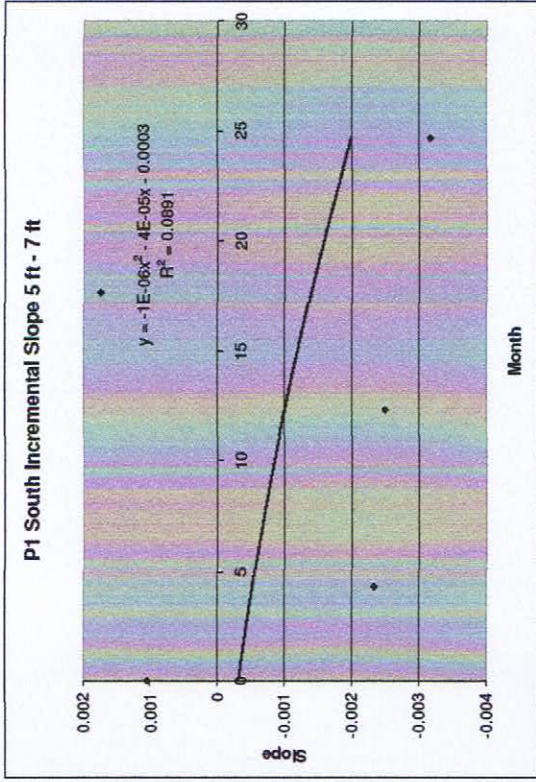
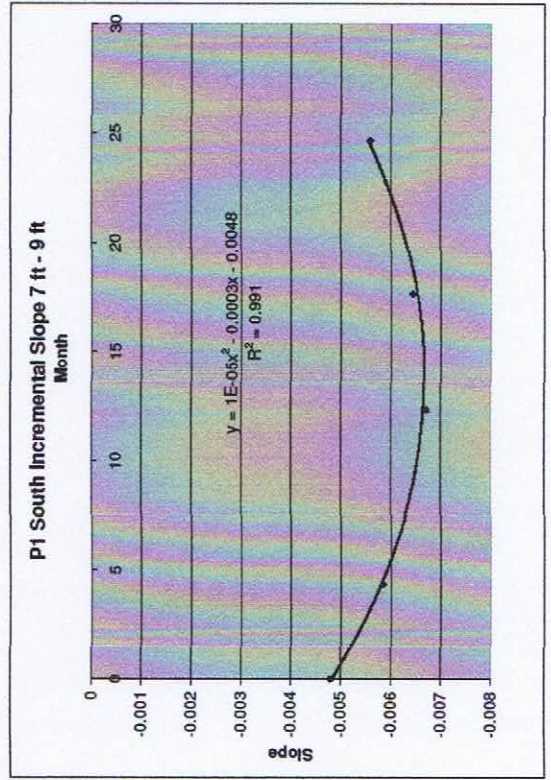
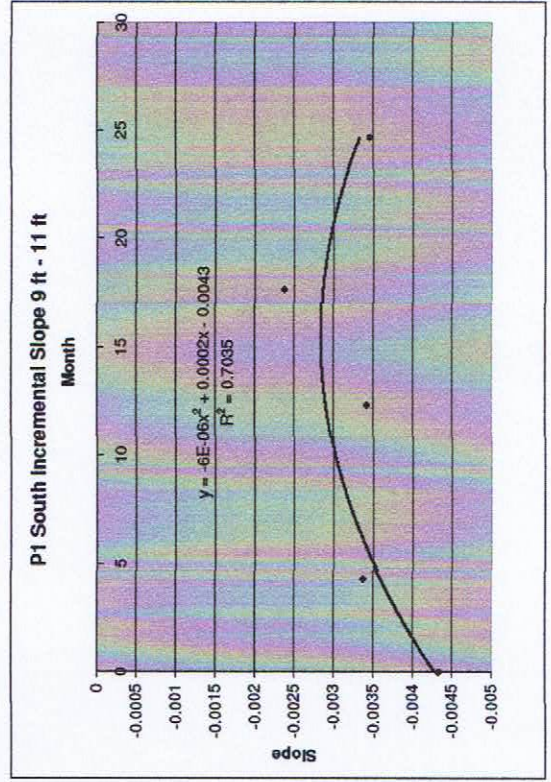
# Pilaster 1

Pilaster ID	Pilaster Location	Segment Location (Feet)	Incremental Slope Projection Equation	Curve Fit to Data	Comments
P1, South Plane	Southwest corner, south inner face	Overall	$Y = 0.000002 x^2 - 0.0001 x - 0.0025$	Fair	Increasing movement trend in an inward tilt with possible start of stabilization.
		3-5	$Y = 0.000004 x^2 - 0.0003 x - 0.0004$	Good	Increasing movement trend in an inward tilt.
		5-7	$Y = -0.000001 x^2 - 0.0004 x - 0.0003$	Poor	Increasing trend in an inward tilt; however, rate of change significantly less than Segment 3-5'.
		7-9	$Y = 0.00001 x^2 - 0.0003 x - 0.0048$	Very Good	Significantly more polynomial vs. linear, suggesting a greater brick and mortar deterioration influence on movement. Graph suggests a shift toward outward movement of pilaster face.
		9-11	$Y = -0.000006 x^2 + 0.0002 x - 0.0043$	Good	Significantly more polynomial vs. linear. Graph suggests a moderating of wall section movement with possible stabilization.

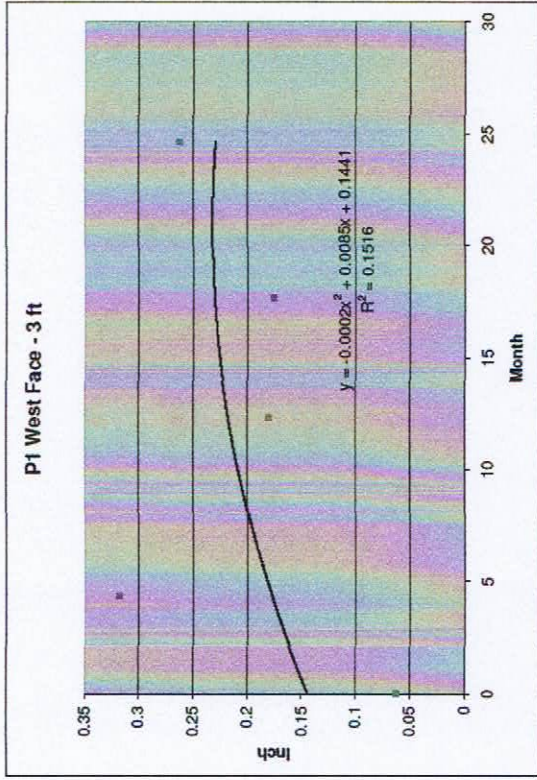
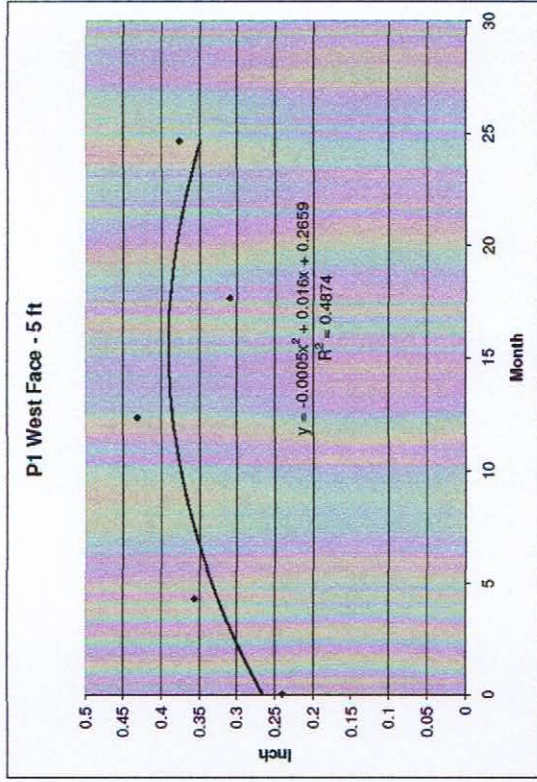
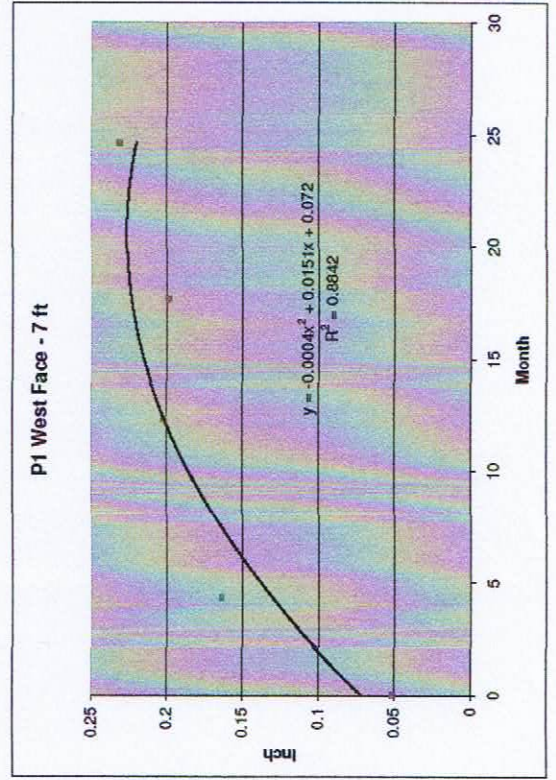
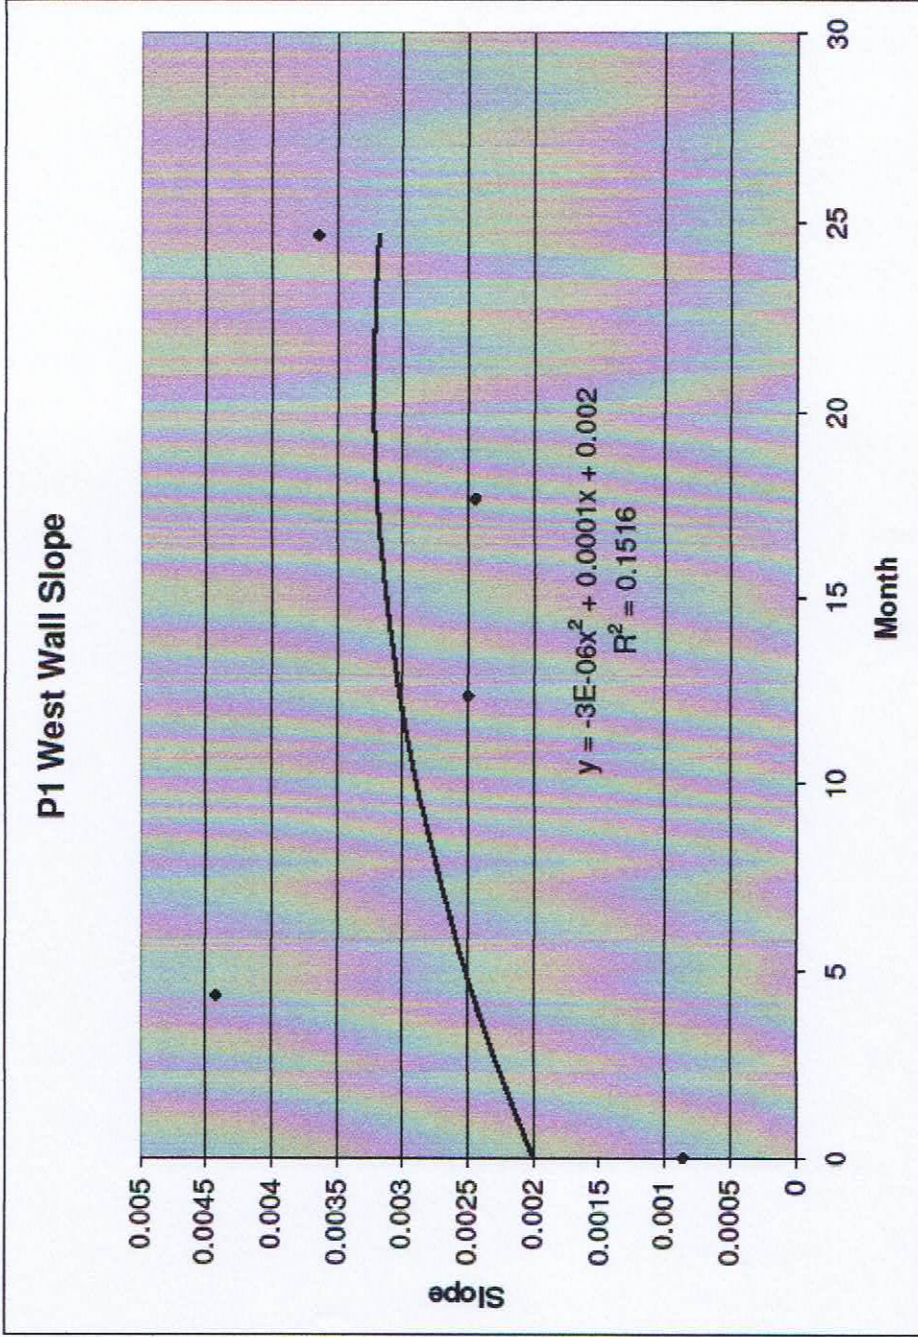
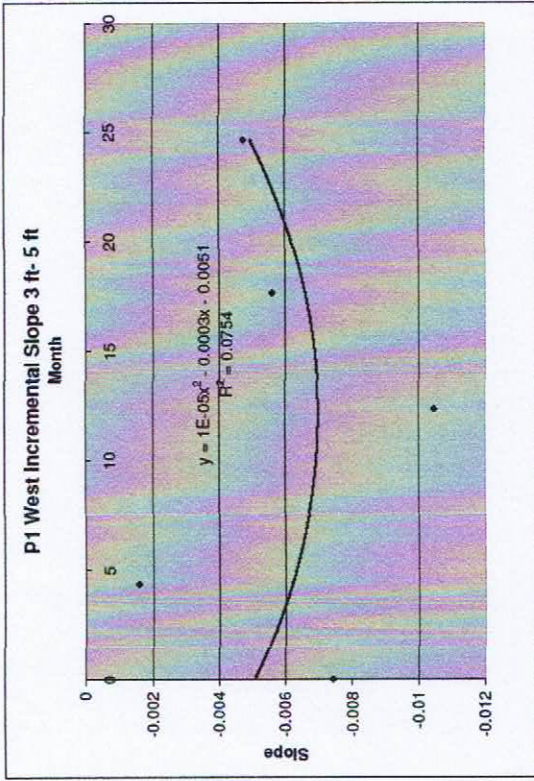
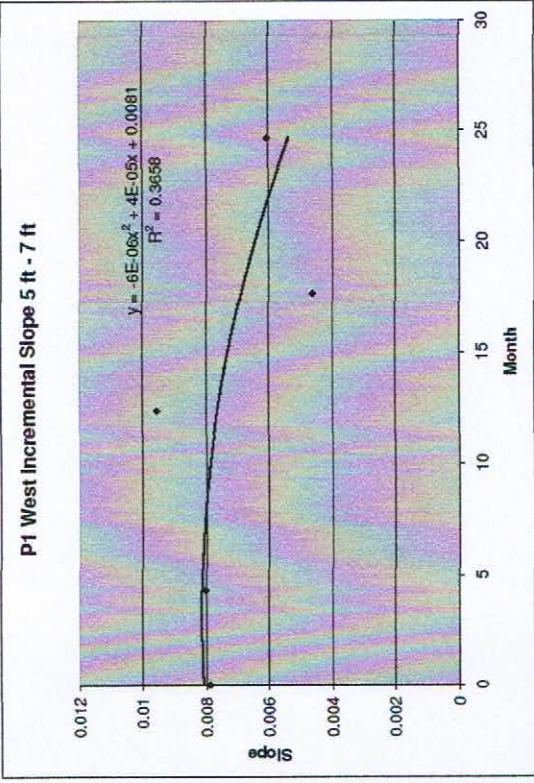
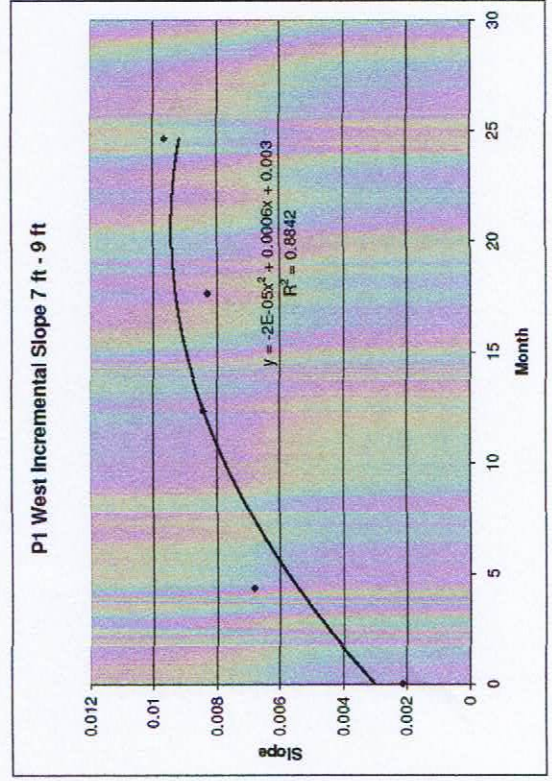
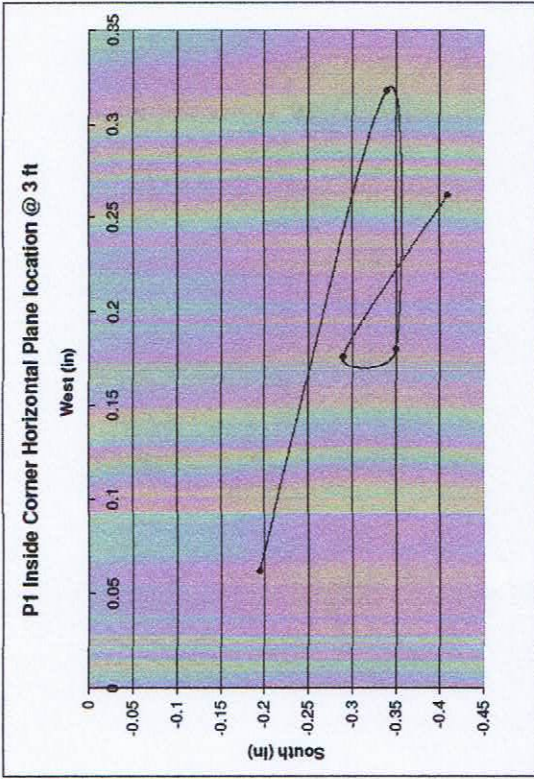
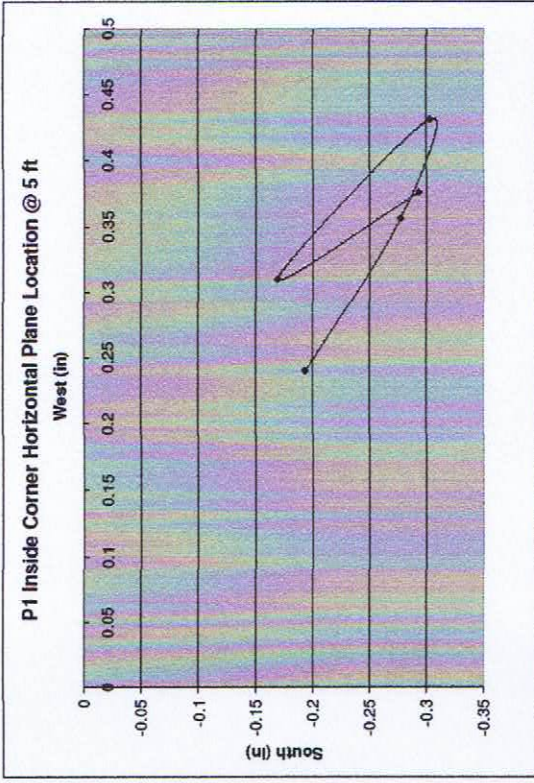
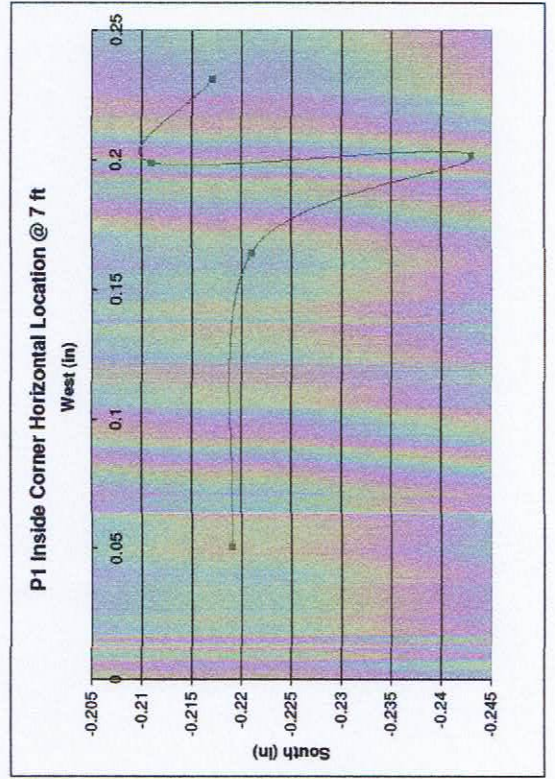
# Pilaster 1

Pilaster ID	Pilaster Location	Feet Above Fdtn Wall	Measurement Projection Equation	Curve Fit to Data	Comments
P1, West Plane	Southwest corner, west inner face	3	$Y = -0.0002x^2 + 0.0085x + 0.1441$	Poor	Stabilization of outward movement suggested.
		5	$Y = -0.0005x^2 + 0.016x + 0.2659$	Fair	Stabilization of outward movement suggested.
		7	$Y = -0.0004x^2 + 0.0151x + 0.072$	Very Good	Stabilization of outward movement suggested.

Pilaster ID	Wall Slope Location	Segment Location (Feet)	Incremental Slope Projection Equation	Curve Fit to Data	Comments
P1, West Plane	Southwest corner, west inner face	Overall	$Y = -0.000003x^2 + 0.0001x + 0.002$	Poor	Graph suggests increasing slope to the west with possible stabilization.
		3-5	$Y = 0.00001x^2 - 0.0003x - 0.0051$	Poor	Graph suggests possibly searching for stabilization with an inward tilt.
		5-7	$Y = -0.000006x^2 + 0.00004x + 0.0081$	Fair	Trending toward a decrease of westward slope.
		7-9	$Y = -0.00002x^2 + 0.0006x + 0.003$	Very Good	Trending toward an increase in westward slope with possible stabilization.

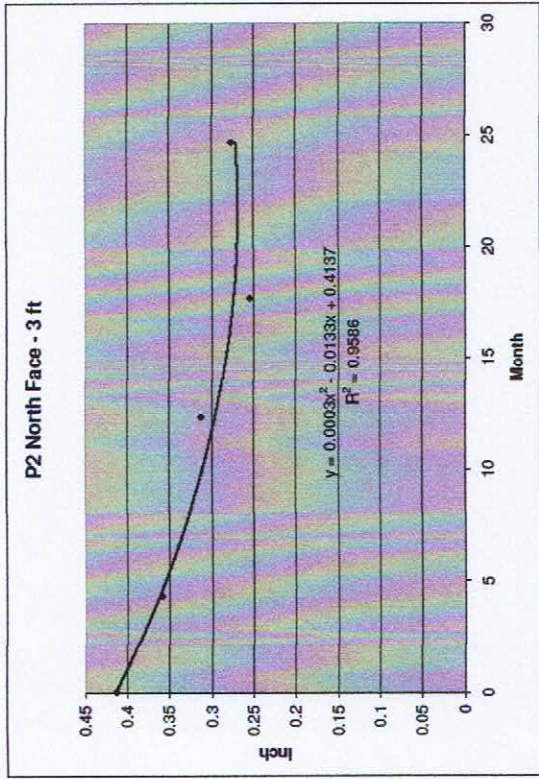
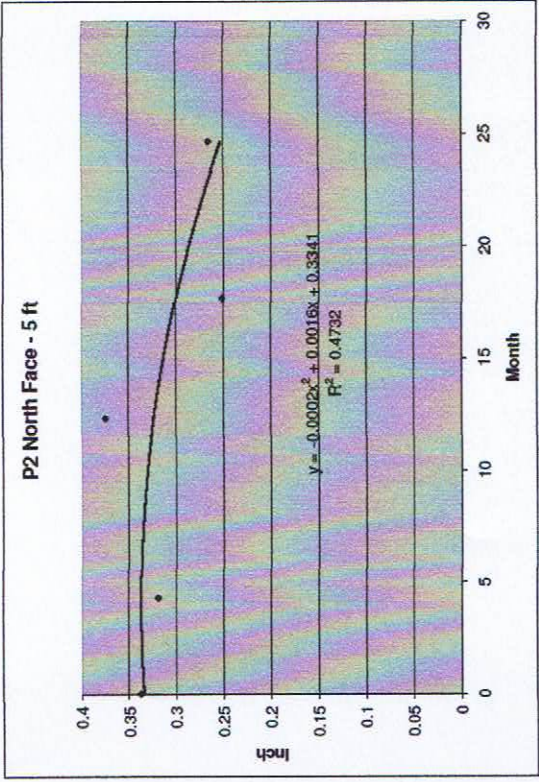
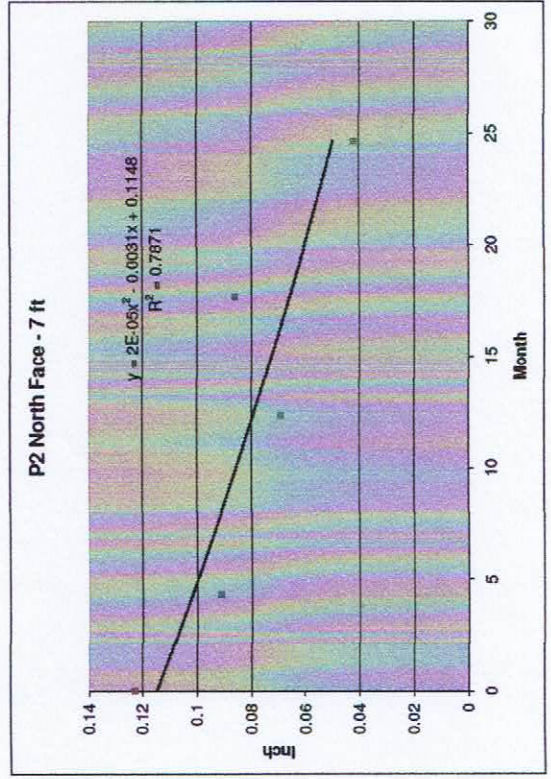
# Pilaster 2

Wall Slope Location	Segment Location (Feet)	Incremental Slope Projection Equation	Curve Fit to Data	Comments
P2, North Plane	Northwest corner, north wall inner face	Overall	$Y = 0.000004 x^2 - 0.0002 x + 0.0057$	Very Good	Plot suggests possible stabilization in northward slope.
		3-5	$Y = 0.00002 x^2 - 0.0006 x + 0.0033$	Good	Plot suggests increasing outward slope transitioning from inward slope or possible stabilization.
		5-7	$Y = -0.000009 x^2 + 0.0002 x + 0.0091$	Poor	Plot suggests possible stabilization.
		7-9	$Y = 0.0000008 x^2 - 0.0001 x + 0.0048$	Good	Plot suggests decreasing outward slope.
