**OLD ALBEMARLE COUNTY JAIL  
PERIMETER WALL STUDY**

**4<sup>th</sup> Street NE  
Charlottesville, Virginia**

Prepared May 28, 2014  
for  
Albemarle County Public Services  
401 McIntire Road  
Charlottesville, Virginia 22902-4596

**Daniel S. Suggs Engineering**  
*Consulting Engineers*

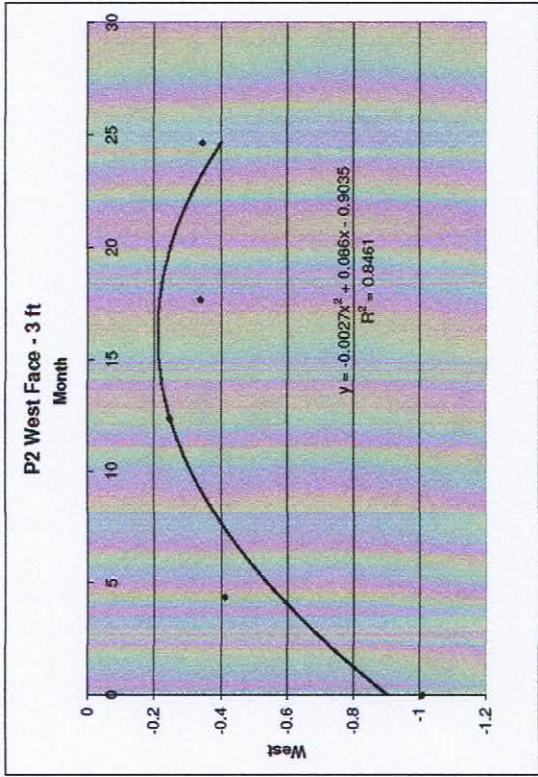
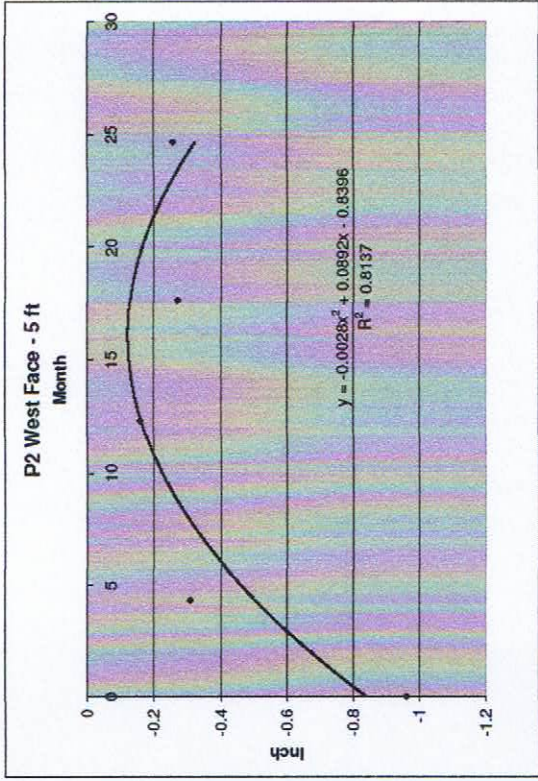
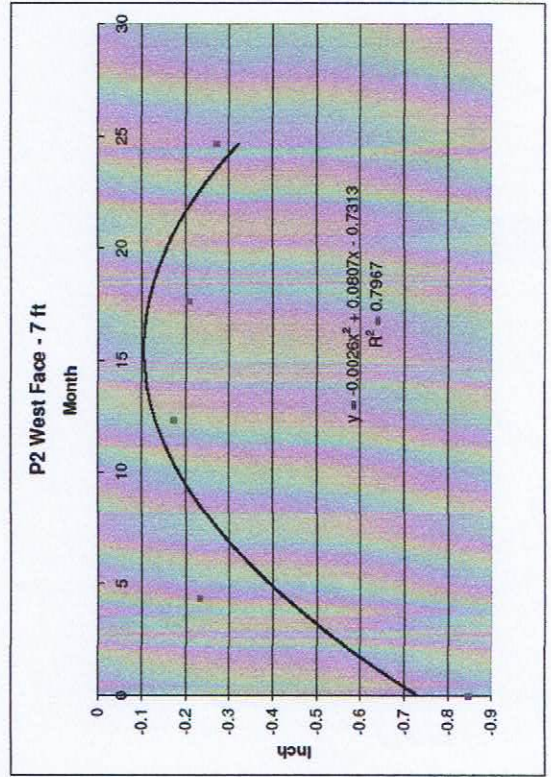
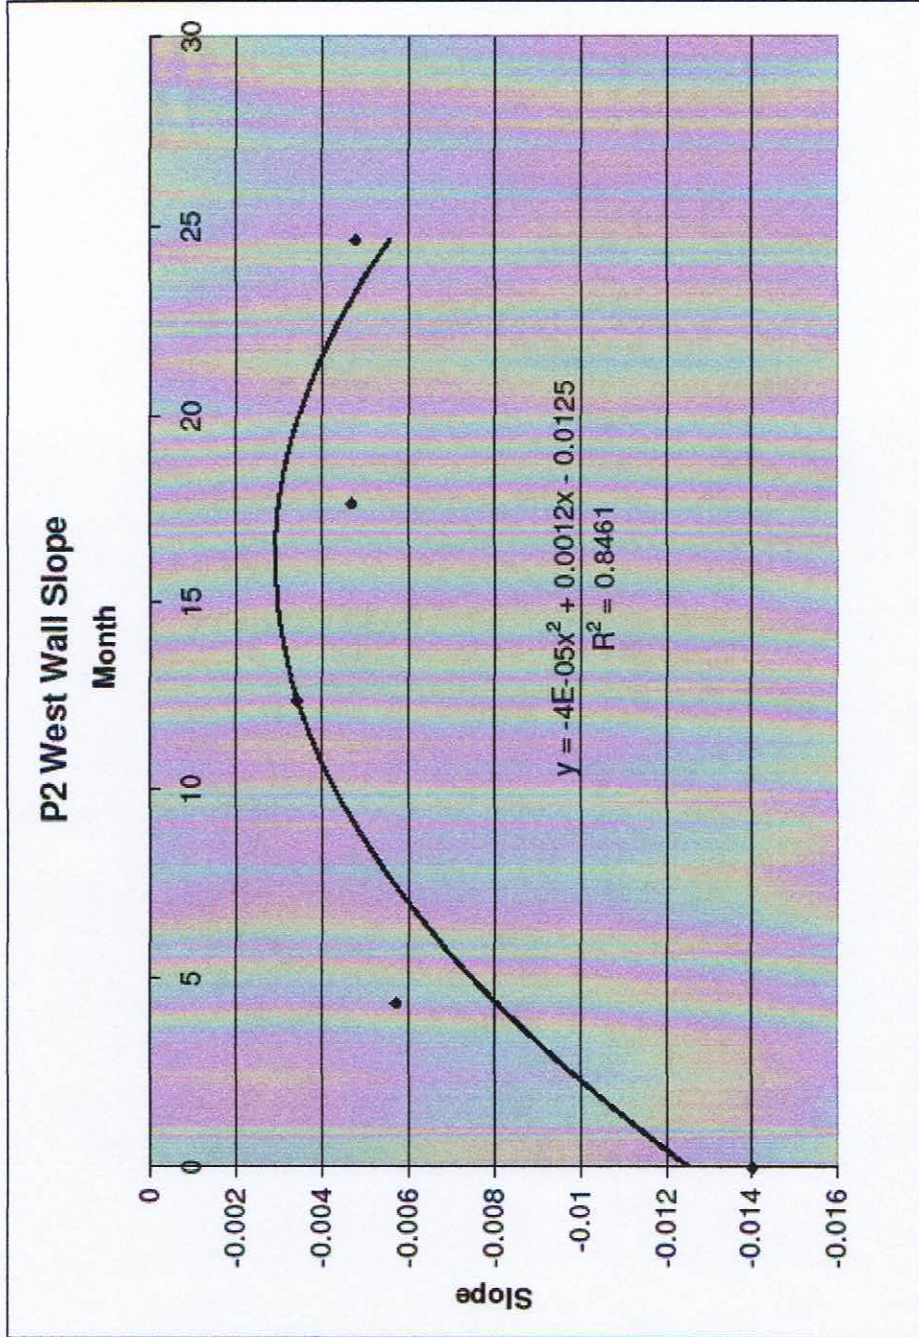
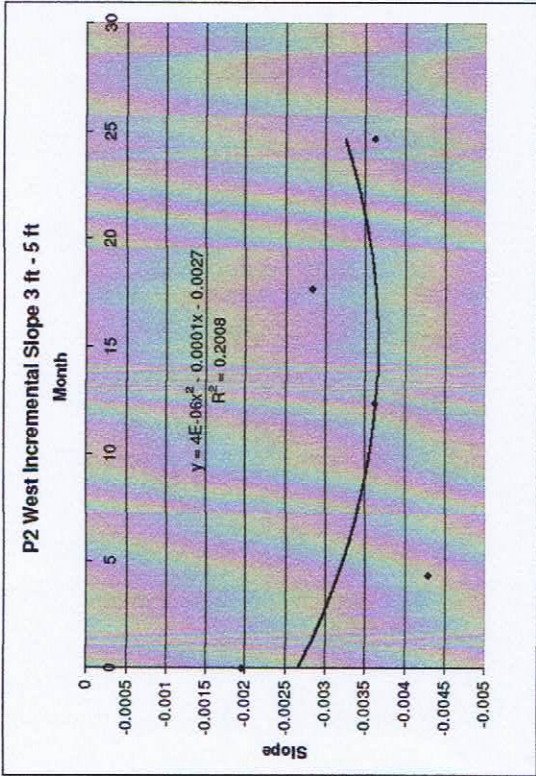
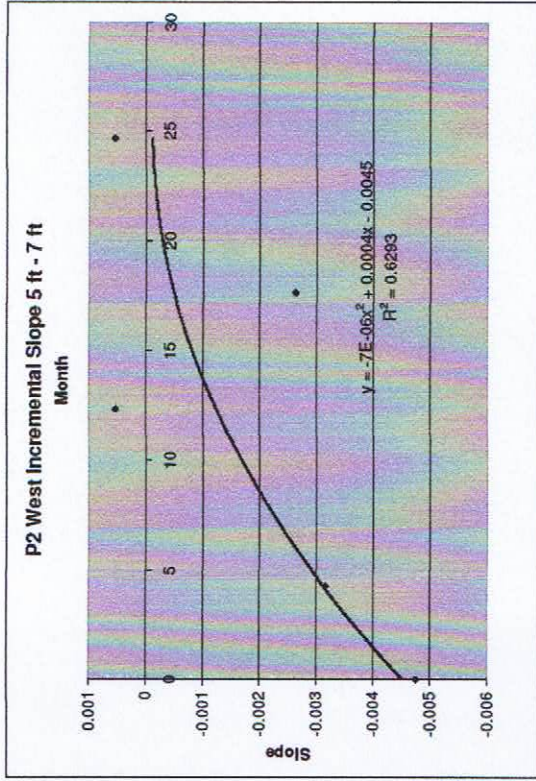
# Pilaster 2

Wall Slope Location	Segment Location (Feet)	Incremental Slope Projection Equation	Curve Fit to Data	Comments
<b>P2, West Plane</b>	Southwest corner, west inner face	Overall	Very Good	Graph suggests increasing slope to the west with possible stabilization.
	3-5	$Y = -0.00004x^2 + 0.0012x - 0.0125$	Poor	Graph suggests possibly searching for stabilization with an inward tilt.
	5-7	$Y = -0.000007x^2 + 0.0004x - 0.0045$	Good	Trending toward a decrease of westward slope.
	7-9	$Y = -0.0001x^2 + 0.0034x - 0.0305$	Good	Trending toward an increase in westward slope with possible stabilization.

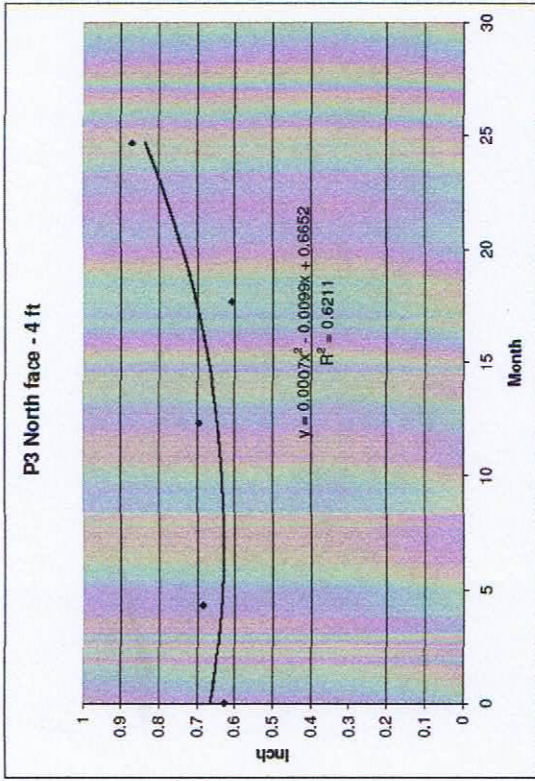
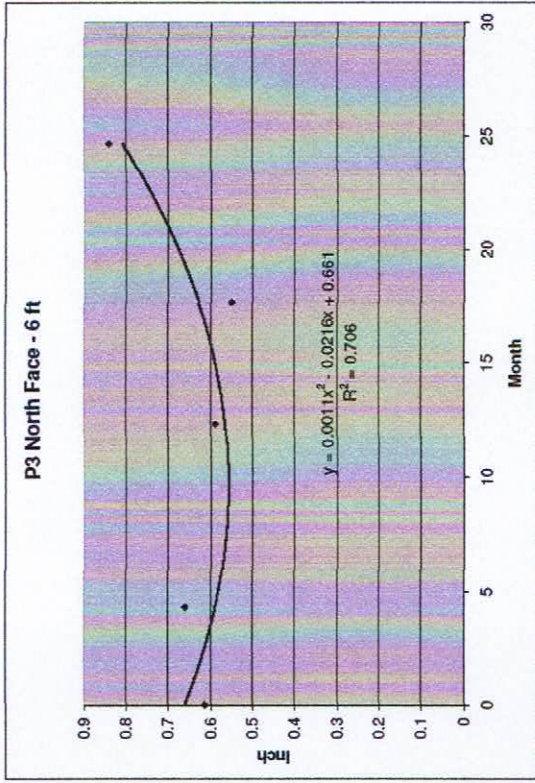
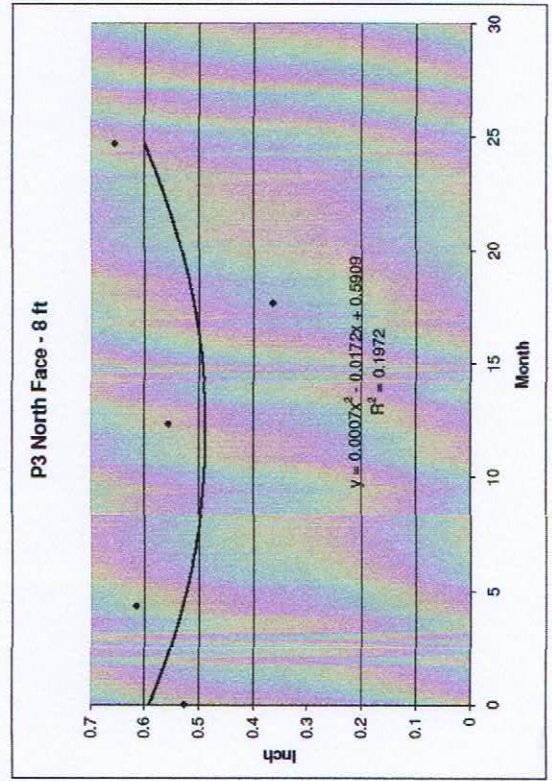
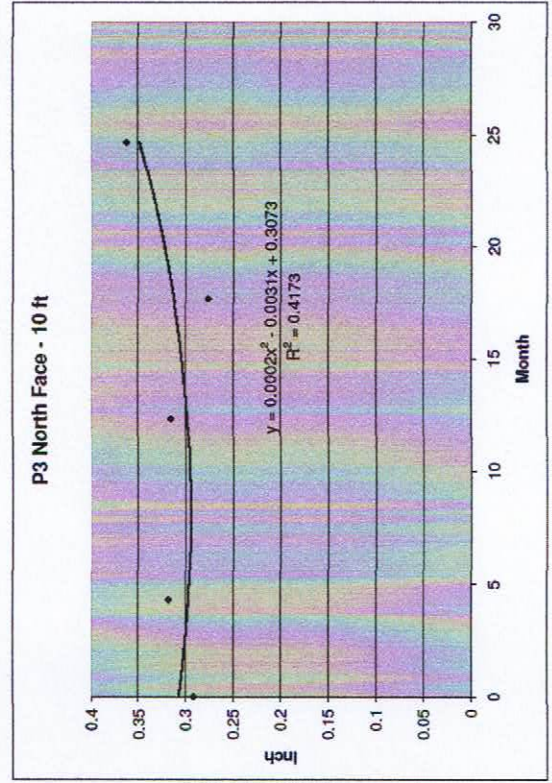
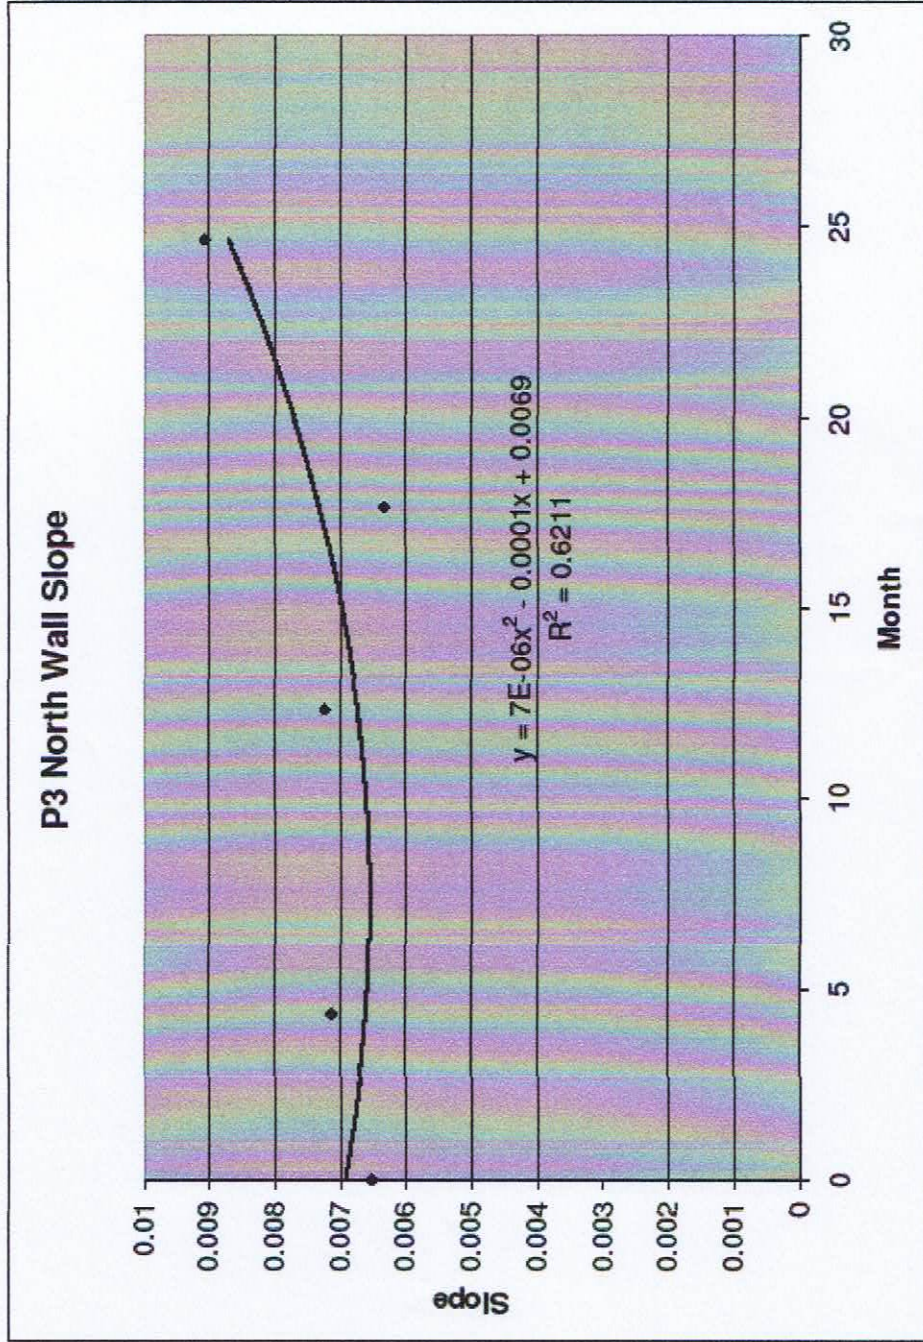
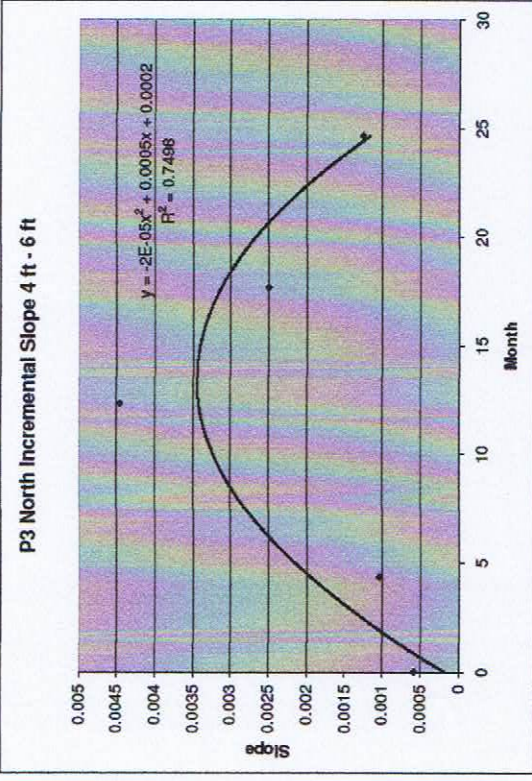
# Pilaster 3

Pilaster ID	Pilaster Location	Segment Location (Feet)	Incremental Slope Projection Equation	Curve Fit to Data	Comments
P3, North Plane	North Wall between P 2 and P4, inner face	Overall	$Y = 0.000007 x^2 - 0.0001 x + 0.0069$	Good	Plot suggests stabilization to possible increase in outward slope.
		4-6	$Y = -0.00002 x^2 + 0.0005 x + 0.0002$	Good	Plot suggests shift from increasing to decreasing outward slope or possible stabilization.
		6-8	$Y = 0.00002 x^2 - 0.0002 x + 0.0029$	Good	Plot indicates increasing outward slope.
		8-10	$Y = 0.00002 x^2 - 0.0006 x + 0.0118$	Poor	Plot suggests change in decreasing outward slope to increasing outward slope or possible stabilization.
		10-12	$Y = 0.000008 x^2 - 0.0001 x + 0.0128$	Fair	Plot indicates possible stabilization.

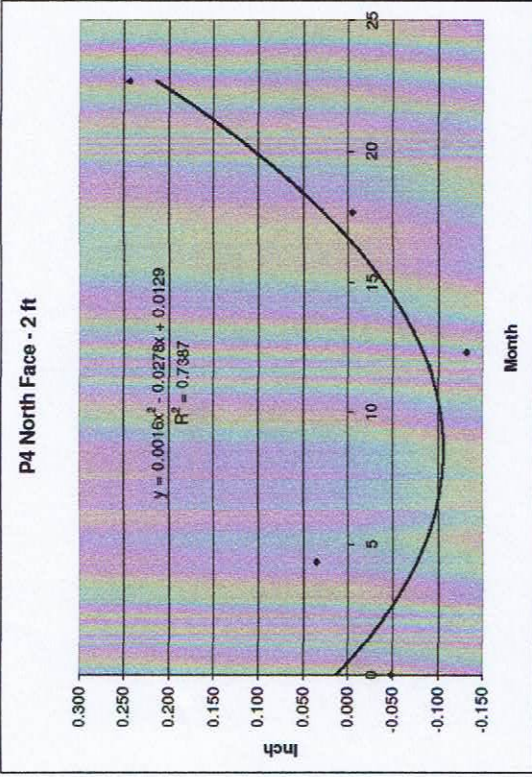
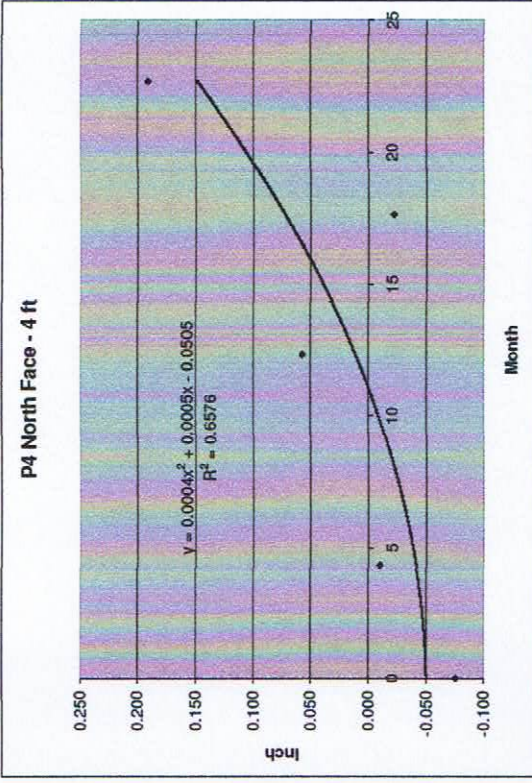
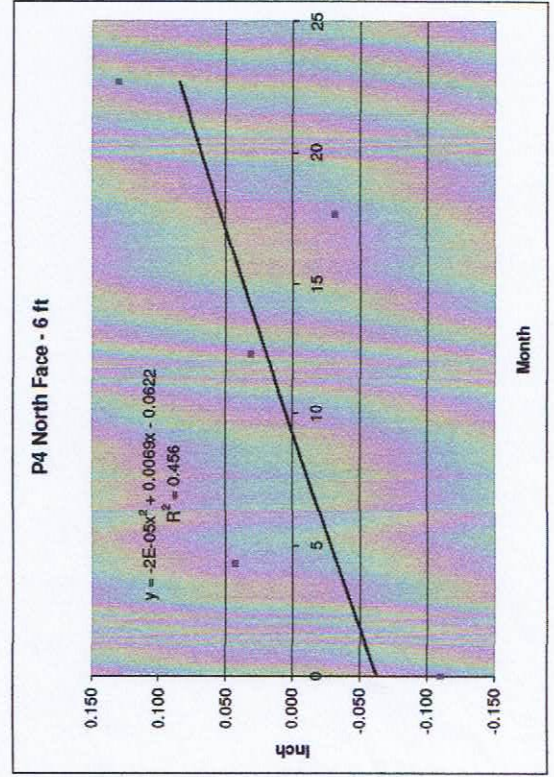
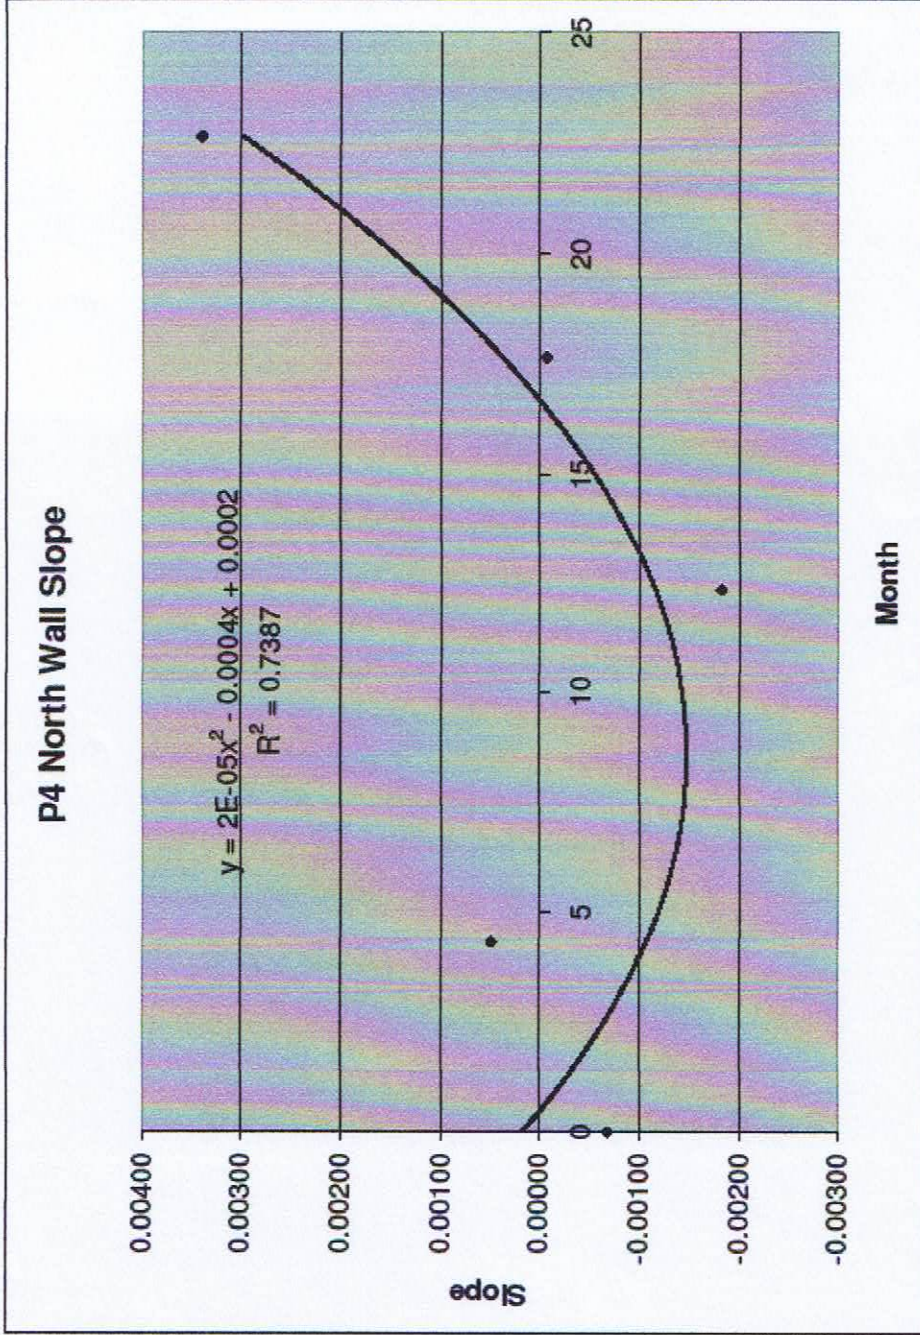
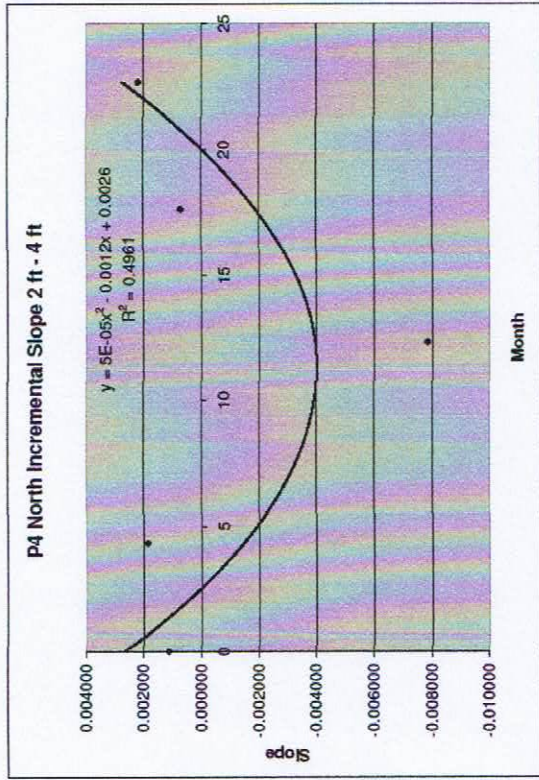
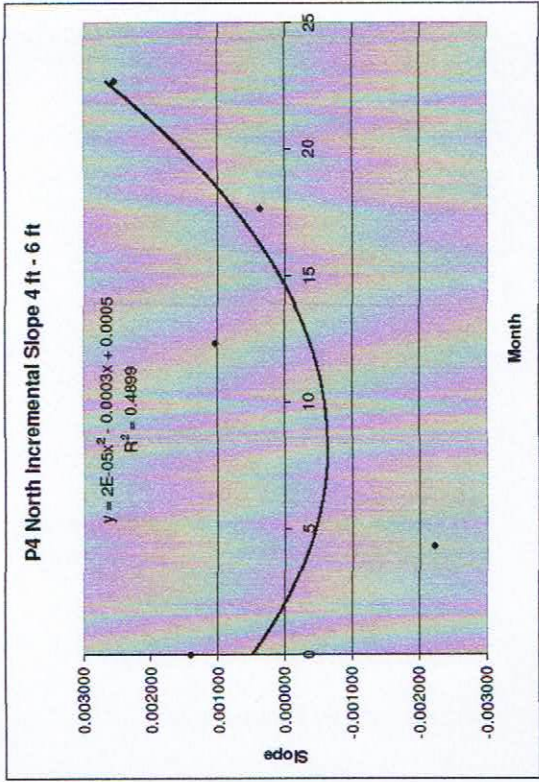
# Pilaster 4

Pilaster ID	Pilaster Location	Segment Location (Feet)	Incremental Slope Projection Equation	Curve Fit to Data	Comments
P4, North Plane	Northeast corner, north wall, inner face	Overall	$Y = 0.00002x^2 - 0.0004x + 0.0002$	Good	Plot suggests change from inward to increasingly outward slope.
		2-4	$Y = 0.00005x^2 - 0.0012x + 0.0026$	Fair	Plot suggests change from inward to increasingly outward slope or possible stabilization.
		4-6	$Y = 0.00002x^2 - 0.0003x + 0.0005$	Fair	Plot suggests shift from inward to increasingly outward slope.
		6-8	$Y = -0.0000008x^2 + 0.0003x - 0.0026$	Fair	Plot suggests increasingly outward slope.

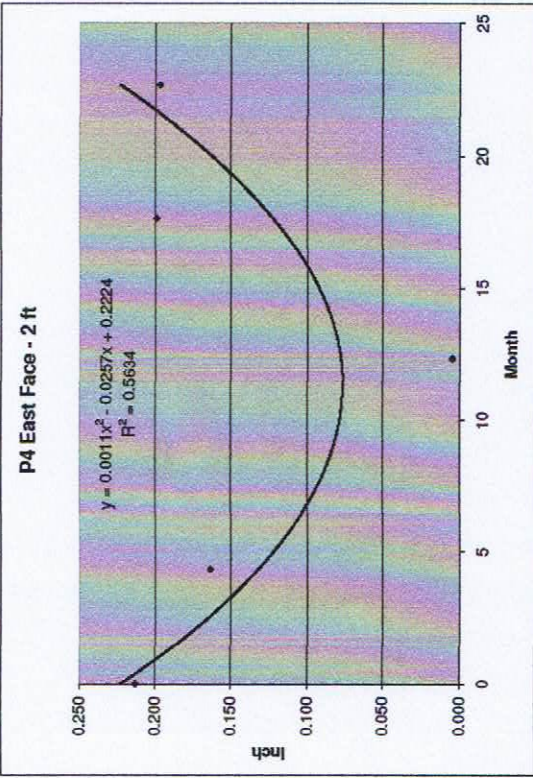
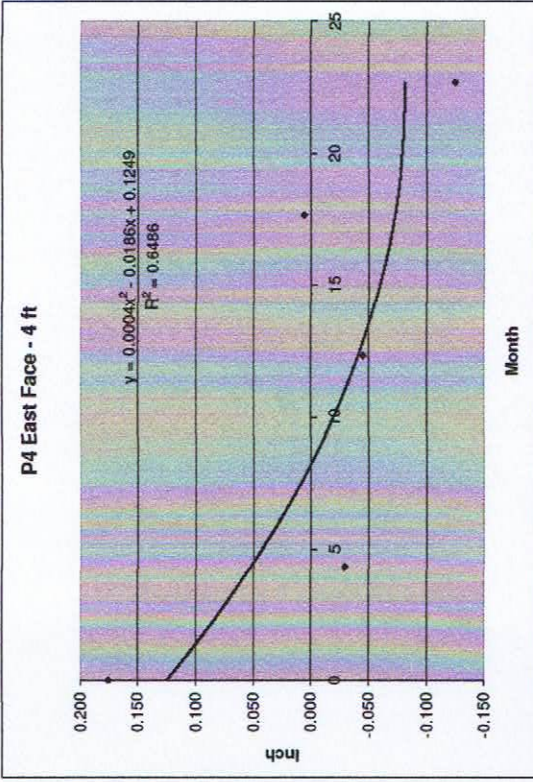
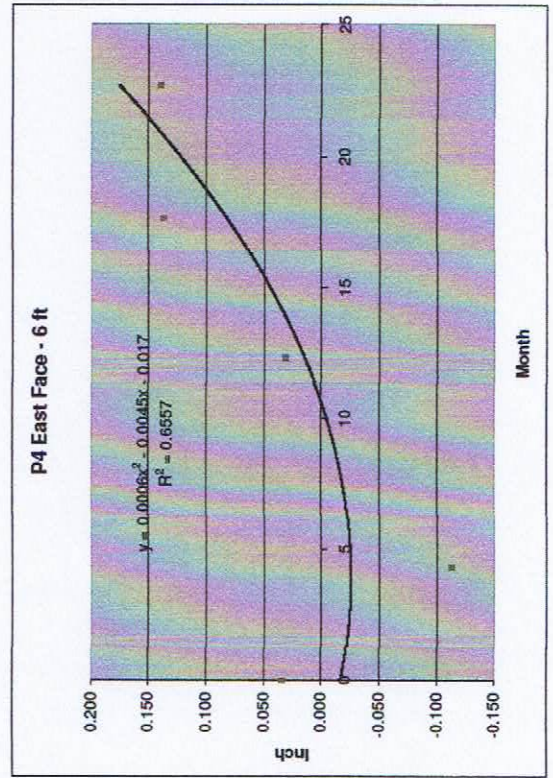
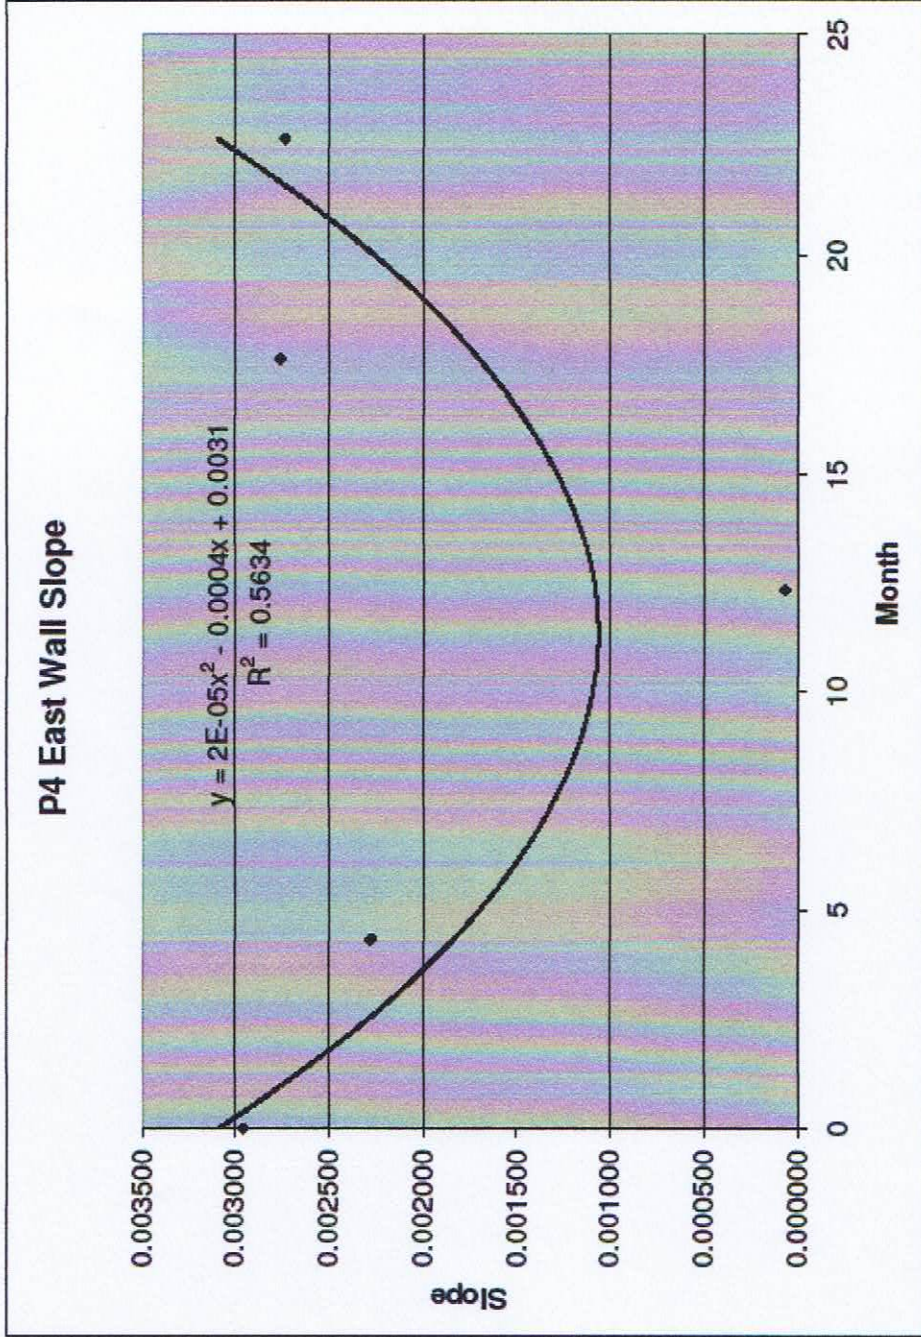
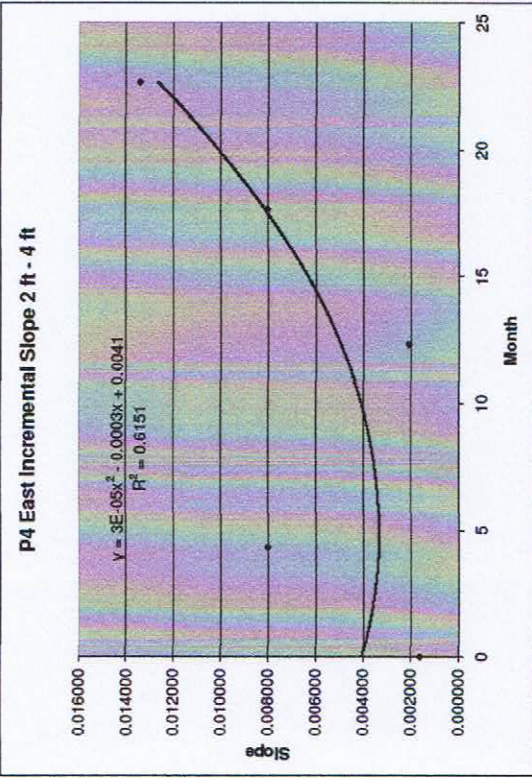
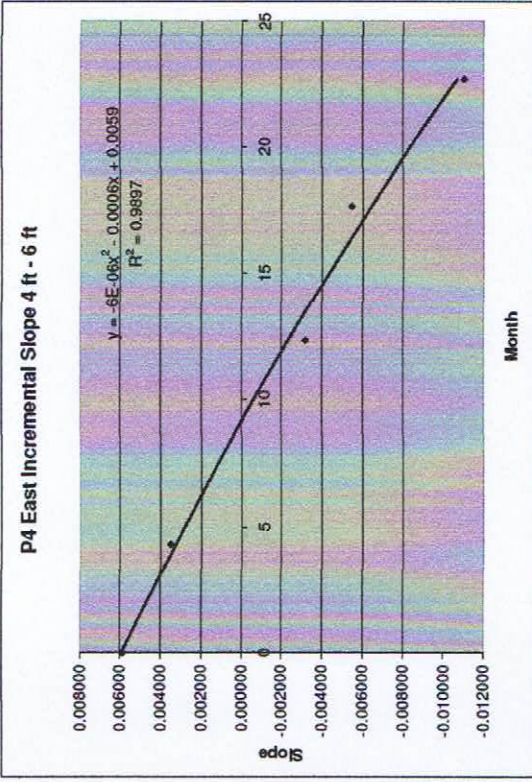
# Pilaster 4

Pilaster ID	Pilaster Location	Feet Above Fdtn Wall	Measurement Projection Equation	Curve Fit to Data	Comments
<b>P4, East Plane</b>	Northeast corner, east inner face	2	$Y = 0.0011 x^2 - 0.0257 x + 0.2224$	Fair	Plot suggests change from decreasing to increasing outward measurement or possible stabilization.
		4	$Y = 0.0004 x^2 - 0.0186 x + 0.1249$	Good	Plot indicates increasing inward measurement.
		6	$Y = 0.0006 x^2 - 0.0045 x - 0.017$	Good	Plot indicates increasing outward measurement.

Pilaster ID	Pilaster Location	Segment Location (Feet)	Incremental Slope Projection Equation	Curve Fit to Data	Comments
<b>P4, East Plane</b>	Northeast corner, east inner face	Overall	$Y = 0.00002 x^2 - 0.0004 x + 0.0031$	Fair	Plot suggests change from inward to increasingly outward slope.
		2-4	$Y = 0.00003 x^2 - 0.0003 x + 0.0041$	Good	Plot suggests change from inward to increasingly outward slope or possible stabilization.
		4-6	$Y = -0.000006 x^2 - 0.0006 x + 0.0059$	Very Good	Plot suggests shift from inward to increasingly outward slope.
		6-8	$Y = 0.00002 x^2 - 0.0002 x - 0.0007$	Good	Plot suggests increasingly outward slope.
