Subject: BAR Action - Lee Park 101 E Market Street - October 20, 2015

CITY OF CHARLOTTESVILLE BOARD OF ARCHITECTURAL REVIEW STAFF REPORT October 20, 2015

# City of Charlottesville, VA Repairs at Lee Park Feasibility Study

October 20, 2014 FINAL DRAFT

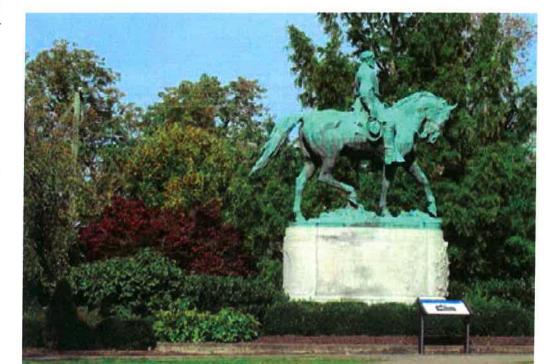
Photograph 1 - Robert E. Lee Monument

Comprised of approximately 45,435 square feet (1.04 AC), the park is home to a monument of the Confederacy General Robert Edward Lee and his horse, Traveller, see Photograph 1. The cast bronze monument was placed atop a white granite pedestal at the highest point in the park where several radial walking paths converge. The statue, a 1-2/3 sized bronze casting of the General and his horse has been cataloged as an "Individually Designated National Register Property."

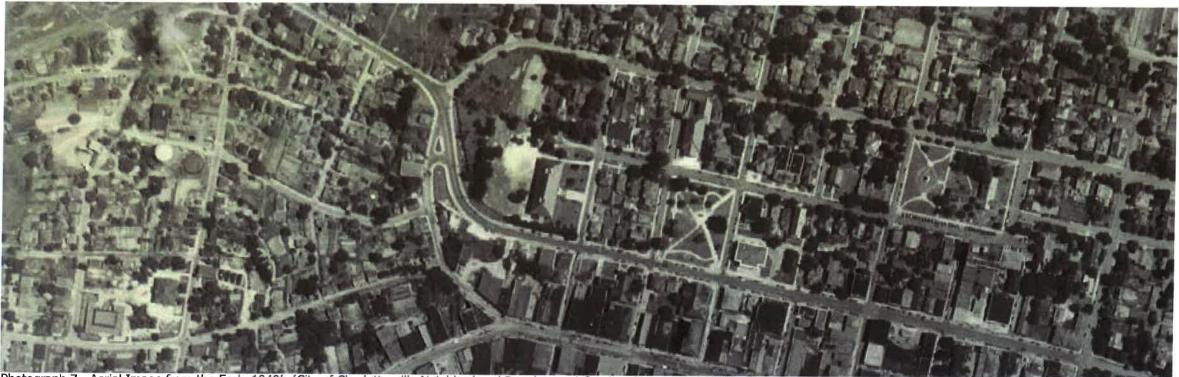
Photograph 7 - Aerial Image from the Early 1940's (City of Charlottesville Neighborhood Development Services Department Archives)

According to archival aerial imagery, the new sidewalk was in place prior to 1950, see Photograph 7, Page 7.

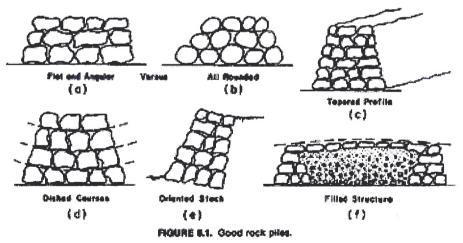
Figure 9 - Example Stacked Stone Walls

Of course, the degree of "out of plumb" may be insignificant as far as these stone walls are concerned. In the past, as well as in the modern times, earth retaining structures are often deliberately battered, or sloped, along one or both faces of the wall, see Figure 9.12 One may expect that a typical retaining wall batter is roughly 1:10 (or, also common, 1 inch per foot), thus over the height of the stone walls, 1 to 2 inches out of plumb may be deliberate. Consequently, where the wall surface was observed as "relatively plumb;" the wall may have experienced some degree of lateral displacement. In either case, the outer face of the wall is varied, as can be easily observed at the project site.
