BAR 19-07-01  
603 Lexington Avenue  
Tax Parcel 520167000  
Richard Zeller, Owner/Applicant  
Rear Shed Demolition and Replacement

**CITY OF CHARLOTTESVILLE  
BOARD OF ARCHITECTURAL REVIEW  
STAFF REPORT  
July 16, 2019**

# Existing Conditions Report

Garden Shed at 603 Lexington Ave.

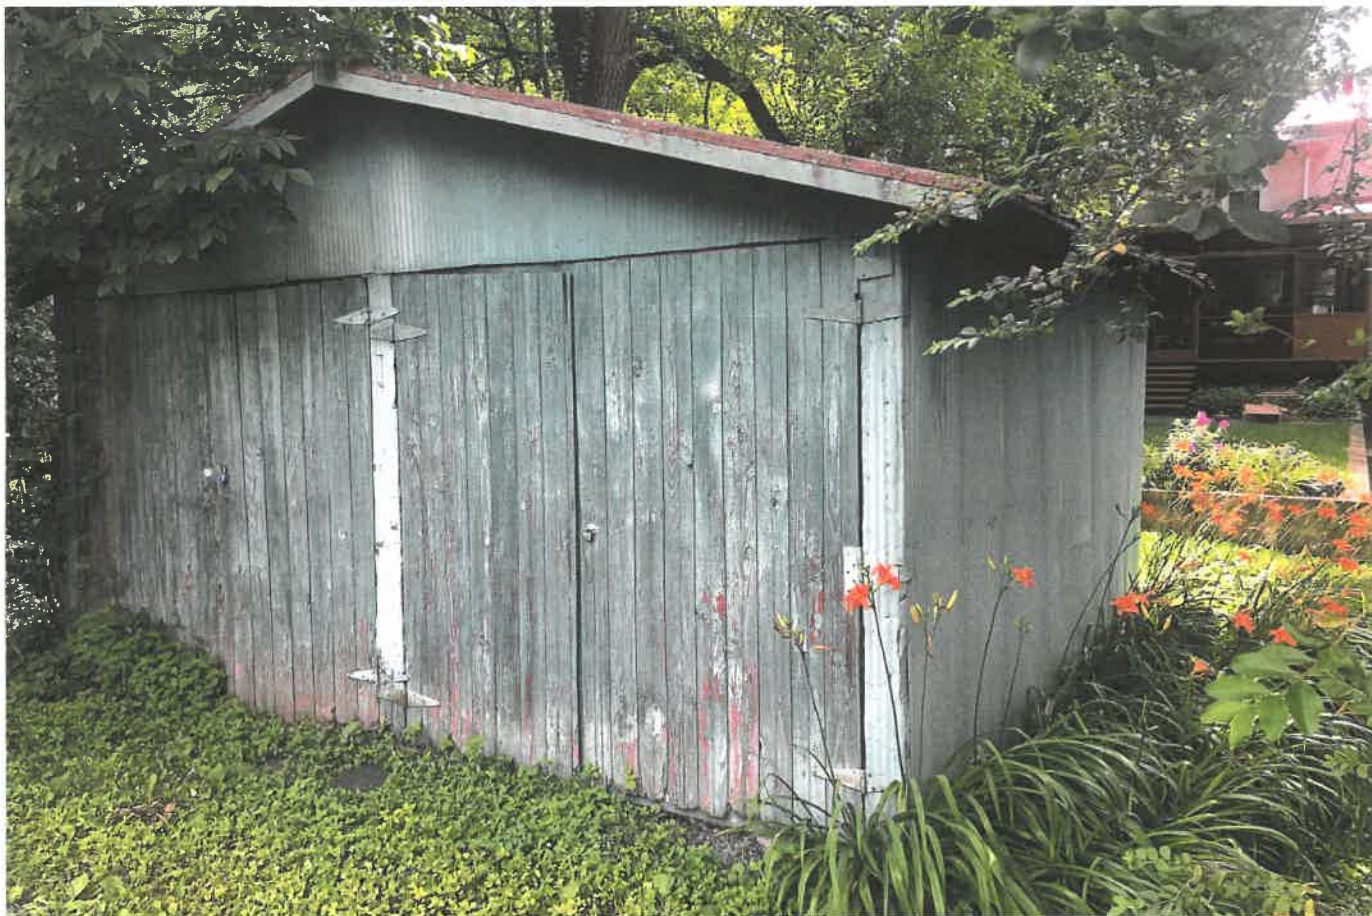
The existing shed sits on a concrete slab. Drainage issues along the north facade of the existing shed has done structural damage to the existing wood framing. The bottom plate along this facade faced significant rot and is no longer present. Many original studs on all facades have rotted through completely and are held in place only by the attachment to the existing metal siding.

The existing corrugated metal siding has significant damage from both drainage issues and previous owners. Along the north facade, the siding along the ground has rusted away where grade has accumulated on the facade and has been subject to water infiltration. On the east facade, the siding is rife with what appear to be bullet holes from previous owners.

Repairing the shed would be intense, from labor, material, and financial perspectives. All exterior siding and roofing is in need of replacement. All existing original wood framing is in need of replacement. New doors would be required if they are desired to be functional. The slab appears to be in sufficient condition to remain for a shed use. As both a neighbor and someone familiar with the intent of the City of Charlottesville Conservation District, I would support demolition and replacement of this existing structure.
