From: Scala, Mary Joy
Sent: Tuesday, December 07, 2010 4:47 PM
To: McHugh, Kathy
Cc: 'John Quale'; 'Marilyn W. Moedinger'
Subject: 608 Ridge Street

From: Scala, Mary Joy
Sent: Monday, December 06, 2010 4:24 PM
To: Brian Hogg; Candace DeLoach; Eryn Brennan (work); Eryn Brennan personal; Faxayres@gmail.com; Fred Wolf; Michael Osteen; Preston Coiner; Syd Knight; William Adams
Subject: 608 Ridge Street Eco ReMOD revision
Attachments: 608 Ridge Street.pdf

This regards the existing house on Ridge Street at the intersection of Elliott and Cherry that Eco MOD is refurbishing.

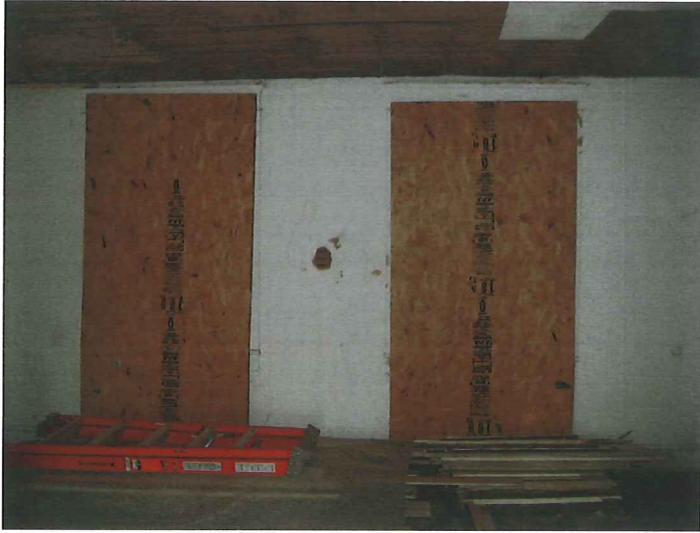
608 Ridge Street Front casement window frames

During demolition, we discovered evidence of hardware for double inswing casement windows in the front location, and no indication of weights or hardware for double hung windows in this location.

We propose windows A+B to now be Pella Architect Series double inswing casement windows, to replicate what was originally present in 1922. The house has a mix of both casement and double hung windows, and we feel it is important to the historic narrative of the house to replace the casement windows on the front of the house, rather than use double hungs as originally approved.

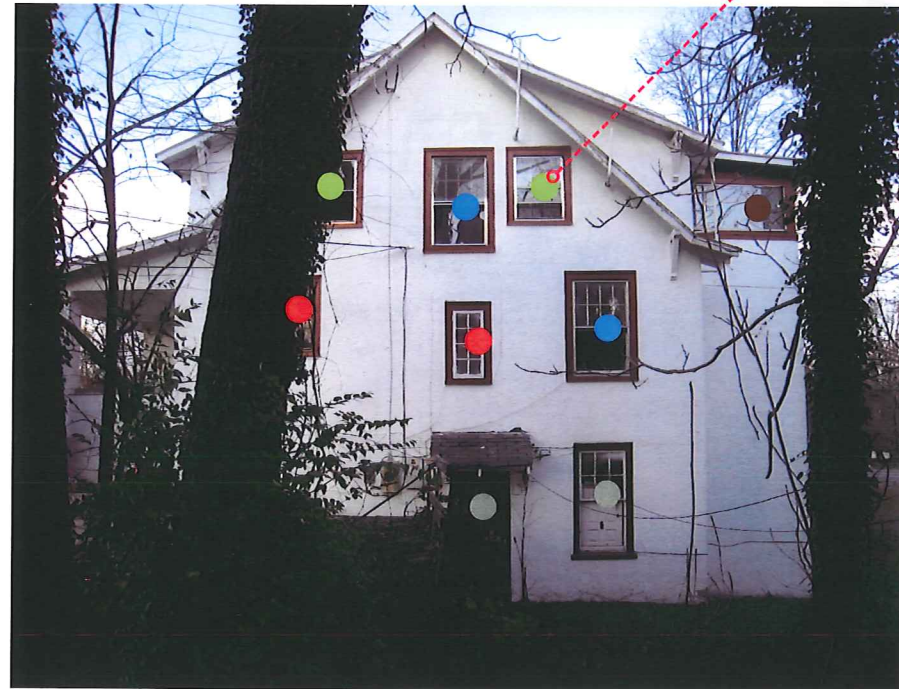
new proposal

The two front windows (yellow dots) were missing, so we originally proposed moving two c. 1922 windows (blue dots) from the south facade to the front location, and replacing the south facade windows with new windows.

Also, we're proposing switching a window on the south facade to a fiberglass unit, as this window is located in the shower. Allowing this window to be fiberglass will prolong its life, the life of the wall assembly, and prevent rot and decay in this area.
