From: Werner, Jeffrey B
Sent: Wednesday, April 17, 2024 4:34 PM
To: Chinh Q. Le
Subject: 712 Ridge Street - BAR action March 2024

Certificate of Appropriateness
BAR 24-03-01
712 Ridge Street, TMP 250067000
Ridge Street ADC District
Owner/Applicant: Chinh Le
Project: Replace doors/windows, remove chimney, construct driveway

Certificate of Appropriateness Application

BAR 24-03-01

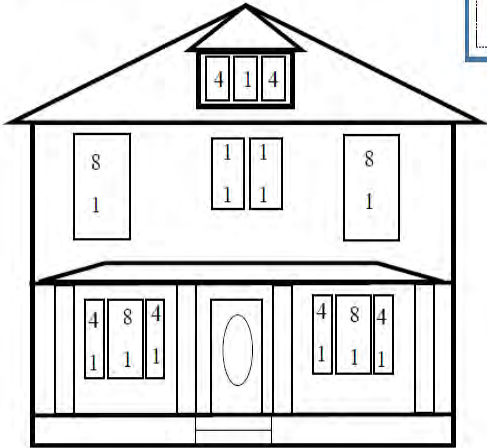
Front Elevation (west)

8	Indicates window with an 8-lite upper sash over a 1-lite lower sash.
1

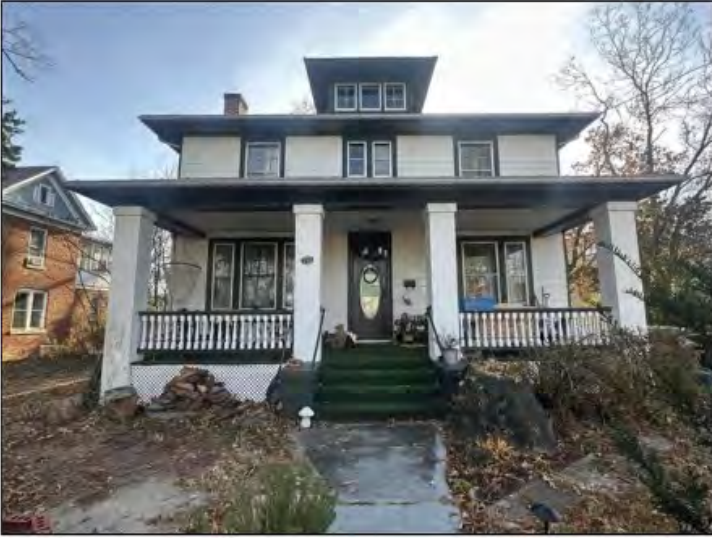
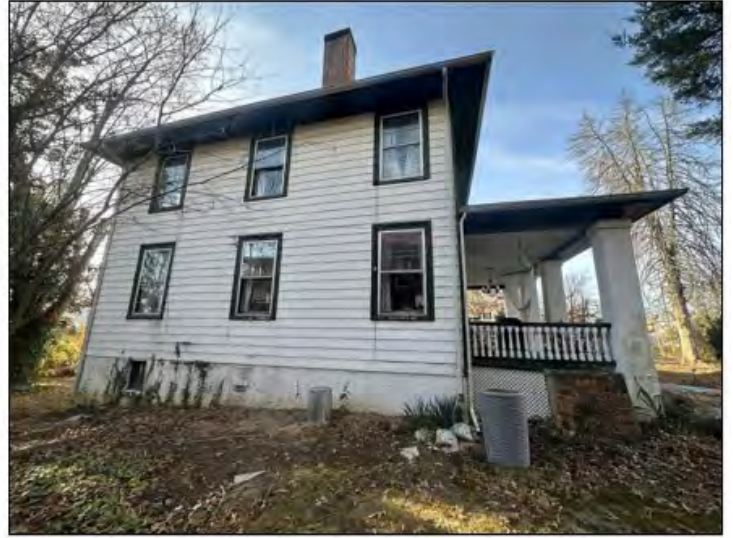
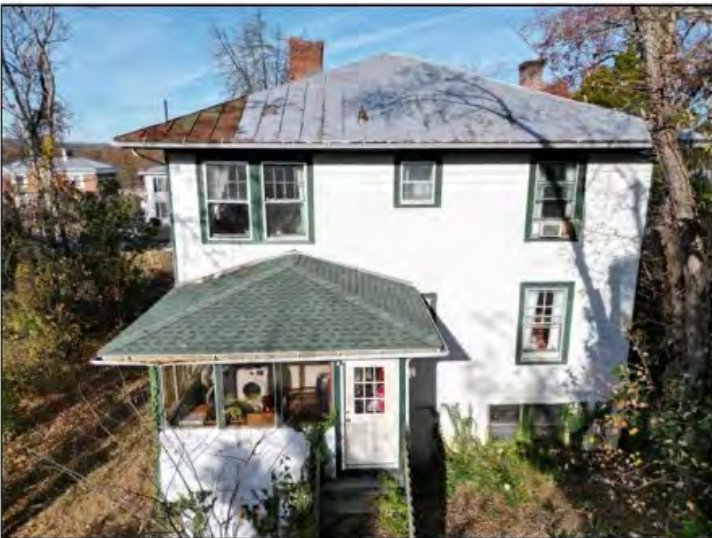
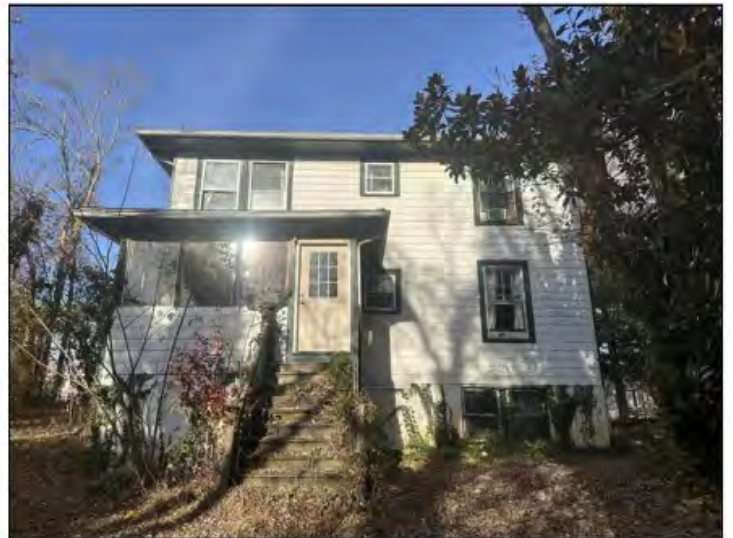
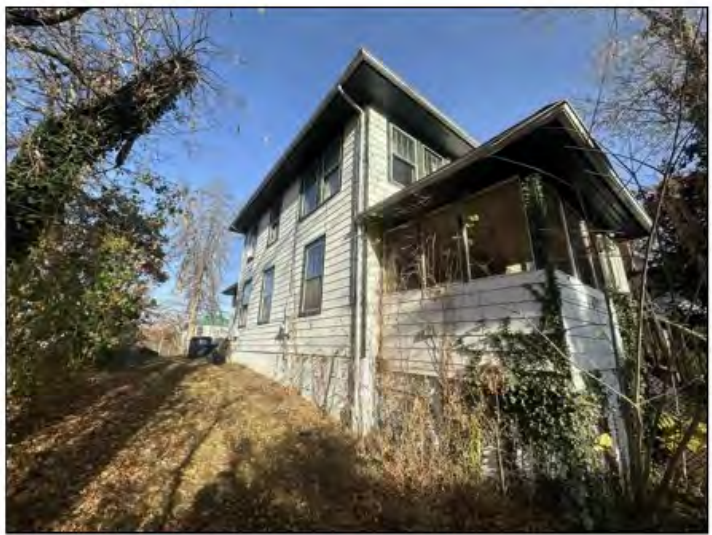
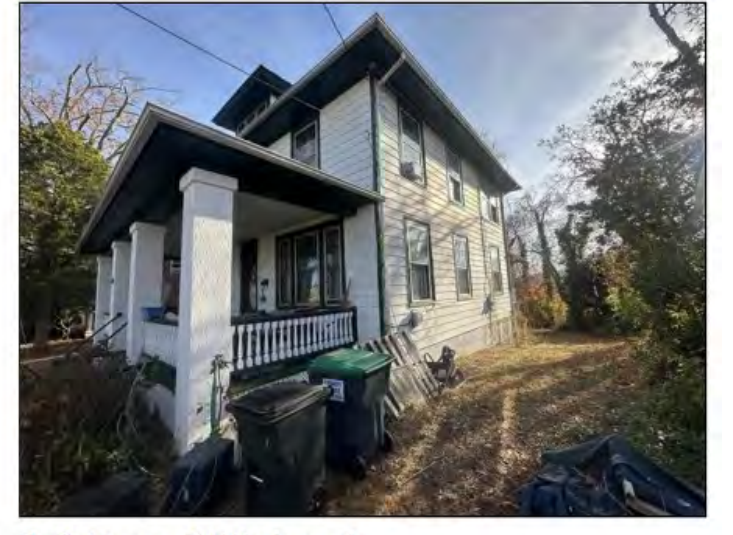
- Windows: Since visiting the property in 2019, it appears the exterior features have continued to deteriorate, with little if any evidence of interim maintenance. Staff cannot say the windows [sash] are beyond repair; however, staff must acknowledge that, unless willing to pay a premium, there are few local options for property owners looking to repair old windows. In discussions with staff, the applicant is willing to—though they would prefer not to—retain the existing sash of the first and second floor window in the primary façade.

If replacements are approved, staff recommends a condition of approval that if the windows have applied grilles on insulated glass, there will be internal spacer bars between the panes.

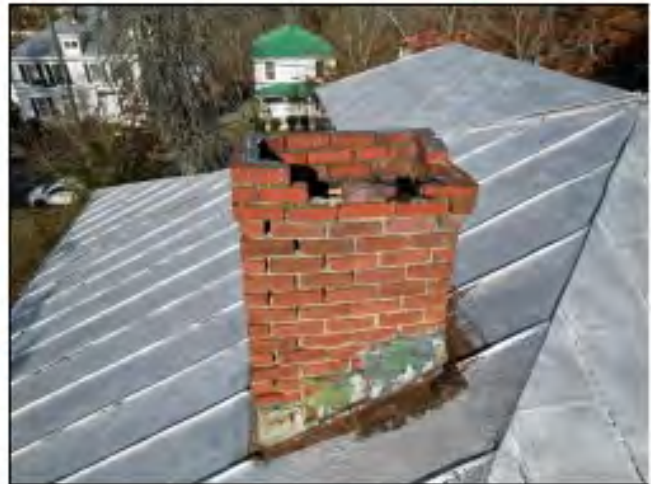
3.5 Item 2(Picture)

The home currently has two chimneys, one on the left side of the house, which is connected to a working fireplace, and one on the right side of the house, which is no longer in use. The housing inspection report we obtained prior to purchasing the house, which is attached, indicates that the chimney on the right side of the house is structurally unsound, unsafe, and needs to be removed or rebuilt. ([see below] See pages 10-11, 12-13; photos included.) The top of the chimney is visibly uneven to the naked eye, and the base of the chimney is also bulging and vulnerable to collapse.

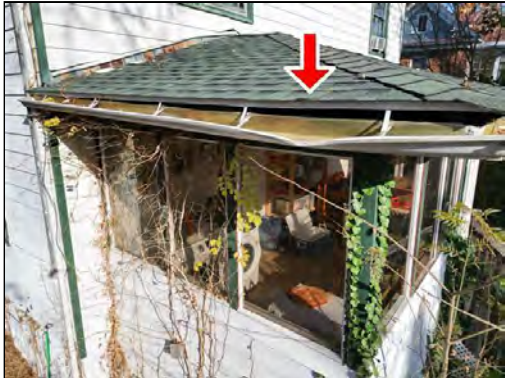
1.3 Item 2(Picture)

(2) The gutter on the rear right side of the home is damaged. This needs to be repaired to ensure the gutter functions properly. A qualified gutter specialist can complete this task.

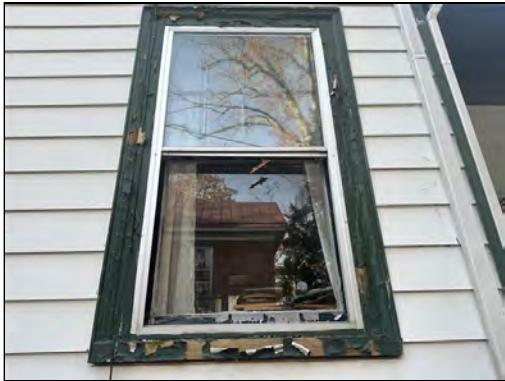
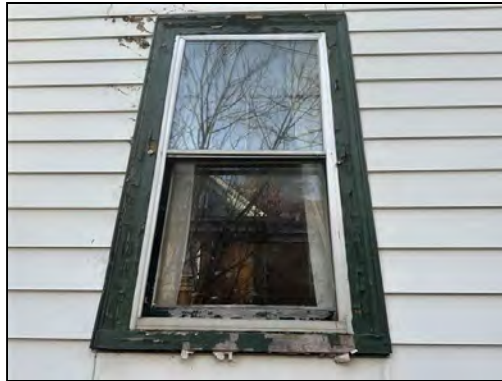
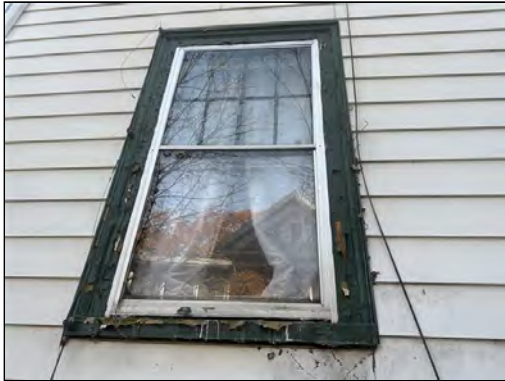
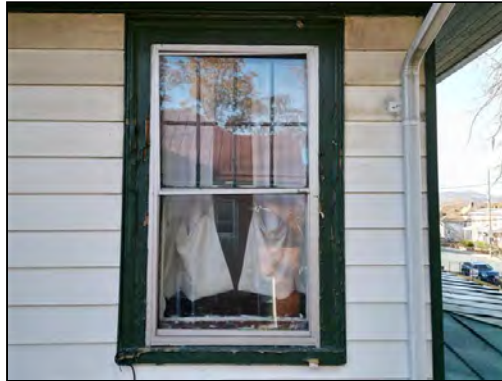
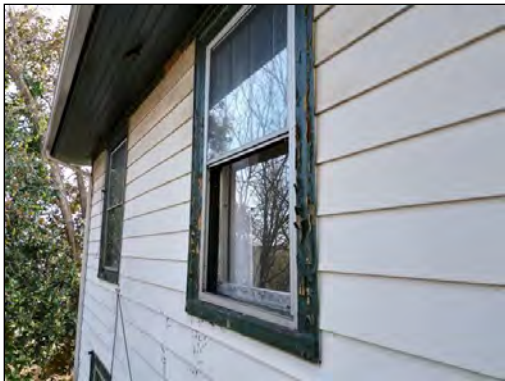
Scrape, caulk, paint the five (5) windows and trim around windows to help ensure the windows don't deteriorate faster and to help prevent water entering into the interior of the home thus causing more issues. This is routine maintenance that happens on every home and should be done every 3-5 years depending on the wear of the paint/caulk used.

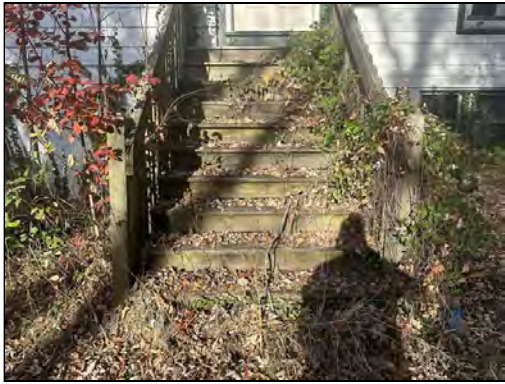
2.3 Item 6(Picture)

(2) The wood steps in the backyard are past their useful life and are in need of replacement. I recommend having a qualified decking contractor replace the steps to current standards.

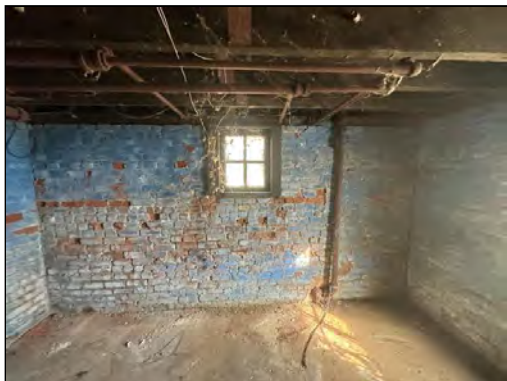
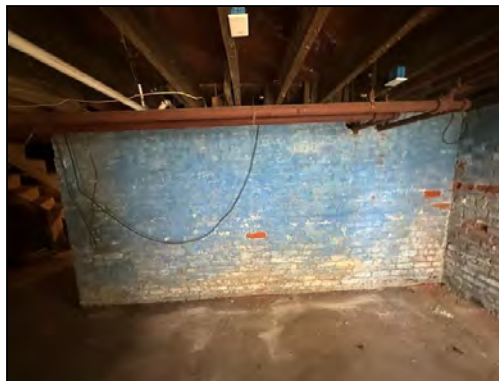
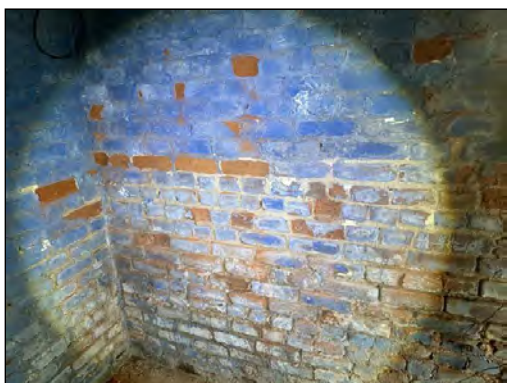
(1) The majority of the below-grade brick foundation at the rear of the home is in need of pointing-up.

This process will help the foundation wall retain its strength as well as preventing animal/pest intrusion from occurring into the crawl spaces of the home. This task can be completed by a licensed masonry contractor.

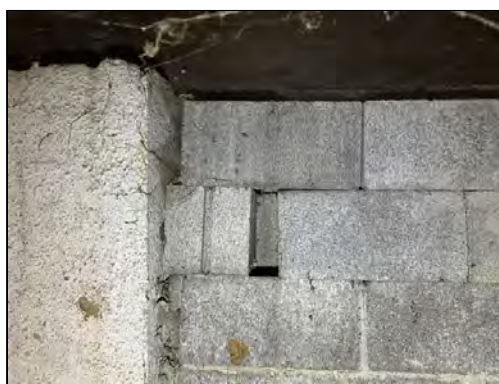
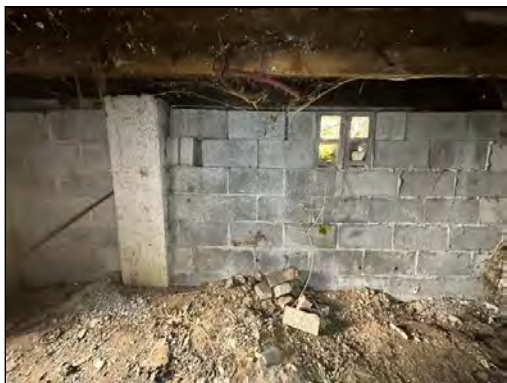
(2) The majority of the above-grade block foundation at the rear of the home is made of dry stacked block without mortar joints. This area needs to be pointed up. This process will help the foundation wall retain its strength as well as preventing animal/pest intrusion from occurring into the crawl spaces of the home. This task can be completed by a licensed masonry contractor.

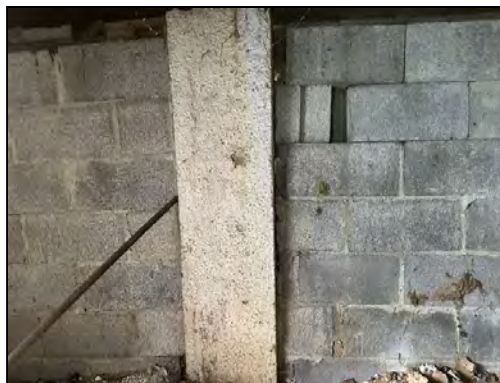
3.0 Item 7(Picture)

(3) The rear CMU foundation wall has settled and is no longer supporting the structure above. I recommend a licensed masonry contractor investigate further and repair the structure.

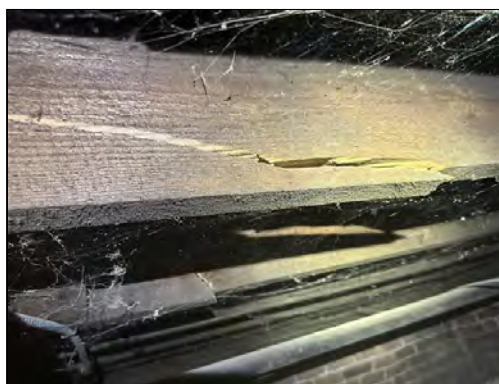
3.3 Item 2(Picture)

There were three (3) cracked floor joist in the basement. The effectiveness of these joist being able to support the floor above has been compromised due to the broken joists. I recommend having a licensed contractor repair as needed to properly support the floor.

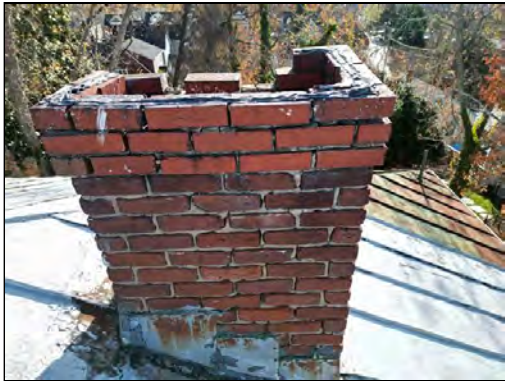
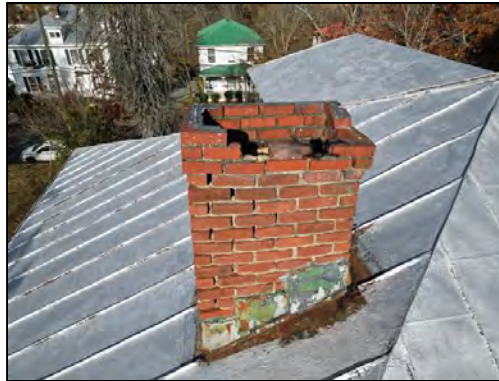
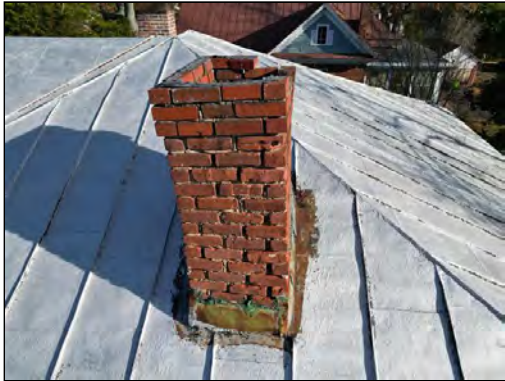
(1) The chimney on the right side of the home needs to be rebuilt as it is unsafe and unstable. I recommend a qualified mason investigate and recommend a solution.

(2) The right side chimney's structural brick is failing and in need of rebuilding. This can impact the effectiveness of any gas-powered appliances' ability to properly ventilate carbon monoxide gas to the exterior. I recommend a licensed mason complete this task.

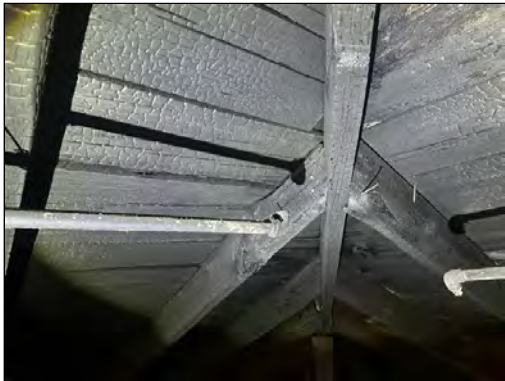
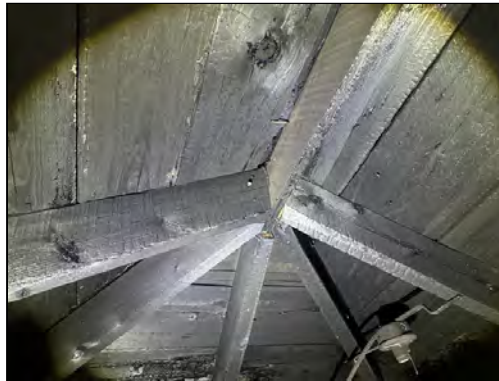
(2) Rafters and sheathing inside the attic indicate evidence of a previous fire. I probed charred wood members with a "stab tool" or awl. I recommend monitoring as my probing revealed that the majority of the charring was superficial as the roof structure was in, stable condition during the inspection.

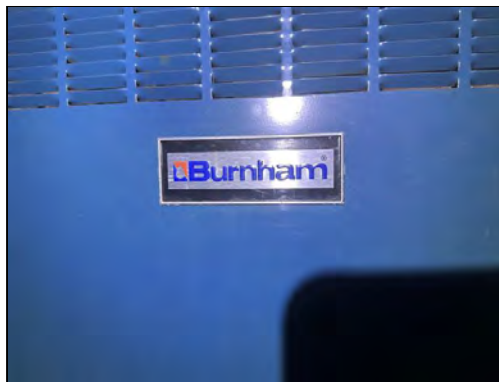
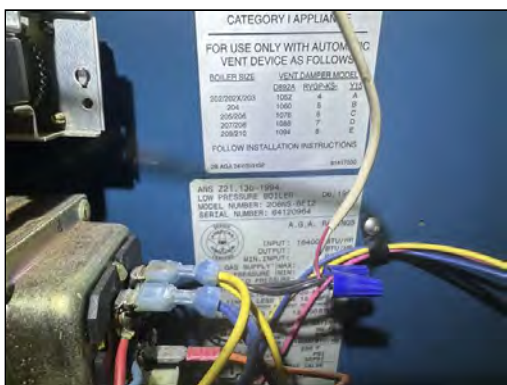
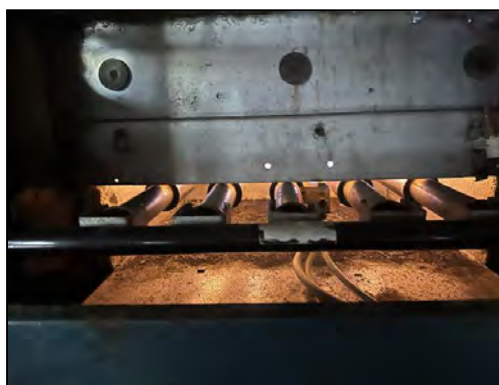
The circulating boiler was working at the time of the inspection. However the unit was not fully combusting the natural gas this is causing the unit to run less efficiently. I recommend a qualified boiler technician inspect further and repair. This unit is past the national life expectancy rate of 15-20 years. I recommend having the unit serviced and starting a budget for it's eventual replacement.

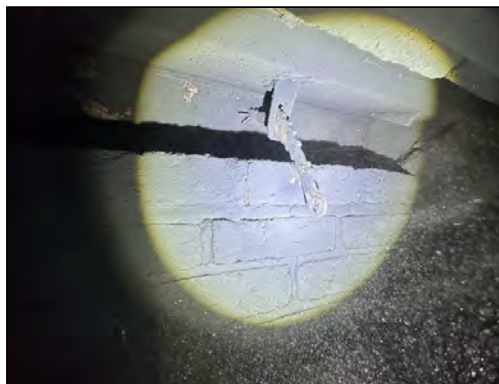
4.5 Item 2(Picture)

(1) I recommend having the chimney inspected by a qualified chimney sweep before use as the inspection conducted today is a visual inspection and does not take into consideration the current status of the inner workings of the chimney flue.

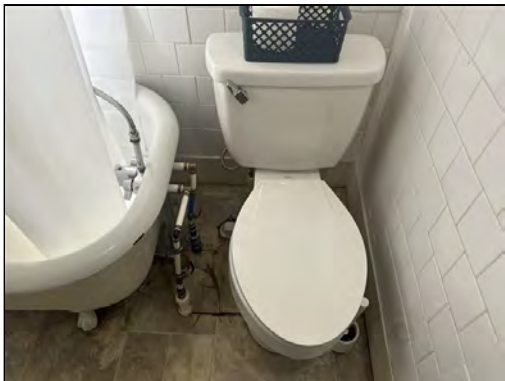
5.1 Item 2(Picture)

(2) The upstairs toilet was loose during the inspection. First, I recommend tightening the T-bolts on the flanges of the toilet. If that does not secure the toilet then the wax ring is more than likely broken and will need to be replaced. I recommend having a licensed plumber investigate further and correct as needed.

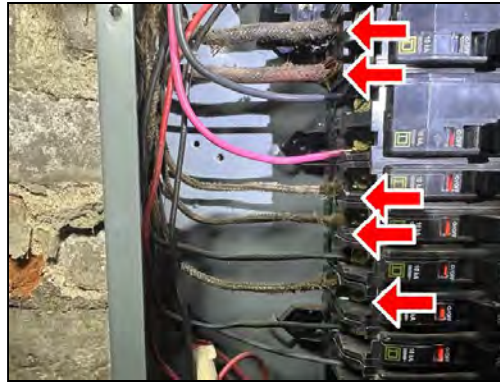
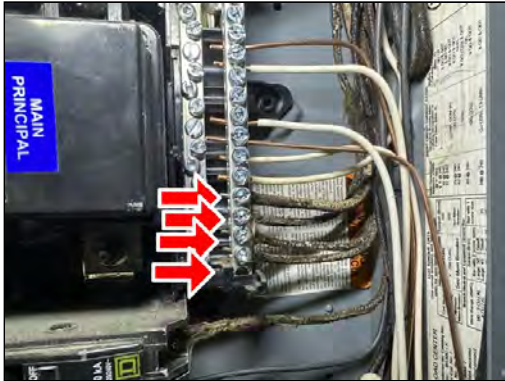
(1) There was cloth wiring present in the panel. This has been known to cause fires in the past and is no longer used in construction today. I recommend having a licensed electrician investigate further and correct as needed for safe operation.

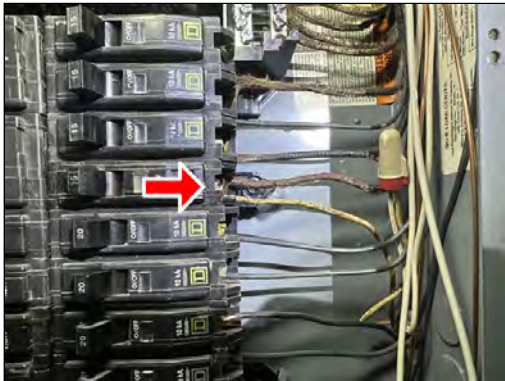
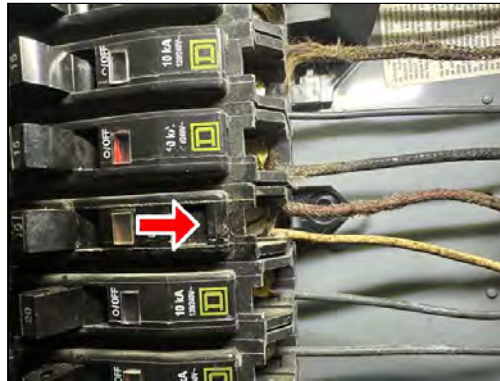
(2) I observed two (2) double taps that were present in the main electrical panel during the inspection. Double taps can lead to overheating of the breaker or could lead to a spark or arc between the wiring. I recommend having a licensed electrician investigate further and correct as needed.

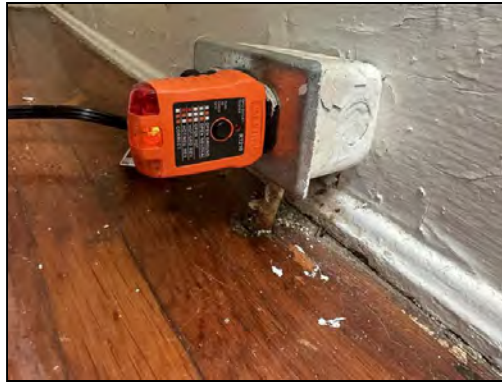
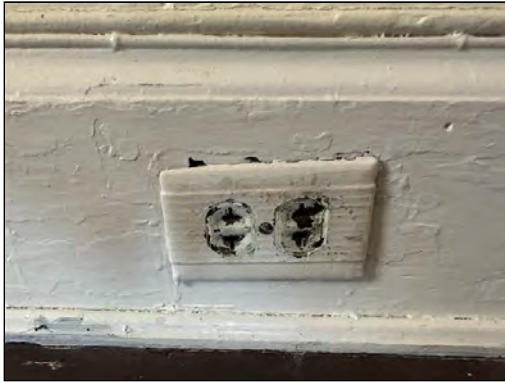
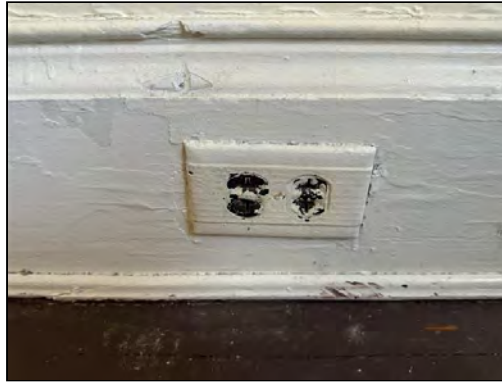
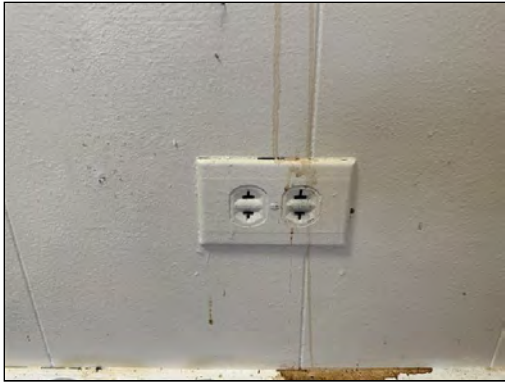
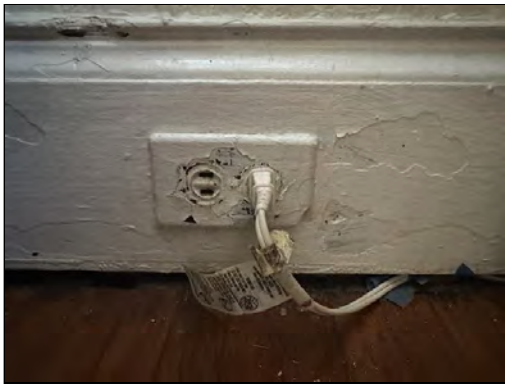
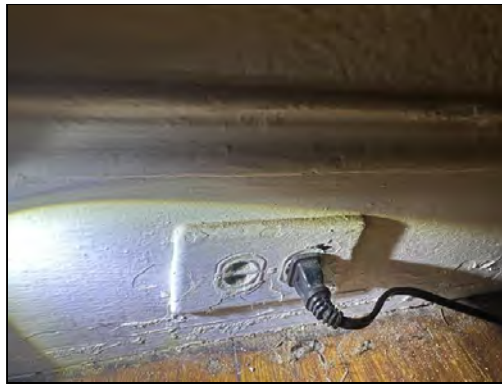
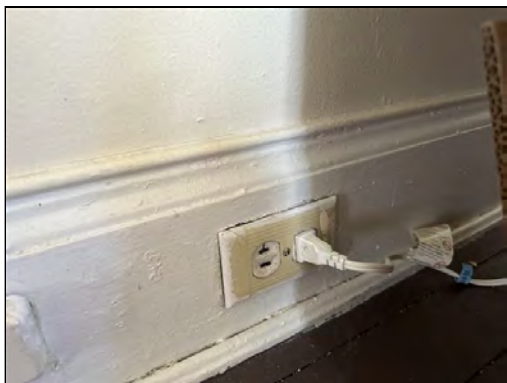
An outlet in the upstairs bedroom has the hot and neutral wires reversed. I recommend having a licensed electrician investigate further and correct as needed. Item 1(Picture)

There was one (1) outlet on the first floor of the home that was not properly grounded during the inspection. I recommend having a licensed electrician investigate further and correct as needed. A properly grounded outlet is important because it protects the appliances connected and people from the potential risk of electrical shock due to a power surge. There were six (6) outlets found during the inspection that are old style two-pronged. Today's devices require a three-pronged out with ground. I recommend a licensed electrician replace these with three-pronged outlets. Item 3(Picture) Item 4(Picture) Item 5(Picture) Item 6(Picture) Item 7(Picture) Item 8(Picture) Item 2(Picture)

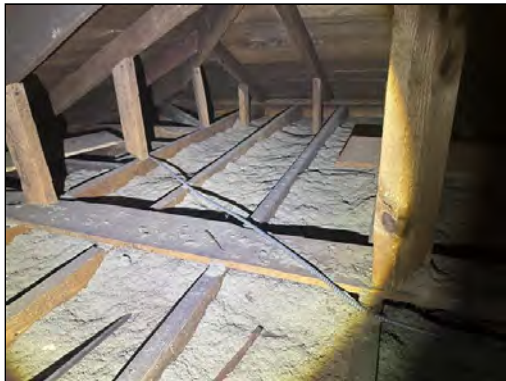
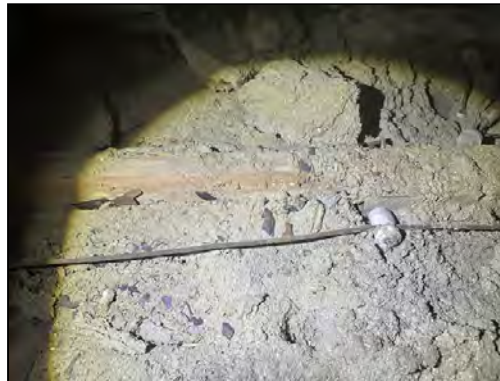
I recommend adding more insulation in the attic as there was not enough present to achieve a minimum R-30 value which is appropriate for this area of the country. This task can be completed by a qualified insulation contractor.

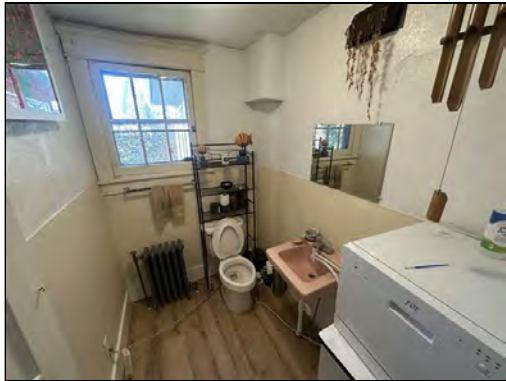
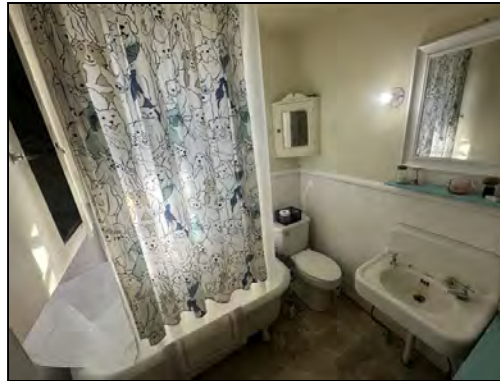
There was no bathroom ventilation fan installed during the inspection. I recommend installing a ventilation fan to help ventilate the home from moisture-laden air.

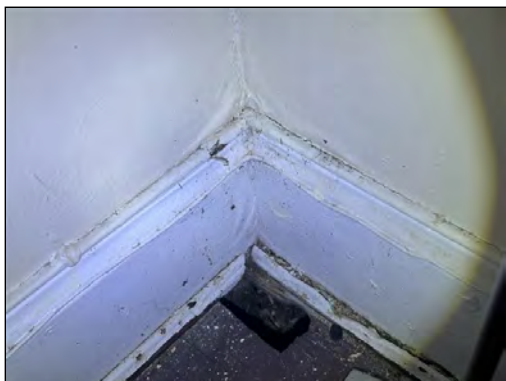
8.2 Item 1(Picture)

(1) There was water damage present in the corner floor area of the main level back bedroom. There was also a hole present in the floor. The area was tested with a moisture meter and was found to be dry at the time of the inspection. I recommend monitoring the area and having a qualified contractor investigate repair the finishes.

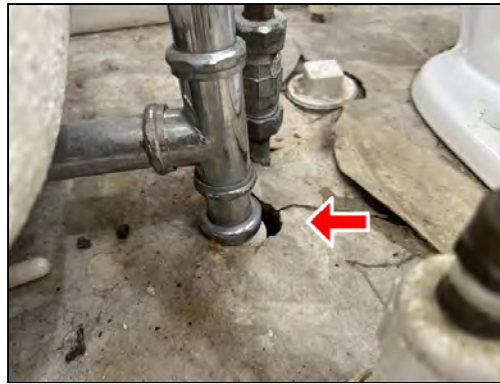
8.2 Item 3(Picture)

(2) There are two (2) areas in the upstairs bathroom where we need to seal around the plumbing penetrations in the floor. I recommend a qualified contractor repair the floor around these penetrations.

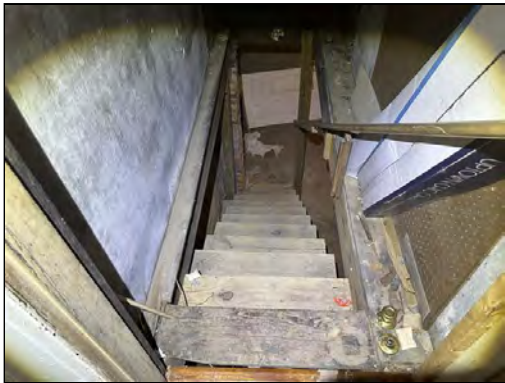
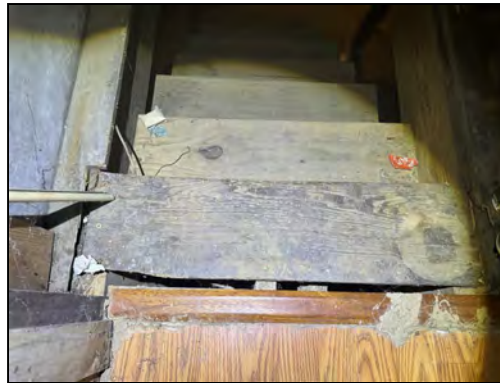
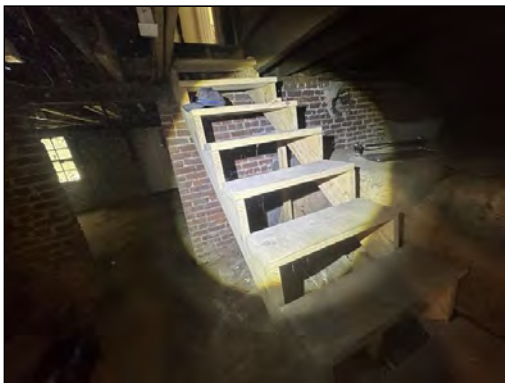
(2) The basement stairs need to be rebuilt with a handrail, proper stair treads and the appropriate balusters to ensure the safety of anyone using the stairs. This can be come completed by a qualified contractor.

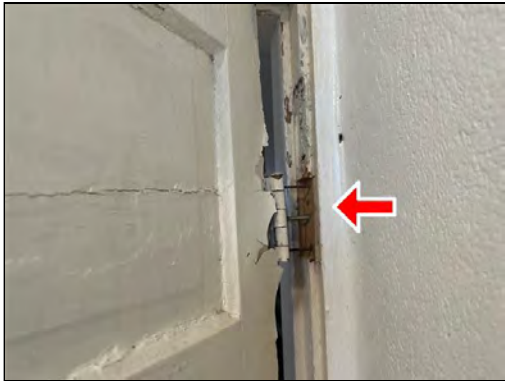
8.5 Item 1(Picture)

The door to the main level half bath was found to be pulling away from the door frame. This is causing the door to not function properly. I recommend a qualified contractor reattach the door to the frame.

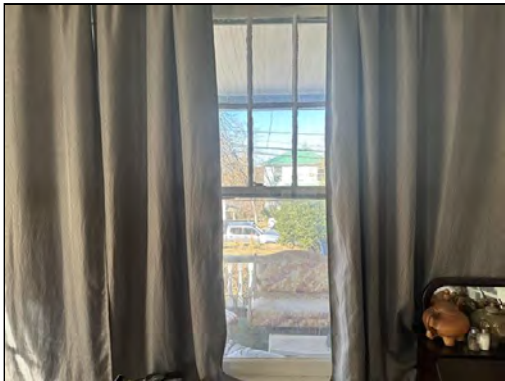
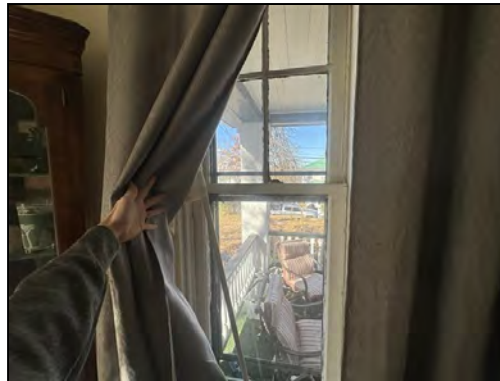
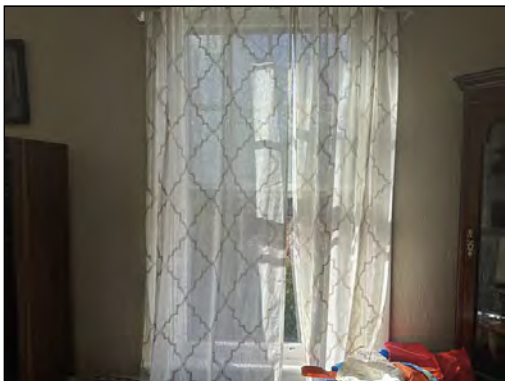
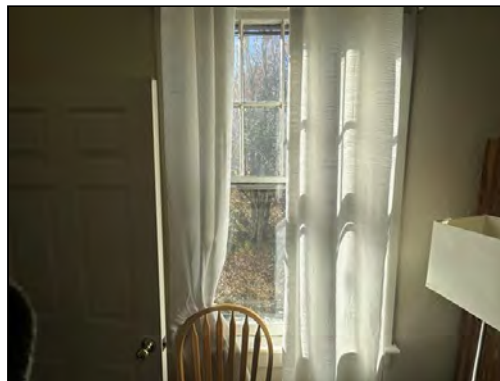
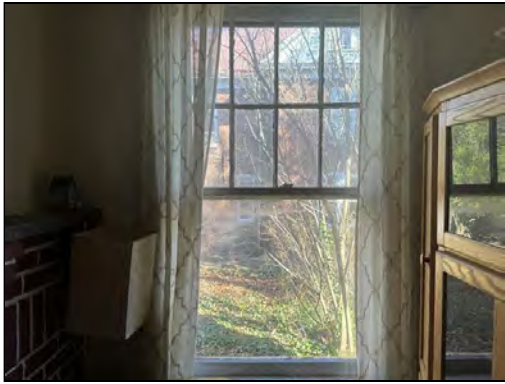
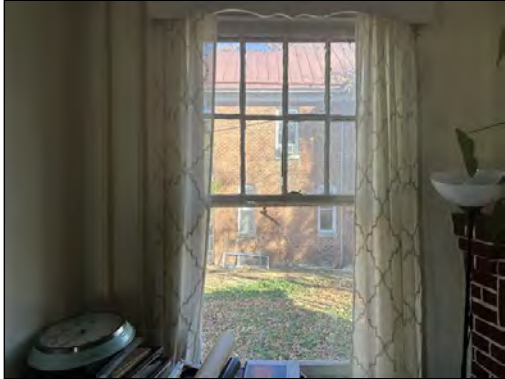
There were ten (10) windows on the main level that would not open at the time of the inspection. There were four (4) windows on the upper level of the home that did not open during the inspection. They have either been painted shut or have been fastened shut. I recommend having a qualified window contractor repair/replace as needed such that the windows operate as designed. Also, windows in bedrooms should be operational for fire egress. This should be considered when addressing the issue.

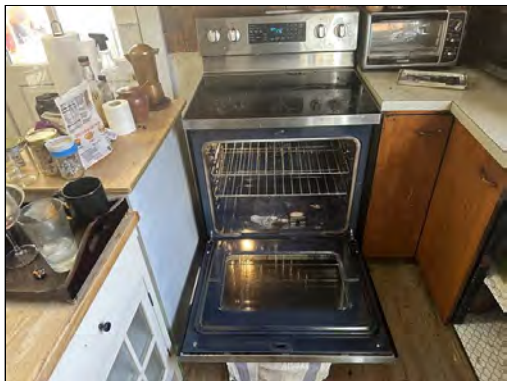
9.1 Item 1(Picture)

The anti-tip device for the range was not installed. I recommend installing the device so that the range does not tip over when used which can be very harmful to a person if this occurs. This task can be completed by a qualified appliance technician.

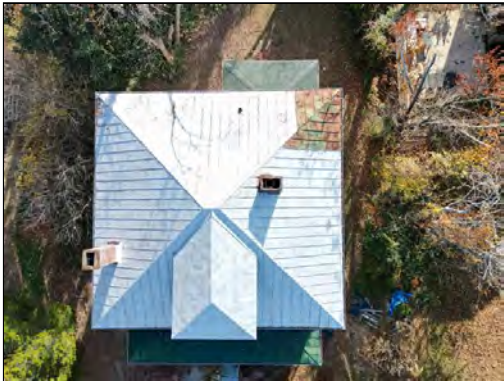
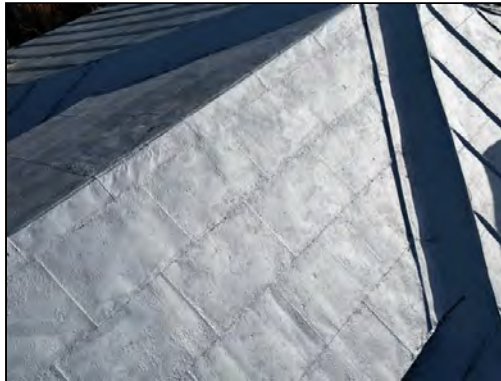
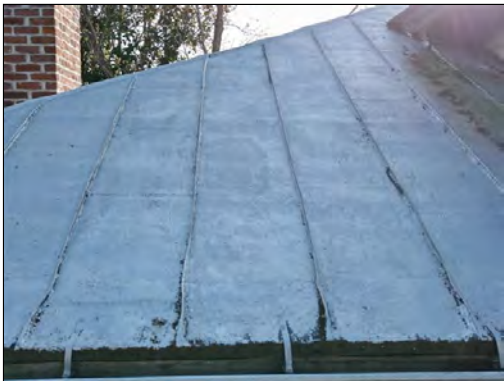
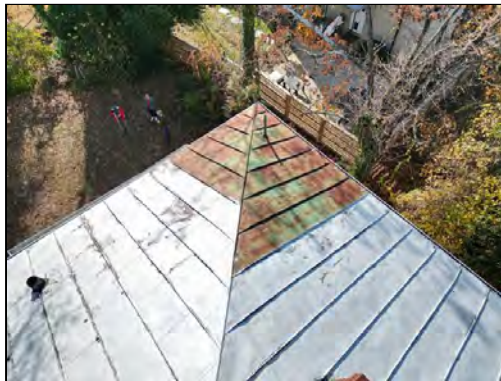
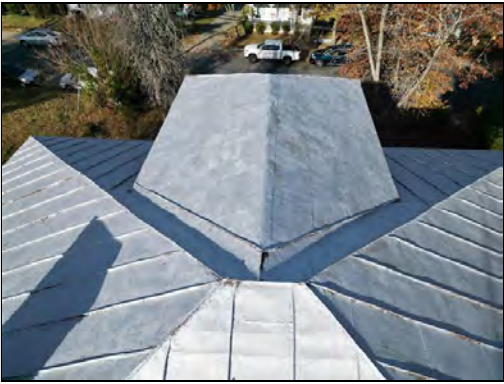
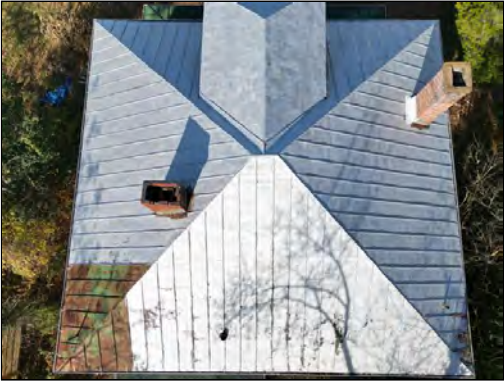
Upon visual inspection, the roof appears to be in good condition for the year that it was installed. However, I always recommend regular maintenance including caulking of pipe boots and removal of debris from valleys. I estimate the roof covering to be original to the home, therefore is approximately 75-80 years old. Standing seam metal roofs typically last 75-100 years with proper maintenance.

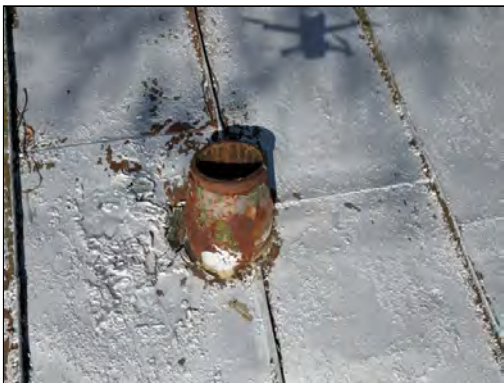
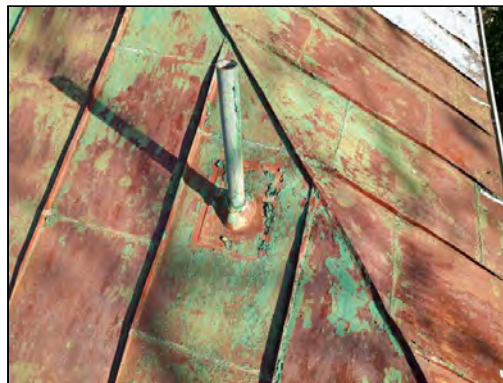
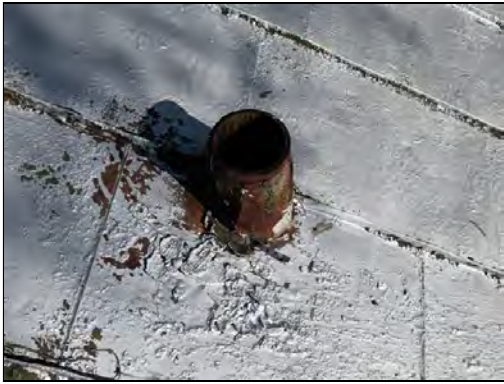
(1) All penetrations through the roof appeared to be in good order at the time of the inspection. It is good practice to caulk plumbing boots or replace the boots altogether every 5 years or so.

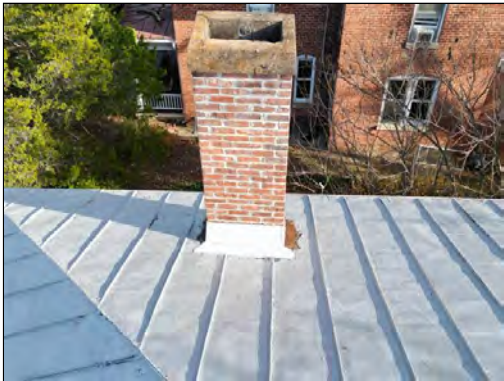
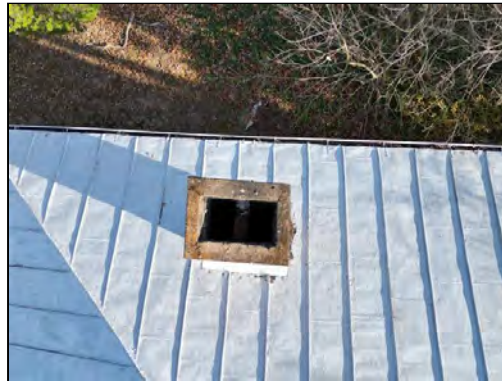
(2) I recommend installing a bird screen and rain guard over the chimney cap(s) to properly protect the flue and interior space from water/pest intrusion. This task can be completed by a qualified chimney sweep.

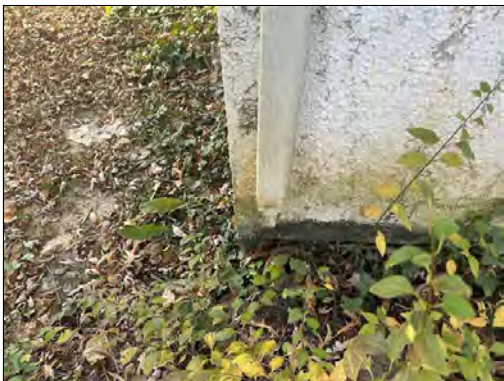
1.3 Item 1(Picture)

(1) I recommend adding downspout extensions (minimum of 5' away from building face) to promote positive stormwater runoff. Moving as much water away from the building face and foundation will help reduce moisture intrusion into the foundation/crawl space/basement and from adversely affecting the structural framing of the home.

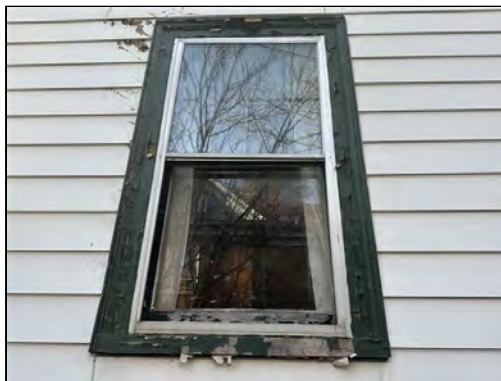
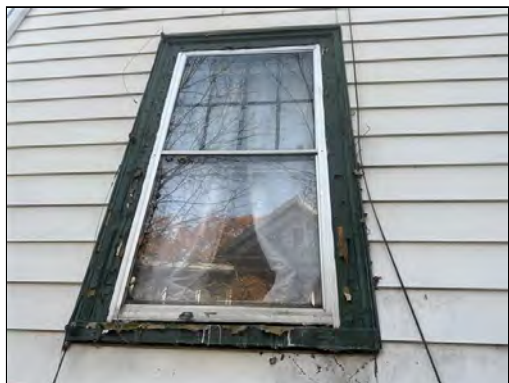
Scrape, caulk, paint the five (5) windows and trim around windows to help ensure the windows don't deteriorate faster and to help prevent water entering into the interior of the home thus causing more issues. This is routine maintenance that happens on every home and should be done every 3-5 years depending on the wear of the paint/caulk used.

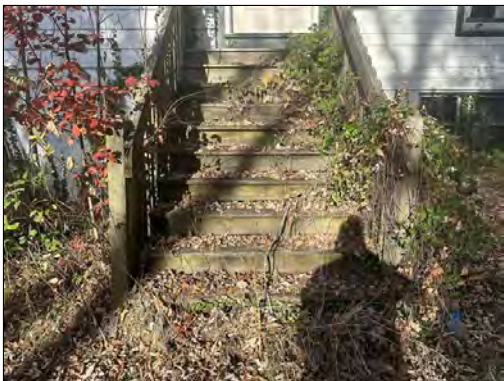
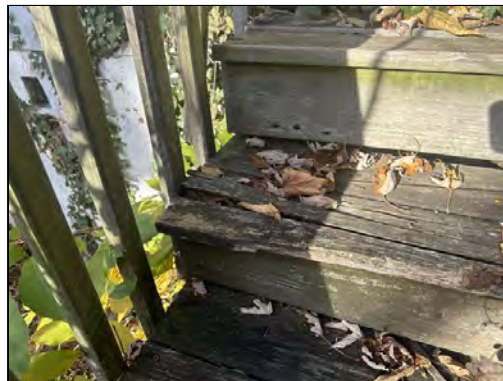
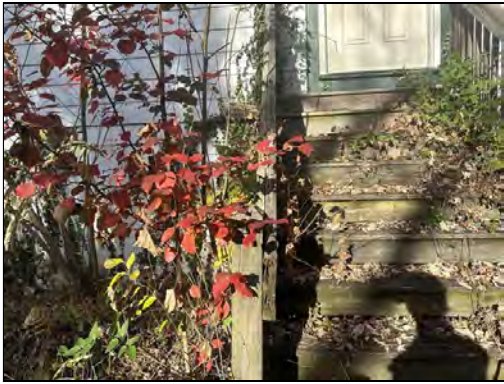
(2) The wood steps in the backyard are past their useful life and are in need of replacement. I recommend having a qualified decking contractor replace the steps to current standards.

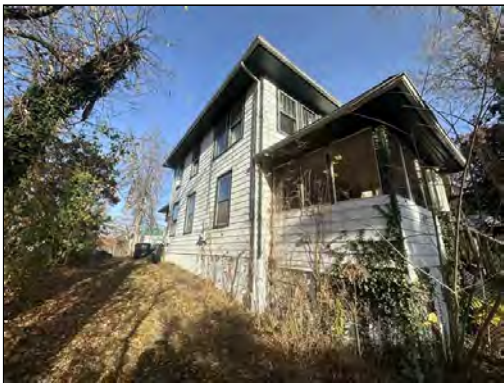
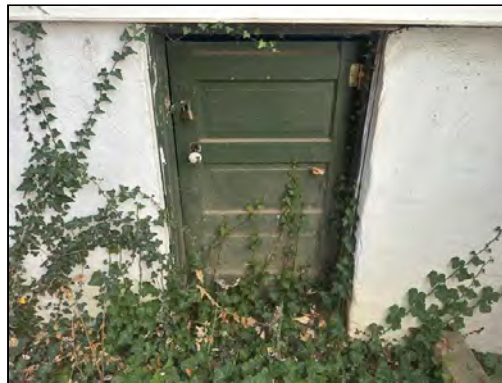
It is good practice to keep all bushes, ivy, and vines a minimum of 12" away from the exterior face of the home. This will help prevent water intrusion into the home.

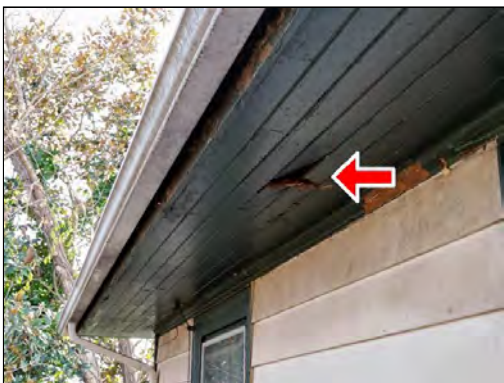
2.5 Item 1(Picture)

There is a hole in the soffit on the left side of the home. This can allow animals to gain access to the attic. I recommend a qualified contractor replace the broken section of the wood soffit. Item 1(Picture)

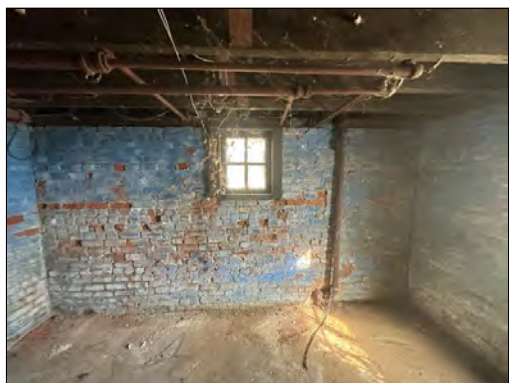
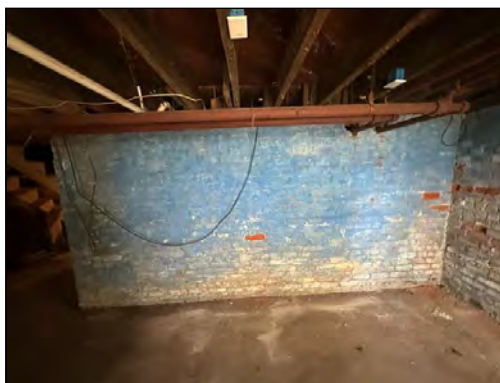
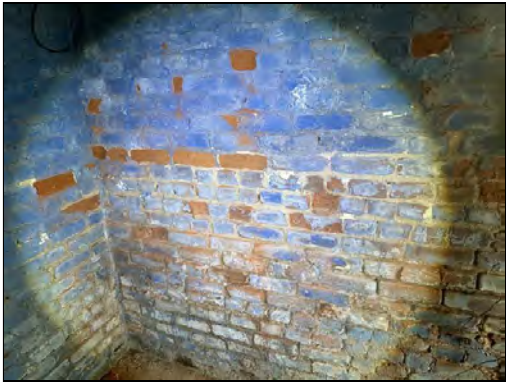
(1) The majority of the below-grade brick foundation at the rear of the home is in need of pointing-up. This process will help the foundation wall retain its strength as well as preventing animal/pest intrusion from occurring into the crawl spaces of the home. This task can be completed by a licensed masonry contractor.

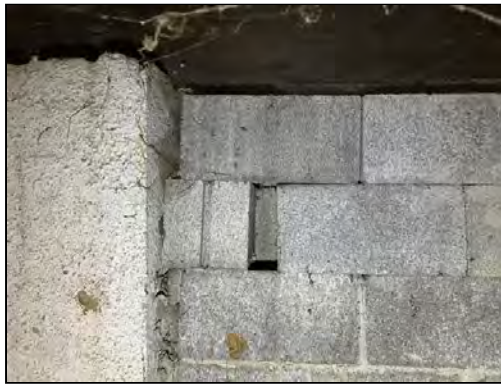
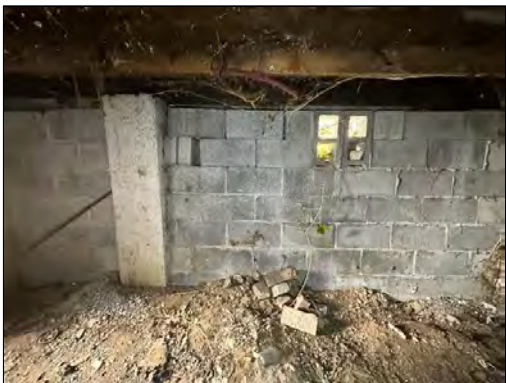
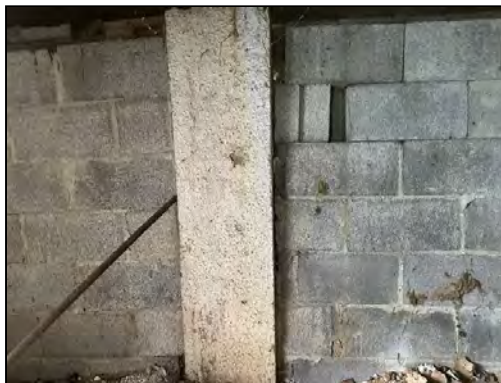
(2) The majority of the above-grade block foundation at the rear of the home is made of dry stacked block without mortar joints. This area needs to be pointed up. This process will help the foundation wall retain its strength as well as preventing animal/pest intrusion from occurring into the crawl spaces of the home. This task can be completed by a licensed masonry contractor.

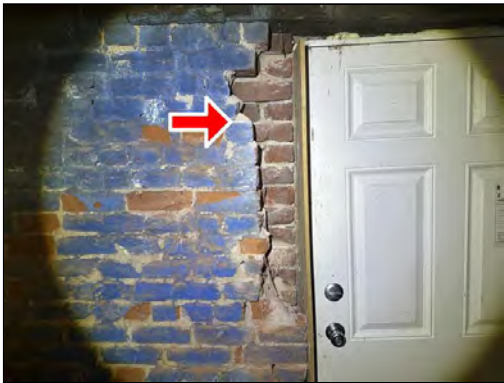
3.1 Item 1(Picture)

The structural brick is missing on the left side of the basement exterior door frame. The brick needs to be replaced to give the door frame proper structural support. I recommend a qualified mason to complete this task.

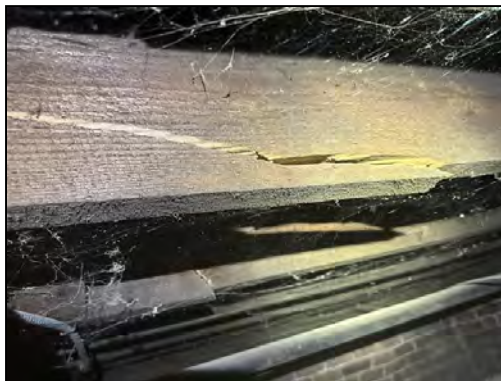
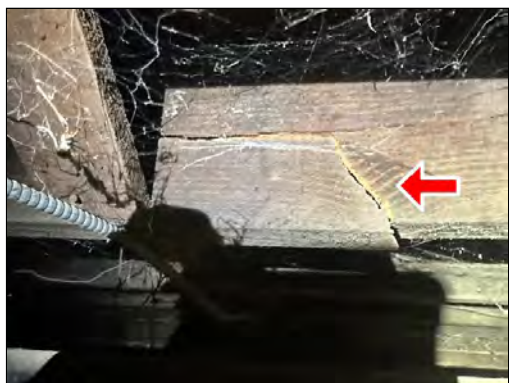
There were three (3) cracked floor joist in the basement. The effectiveness of these joist being able to support the floor above has been compromised due to the broken joists. I recommend having a licensed contractor repair as needed to properly support the floor.

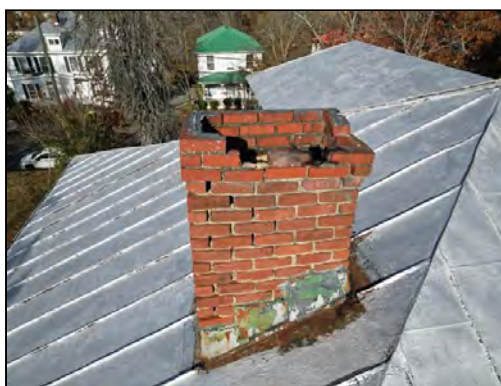
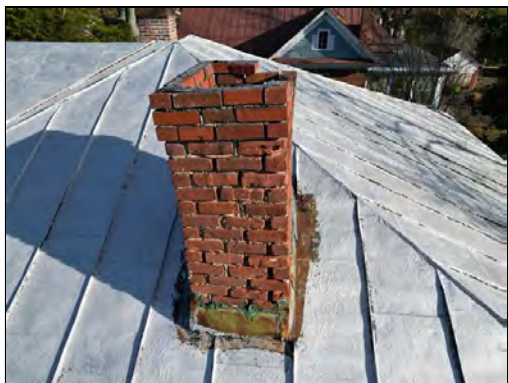
(1) The chimney on the right side of the home needs to be rebuilt as it is unsafe and unstable. I recommend a qualified mason investigate and recommend a solution.

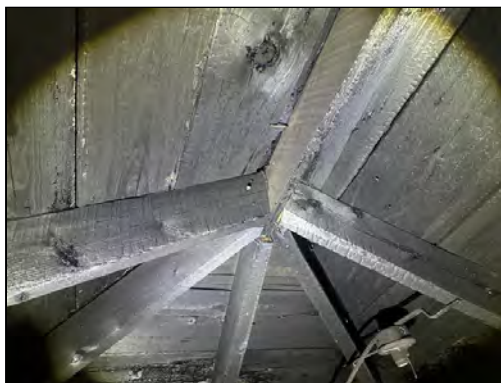
3.5 Item 5(Picture)

(2) Rafters and sheathing inside the attic indicate evidence of a previous fire. I probed charred wood members with a "stab tool" or awl. I recommend monitoring as my probing revealed that the majority of the charring was superficial as the roof structure was in, stable condition during the inspection.
