From: Werner, Jeffrey B
Sent: Wednesday, April 17, 2024 4:34 PM
To: Chinh Q. Le
Subject: 712 Ridge Street - BAR action March 2024

Certificate of Appropriateness
BAR 24-03-01
712 Ridge Street, TMP 250067000
Ridge Street ADC District
Owner/Applicant: Chinh Le
Project: Replace doors/windows, remove chimney, construct driveway

Certificate of Appropriateness Application

BAR 24-03-01

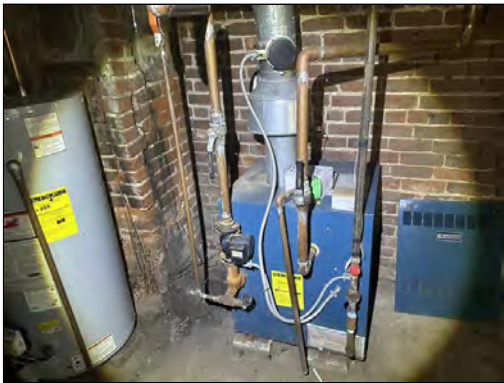
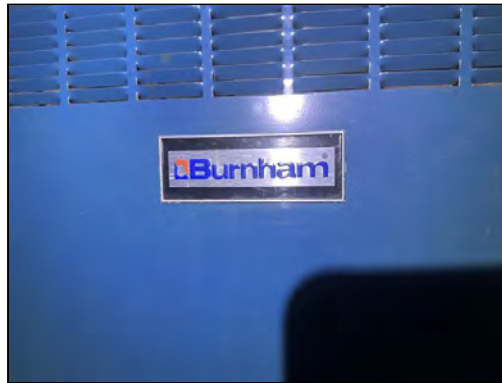
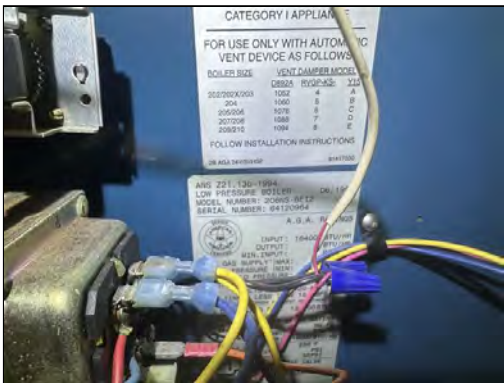
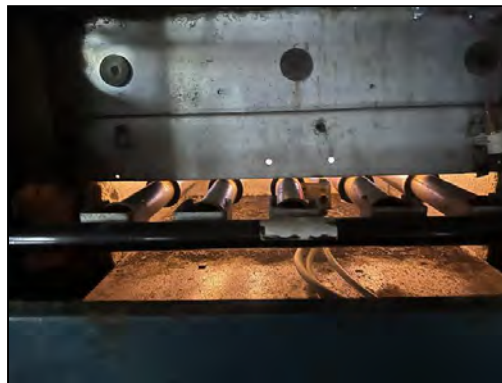
The circulating boiler was working at the time of the inspection. However the unit was not fully combusting the natural gas this is causing the unit to run less efficiently. I recommend a qualified boiler technician inspect further and repair. This unit is past the national life expectancy rate of 15-20 years. I recommend having the unit serviced and starting a budget for it's eventual replacement.

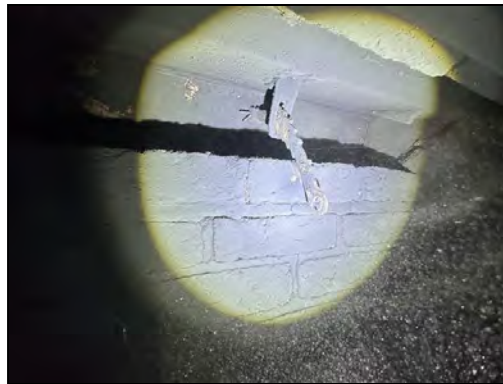
4.5 Item 2(Picture)

(1) I recommend having the chimney inspected by a qualified chimney sweep before use as the inspection conducted today is a visual inspection and does not take into consideration the current status of the inner workings of the chimney flue.

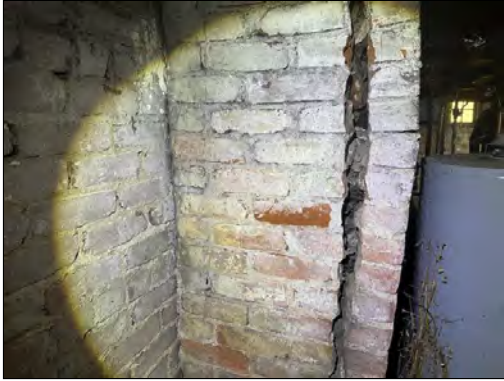
4.5 Item 3(Picture)

(2) The right side chimney's structural brick is failing and in need of rebuilding. This can impact the effectiveness of any gas-powered appliances' ability to properly ventilate carbon monoxide gas to the exterior. I recommend a licensed mason complete this task.

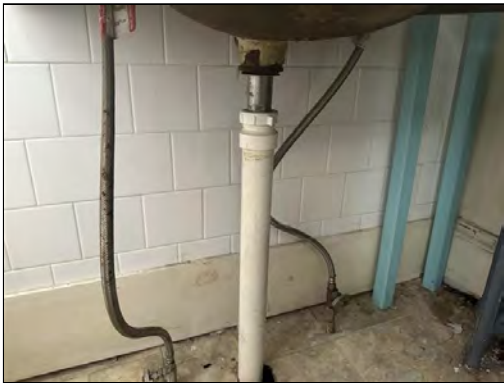
5.1 Item 1(Picture)

(1) There is no P-Trap installed at the upstairs bathroom sink. A P-Trap Is designed to get sewer gases from back flowing into the home. I recommend a licensed plumber investigate and the necessary repairs to each sink.

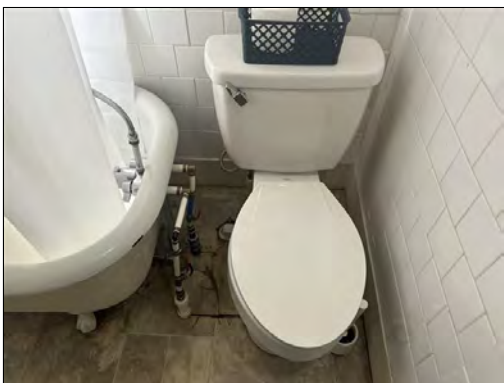
5.1 Item 2(Picture)

(2) The upstairs toilet was loose during the inspection. First, I recommend tightening the T-bolts on the flanges of the toilet. If that does not secure the toilet then the wax ring is more than likely broken and will need to be replaced. I recommend having a licensed plumber investigate further and correct as needed.

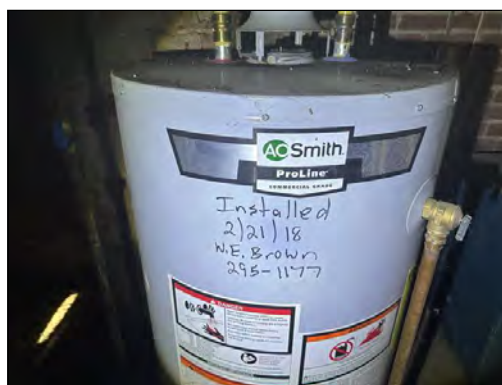
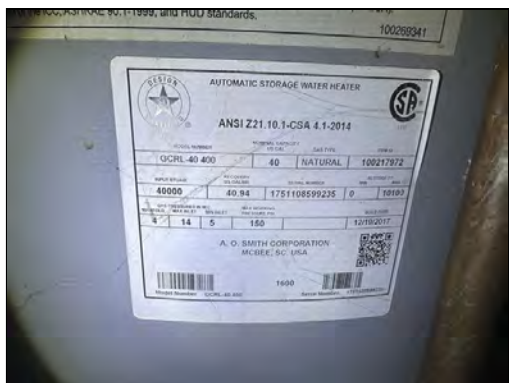
Overall, the water heater was in good working condition during the inspection. Hot water was present at all fixtures in an appropriate time with acceptable functional flow. With proper maintenance (yearly flushing of the unit), this unit could last well beyond the national average of 10 years.

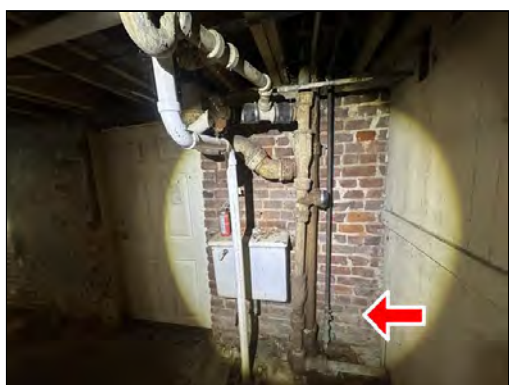
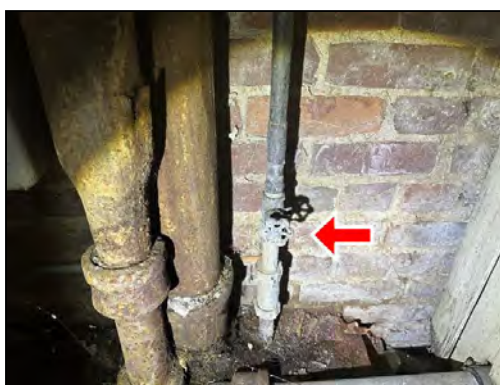
The main water shutoff valve is located in the basement at the rear of the home.

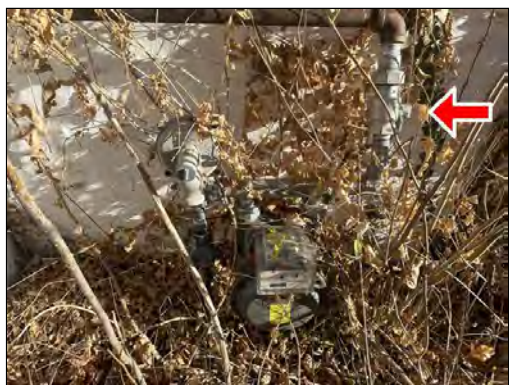
5.5 Item 1(Picture)

The main gas shutoff is located at the meter on the exterior rear of the home.

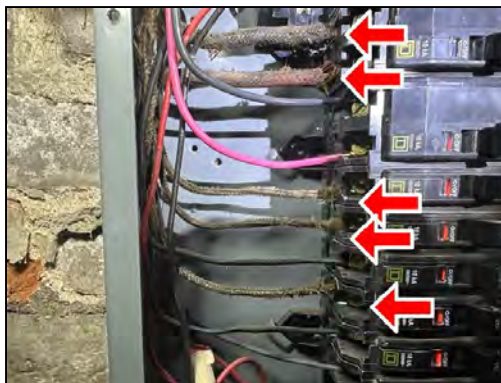
6.2 Item 2(Picture)

(1) There was cloth wiring present in the panel. This has been known to cause fires in the past and is no longer used in construction today. I recommend having a licensed electrician investigate further and correct as needed for safe operation.

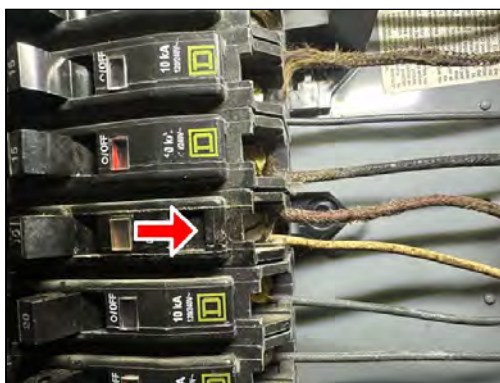
6.2 Item 5(Picture)

(2) I observed two (2) double taps that were present in the main electrical panel during the inspection. Double taps can lead to overheating of the breaker or could lead to a spark or arc between the wiring. I recommend having a licensed electrician investigate further and correct as needed.

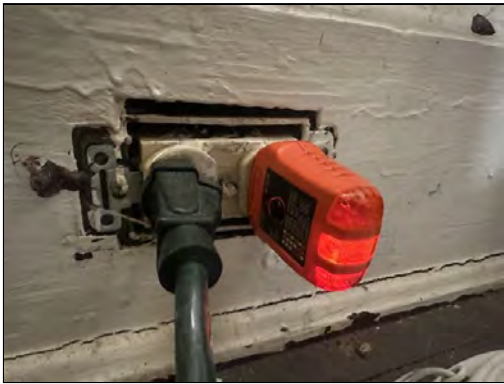
6.3 Item 1(Picture)

An outlet in the upstairs bedroom has the hot and neutral wires reversed. I recommend having a licensed electrician investigate further and correct as needed. Item 1(Picture)

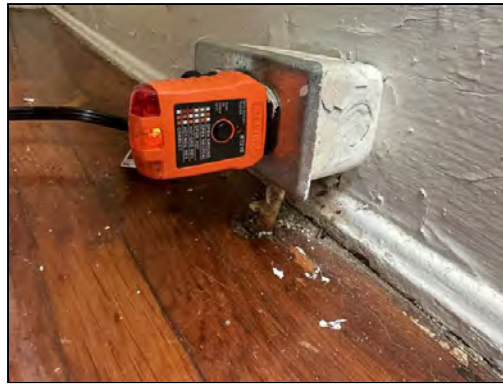
6.3 Item 2(Picture)

There was one (1) outlet on the first floor of the home that was not properly grounded during the inspection. I recommend having a licensed electrician investigate further and correct as needed. A properly grounded outlet is important because it protects the appliances connected and people from the potential risk of electrical shock due to a power surge. There were six (6) outlets found during the inspection that are old style two-pronged. Today's devices require a three-pronged out with ground. I

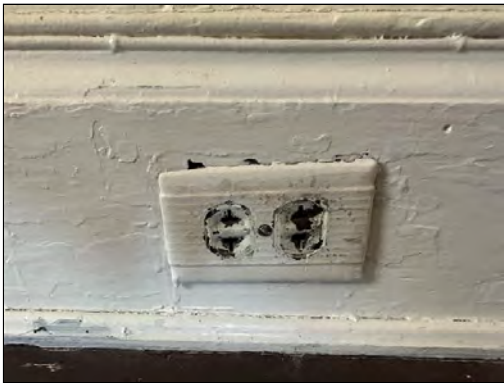
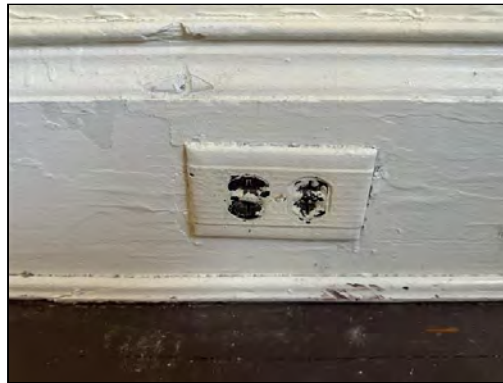
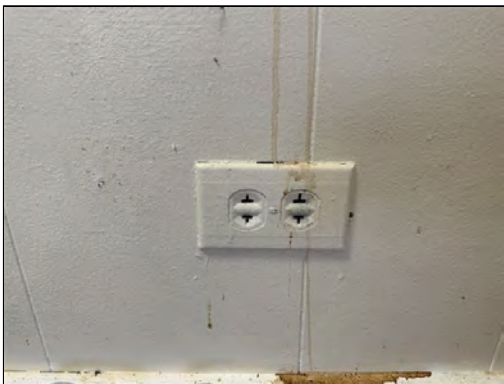
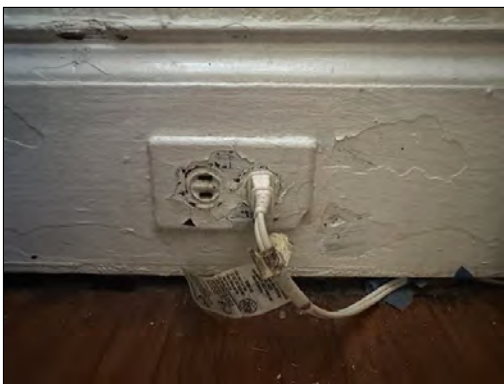
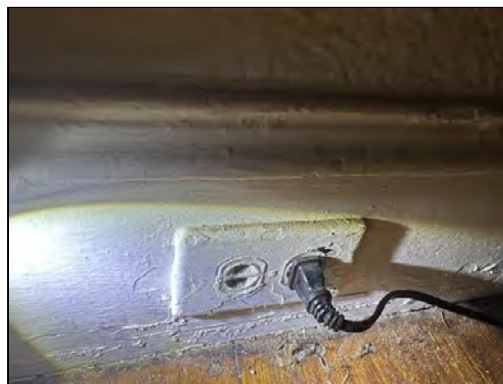
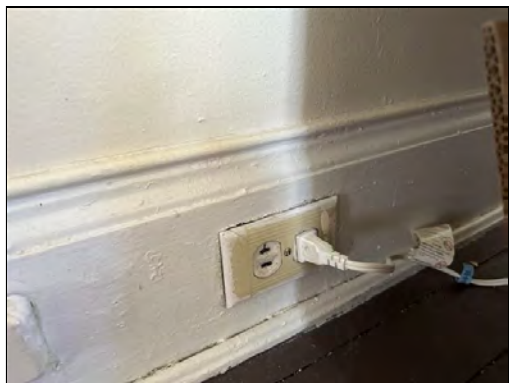
[recommend a licensed electrician replace these with three-pronged outlets.](#)Item 3(Picture) Item 4(Picture)
Item 5(Picture) Item 6(Picture) Item 7(Picture) Item 8(Picture)Item 2(Picture)

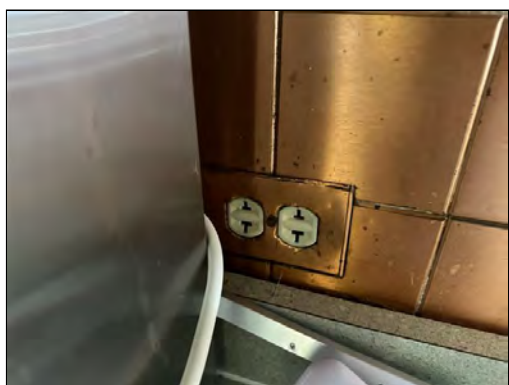
6.4 Item 1(Picture)

The outlet in the kitchen is not properly GFCI-protected. Any exterior, garage, or outlet within 6' of a plumbing fixture must be GFCI-protected to protect both the appliances and people from the potential of electrical surges that can harm the appliance or people. I recommend having a licensed electrician investigate further and correct as needed.

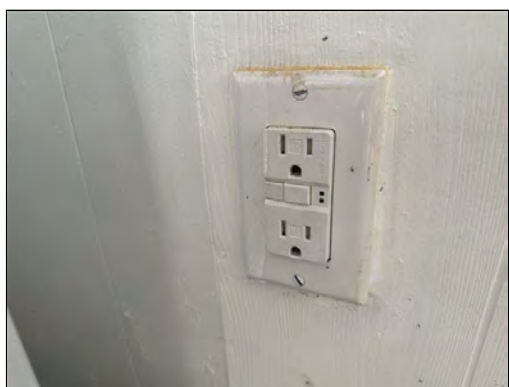
6.5 Item 1(Picture)

The laundry room GFCI outlet was not functioning properly at the time of the inspection. I recommend a licensed electrician replace it with a new GFCI outlet.

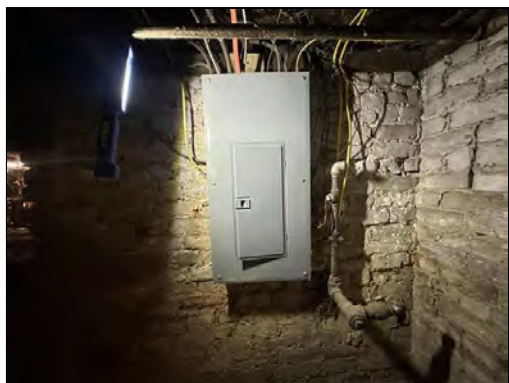
6.7 Item 1(Picture)

The main panel is located in the basement on the rear right side of the home.

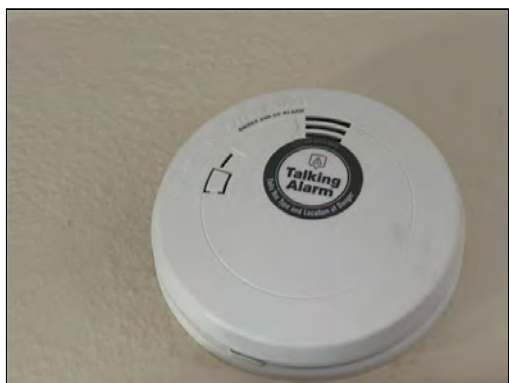
6.8 Item 1(Picture)

The smoke detectors were working properly during the inspection. The smoke detectors should be tested at common hallway to bedrooms upon moving in to the home. I recommend replacing all batteries upon moving in to the home. All smoke detectors should be replaced every 10 years maximum.

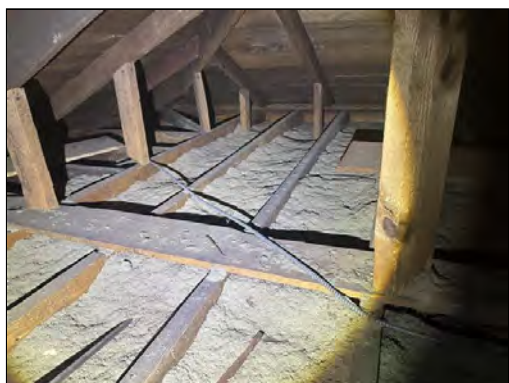
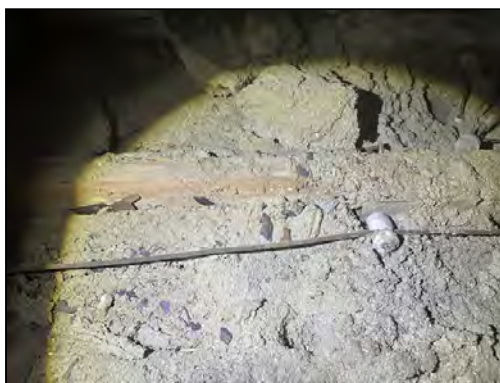
I recommend adding more insulation in the attic as there was not enough present to achieve a minimum R-30 value which is appropriate for this area of the country. This task can be completed by a qualified insulation contractor.

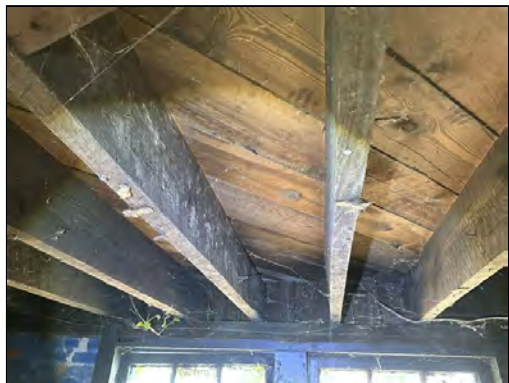
7.1 Item 1(Picture)

There was no insulation present under the floor system during the inspection. I recommend having a qualified insulation contractor install enough insulation to achieve a minimum R-19 value which is needed for this area of the country.

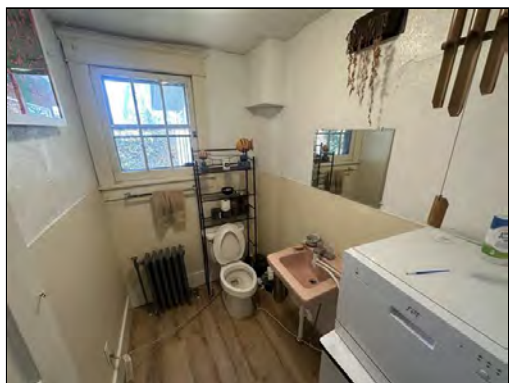
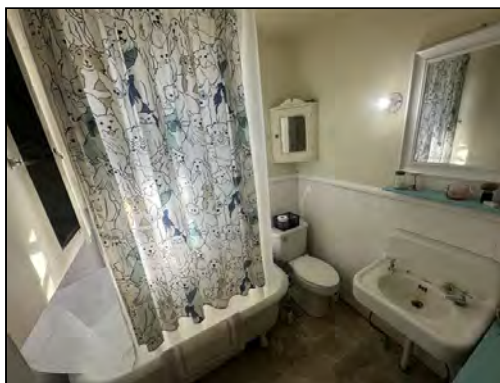
There was no bathroom ventilation fan installed during the inspection. I recommend installing a ventilation fan to help ventilate the home from moisture-laden air.

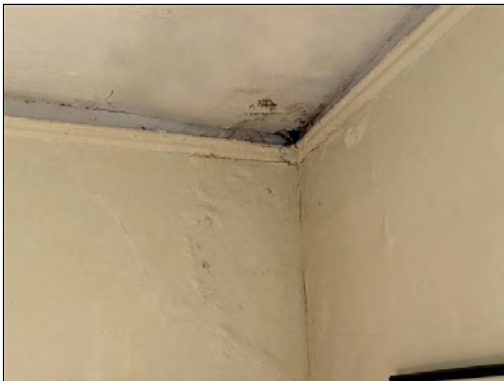
8.1 Item 1(Picture)

There was water damage present on the ceiling of the main level back bedroom. The area was tested with a moisture meter and was found to be dry at the time of the inspection. I recommend monitoring the area and having a qualified contractor repair the finishes.

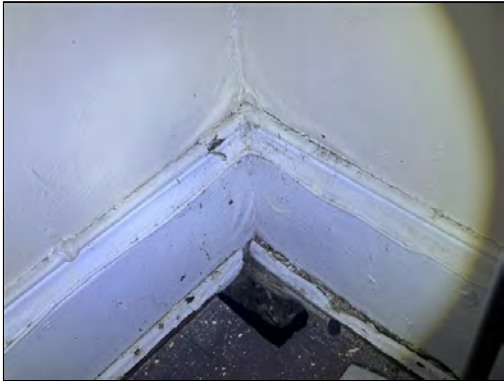
8.2 Item 1(Picture)

(1) There was water damage present in the corner floor area of the main level back bedroom. There was also a hole present in the floor. The area was tested with a moisture meter and was found to be dry at the time of the inspection. I recommend monitoring the area and having a qualified contractor investigate repair the finishes.

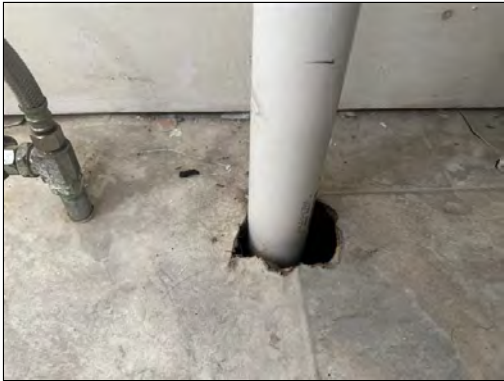
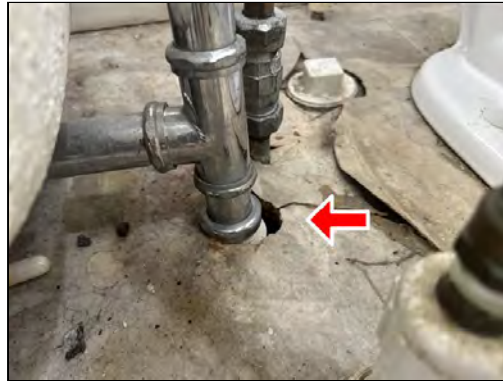
(2) There are two (2) areas in the upstairs bathroom where we need to seal around the plumbing penetrations in the floor. I recommend a qualified contractor repair the floor around these penetrations.

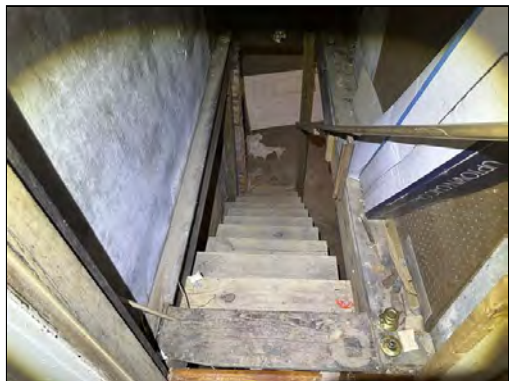
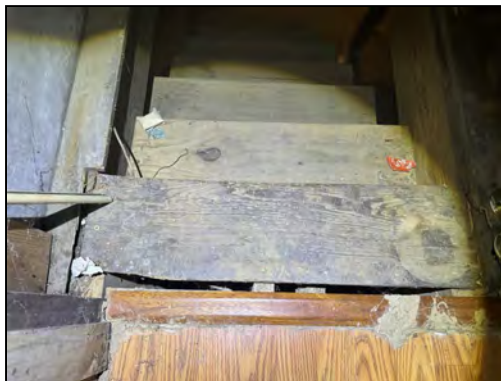
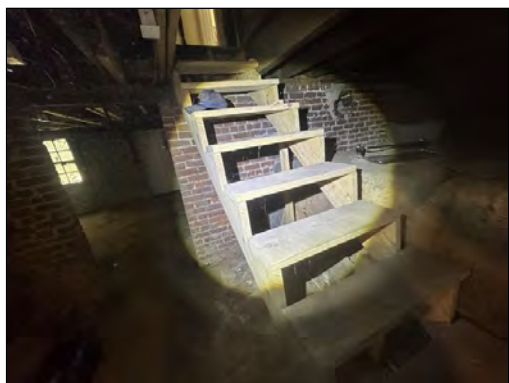
(2) The basement stairs need to be rebuilt with a handrail, proper stair treads and the appropriate balusters to ensure the safety of anyone using the stairs. This can be come completed by a qualified contractor.

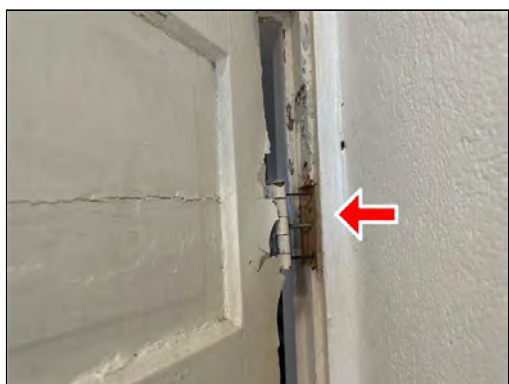
8.5 Item 1(Picture)

The door to the main level half bath was found to be pulling away from the door frame. This is causing the door to not function properly. I recommend a qualified contractor reattach the door to the frame.

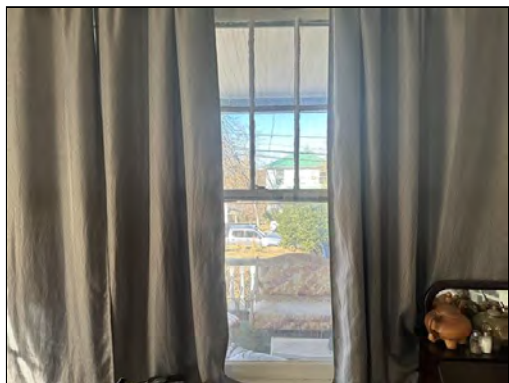
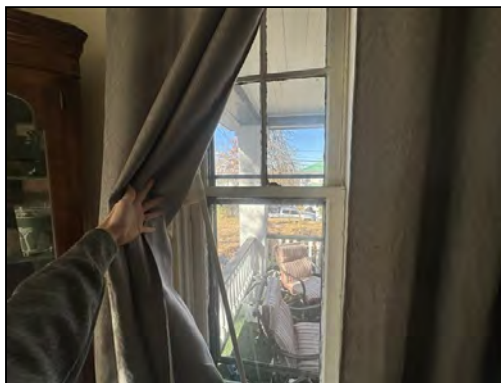
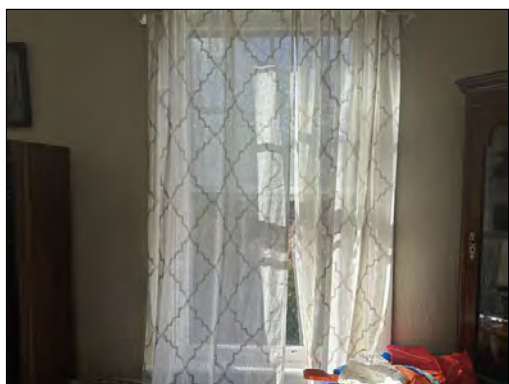
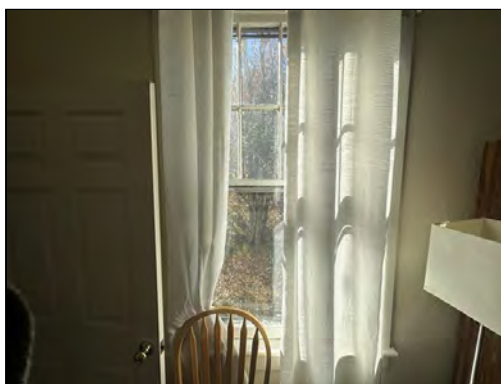
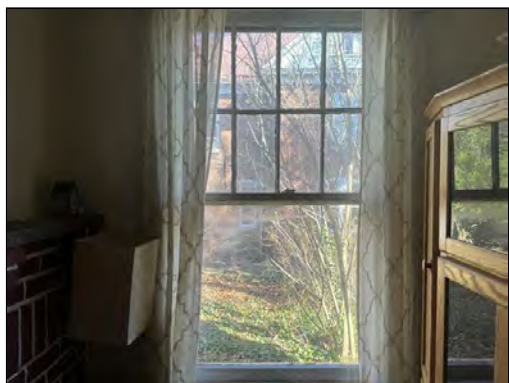
There were ten (10) windows on the main level that would not open at the time of the inspection. There were four (4) windows on the upper level of the home that did not open during the inspection. They have either been painted shut or have been fastened shut. I recommend having a qualified window contractor repair/replace as needed such that the windows operate as designed. Also, windows in bedrooms should be operational for fire egress. This should be considered when addressing the issue.

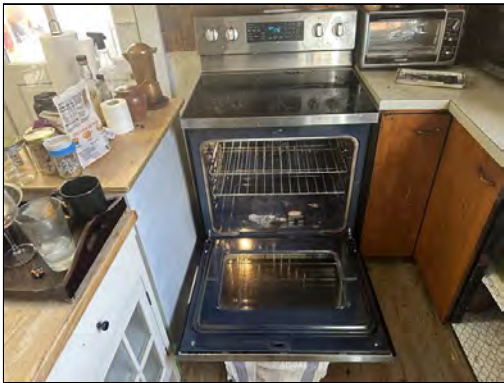
9.1 Item 1(Picture)

The anti-tip device for the range was not installed. I recommend installing the device so that the range does not tip over when used which can be very harmful to a person if this occurs. This task can be completed by a qualified appliance technician.

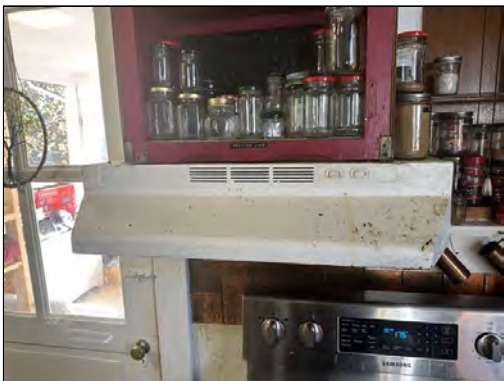
9.2 Item 1(Picture)

The exhaust fan did not function at the time of the inspection. I recommend replacing it with a unit that vents to outside the home. A qualified contractor can complete this task.
