**CITY OF CHARLOTTESVILLE
BOARD OF ARCHITECTURAL REVIEW
STAFF REPORT
September 21, 2021**

BAR 21-09-01

209 2nd Street, SW, Tax Parcel 280077000

Project: Alterations to existing structure

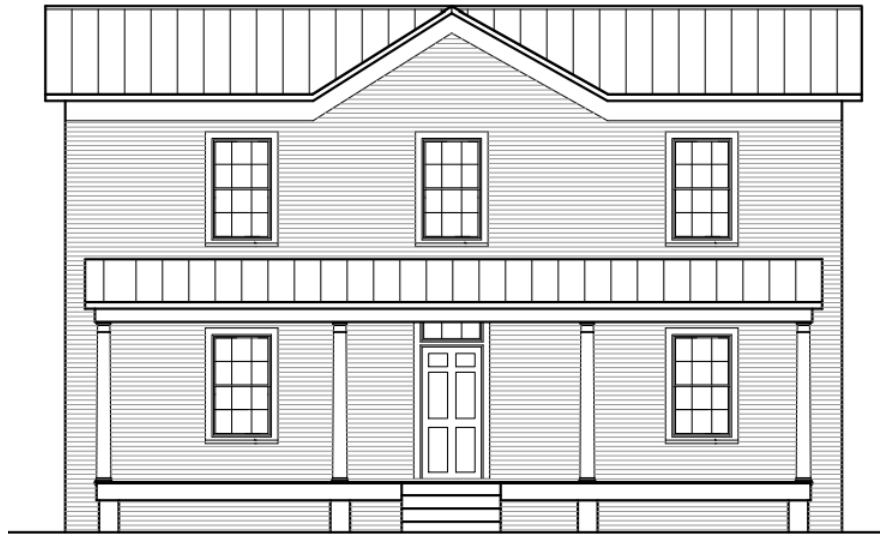
4) FRONT ELEVATION

Existing
(from Aug 2019 submittal)

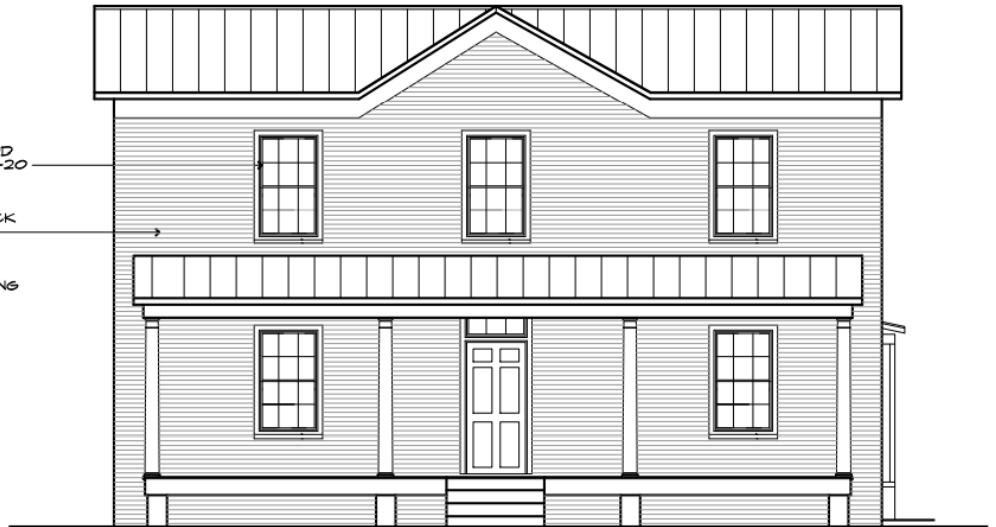
4) FRONT ELEVATION

Approved August 2019

- PAINT EXIST. WOOD WINDOWS BM 2130-20
- PAINT EXIST. BRICK BM OC-122
- PAINT EXIST. SIDING BM OC-122
- PAINTED 5'X12' WALK-IN IV' SHED ROOF ABOVE
- MARRA FORNI PIZZA OVEN

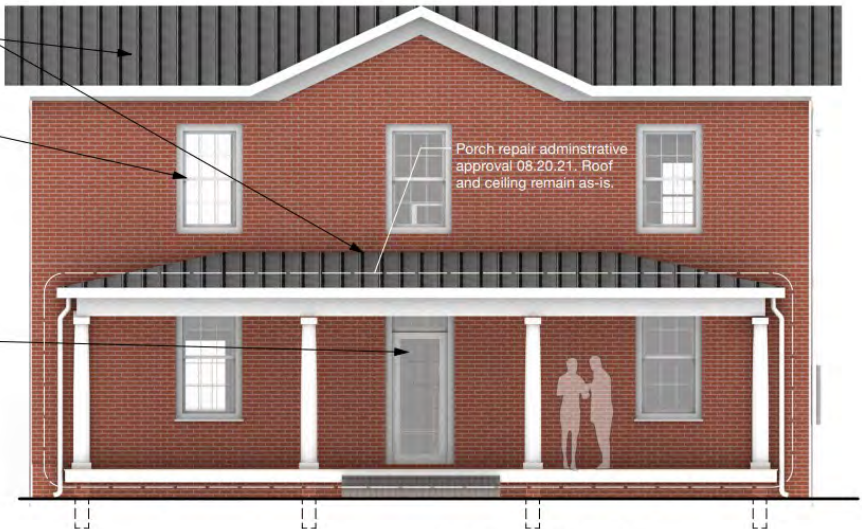
1 FRONT ELEVATION
A1.5 3/16" = 1'-0"

- existing new standing seam roof (typ)
- innovate all existing windows to meet egress, reglaze, repaint, repair weights, replace hardware as required.
- new egress door

Porch repair administrative approval 08.20.21. Roof and ceiling remain as-is.

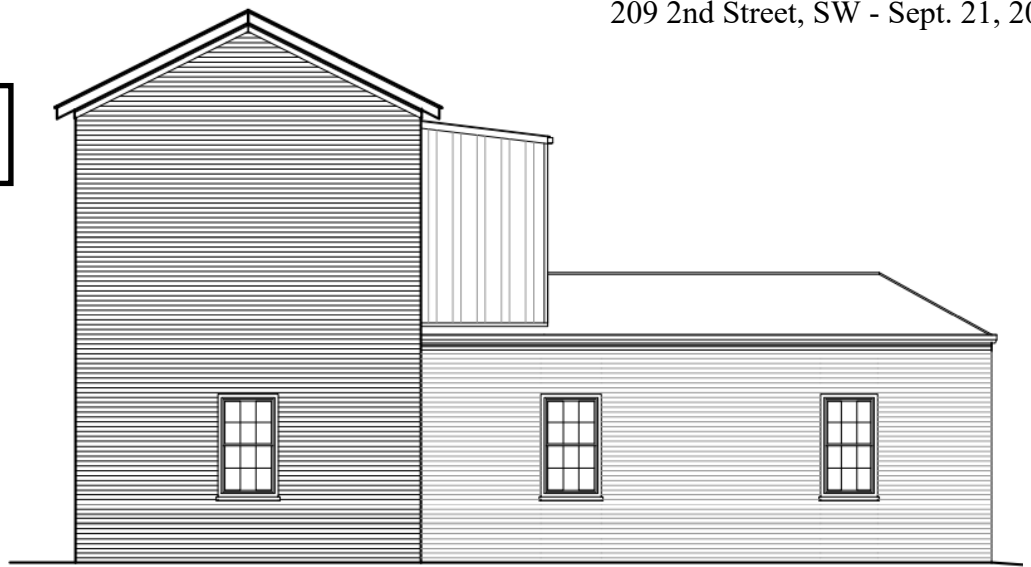
2 EXISTING RIGHT SIDE ELEVATION

Existing
(from Aug 2019 submittal)

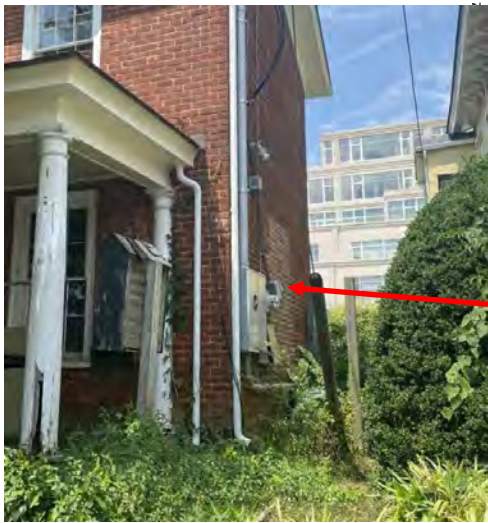
Staff note (9/2021): This window has already been removed. See staff report for discussion.

- Accept the change and completed brick work.
- If extant, the original window could be reinstalled; however, due to the proposed use, the public safety code requires this be a fire-rated wall, including the window. As such, any replacement will require a new, fire-rated window.
- Allow the bricked opening, but require it be installed as inset panel, not flush with the exterior wall, thus expressing the change from the original.

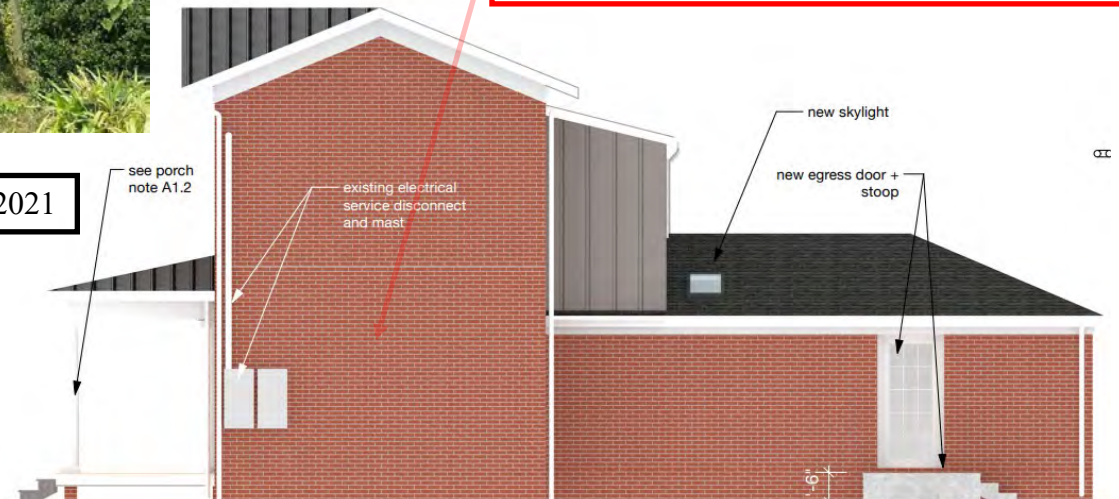
Proposed September 2021

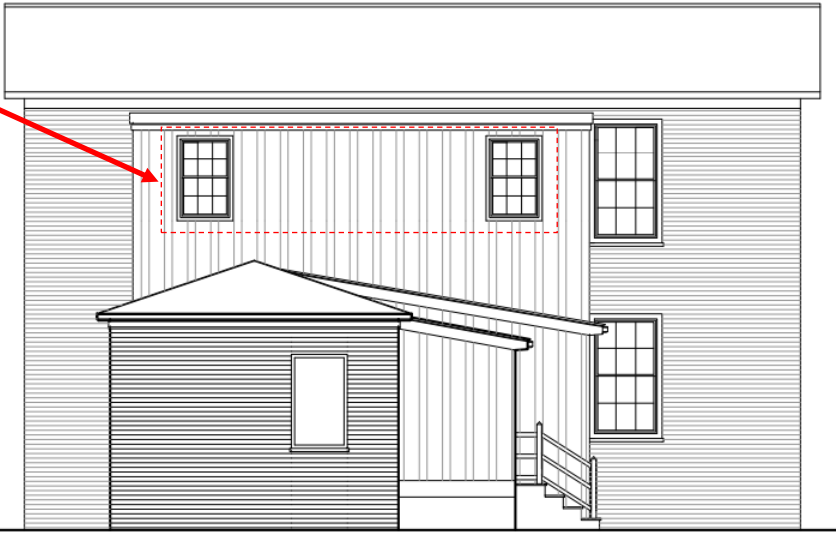
EXISTING REAR ELEVATION

Existing
(from Aug 2019 submittal)

Staff note (9/2021): Windows shown incorrectly. Existing are single sash. (see below.)

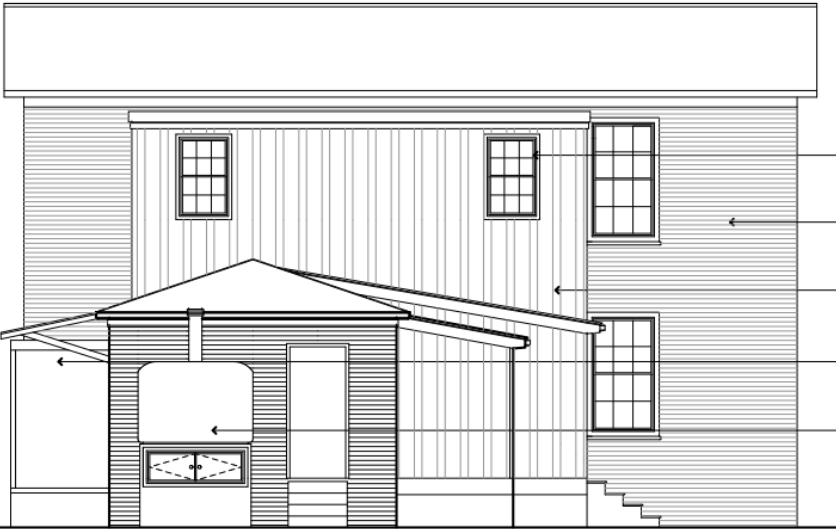
3 REAR ELEVATION

Approved August 2019

Siding is existing board and batten.

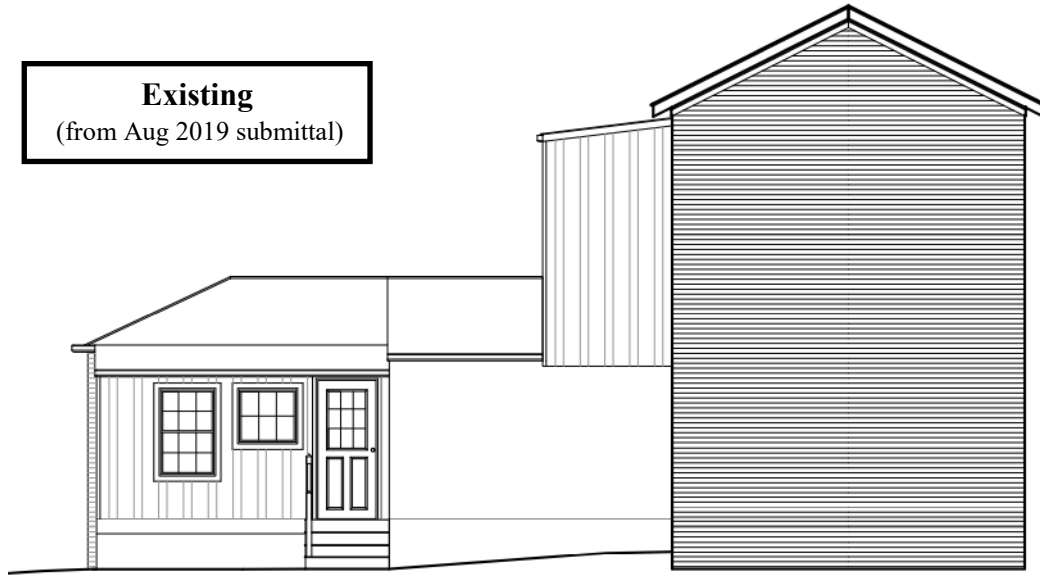
① EXISTING LEFT SIDE ELEVATION

Existing
(from Aug 2019 submittal)

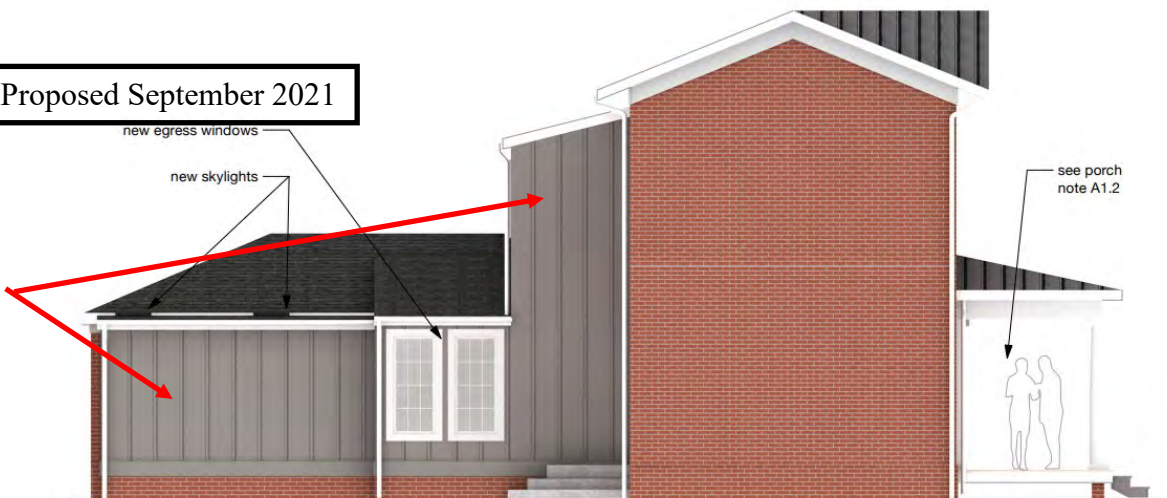
5 LEFT ELEV (FACING 213)
A1.3 3/16" = 1'-0"

Proposed September 2021

Siding is existing board and batten.

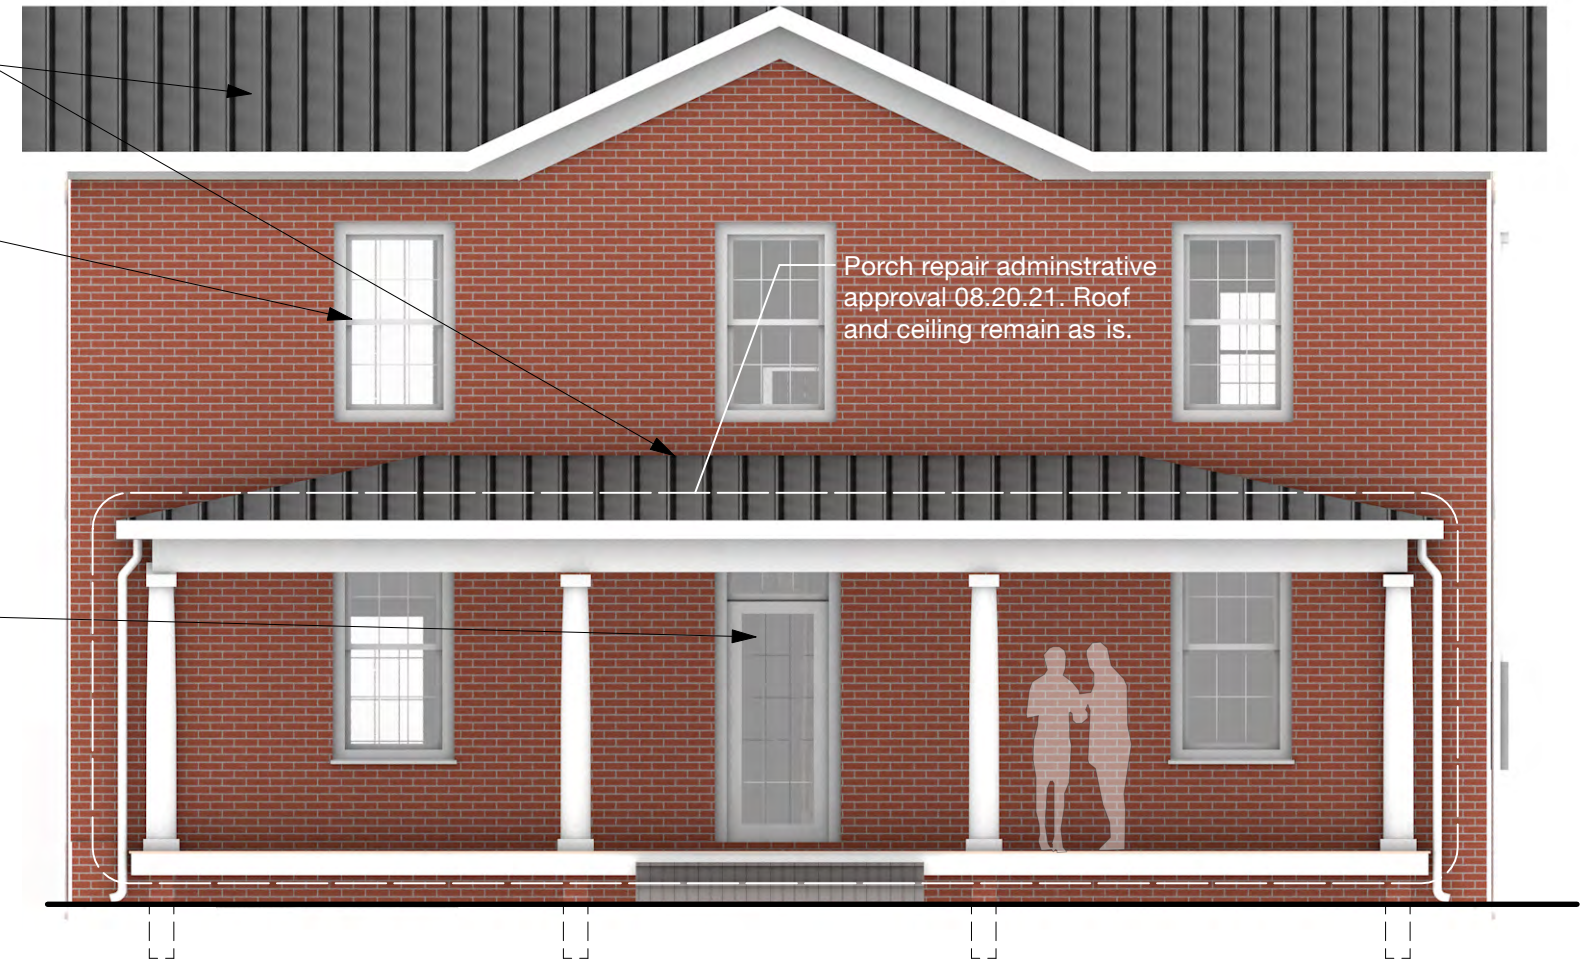
1 FRONT ELEVATION
A1.5 3/16" = 1'-0"

replace rotted windows with new to match previous submission

paint existing siding

new window replaces previous approved door opening. match existing brick and mortar below

existing door

new landing and steps

- replace rotted windows with new to match previous submission
- paint existing siding
- new skylight
- new window replaces previous approved door opening. match existing brick and mortar below

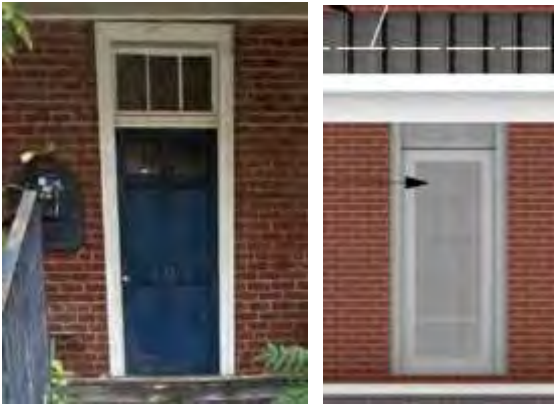
Staff: Entry door replacement.

Yes. Frame, trim, and transom remain. New door is IG (I hate not having spacer bars). Attached is a quote for windows and doors. Be advised that supply chains are completely fubar right now. Marvin is 22 weeks out (not doing that). Anderson quote attached (12 weeks). All have 5/8" putty munitins to match existing. Not sure what you mean by door and transom lites aligning. Lites in the existing door don't align. Door lites will never align with transom lites because any glass door has a wider stile than the transom sash. (The existing heavy horizontal intermediate head breaks this visual alignment). Doors come standard 15 lite unless you all prefer a 10 lite which they can do. Basically, the new door replaces the blue door. Everything else remains.

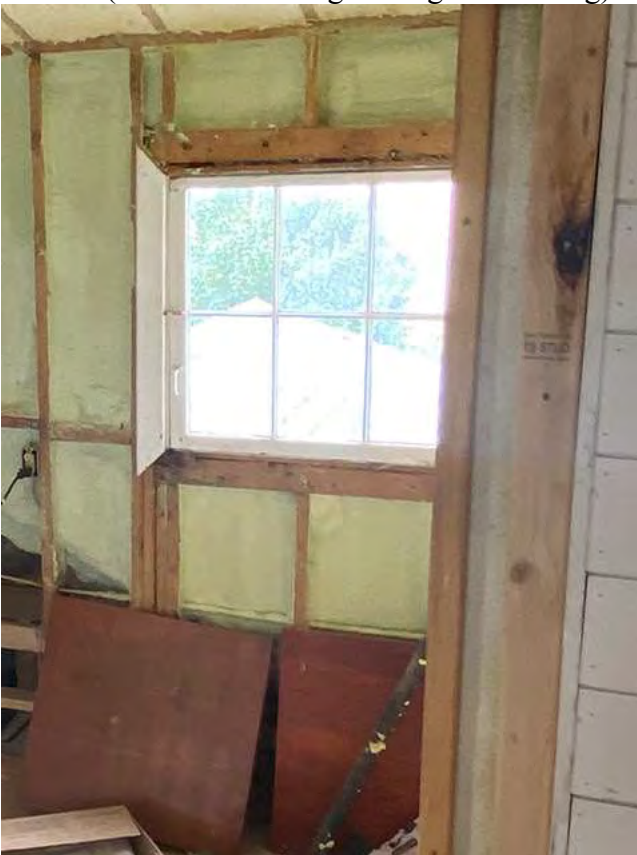
Interior (note water damage + original framing)

- 2019 approval: Existing windows to remain.
- 2021 request: Replace windows to *match existing*; however, the photos indicate the originals have been removed. What's the plan?
- Additionally, to approve window replacements, applicant must provide information on the existing conditions and why replacement, vs repair, is necessary.
- Provide cut sheets on the proposed windows.

Applicant: This one is a bit muddy. My understanding is the 2019 approval only correctly depicted the right window. The left one is still in place and my understanding is they never matched. The left one is a simple in-swing hinge and a rotting thermal disaster that leaks (no weather seal, no flashing, water damage on framing etc) For the right side, I don't have the history on what is there now, but it needs to come out. Matching the drawings of the 2019 approval seemed to make the most sense, especially given failure of the left side, and non-

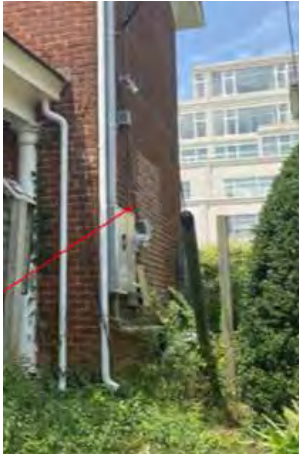
Staff: First floor, north window.

Request to remove window and brick the opening. Photos indicate this has already been done. The BAR may not approve this and require the window be reinstalled. Was the window retained?

Applicant: The bricked-in condition was existing when I came on board, so I did not include a request to modify it in this submission (left it alone). Wasn't sure how to handle it. If the BAR does request that a window be re-installed, best we can do is replace it with a new one that matches as closely as possible and be fire-rated. But appears this still might not meet

the building code. (The other end of the building does not have an opening). This north end of the building is approximately 3' from the property line (hard to tell). The building code (VRC R302.1) does not allow openings 3' or less from a property line. Additionally, any penetration/opening less than 5' is required to be fire rated, which an existing window clearly would not have met and would have been required to be replaced regardless to meet VEBC (2018) (601.1), which stipulates that alterations shall comply with the current VCC. Let me know how you all want to address this.

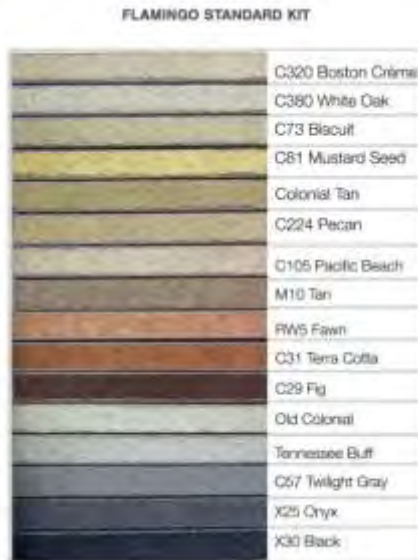
Staff: Mortar repairs. House dates to c1880. Confirm that an appropriate mortar must be used.

Applicant: Lehigh Flamingo masonry cement, type N
<https://www.lehighhanson.com/products/cement/colored-masonry-Cement>
 Match existing color. pacific beach C105 or equal. Determine in the field.

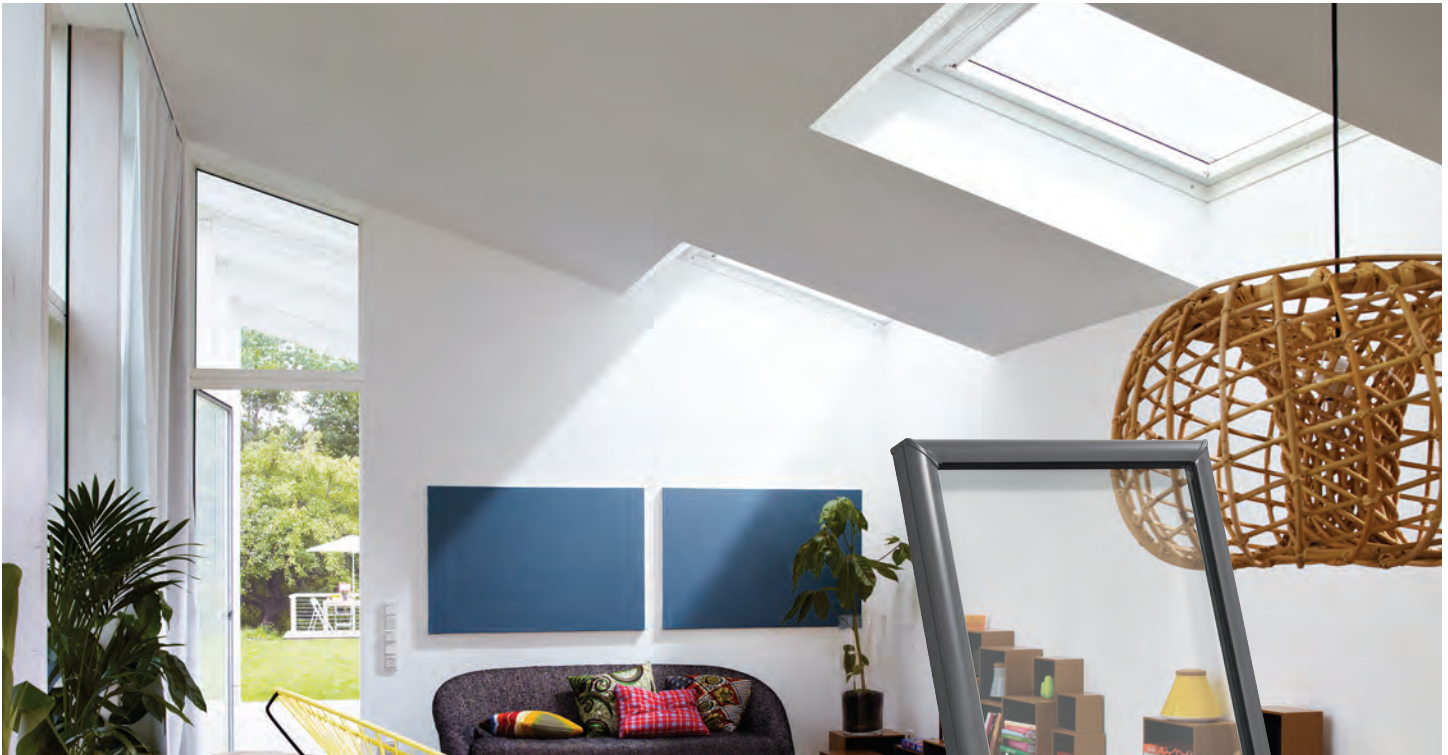
Fixed Skylight FCM Model

VELUX Fixed Skylights are perfect for visually expanding and transforming areas, such as hallways, stairwells, and other closed-in, dark spaces with bright light and sky views. As an economical choice, fixed skylights create a spacious home full of natural light.

Applicant: Velux. Fixed. FCM 2222 over bath 1, Fixed CFP 6060 for baths 2+3.

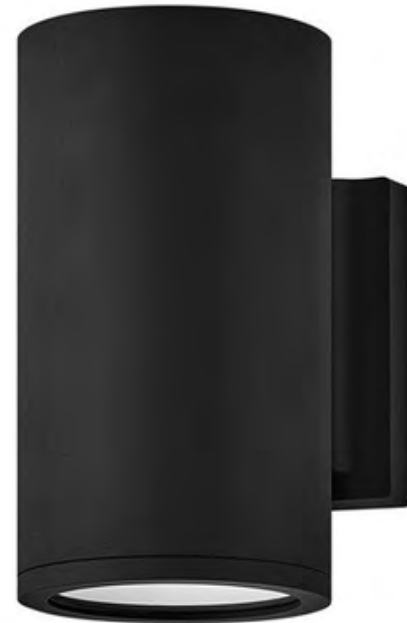
The Silo Dark Sky Outdoor Wall Sconce is the perfect addition to exteriors from coastal to modern. The compact design blends seamlessly into your space. Dark Sky Ordinance was developed as outdoor lighting standards that reduce glare, light trespass, and sky glow. Coated with anti-fading finishes, for maximum durability in harsh climates. Finished in Architectural Bronze, Black, and Satin White with an Etched Glass diffuser. Dark Sky and JA8 complaint. Wet location rated. UL and CSA listed.

Shown in: Black / Etched Glass

SHADE COLOR	Etched Glass
BODY FINISH	Black
WATTAGE	6.5W
DIMMER	Standard 120V
DIMENSIONS	4.5"W x 8"H x 5.75"D
LAMP	1 x MR16/GU10/6.5W/120V LED
