Board of Architectural Review (BAR) Certificate of Appropriateness

Physical Street Address: 212 WINE STREET
City Tax Map/Parcel: MAP 33 PARCEL 32A

Name of Historic District or Property: 212 WINE ST.

2121 Wine Street – Exterior Restoration
April 29, 2008

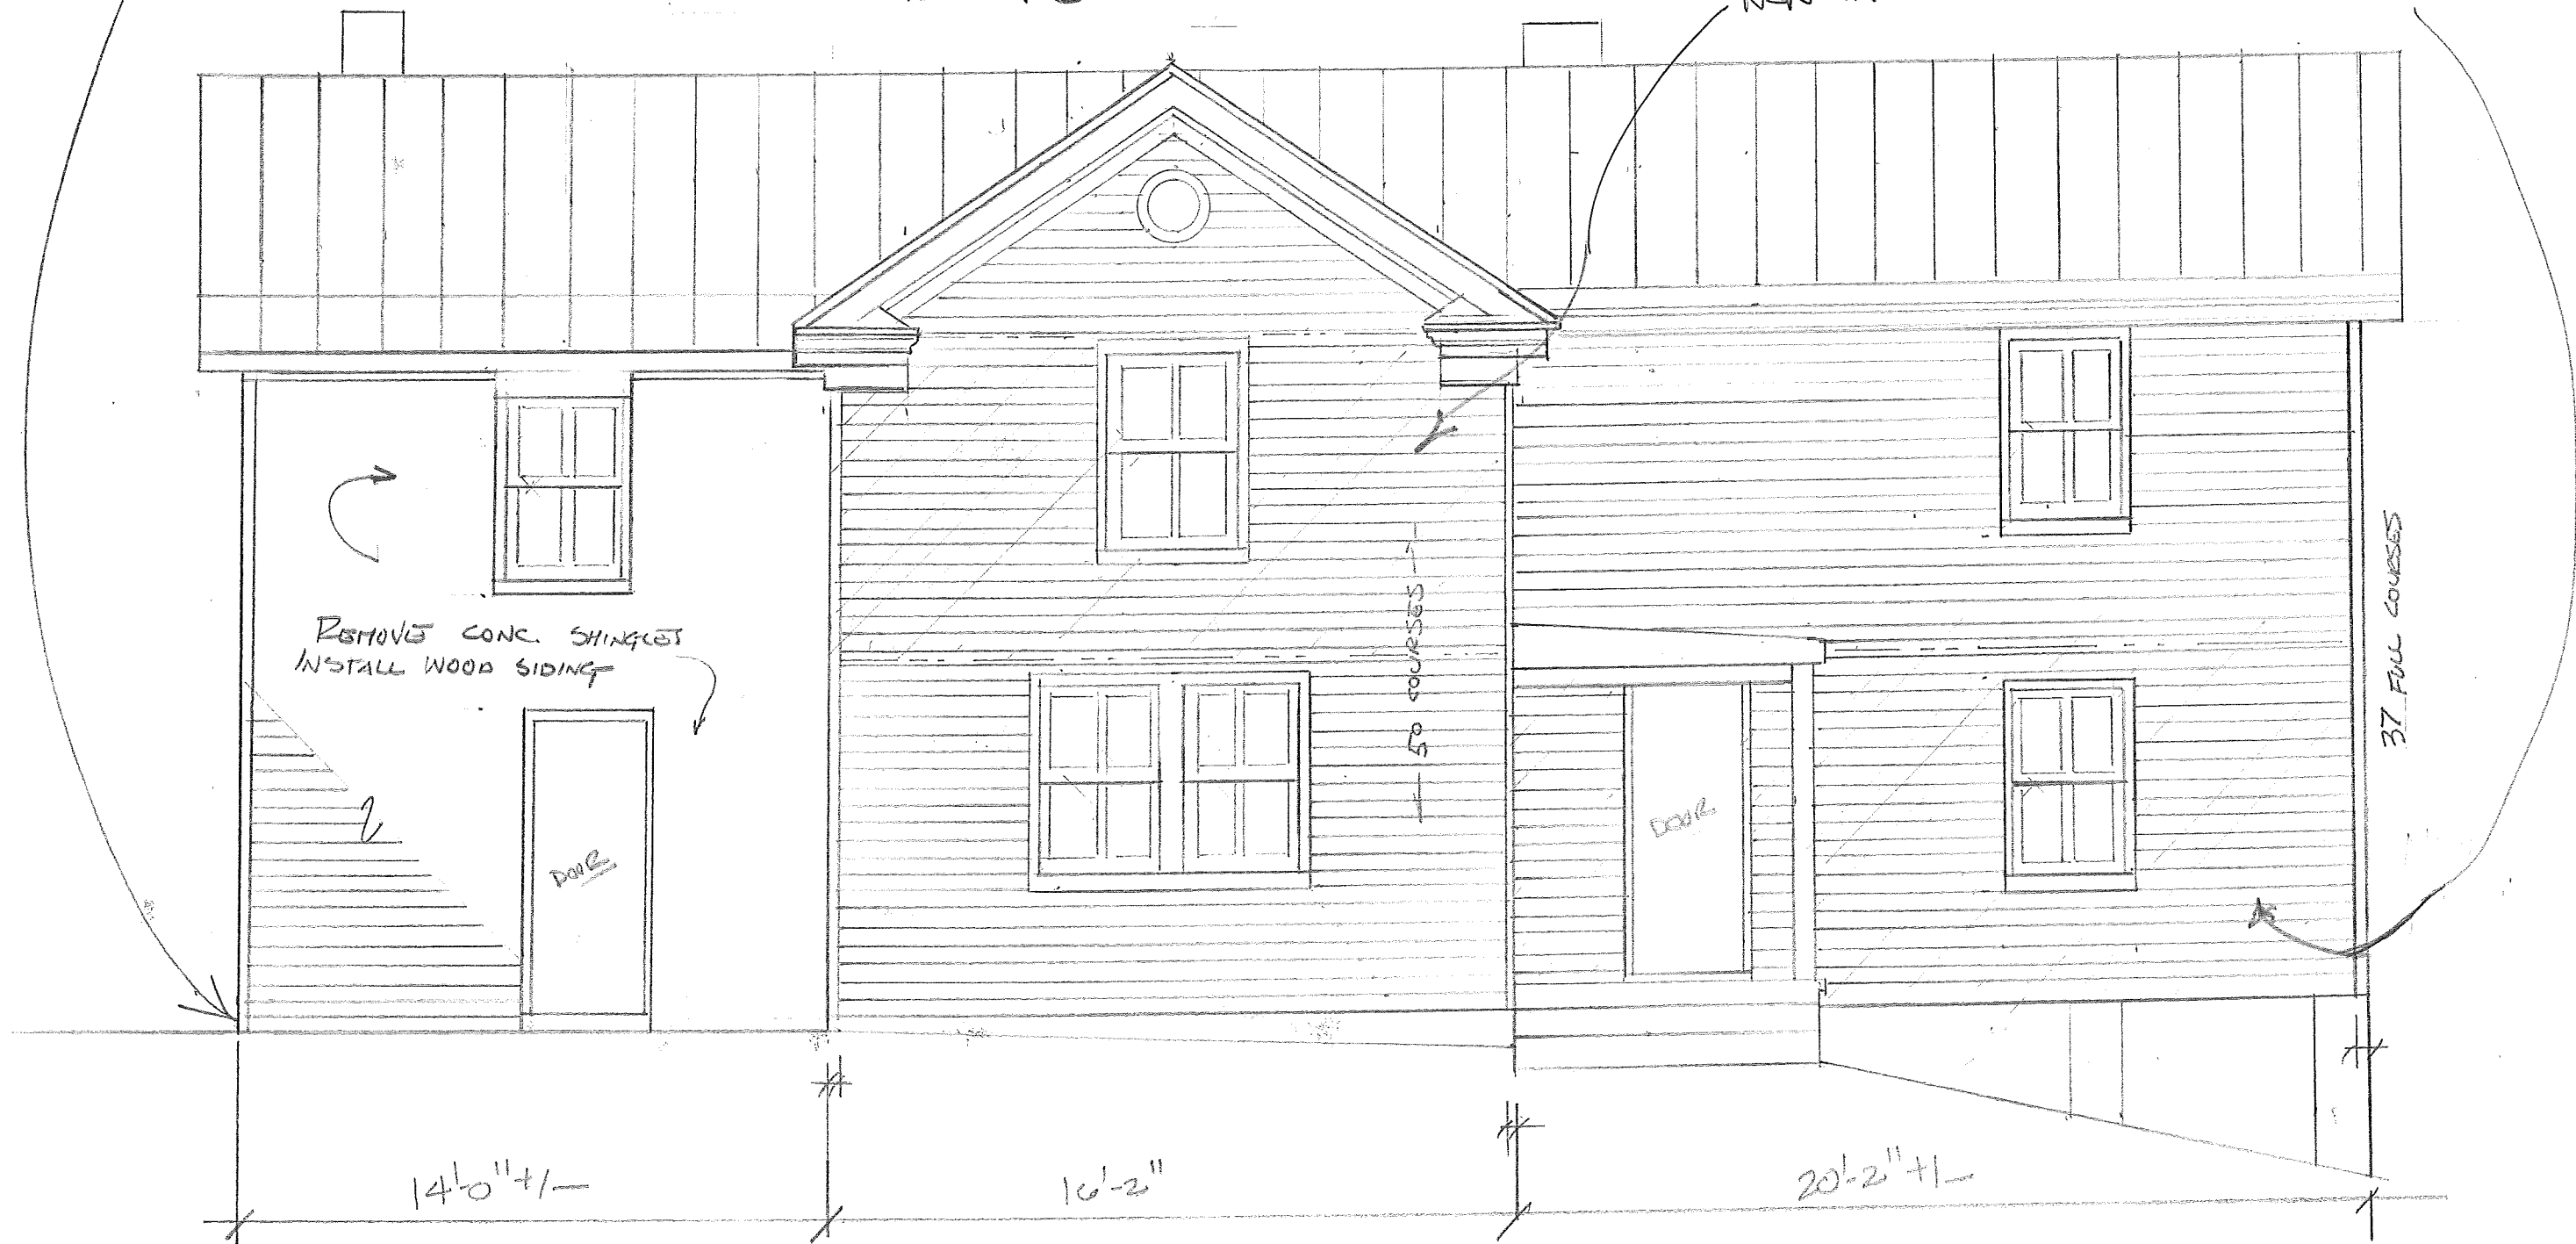
NORTH ELEVATION
H11

NEW INSULATION @ WALL CAVITY

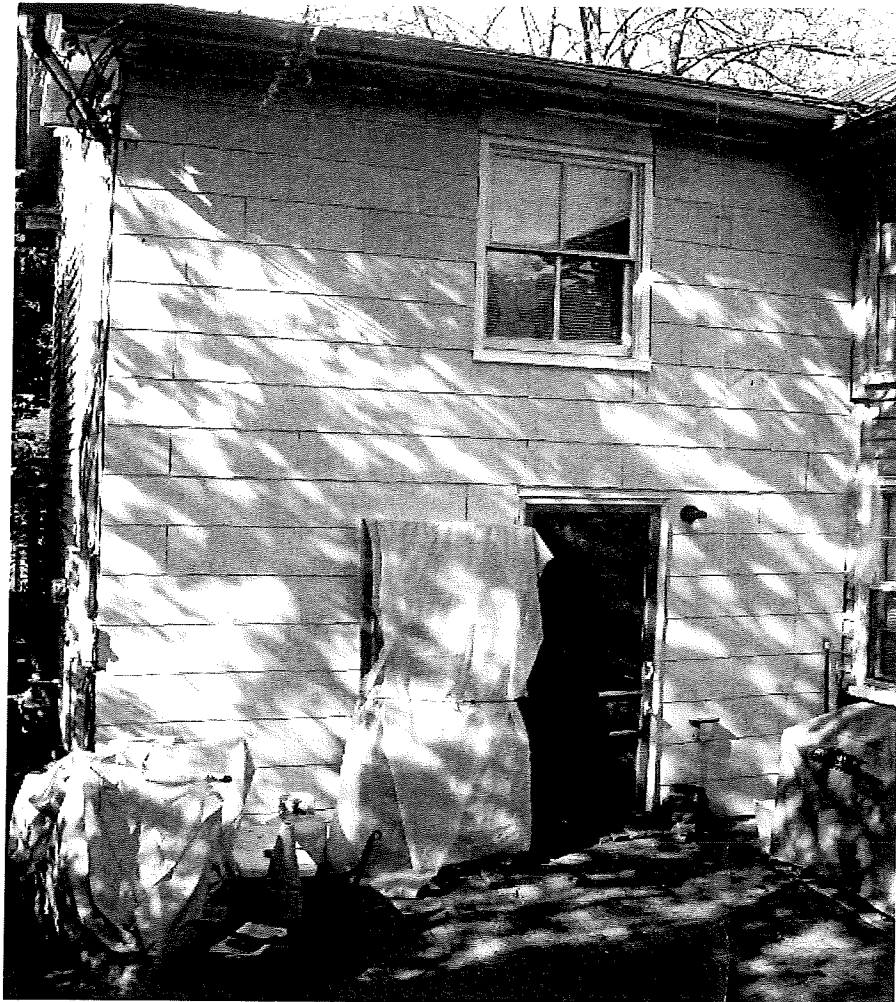
North Elevation
(east side)

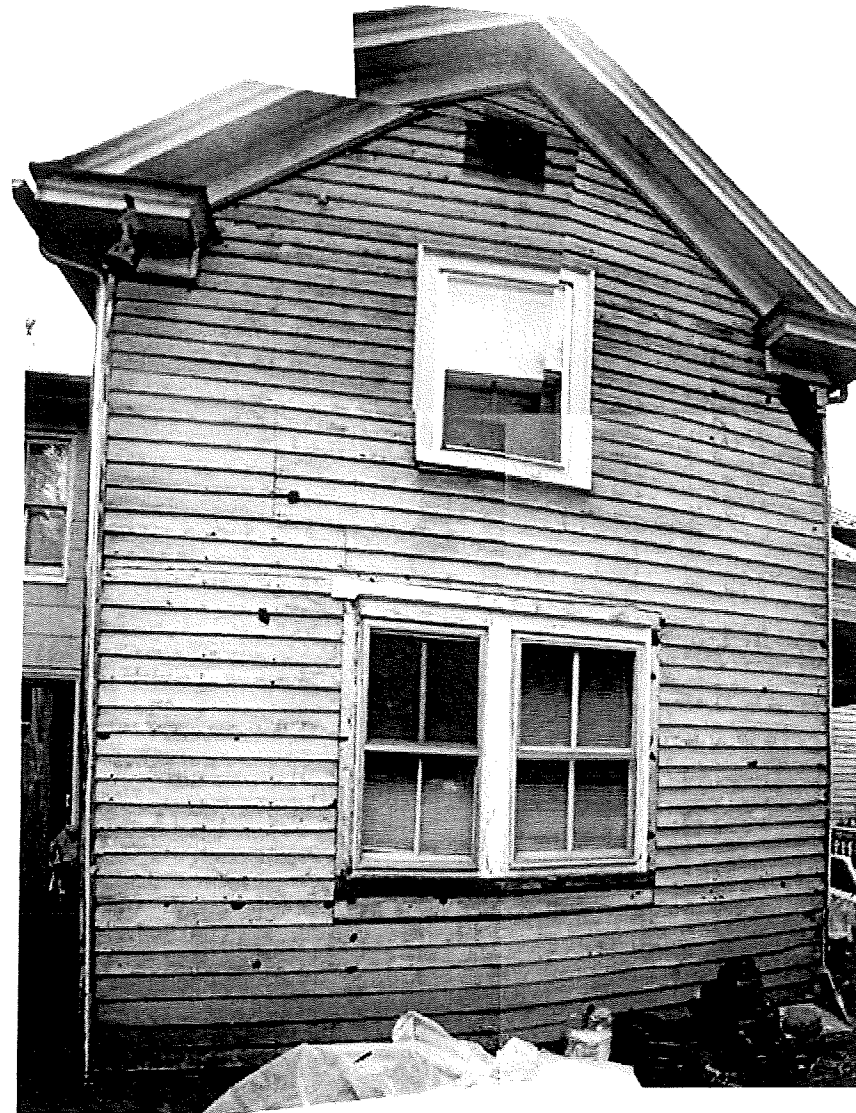
North Elevation
(center section)

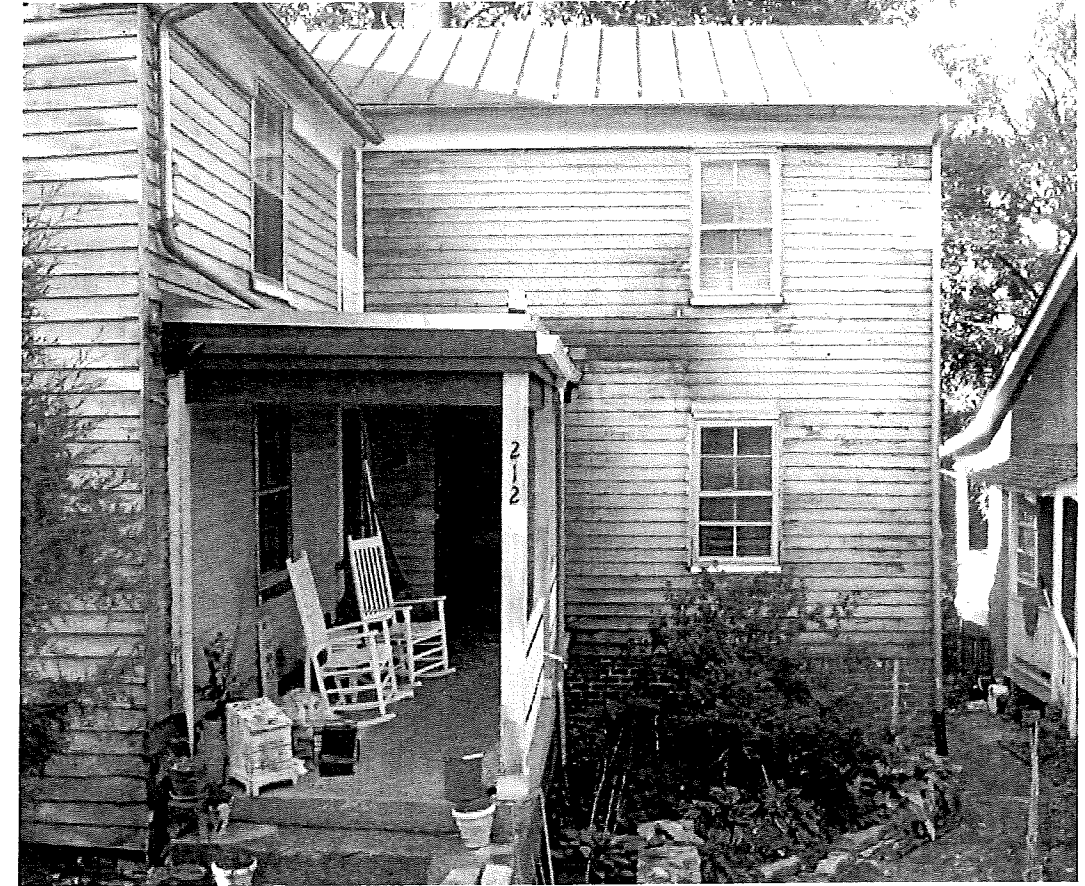
North Elevation
(west side)

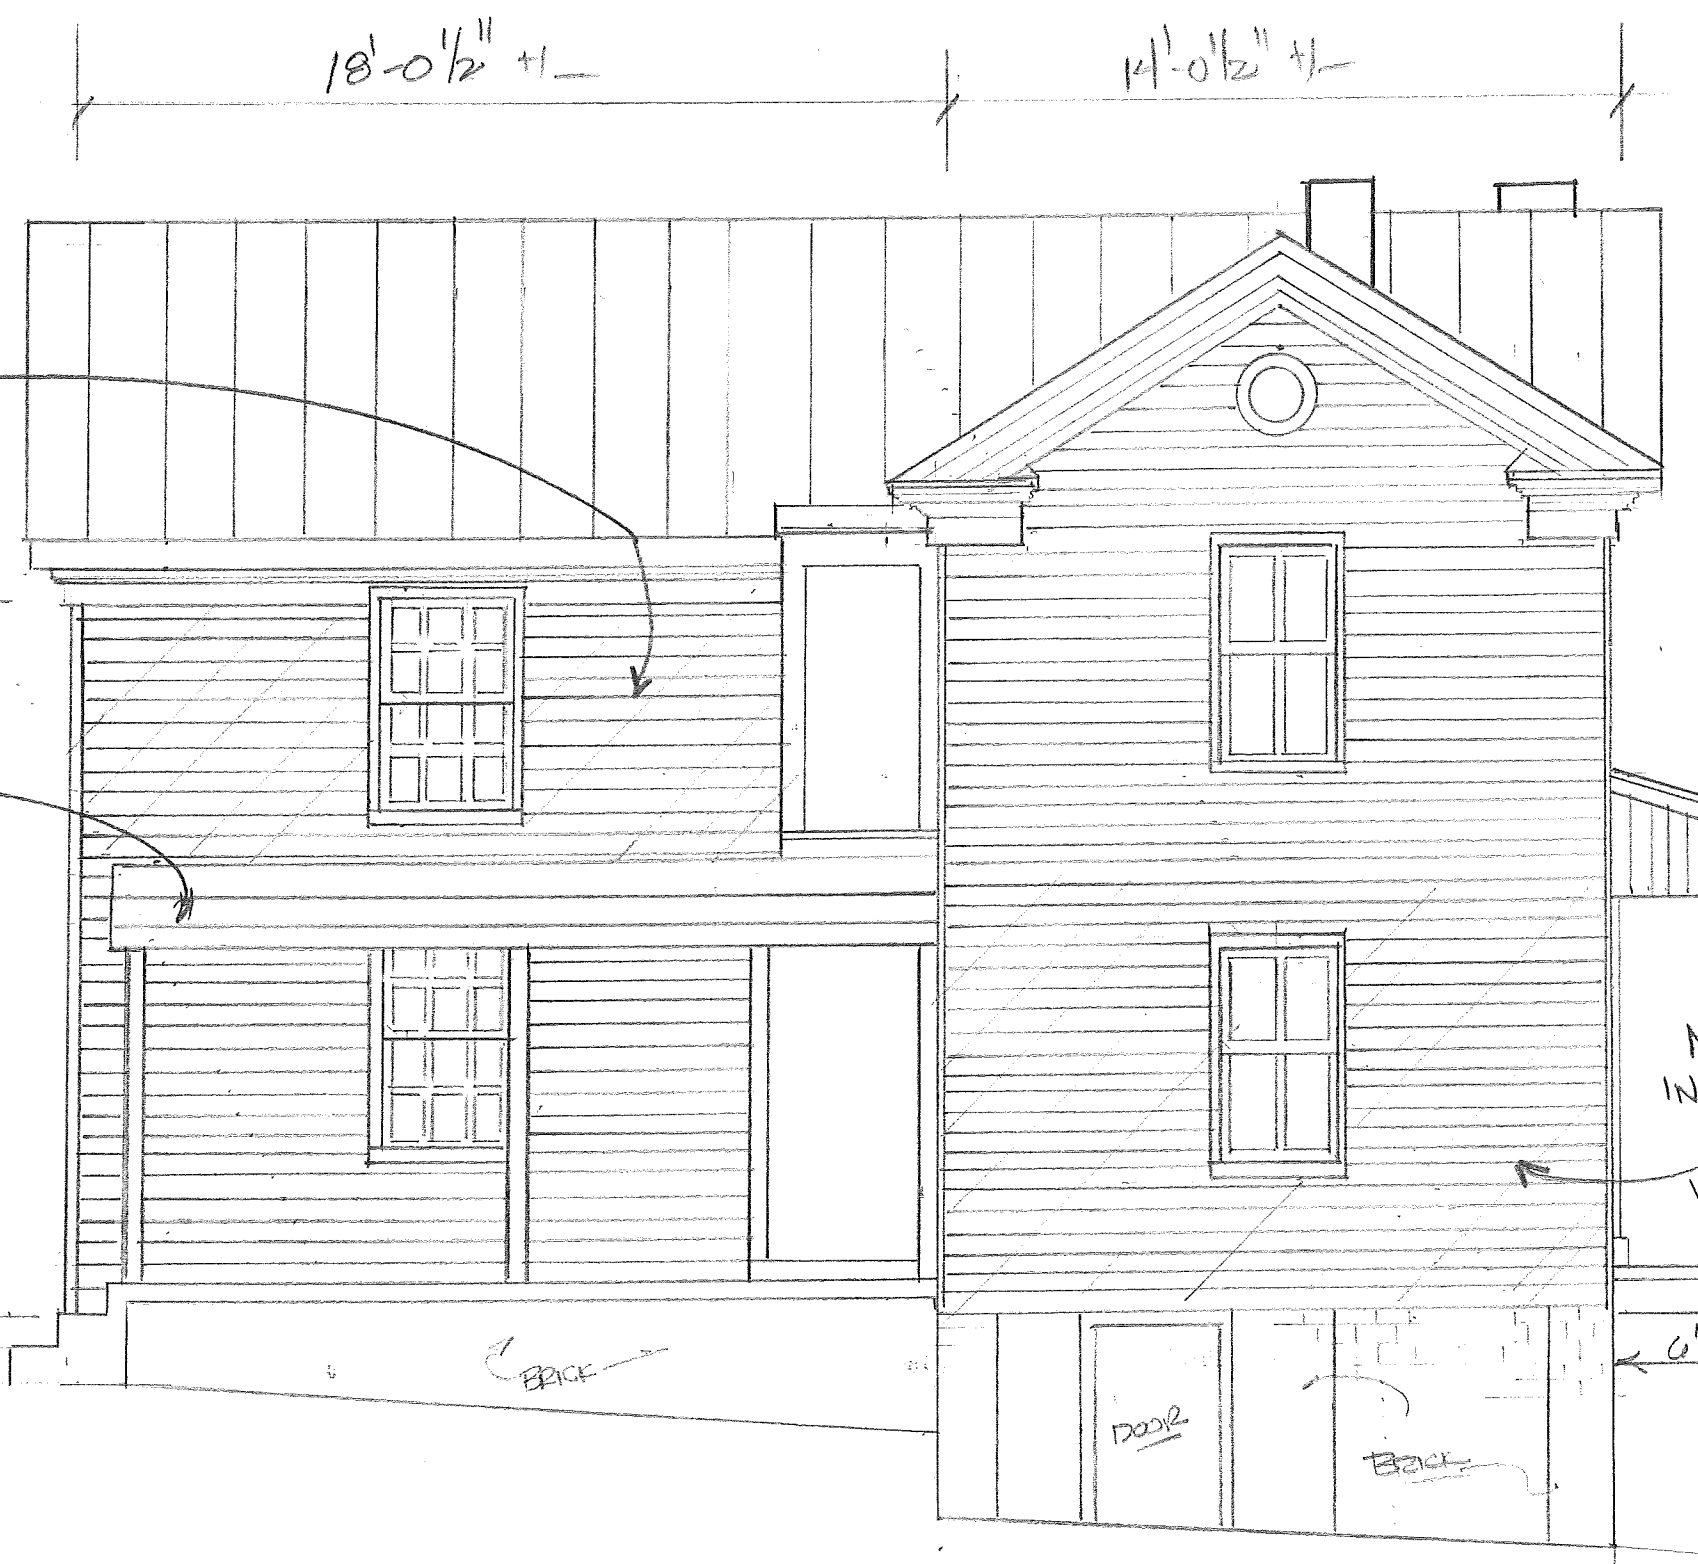
WEST ELEVATION

NEW
INSULATION @
WALL CAVITY

REMOVE FLAT ROOF
& REBUILD NOW TO
MATCH ORIGINAL.
SEE ATTACHED DETAILS

REMOVE &
REBUILD EXIST
PORCH -
SEE ATTACHED
DETAIL.

NEW
INSULATION
@
WALL

Remove existing to allow work on exterior siding, window and door.
Strip, repair, prime and paint original posts, railing and brackets for re-use in new.
Construct new porch per details.
Review possible window wall which incorporates original posts and railing.

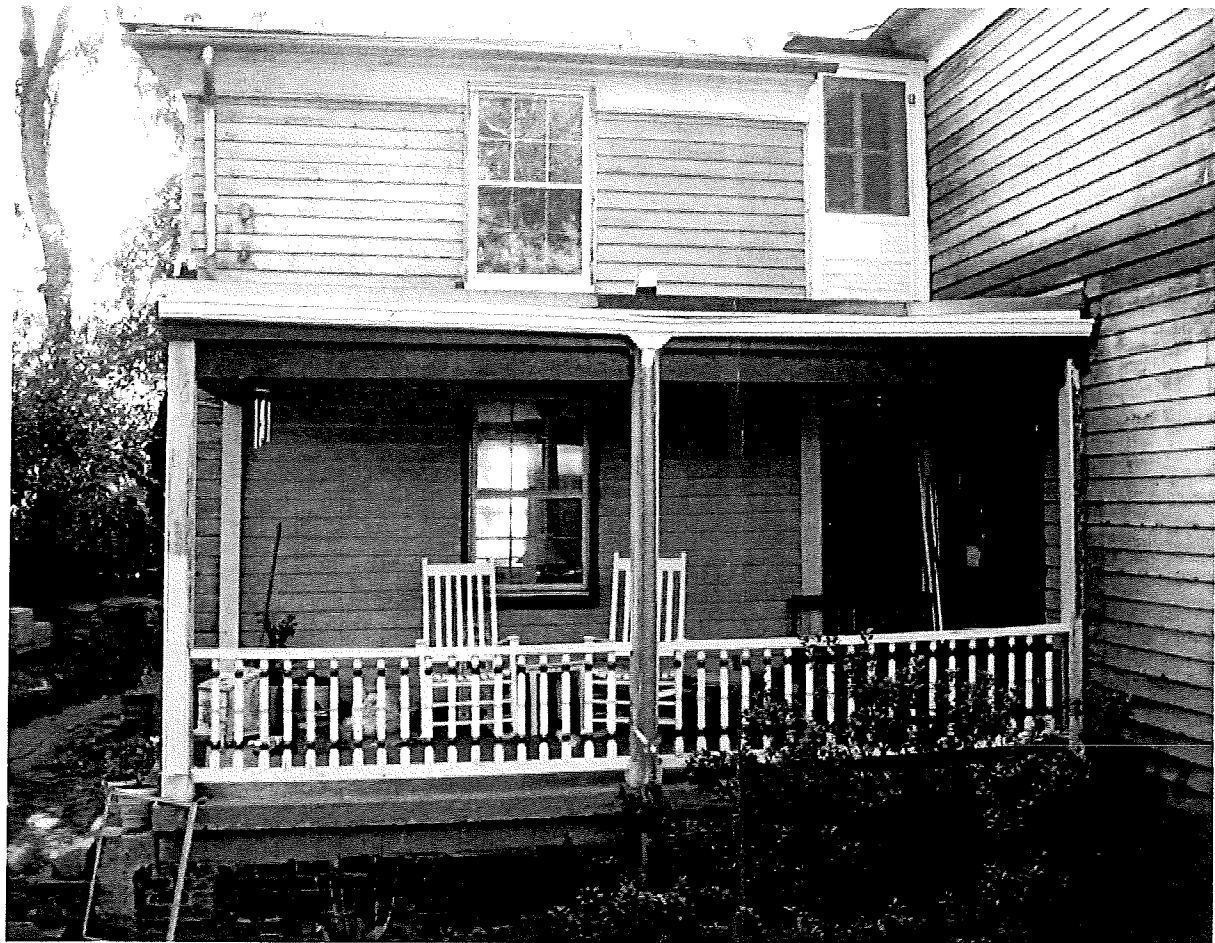
West Elevation at Front

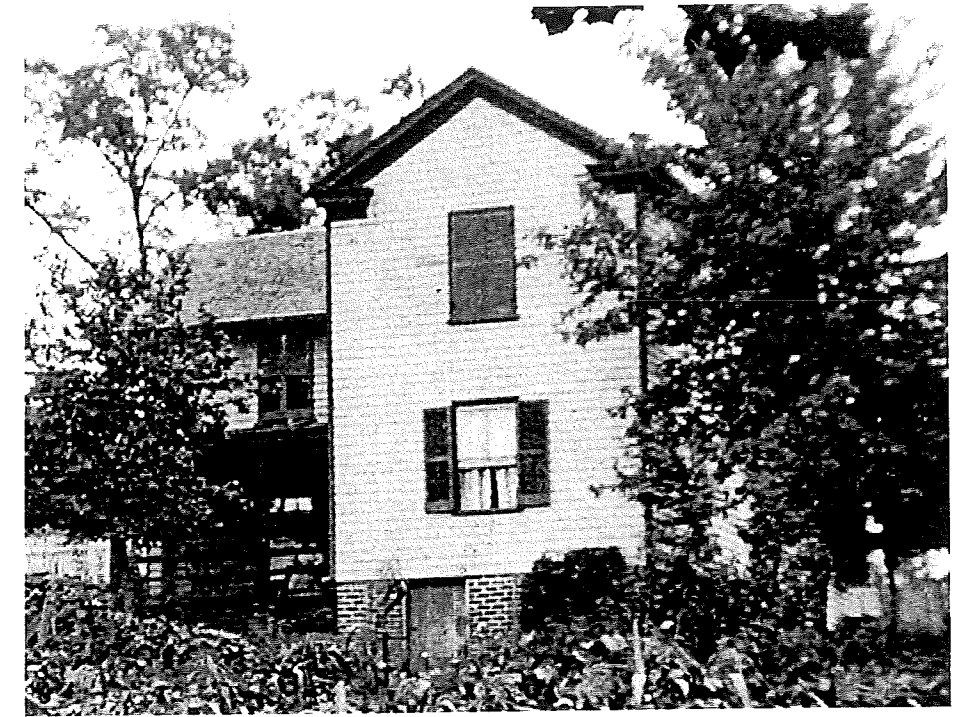
East Elevation
(circa 1890)

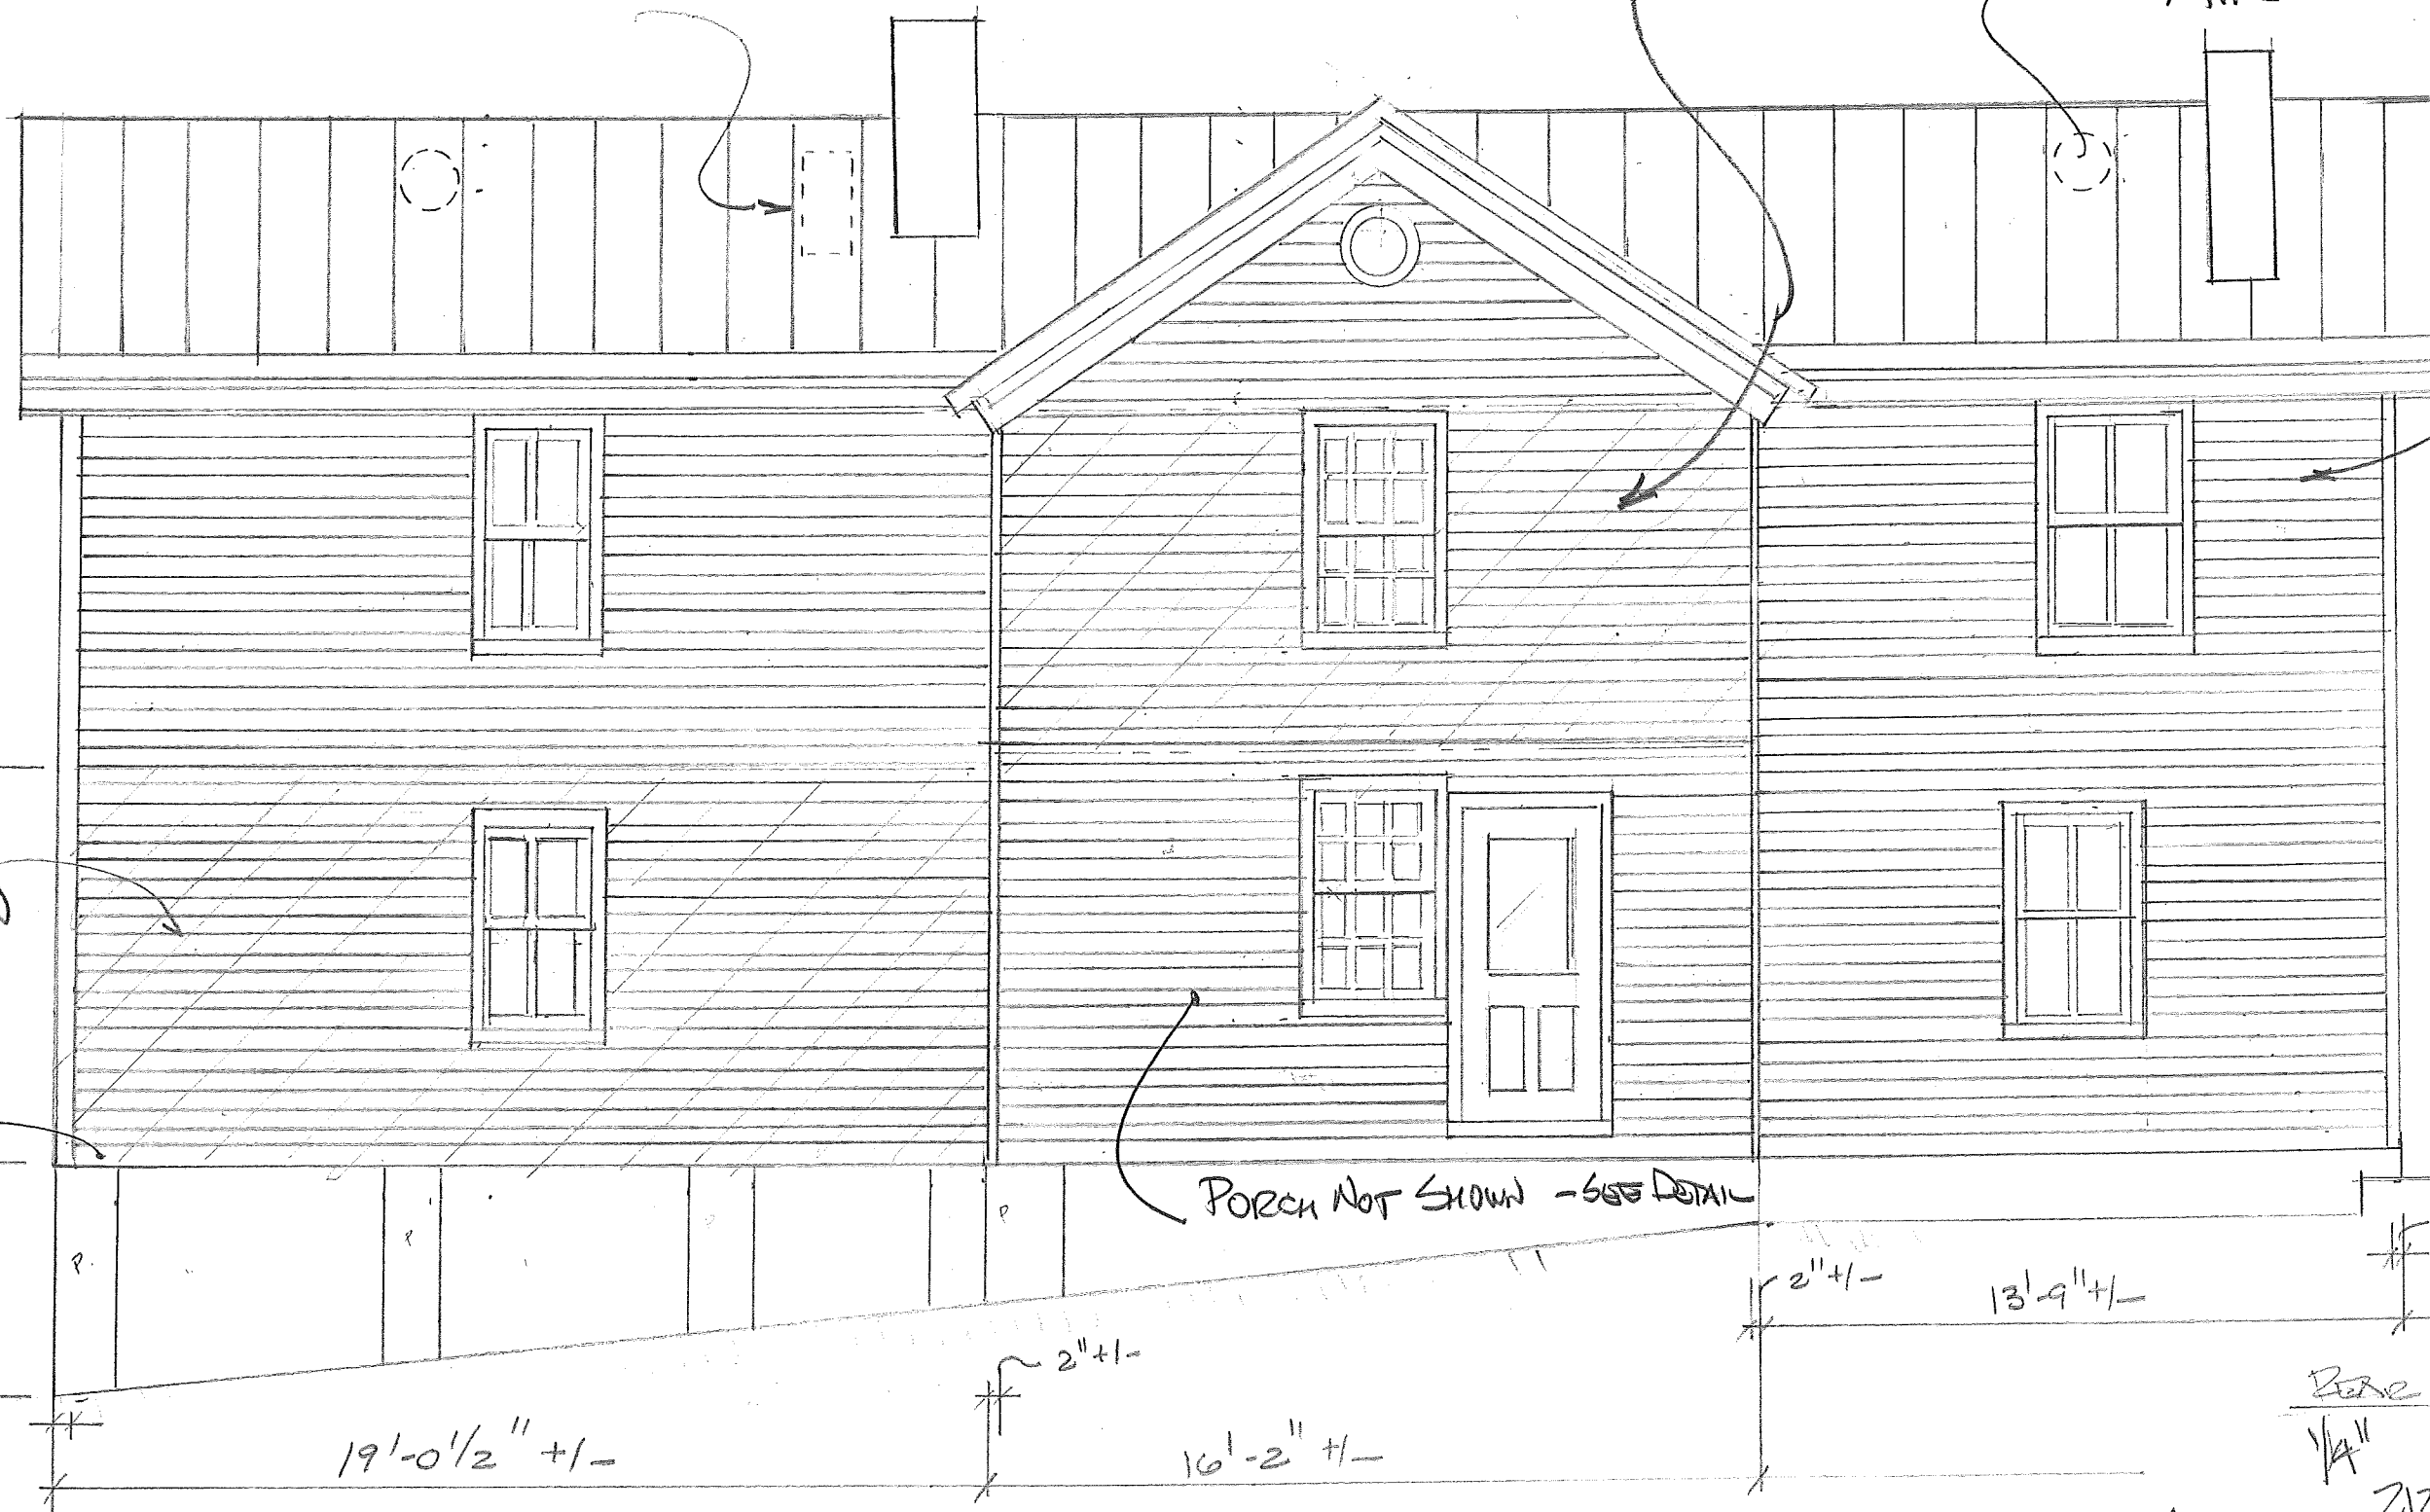
REAR ELEVATION - SOUTH

SKYLIGHT OR LIGHT TUBE?

ADD VENT FANS @
ATTIC

EXISTING
SIDING
TO REMAIN

NEW
INSULATION
& WALL
CAVITY.

PORCH NOT SHOWN - SEE DETAIL

NEW
Drip
CAP
(TYP)

Install electric attic vent fans at rear elevation.
Consider either small operable skylight or light tube near west chimney.

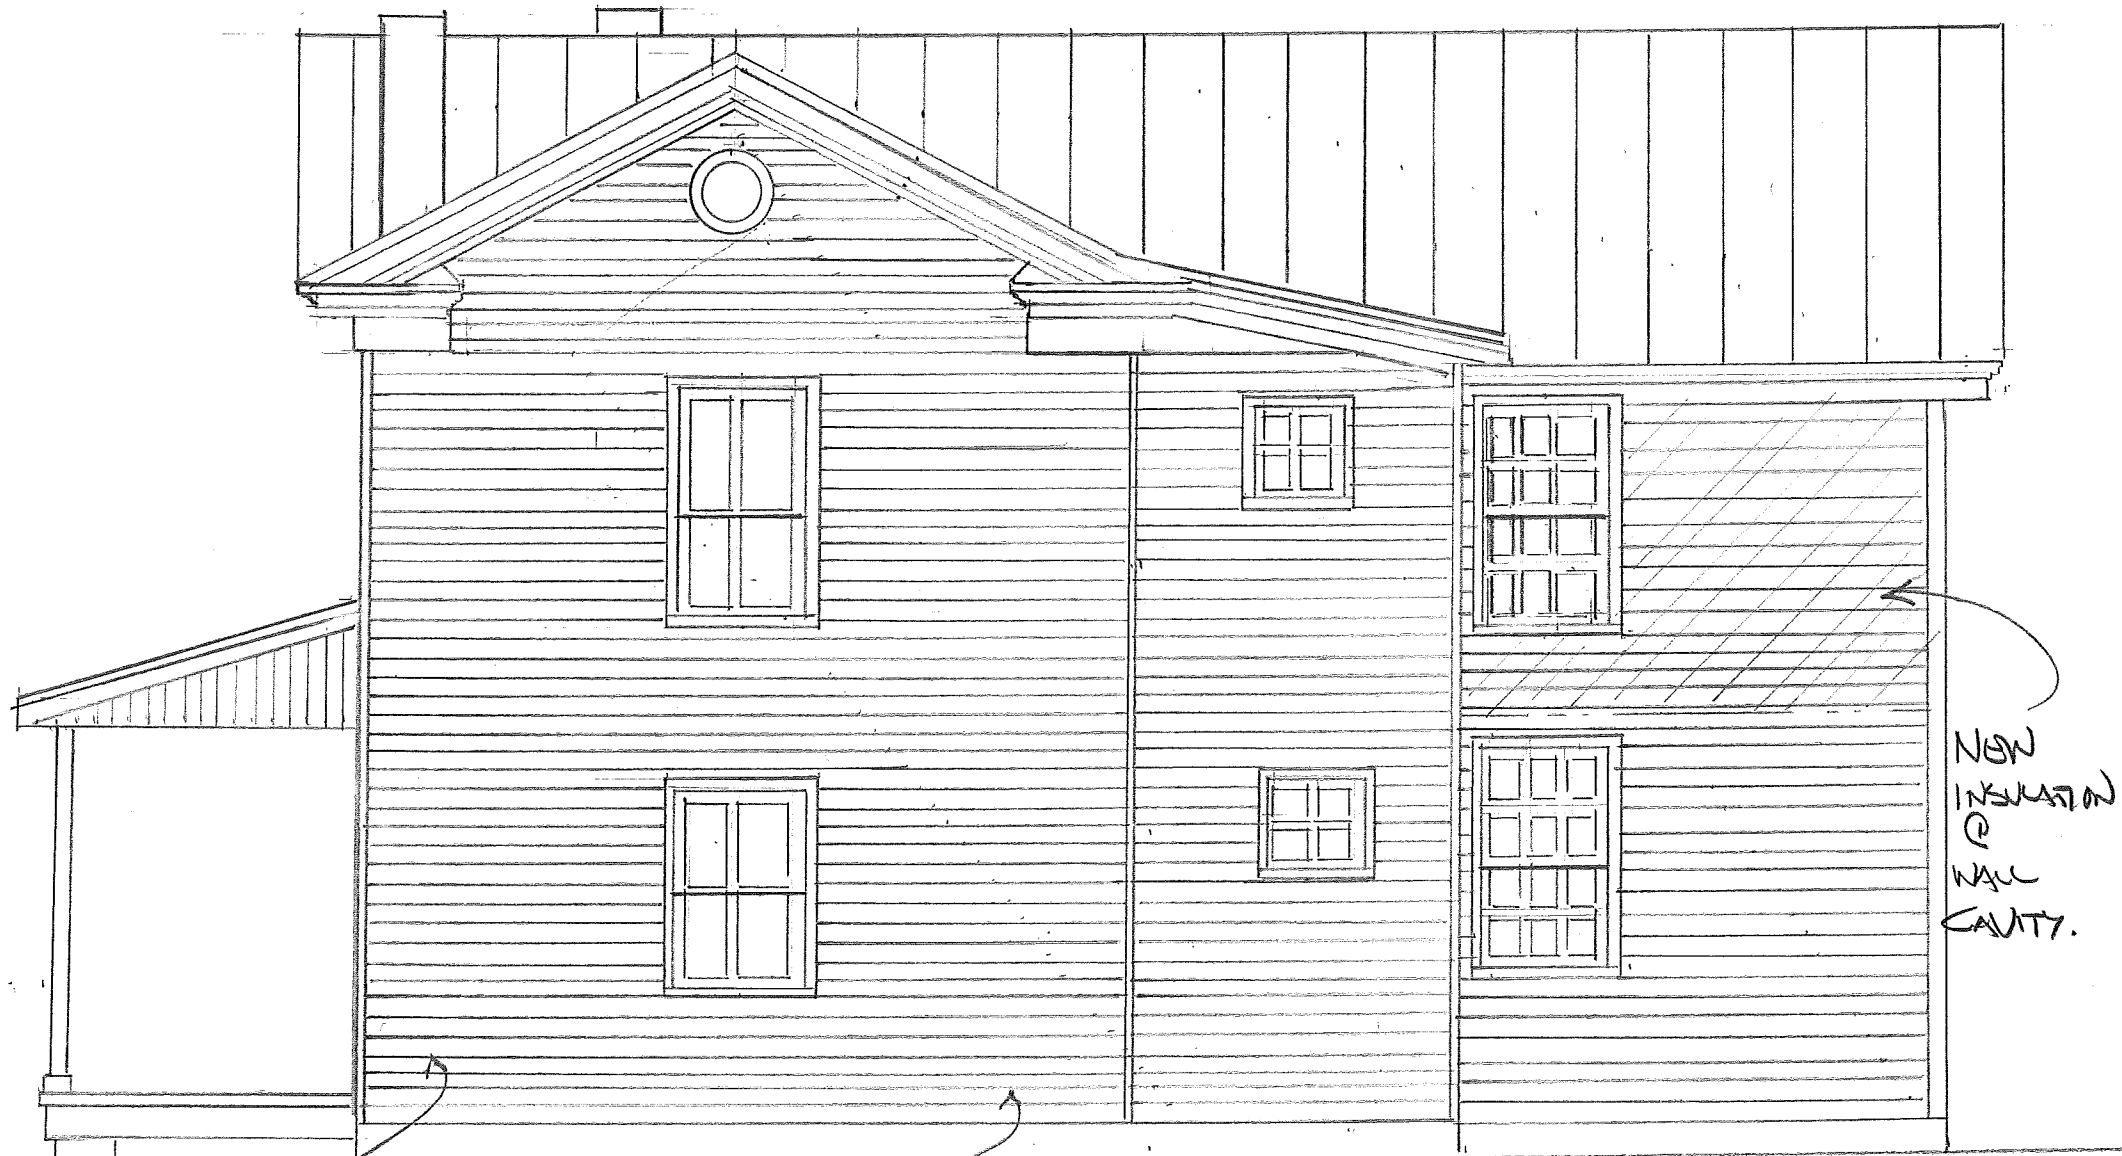
EAST ELEVATION
1/4" 4/12/03
212 WINE ST.

REPAIR OUTDOOR
FAUCET - EXTEND OUT.

REWORK GAS PIPE TO CELLAR

NEW
INSULATION
@
WALL
CAVITY.

Reroute existing gas line to cellar—either through house or underground.

Extend spigot at east wall to extend beyond wood siding; patch wall opening.

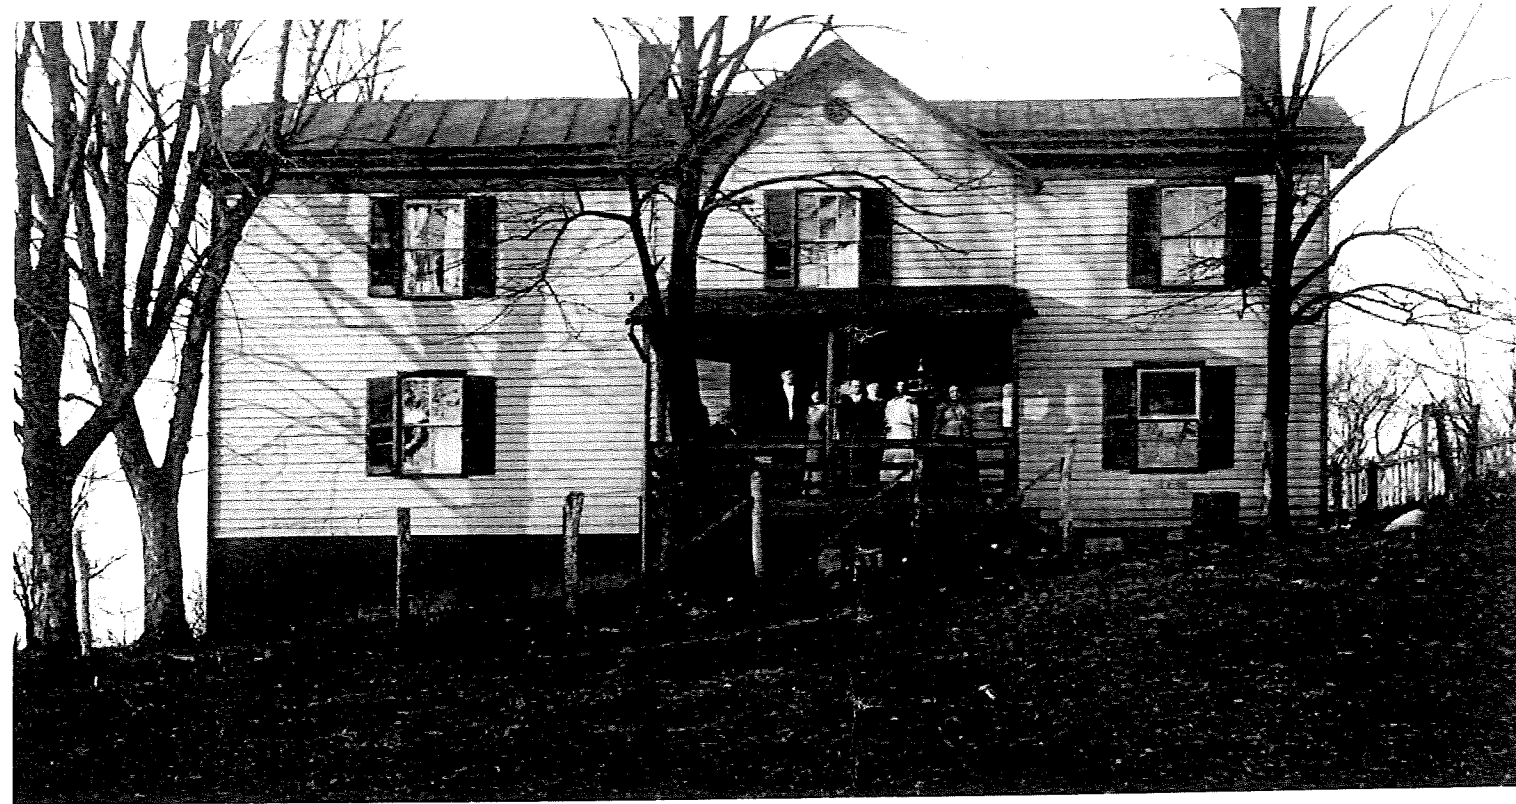
Back Porch

Sandy and I could not decide on what to do with any sort of windows on the back porch, so my plan is to simply reconstruct to match the existing, using the added dimension I have noted. We will probably have to think about it as we go and revisit at a later date; if at all. It's in bad shape and needs to be rebuilt no matter what, so at the very least I need to get the OK to dismantle it so we properly and easily can access the siding behind it.

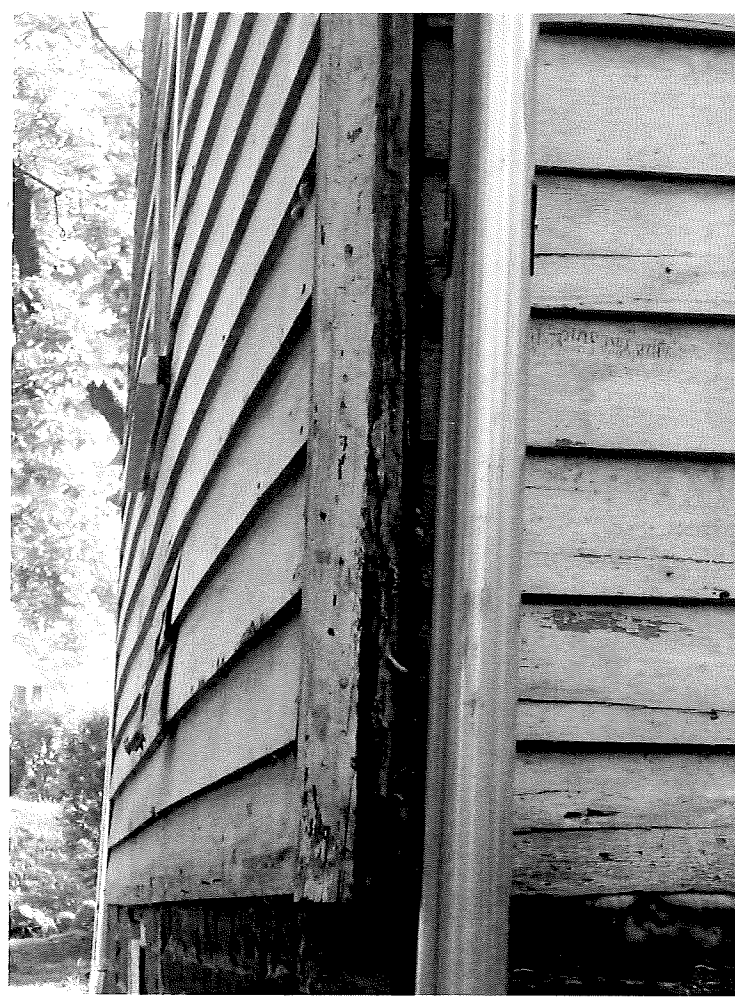
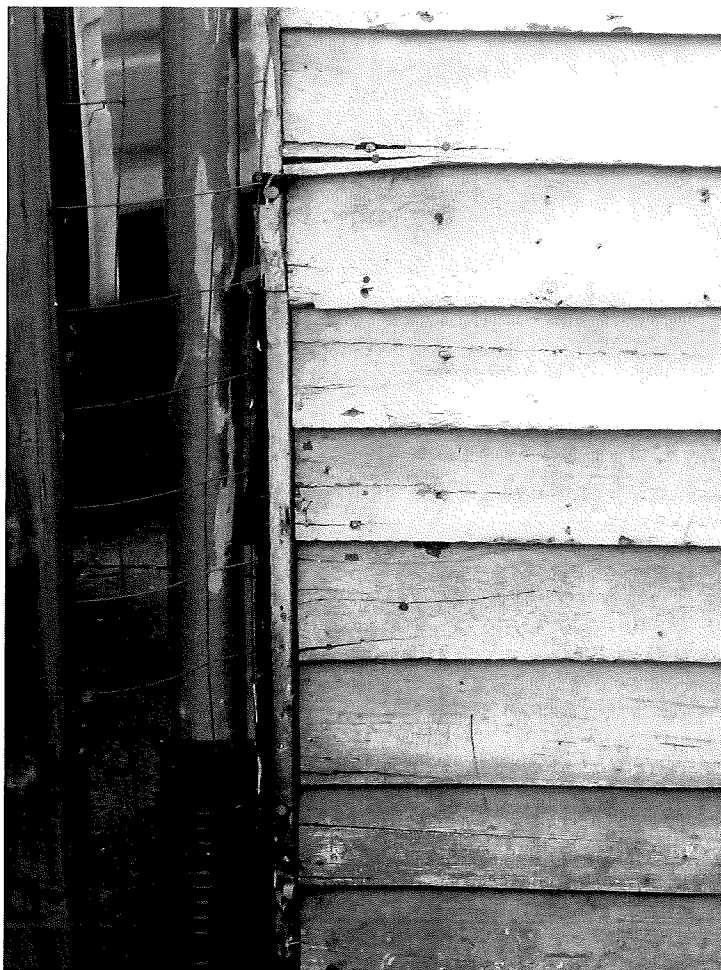
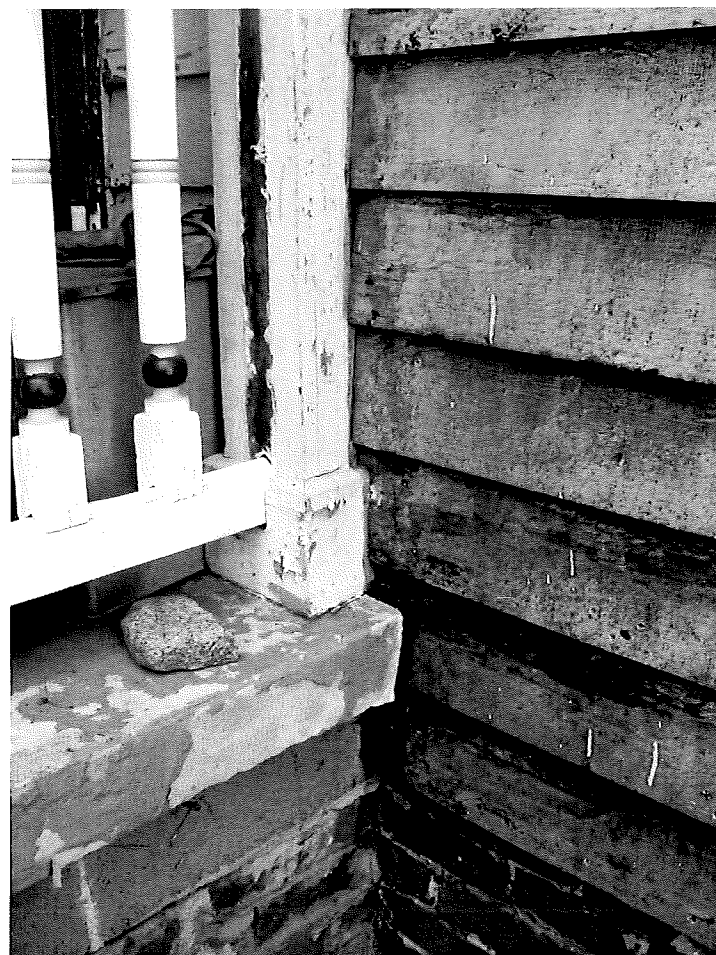
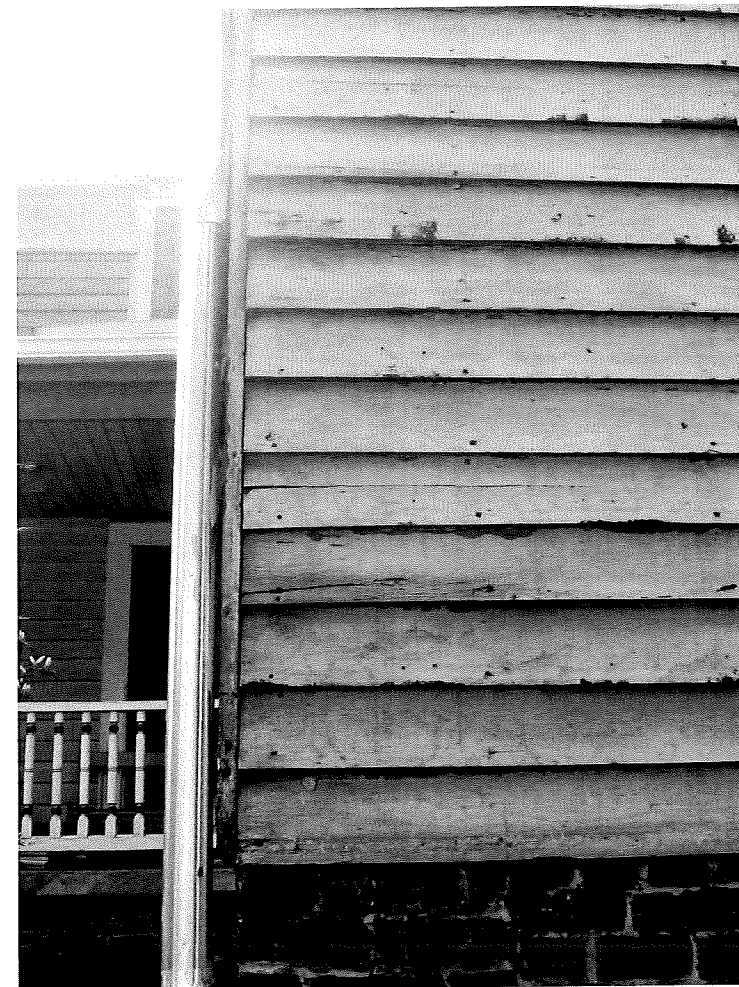
Condition of Existing Siding

Remove original siding; strip paint; repair usable boards; prime; reinstall siding which effort to place as much original material on north façade, followed by east, then south façade. East façade to be last; using new material—as necessary, here.
Replace corner boards to match existing.
Before removing siding, construct story poles of original spacing; use when reinstalling siding.
Before installing repaired/new siding, install Tyvek house wrap at all exposed walls.
Install Ice&Water Guard at corners and at low siding courses where near grade.
Replace bottom course of siding with new wood drip cap similar to house at east end of Wine and Park Street. *Note: This differs from original material but no drip edge exists, some walls are extremely close to grade, and house had extensive termite damage. Resolving water infiltration is critical to long-term stabilization of this house.*
