Board of Architectural Review (BAR) Certificate of Appropriateness

Physical Street Address: 212 WINE STREET
City Tax Map/Parcel: MAP 33 PARCEL 32A

Name of Historic District or Property: 212 WINE ST.

2121 Wine Street – Exterior Restoration
April 29, 2008

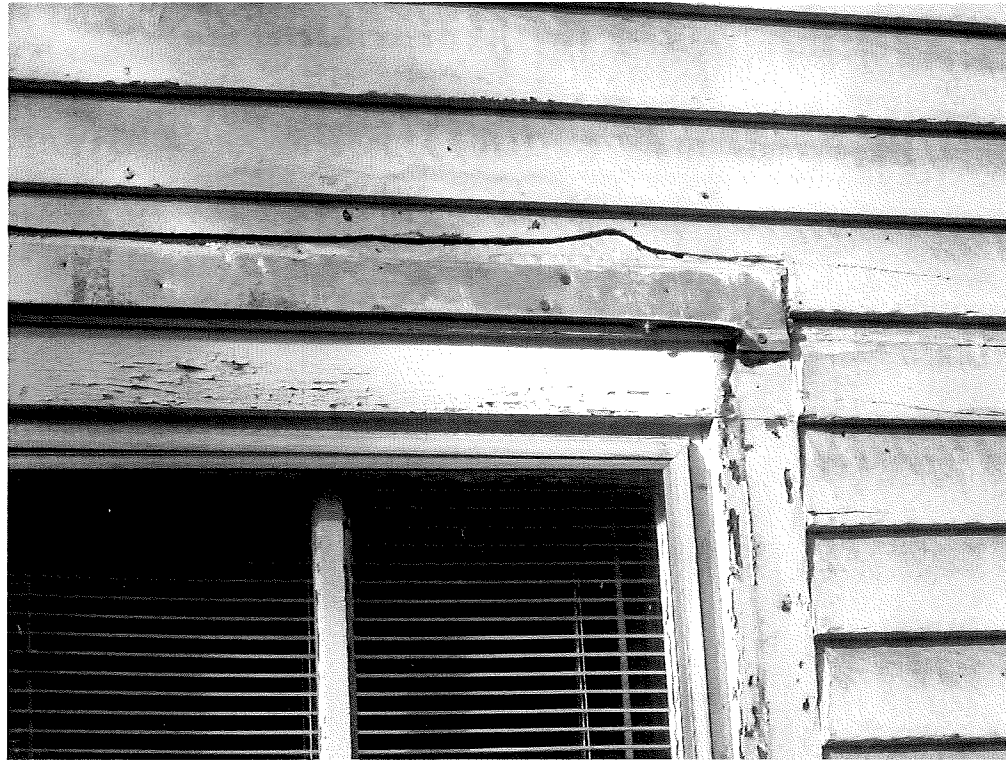
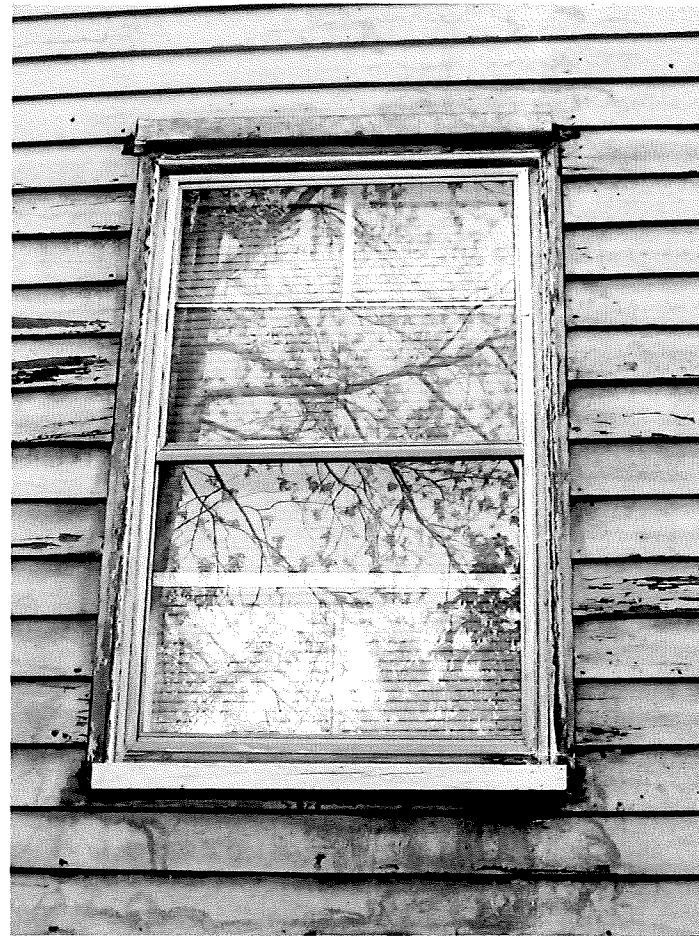
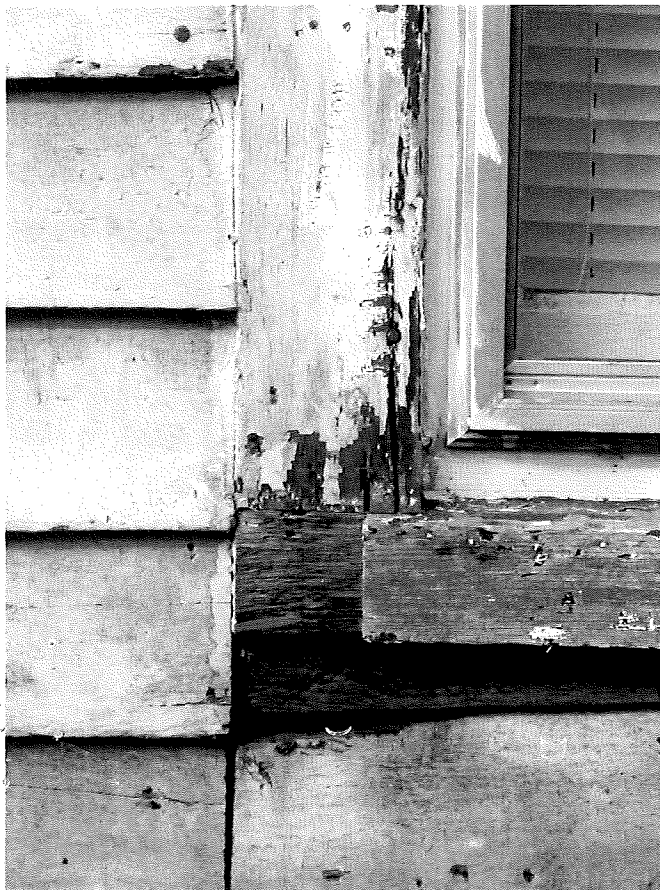
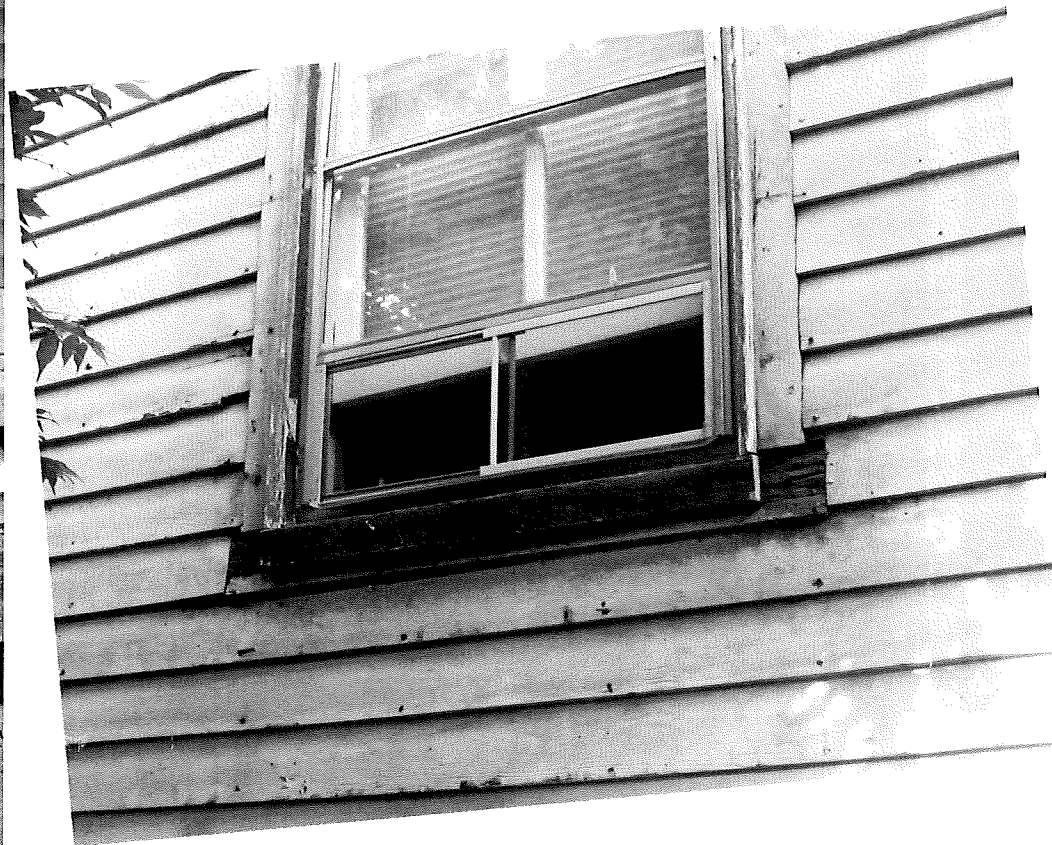
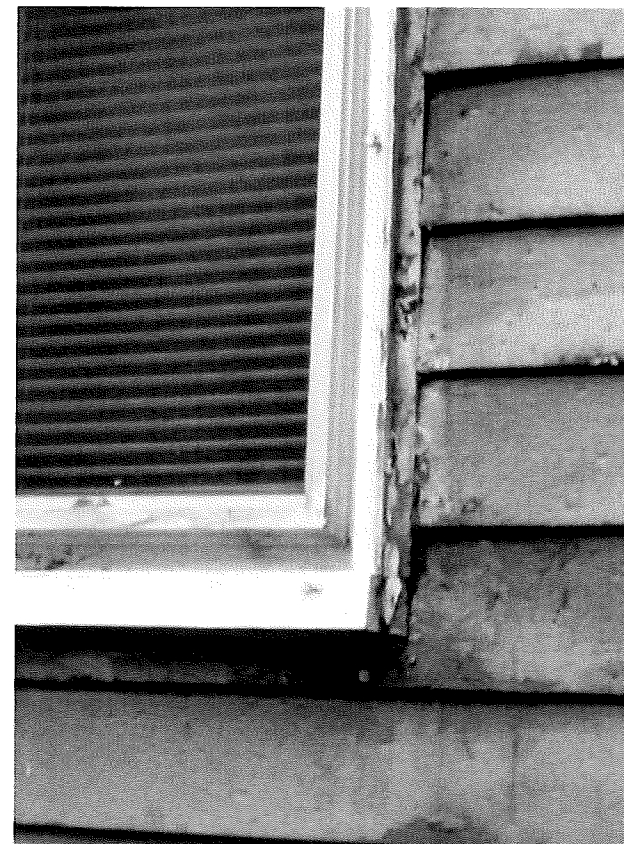
Condition of Existing Window Trim and Sill

Repair/replace drip cap where needed.
Install new flashing cap
Scrape, prime, and paint trim and sills.
Discuss repairing damaged sill-horns.
