Certificate of Appropriateness

23-03-04

130 Madison Lane, TMP 090138000

Project: Rehabilitation

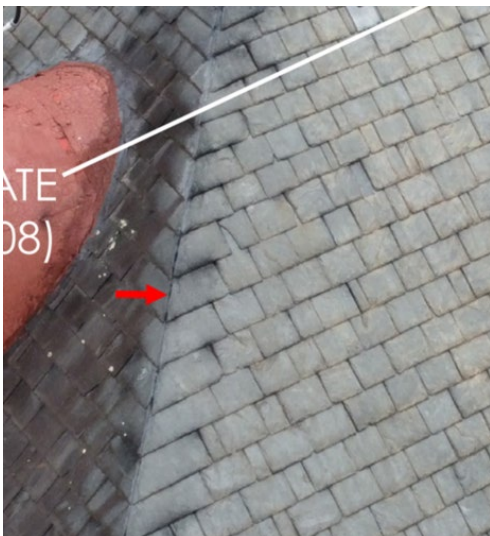
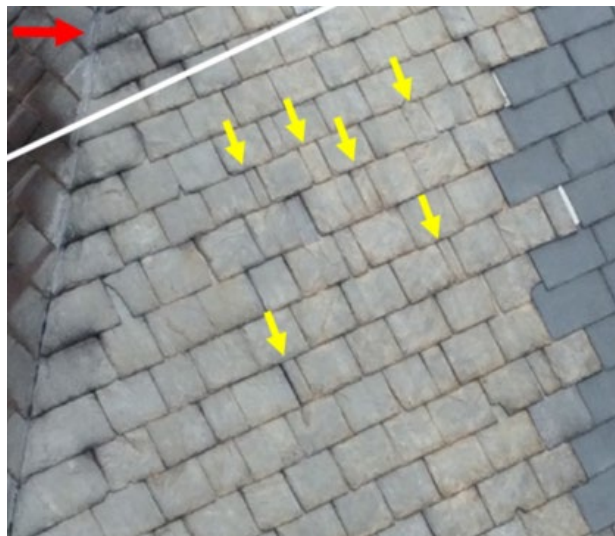
Additionally: (Images below from the applicant's submittal. **See Appendix - 3/15/2023 e-mail re: roof questions.**)

- 1) The existing slate has mitered hips. Applicant is proposing a hip cap. The BAR should determine if that detail should be retained or allow cap. (Staff recommends a cap is preferable, relative to mitigating leaks.)
- 2) The existing slate include *splits* worked in between whole shingles. Staff believes the roof dates to the 1916 construction; however, because there is no apparent decorative pattern, might this suggest the *original* slate was salvaged material, not new?

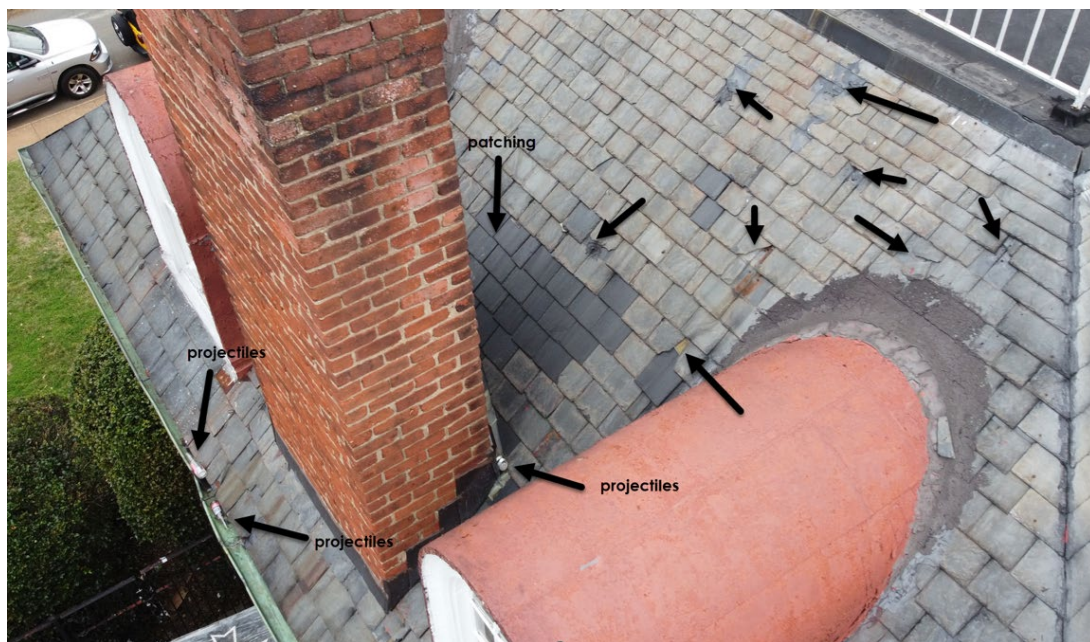
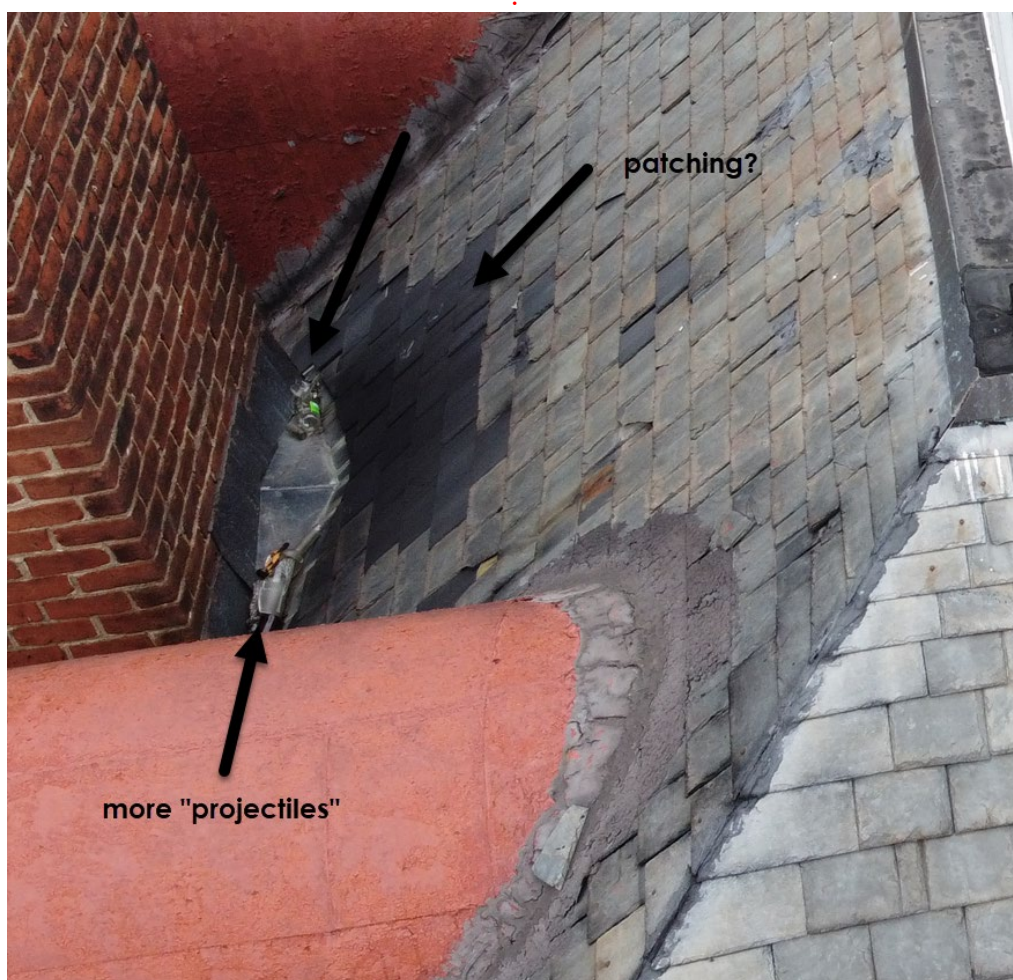
One point I think is important is that the tile has already been haphazardly patched and repaired with synthetic tile over the years. This patching and repairing has occurred on all four sides, and mostly around trouble areas (crickets, valleys, etc.). Unfortunately, I think this slate takes some abuse. Whether from various projectiles, or people walking on it, or salvaged materials, it's got a few worrisome spots, from where I sit. We took our drone up for a flyaround, and I'll share those files at the link below. The high-quality imagery allows some pretty detailed zooming, so you can investigate the shingles, as well.

JWerner: The slate is very likely original to the building, but I'm wondering if it was installed as *salvaged slate*. I've seen older roofs that don't look that rough and why are there so many *splits* in between whole shingles? (See the first two pics below.) My point: If the slate is 100 years old, it's difficult to support its removal and replacement. At the very least, the salvageable shingles should be re-installed. However, if the material is *older than 1916*—and yes, I know rock is millions of years old—then maybe replacement is warranted. Thoughts?

KSchafer: I don't know if the slate was originally salvaged, but I do know it's not in great shape. "Rough" is how I would describe it as well, though I am not entirely sure why it is so rough. My initial thought regarding the varying shingle sizes was that it was done for decoration (a kind of roof tile pattern) or perhaps just because they were utilizing the sizes available - but I am not sure if that was a technique employed at this time, or why it would be employed on this structure. The shingle could very well be salvaged, to your point. The varying widths seem random, both in installation and size, which would support your theory.

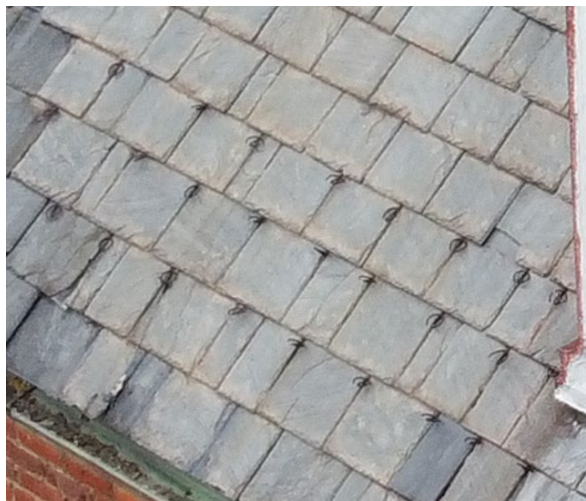
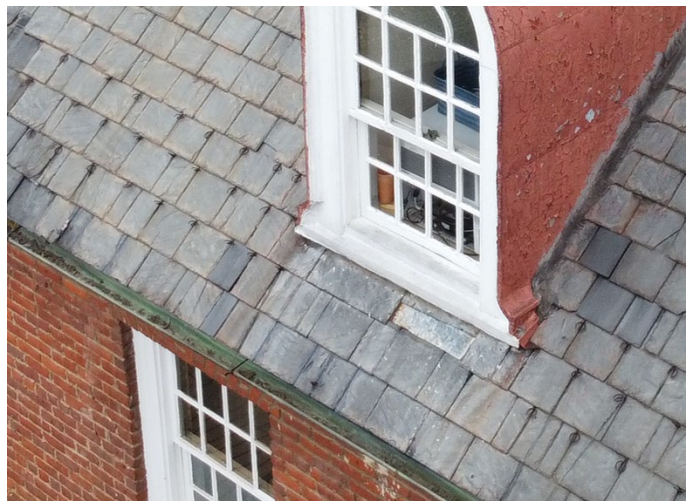
JWerner Finally, out of curiosity, looking at the bottom photo below, what are the small, I assume metal, loops? Possibly from old ice guards? I thought they might be clips from prior shingles repairs, but they are only in those three courses.

KSchafer: I believe them to be snow guards, yes. They are on those three courses our all four sides of the hip. I am not sure if they are original, as this historic photo doesn't appear to show them, but I'm zoomed in through a tree branch, so it's a little hard to tell what is what. We are proposing the following snow guard in copper, which has a similar profile to the existing guards, and is meant to work with the proposed slate.

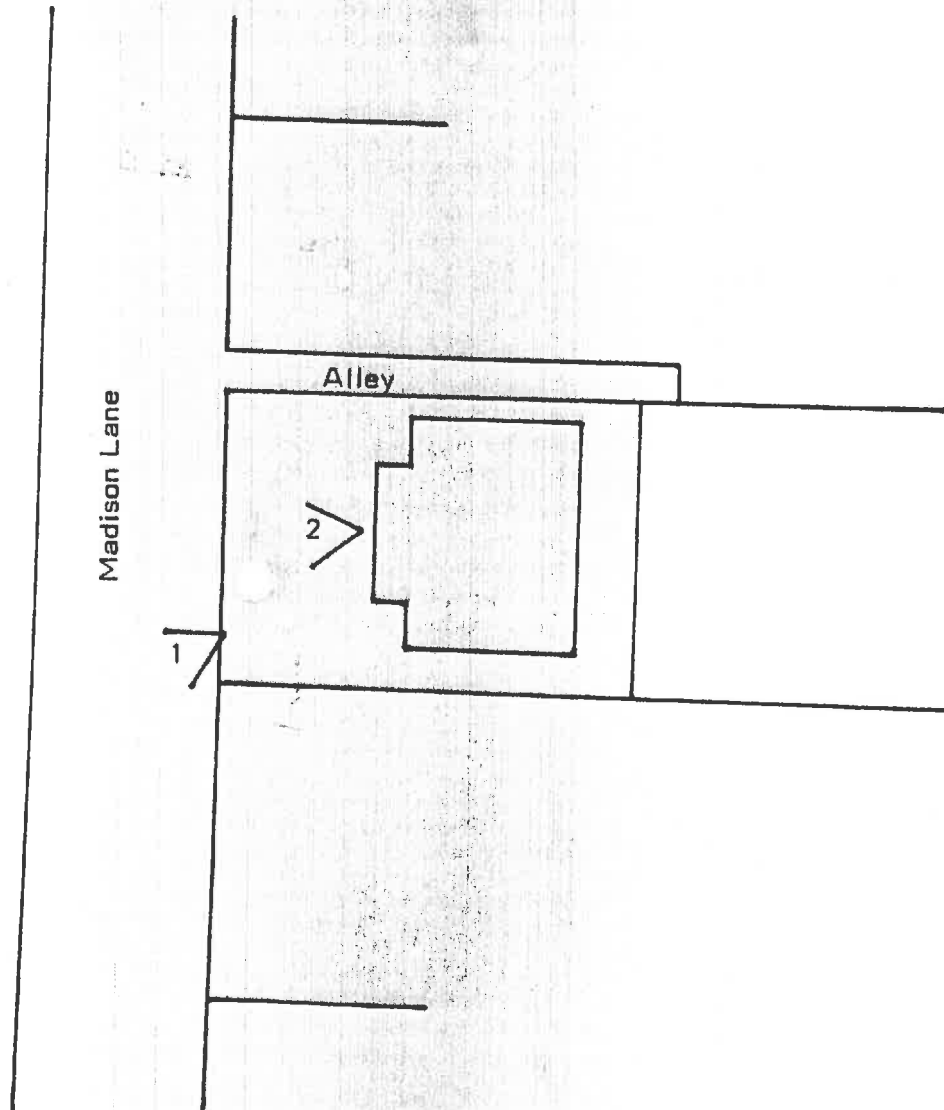
SAINT ELMO HALL
130 Madison Lane

Numbered arrows show locations
where photographs were taken

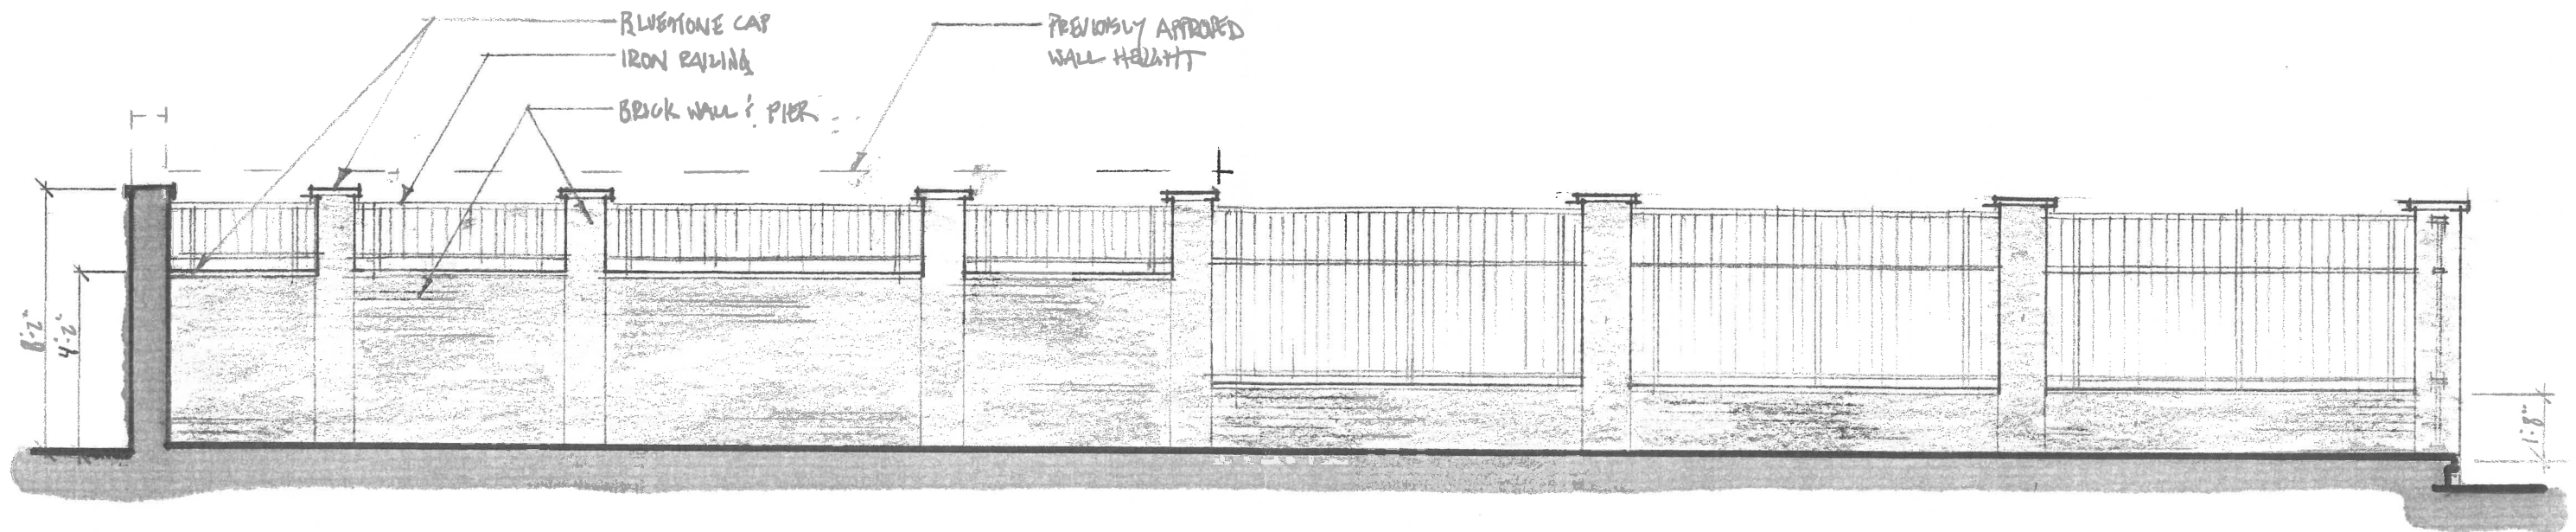
① SOUTH COURTYARD ELEVATION
1/4" = 1'-0"

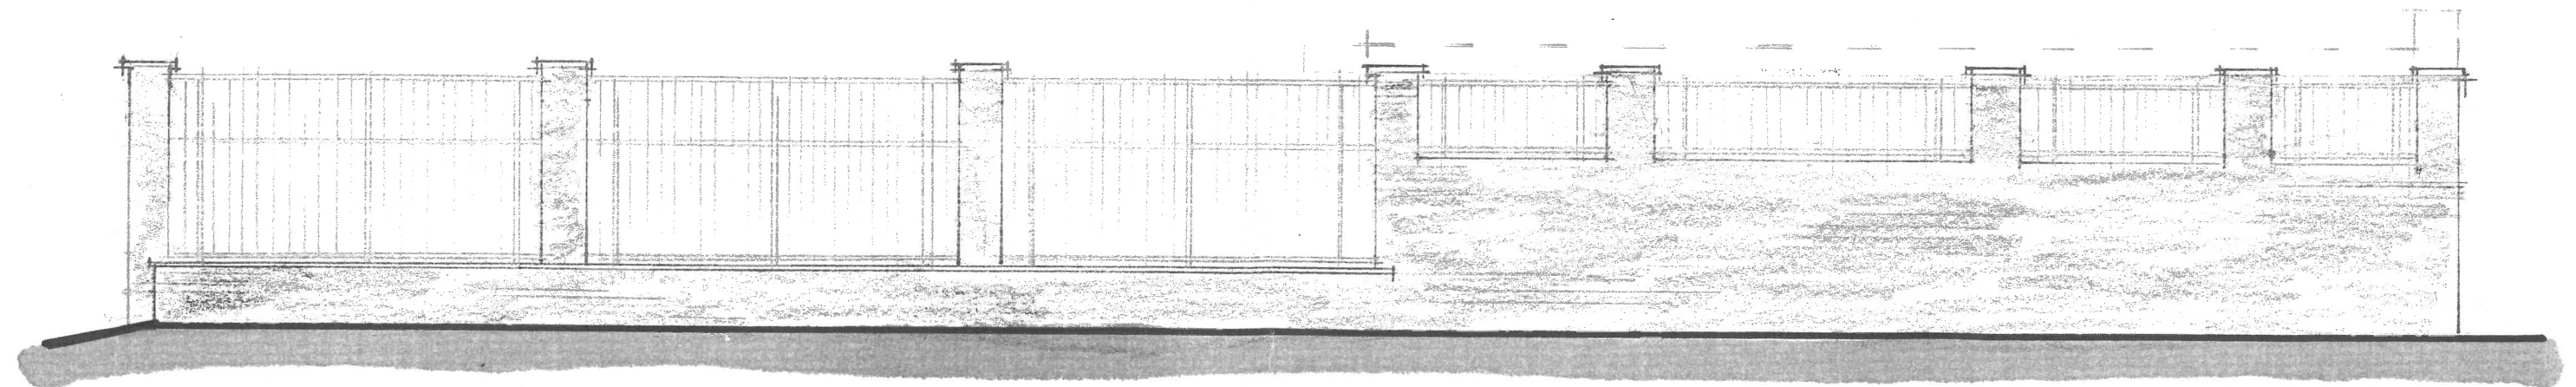
② SOUTH FENCE ELEVATION

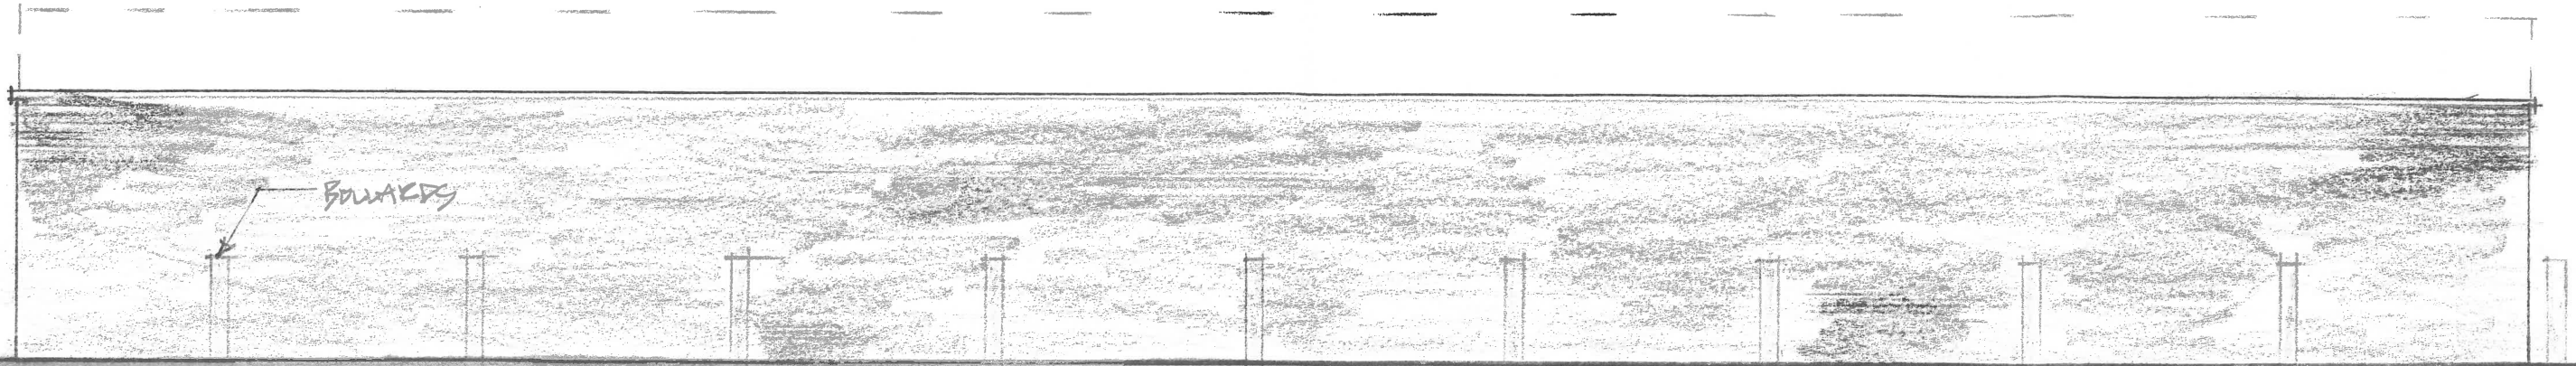
① EAST FENCE ELEVATION

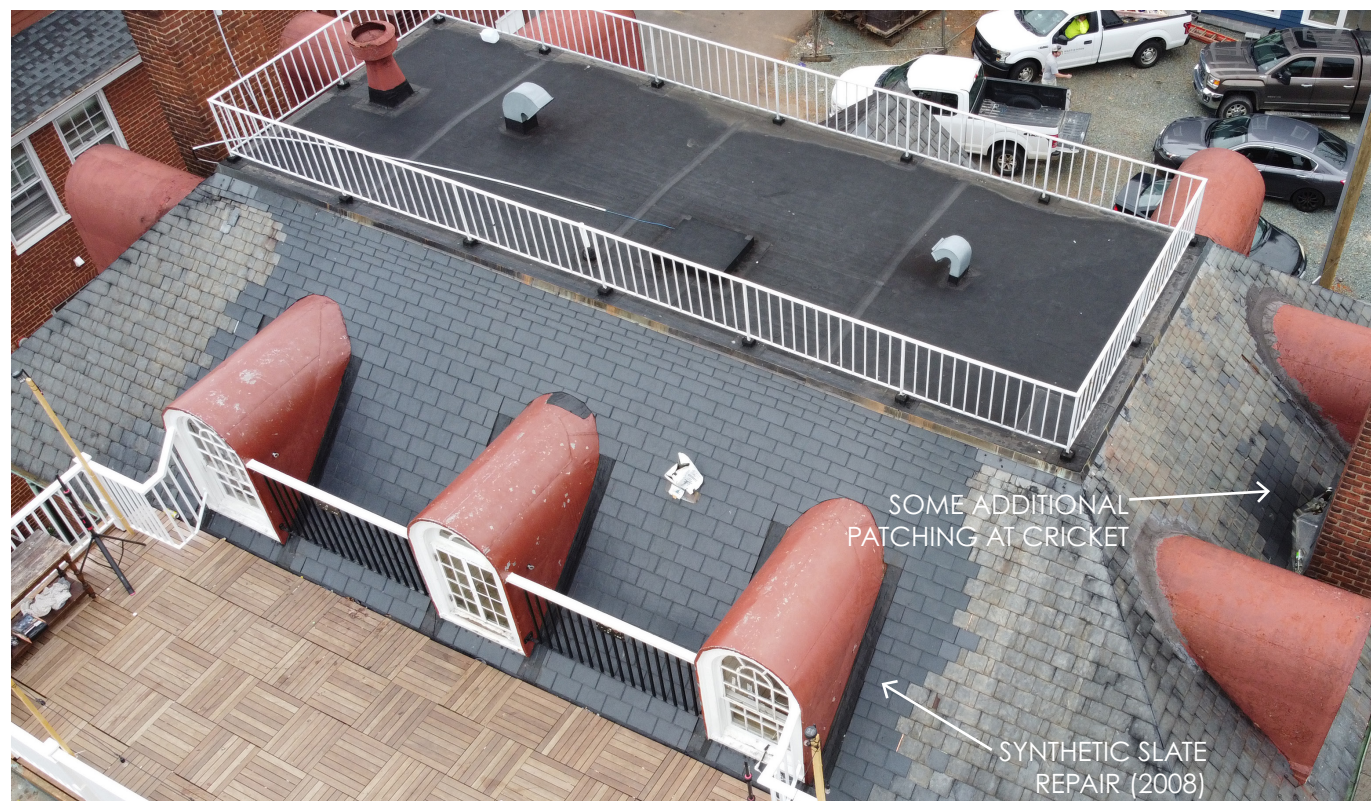
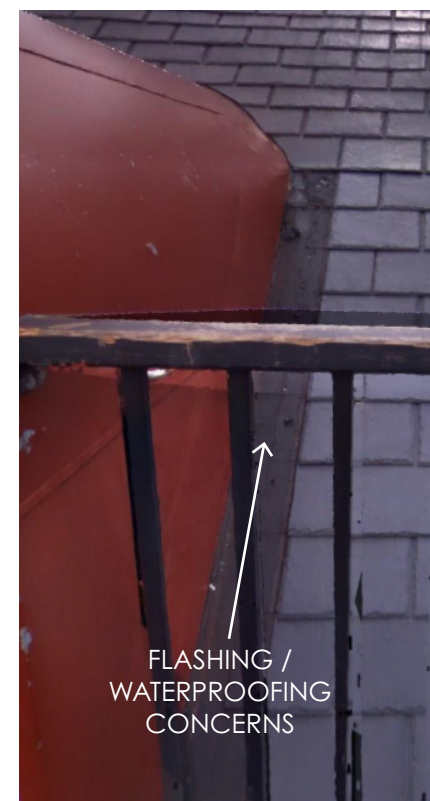
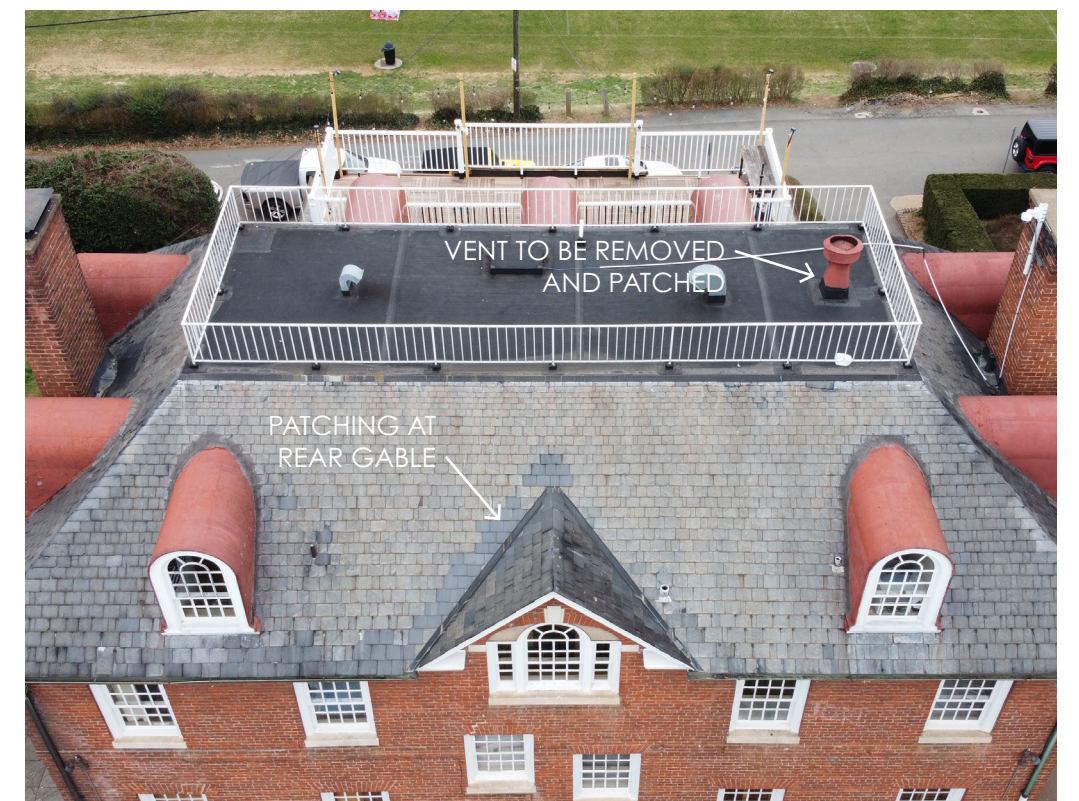
DESCRIPTION OF PROPOSED WORK

Replace deteriorating slate shingles with synthetic slate tiles, retaining aesthetic qualities and lowering weight.

Repair "crow's nest" roof and remove vents no longer in use.

Replace all existing copper flashing.

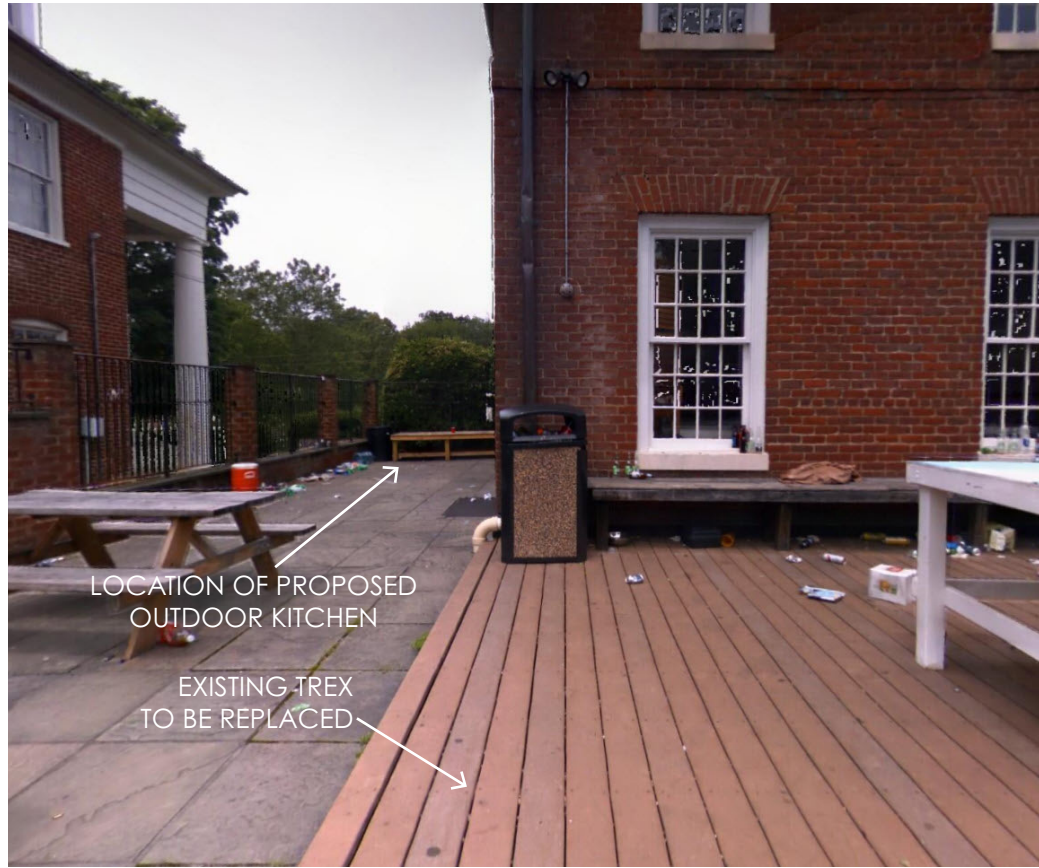
DESCRIPTION OF PROPOSED WORK

- Removal of existing trex decking.
 - Reinforcing the floor for designed live load of 100PSF (code minimum for assembly space).
 - Weatherproofing of basement ceiling to prevent further water infiltration.
 - Installation of new trex decking above new waterproofing and sleeper system.
- NOTE: The decking is above a 1984 basement expansion, not original to the historic house. The patio and site walls are from a 2008 addition, and not original to the historic house.

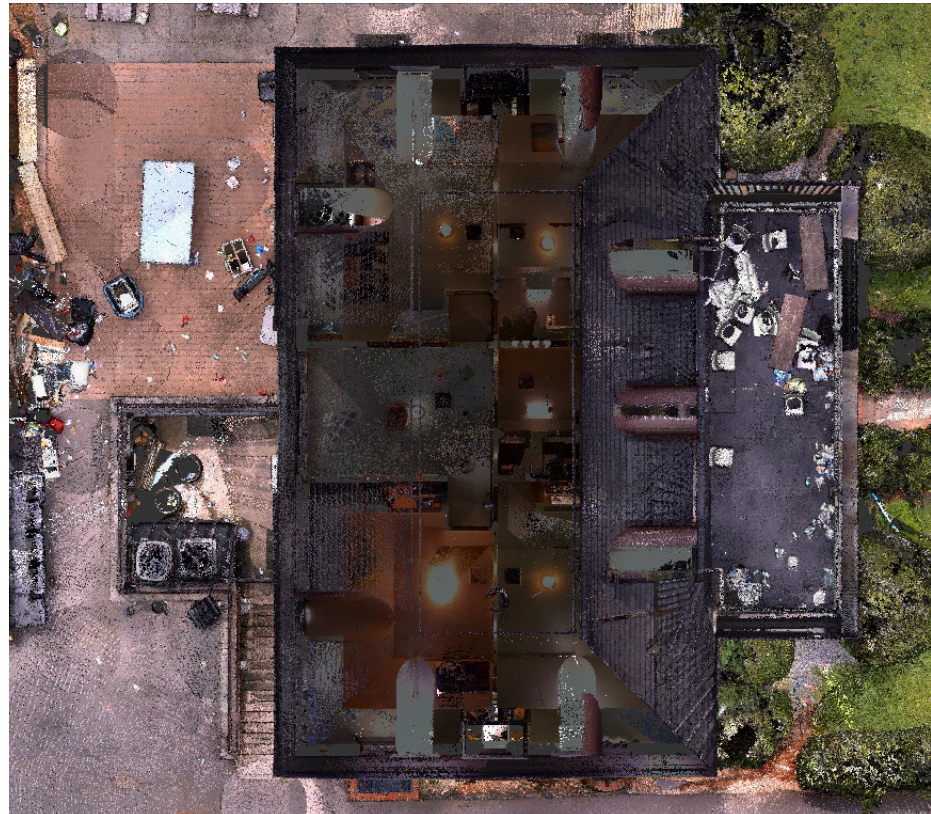
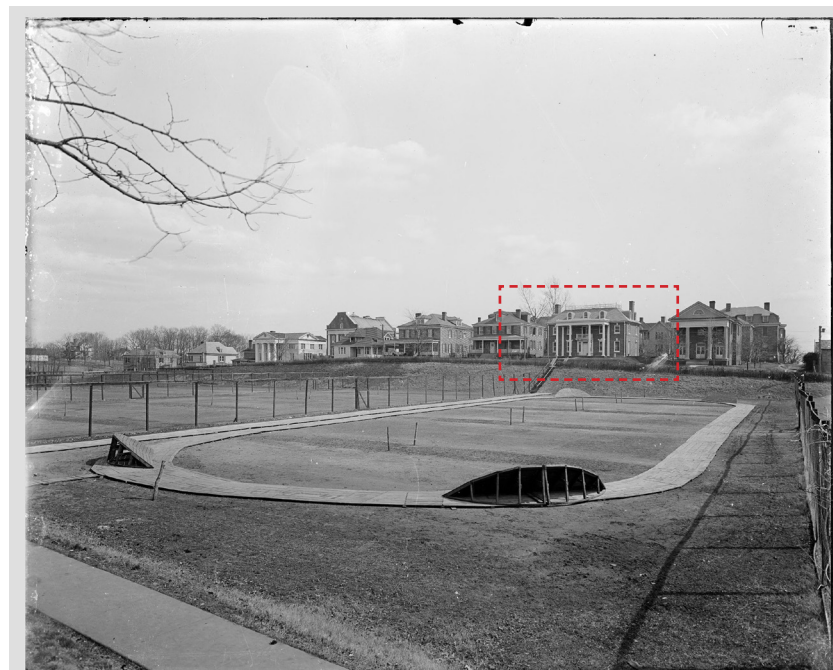
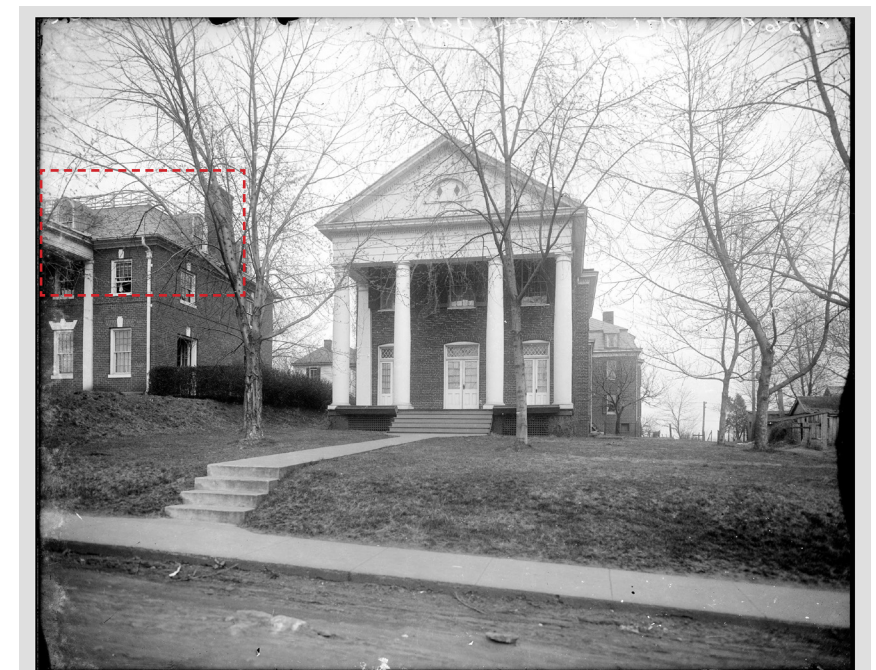
Images from UVA's Special Collections library (specifically Holsinger Studio Collection, ca. 1890-1938) reveal the original wooden railing around the roof.

Using these images as templates, modeling software can be used to recreate the railings' proportions and dimensions through a "photomatch" function.

Restoring the wooden railing replaces the existing metal railing.

Selecting corner post finials and railing profiles based on photographic evidence and popular styles in 1890S.

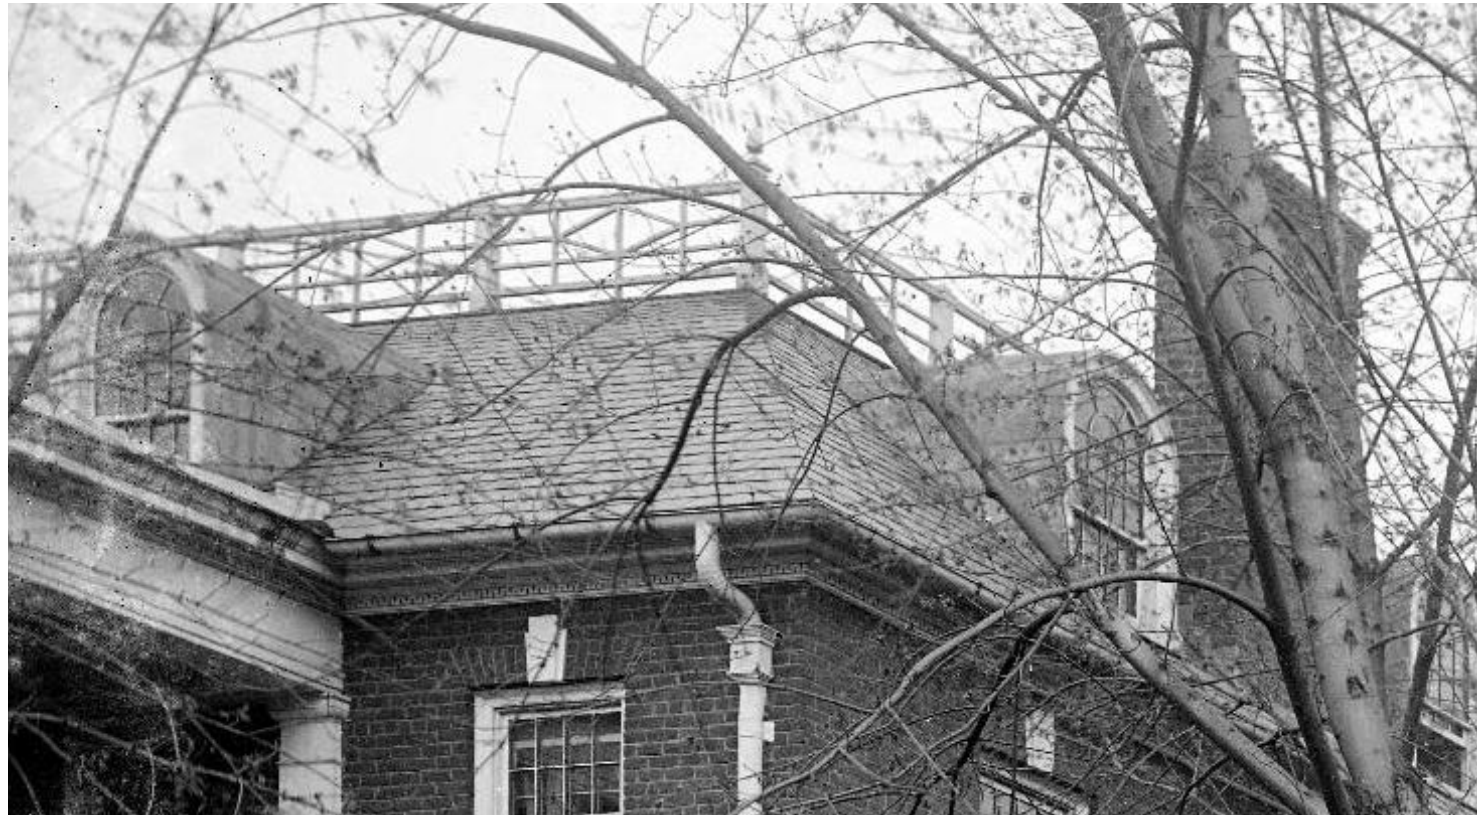
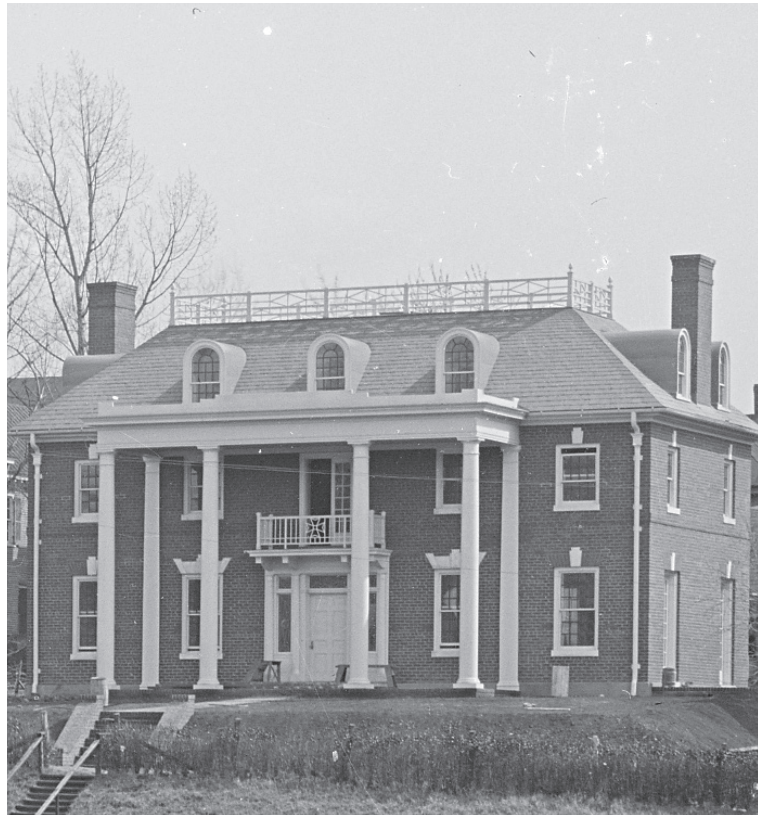
STEP 3: UTILIZE DIGITAL NEGATIVES OF HISTORIC PHOTOS

Images from UVA's Special Collections library (specifically Holsinger Studio Collection, ca. 1890-1938) reveal the original wooden railing around the roof.

Using these images as templates, modeling software can be used to recreate the railings' proportions and dimensions through a "photomatch" function.

Restoring the wooden railing replaces the existing metal railing. Selecting corner post finials and railing profiles based on photographic evidence and popular styles in 1890S.

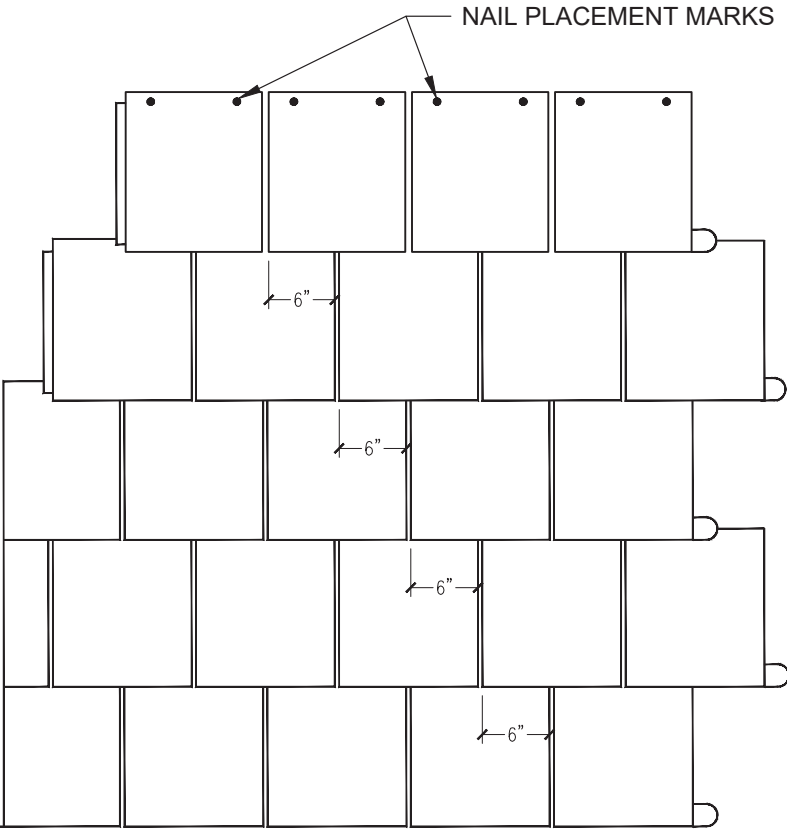
BELLAFORTE SLATE 6 INCH
OFFSET PATTERN

SCALE: N.T.S.

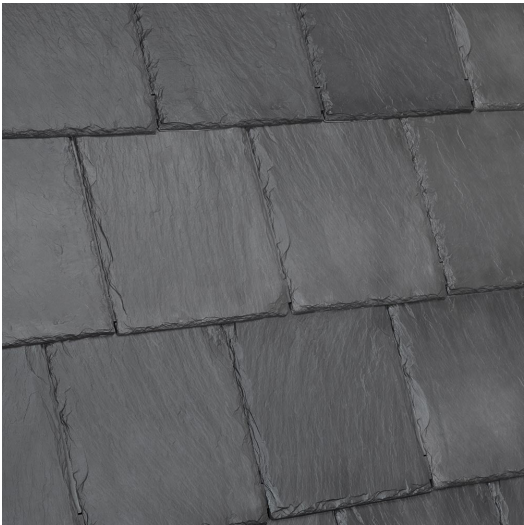
DAVINCI' "BELLAFORTE" SLATE
POLYMER ROOF IN "SLATE GRAY"
