From: Scala, Mary Joy
Sent: Tuesday, April 22, 2014 2:06 PM
To: 'valaw1126@comcast.net'; David Kariel (dkariel@cstone.net)
Subject: BAR Action April 15, 2014 - 632 Ridge Street

RE: 632 Ridge Street
Main house maintenance and upgrades; cottage renovation

Exterior Work at 632 Ridge Street Main House and Cottage

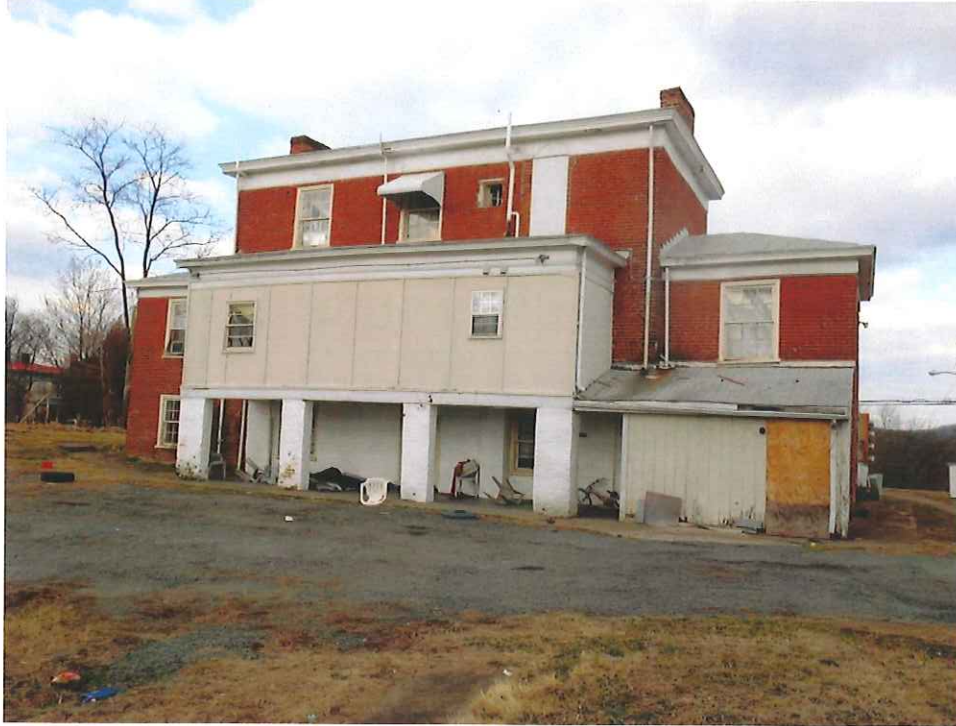
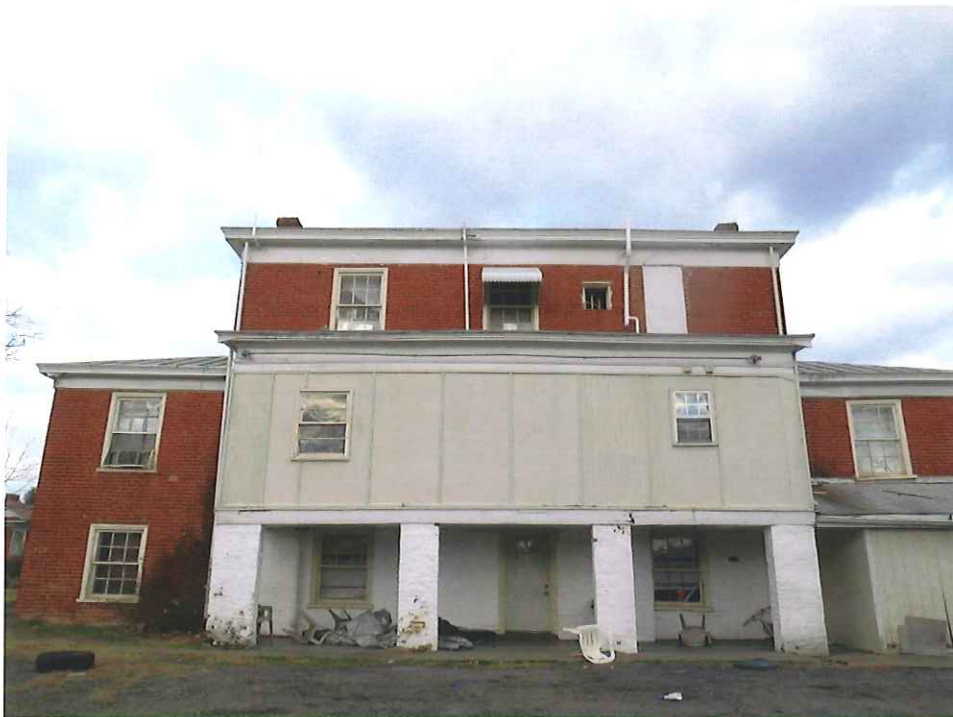
2. Replace deteriorated T-1-11 siding and trim at rear second floor enclosed porch, rear wall of under porch and small addition at northeast corner with standard Hardiplank lapped siding with visible grain. Repair trim and roof flashings as required.

Enclosed back porch to be re-sided.

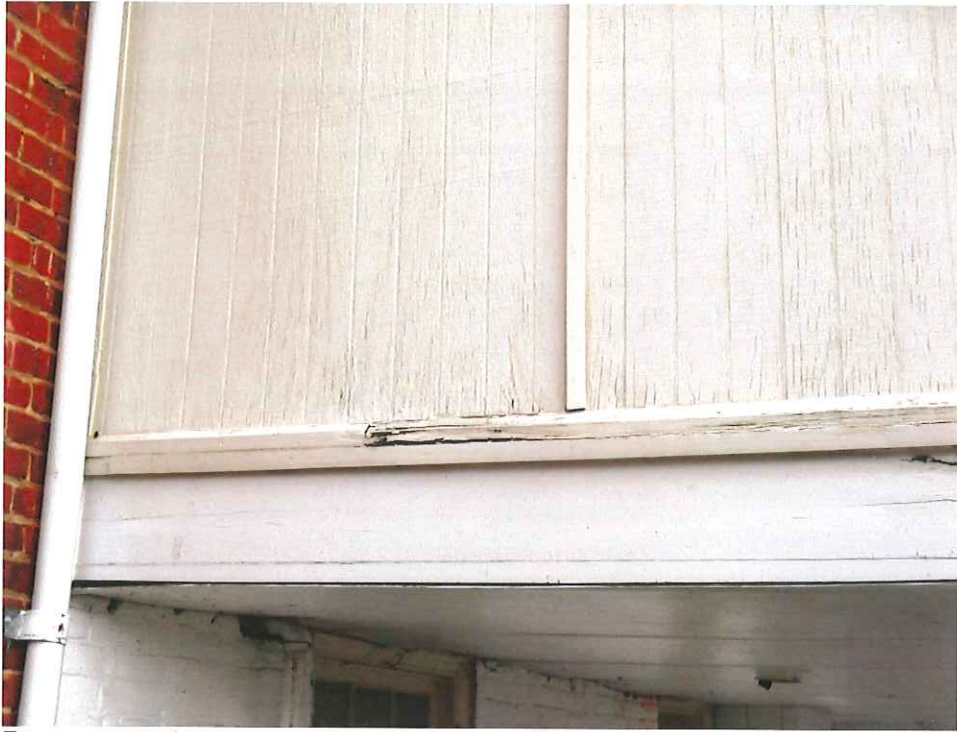
Remove rotted wood trim. Lap existing horizontal trim with concealed "Z" flashing run under new Hardiplank siding.

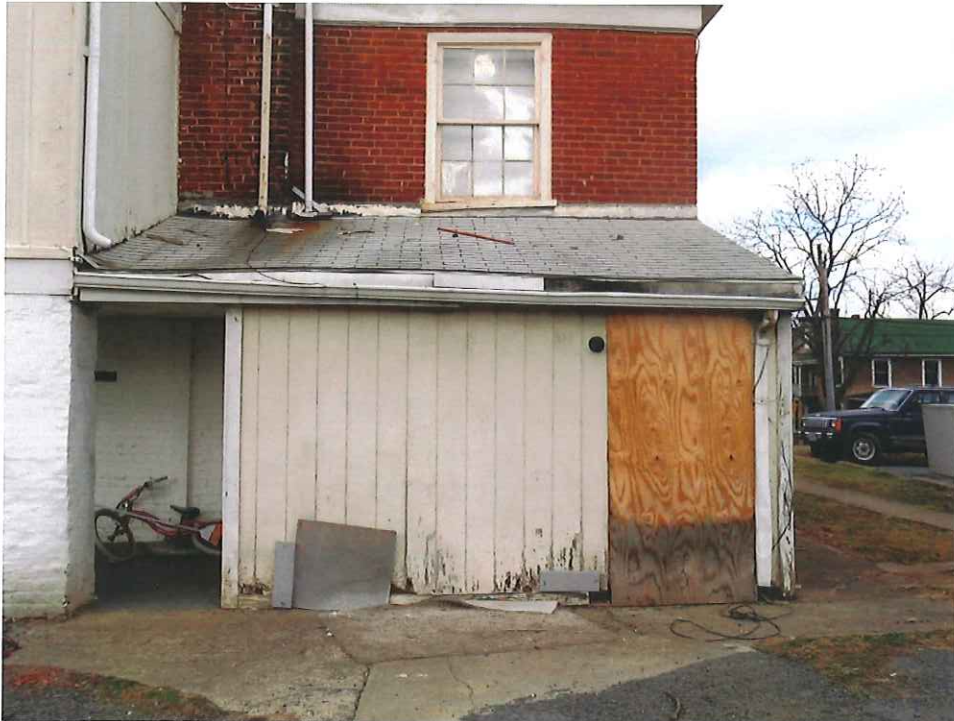
Rear addition to be re-sided. Provide concealed flashing behind siding and seal at slab level, to keep water from seeping in under wall. Replace damaged sill and framing inside as required.

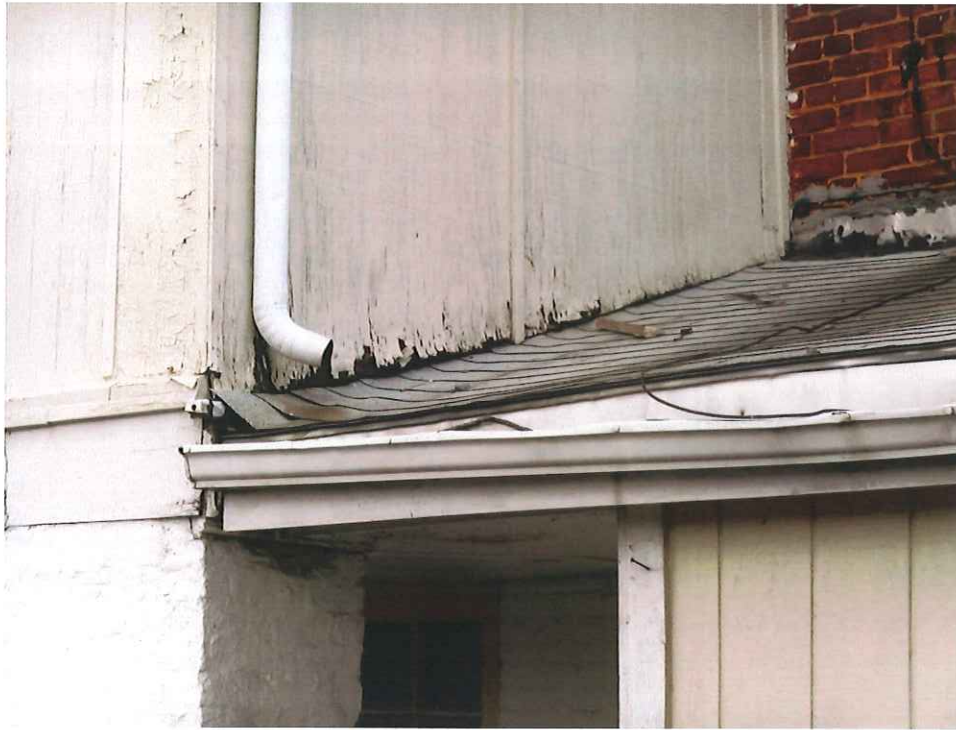
Provide new flashing under new Hardiplank siding and shingles.

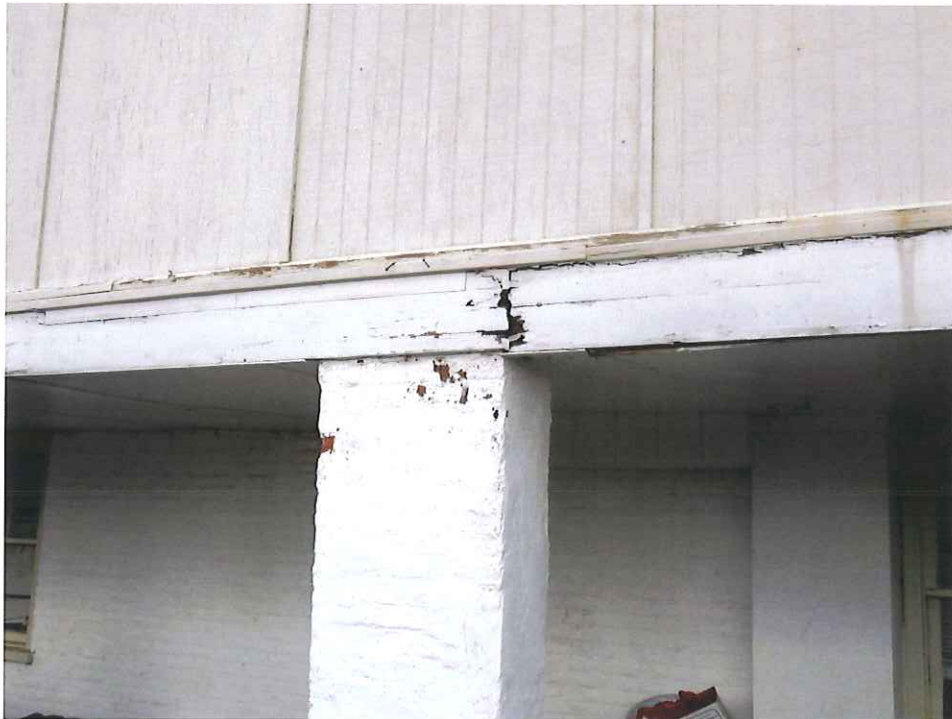
Remove trim and repair beam with wood rot at enclosed back porch. Provide new Hardiplank siding above.

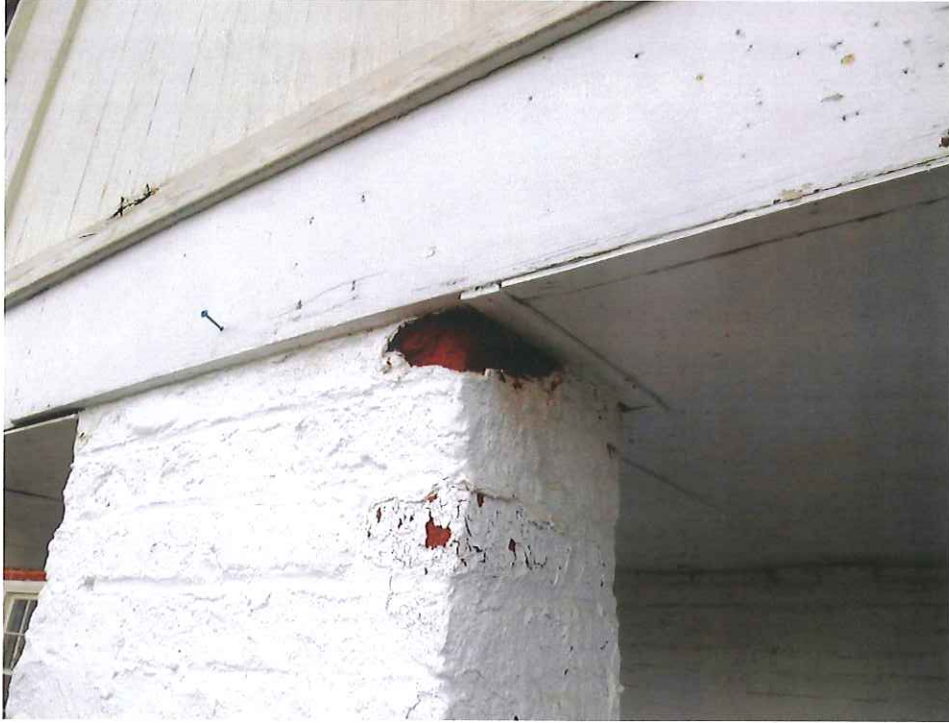
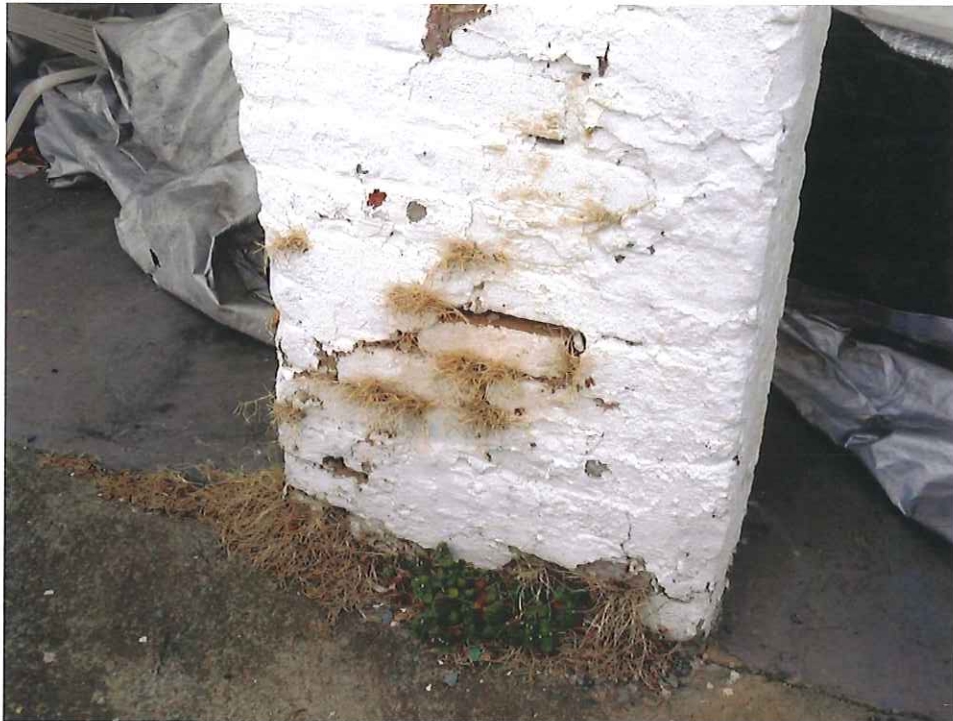
3. Brick piers at rear to be repaired and repainted.

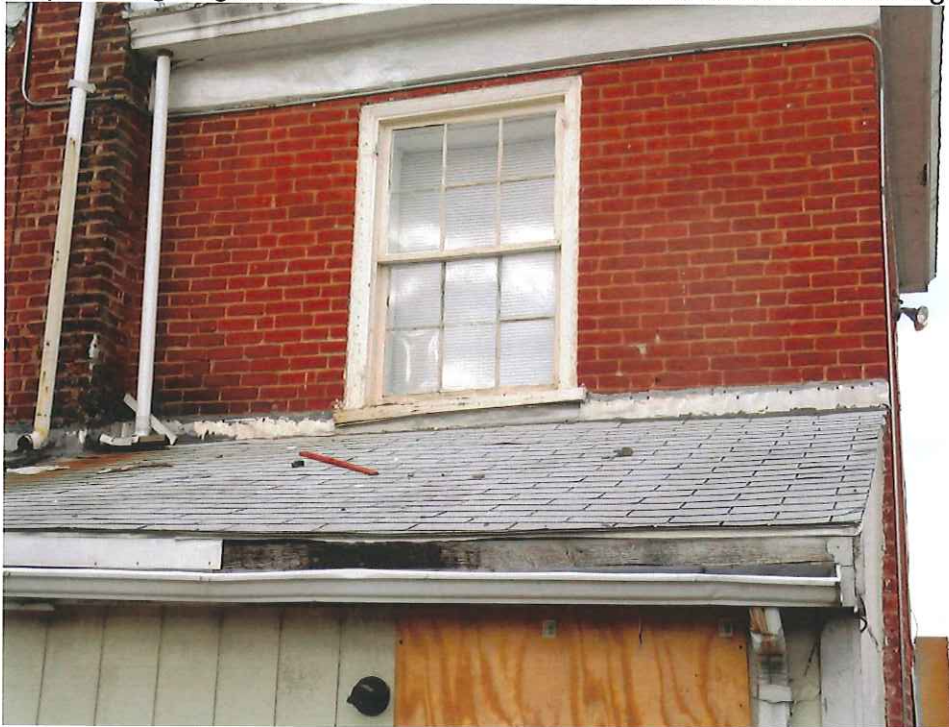
5. Replace ogee gutters at rear with new half round white aluminum gutters.

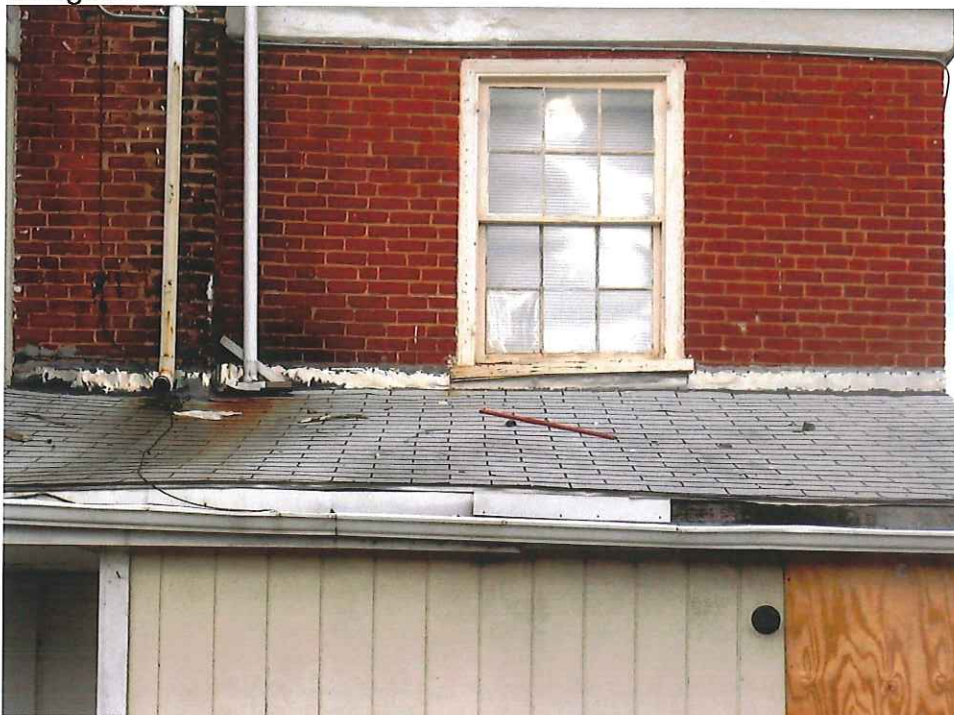
6. Remove and replace aluminum flashing secured with nails and caulk. Replace with brown colored aluminum flashing let into brick mortar joints and lapped over shingles.

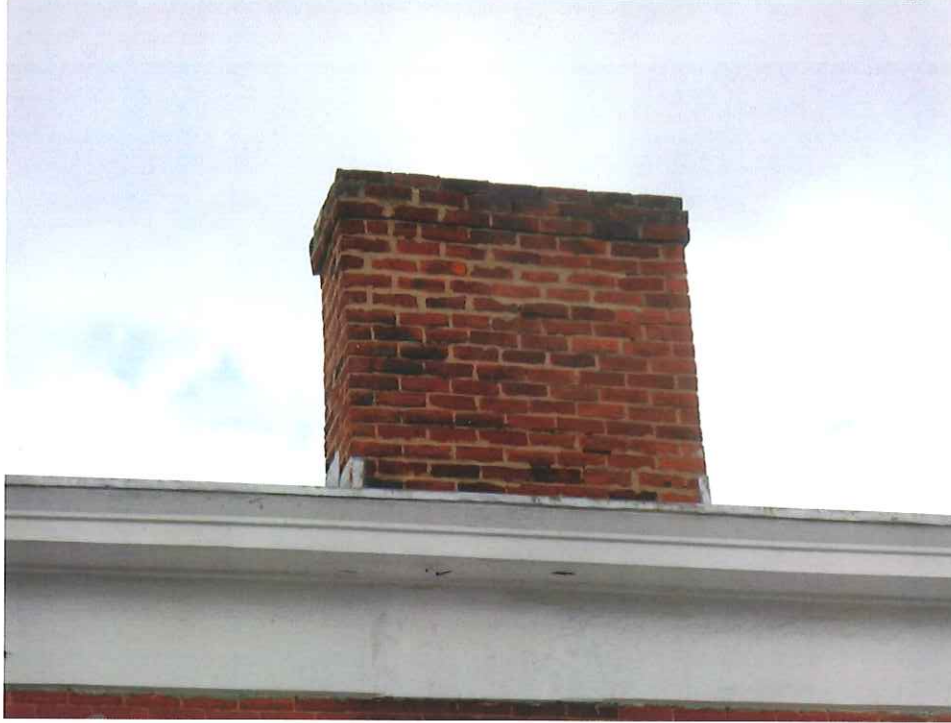
7. Install metal caps over the two abandoned end chimneys to keep out rainwater and birds. Secure at top of chimneys so metal is not visible from ground.

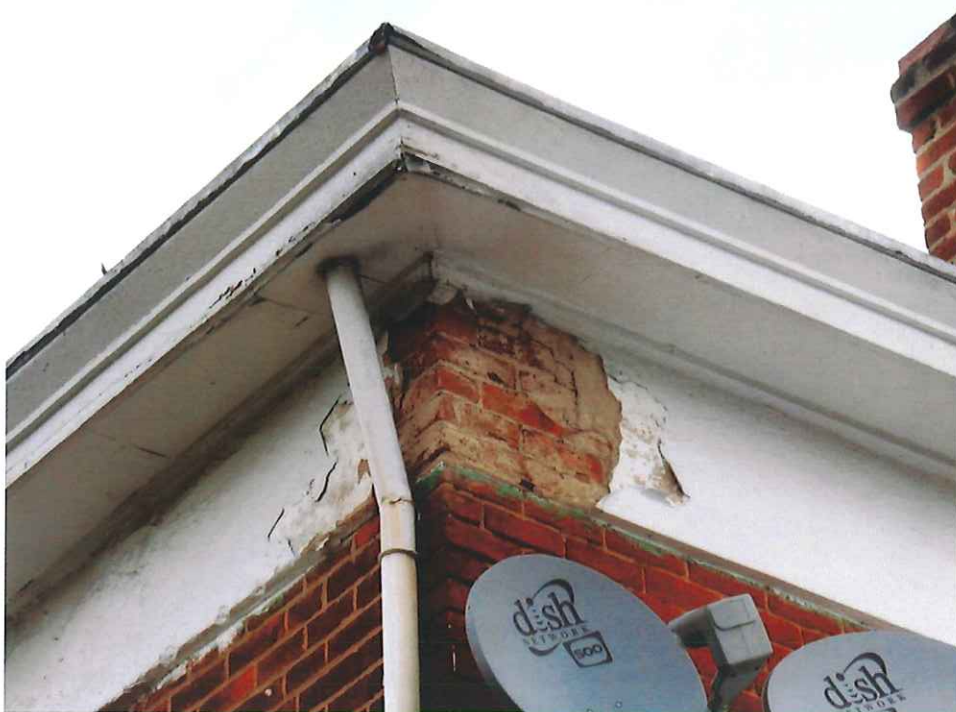
8. Repair and repaint roof to stop leaks at built in gutters. Repair damage to plaster cornice and soffits with wood rot.

Repair soffit and plaster at 2nd floor cornice and repaint.

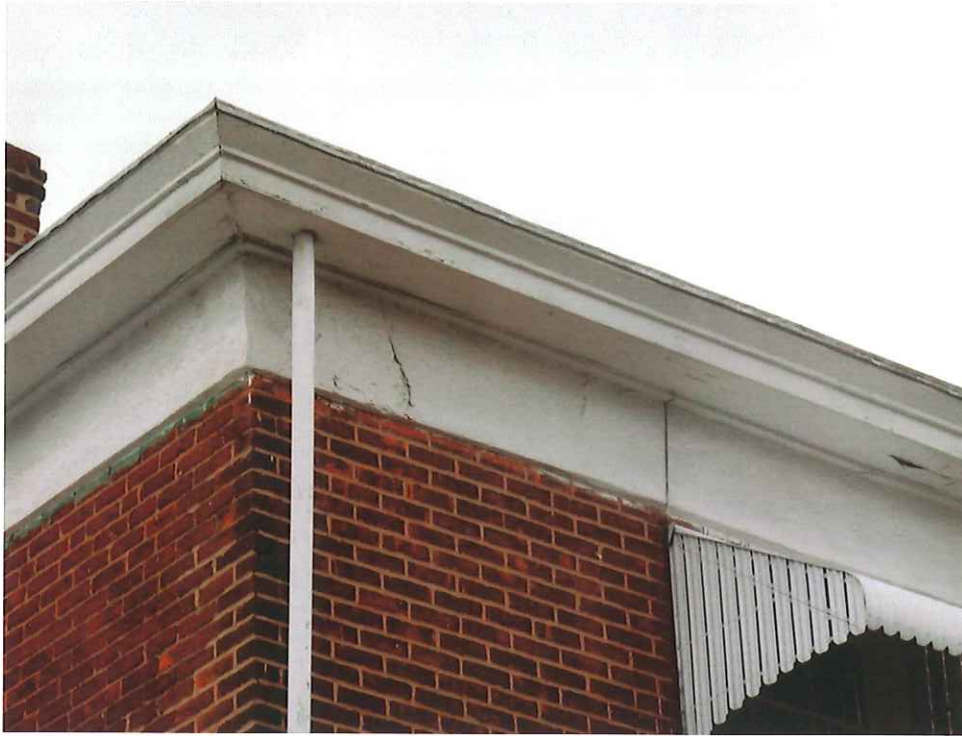
Repair damaged plaster.

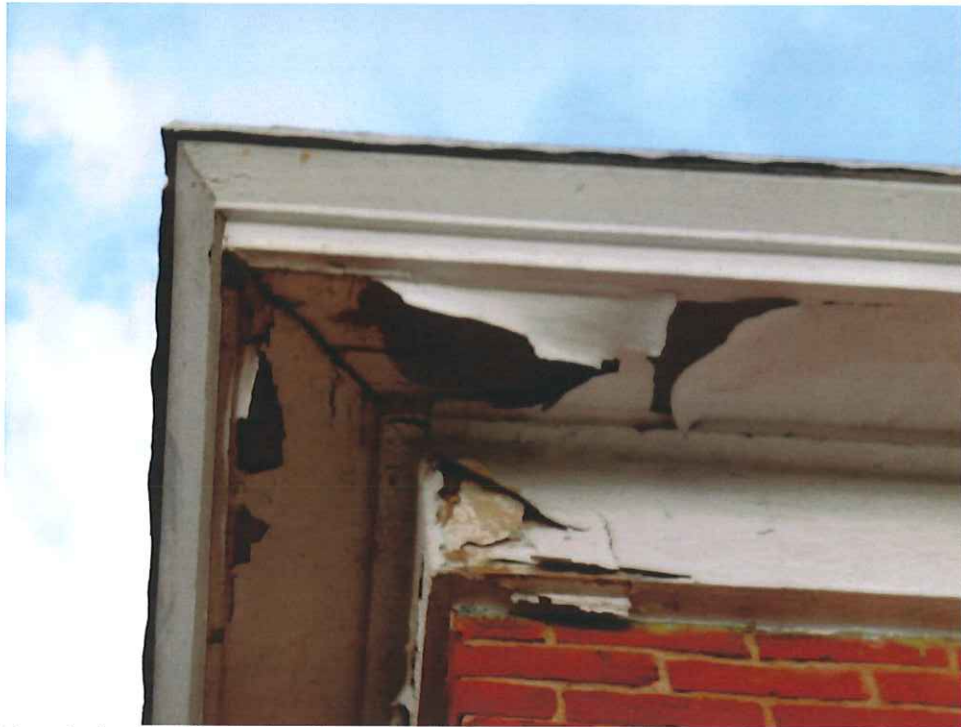
Repair damaged wood soffit at rear corner.

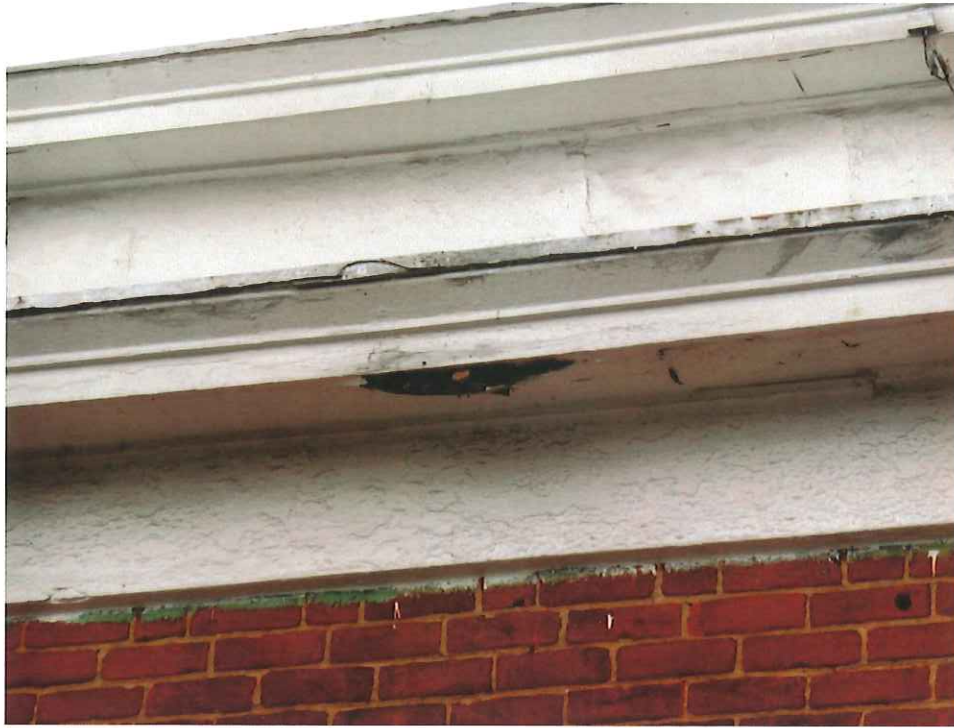
Repair small sections of water damaged wood soffits.

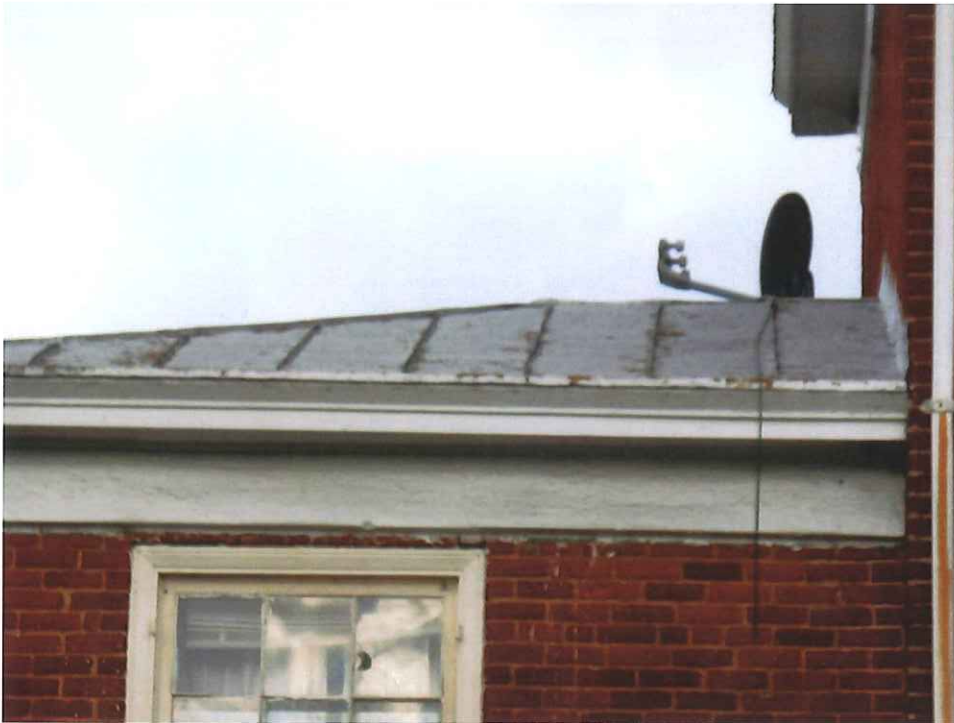
Investigate condition of gutters and repair any rusted sections. Scrape, prime and repaint existing standing seam roof with silver roof paint matching existing.

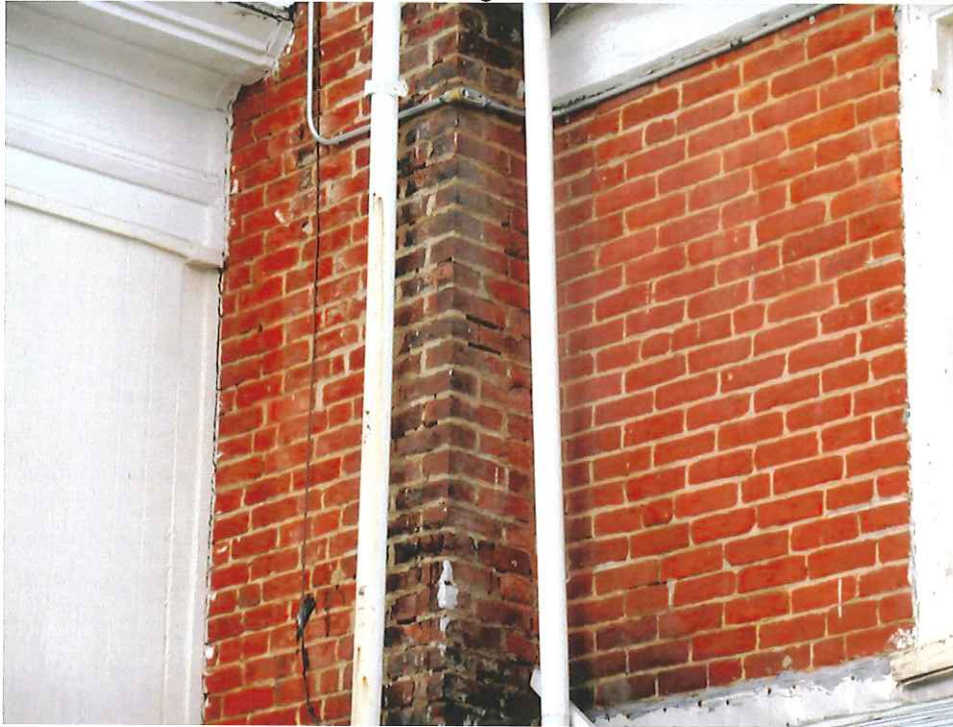
9. Repoint brick with mortar matching historic color and low cement content.

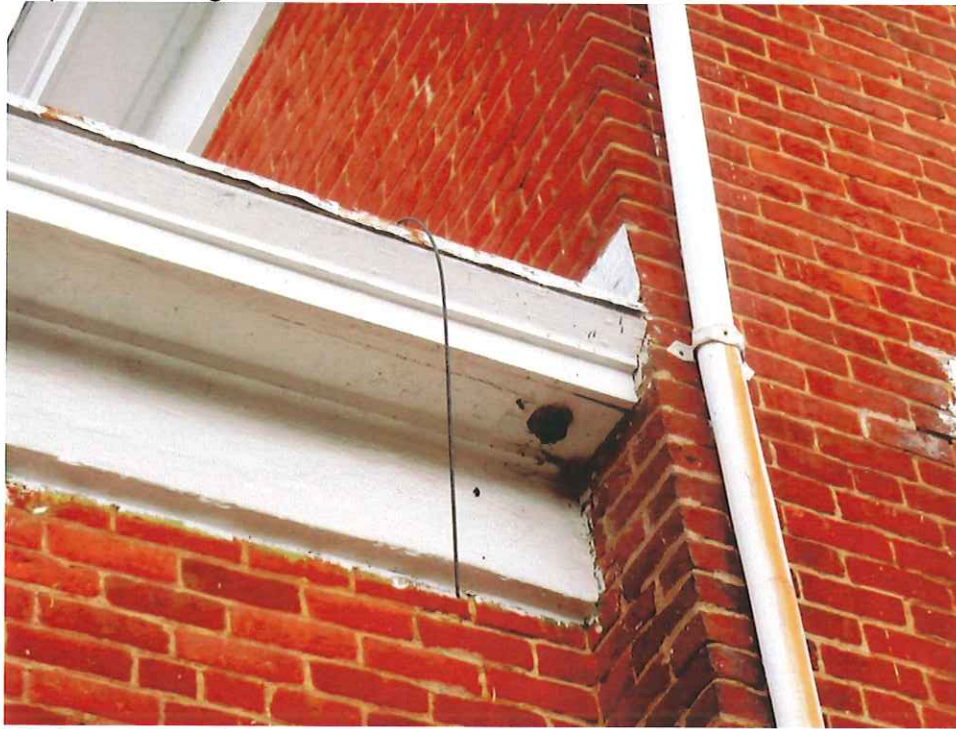
10. Downspouts are rusted, have rust holes and are missing sections. Replace all downspouts that are significantly rusted or missing insuring connections at gutters are watertight. Provide smaller diameter round galvanized downspouts. Repair rusted gutter connections with new metal.

Missing downspouts.

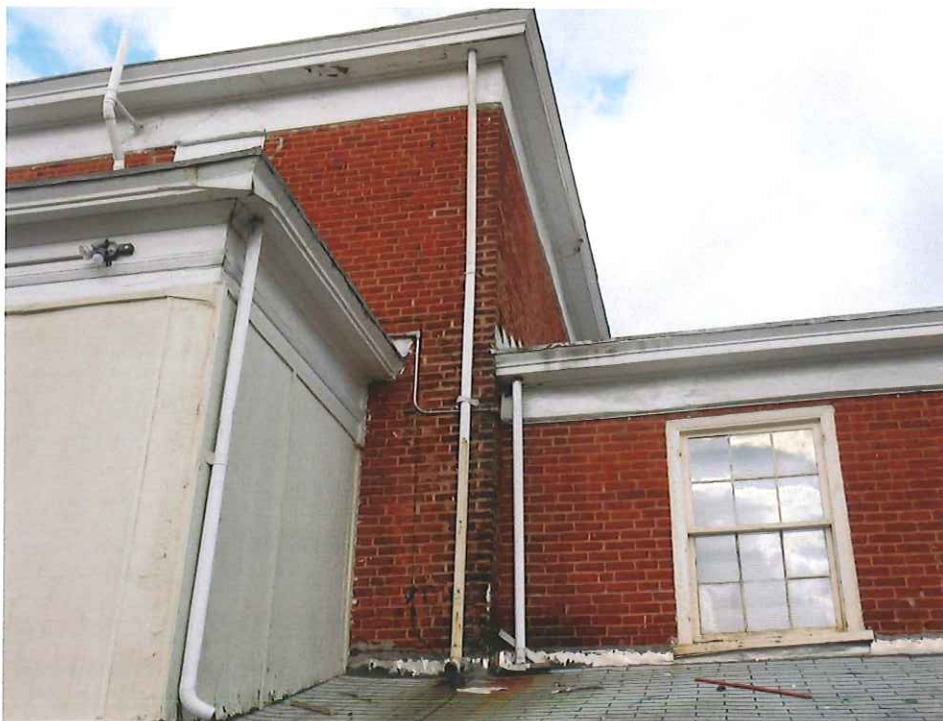
Rust-through holes in downspouts.

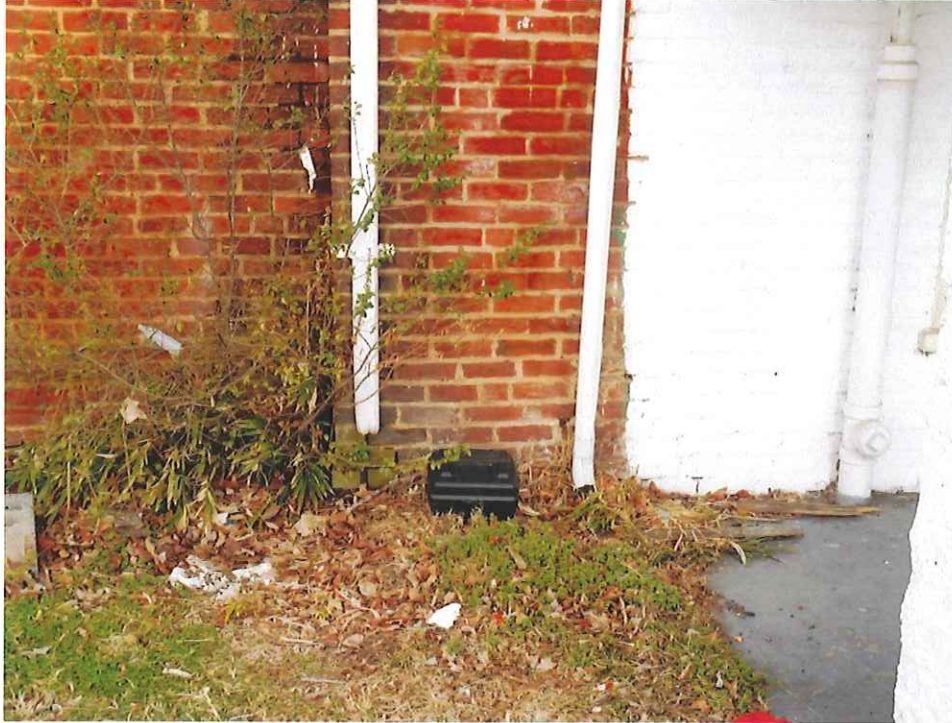
11. Provide underground downspout extensions where missing. Run to daylight at locations identified by owner.

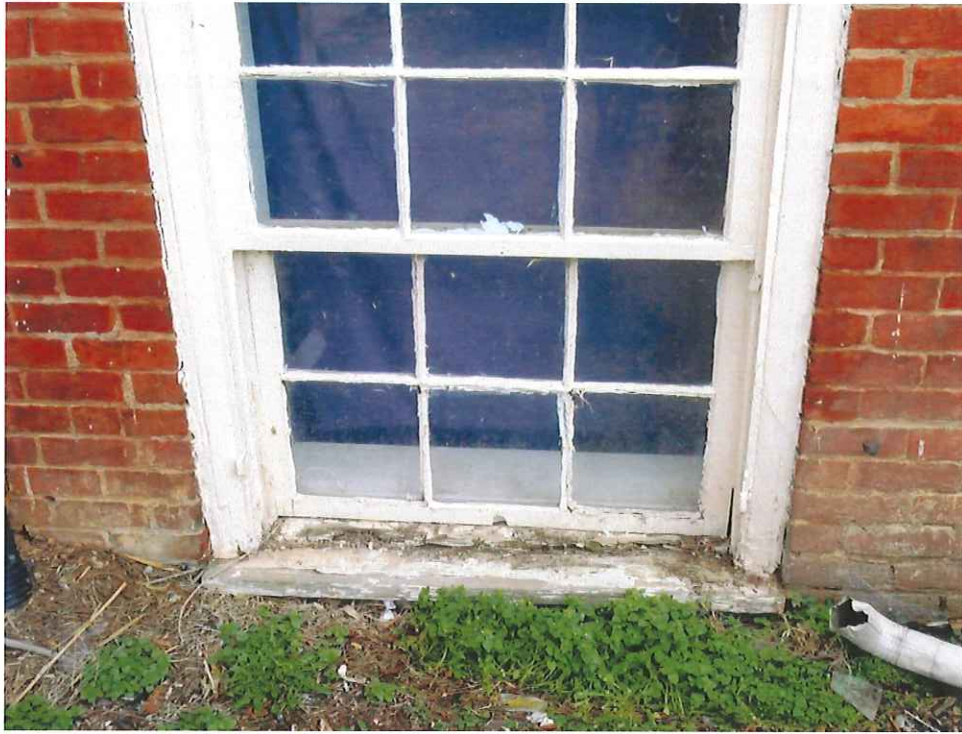
Basement window sills have wood rot. Lower grade soil to provide for drainage away from the building and replace damaged wood.

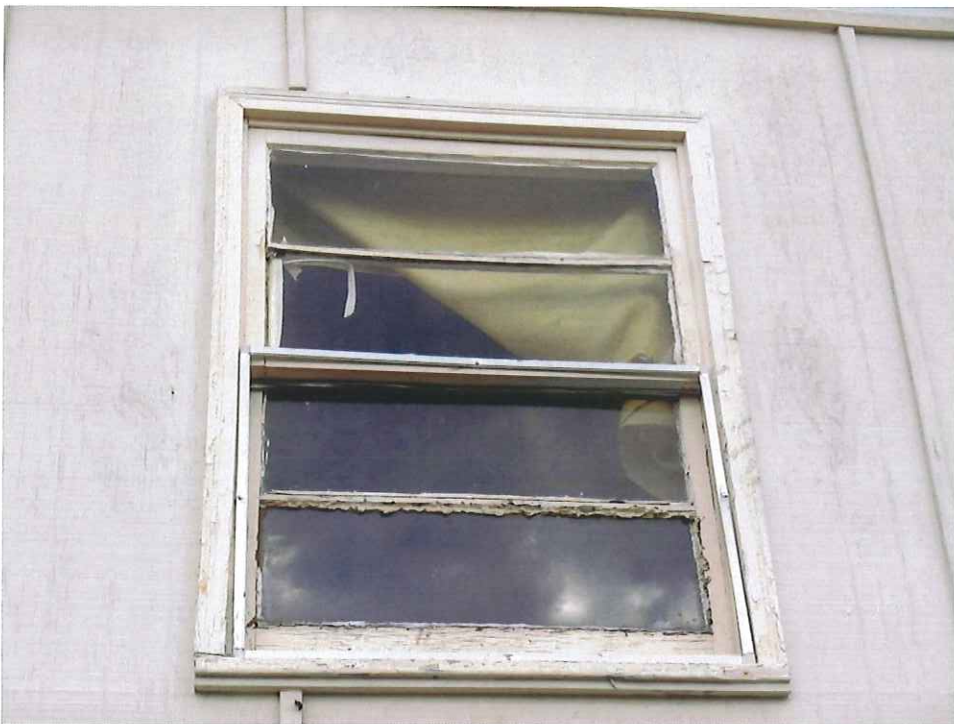
Windows from the 1960's at enclosed back porch to be maintained.

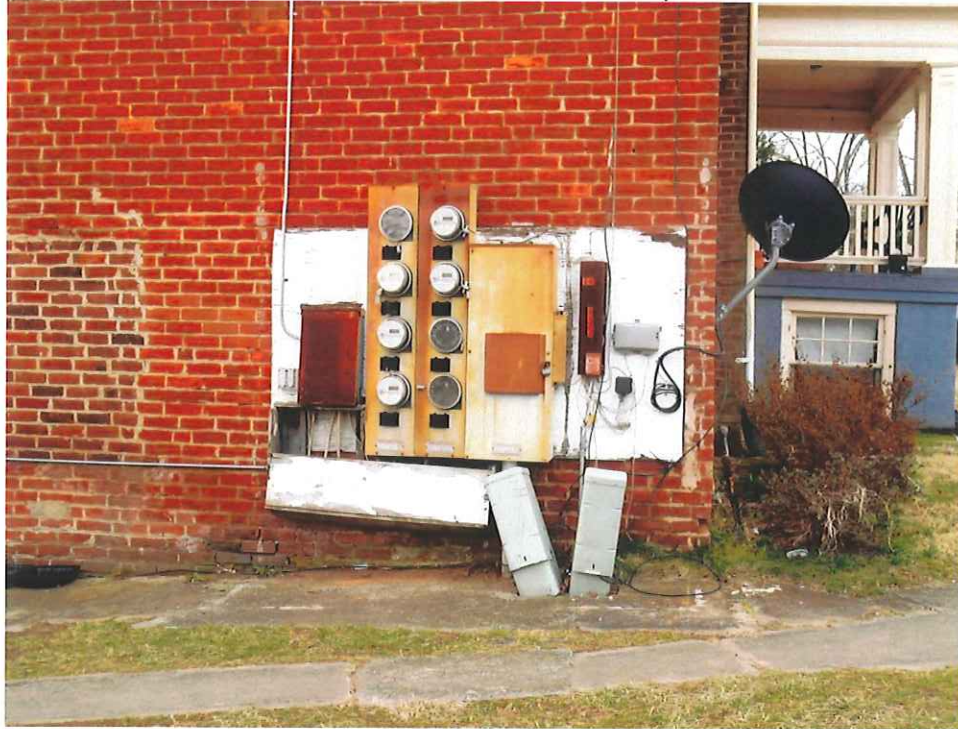
16. Consolidate equipment at plywood panel trimming off edges. Paint plywood mounting board and equipment boxes terracotta color to match brick. Repair wood trim covering conduit at bottom of meter panel.

Approved (7-0) as submitted, but address the utility meter area by cleaning up the extra plywood, and putting a simple wood sloped roof over it and painting it all medium gray; and retain/repair as much as possible the cottage windows (rather than replacing them.)

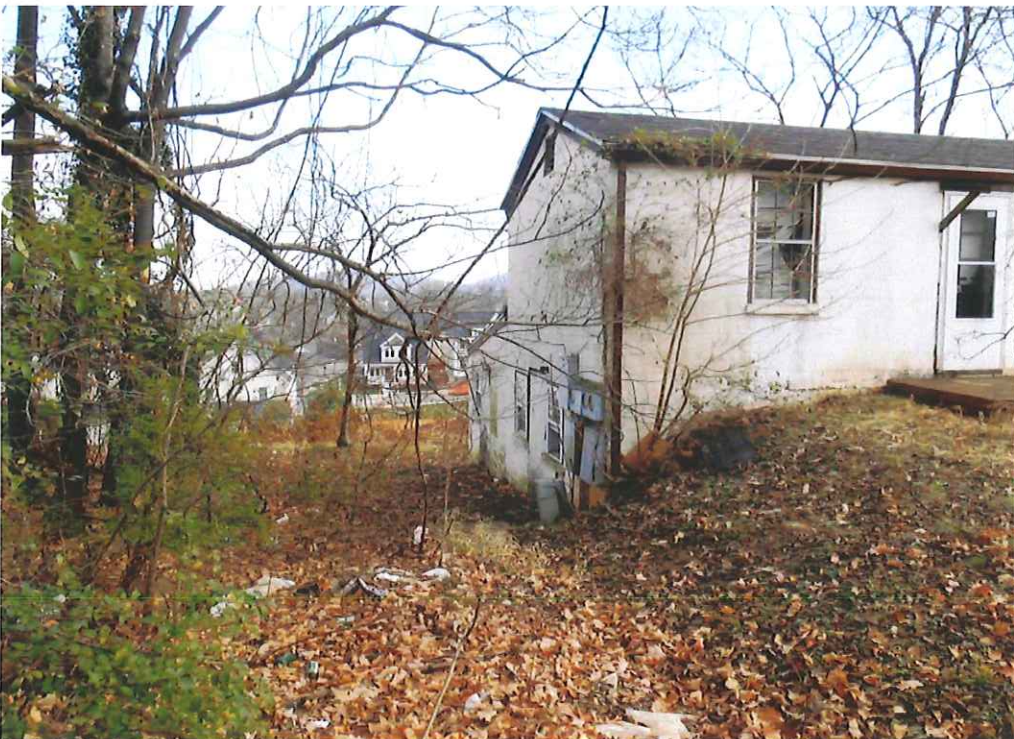
Front NW Corner

The exterior is to be renovated as part of a full building renovation. See following elevation construction drawing for new work, and photos below for existing conditions.

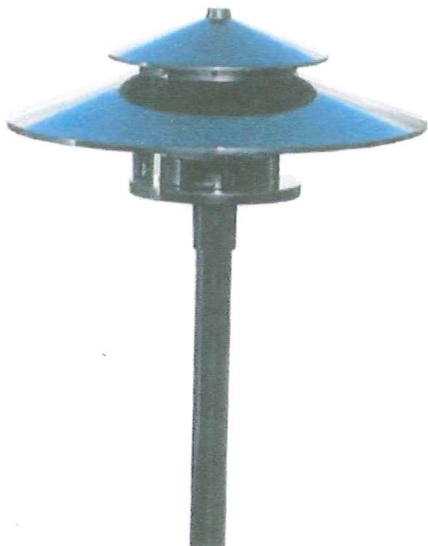
PTL3419 LED Path Light

LED Path Light - Durable

Timeless cast aluminum path lights for illuminating walkways and other pedestrian areas. LED and T-3 halogen sources provide even illumination in a compact, durable, beautiful luminaire.

Frosted tempered glass lens.
