307¹/₂ 5th Street SW 104-0213-0181

308 5th Street SW 104-0213-0164

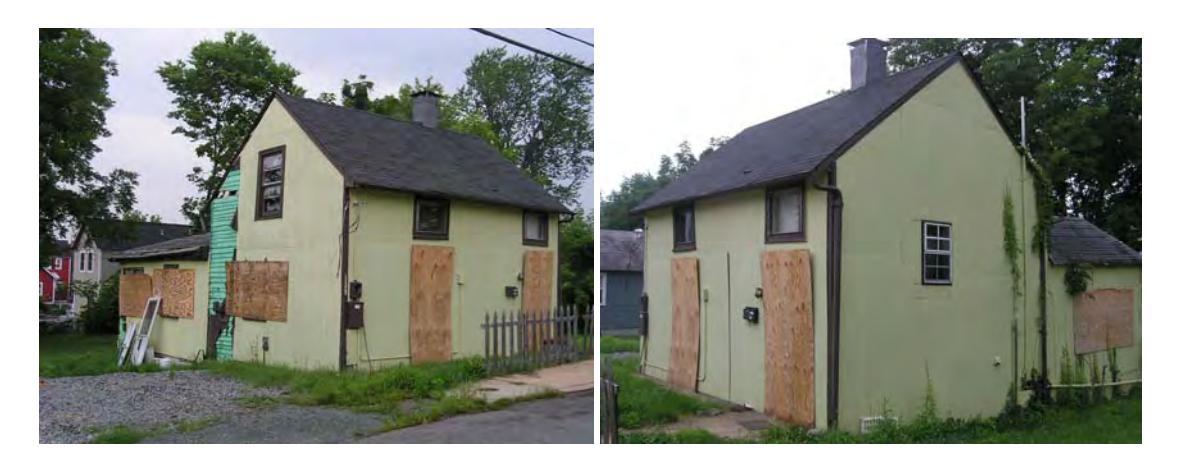
Primary Resource Information: **Single Dwelling**, **Stories 1.50**, **Style: Other, ca 1870** July 2006: This currently abandoned 1½-story, 2-bay, frame dwelling was constructed in at least three sections. The modest house originally began as a 1-bay, 1½-story unit made up of the northern most part of the current dwelling. This would have included the current interior brick flue located within the steeply-pitched gabled roof. The front of the house was enlarged to its current configuration of two bays and then extended to the rear with a 1-story gable end wing and a side shed-roofed lean-to. The original weatherboard siding is visible beneath the current T-111 siding and the roof is now clad in asphalt shingles. None of the windows appear original and include jalousie windows with missing glass in the ½-story, boarded windows on the front and also on the rear wings, and modern 1/1 and 4/4-sash on the side elevation. Few details are evident as the house has been mothballed.

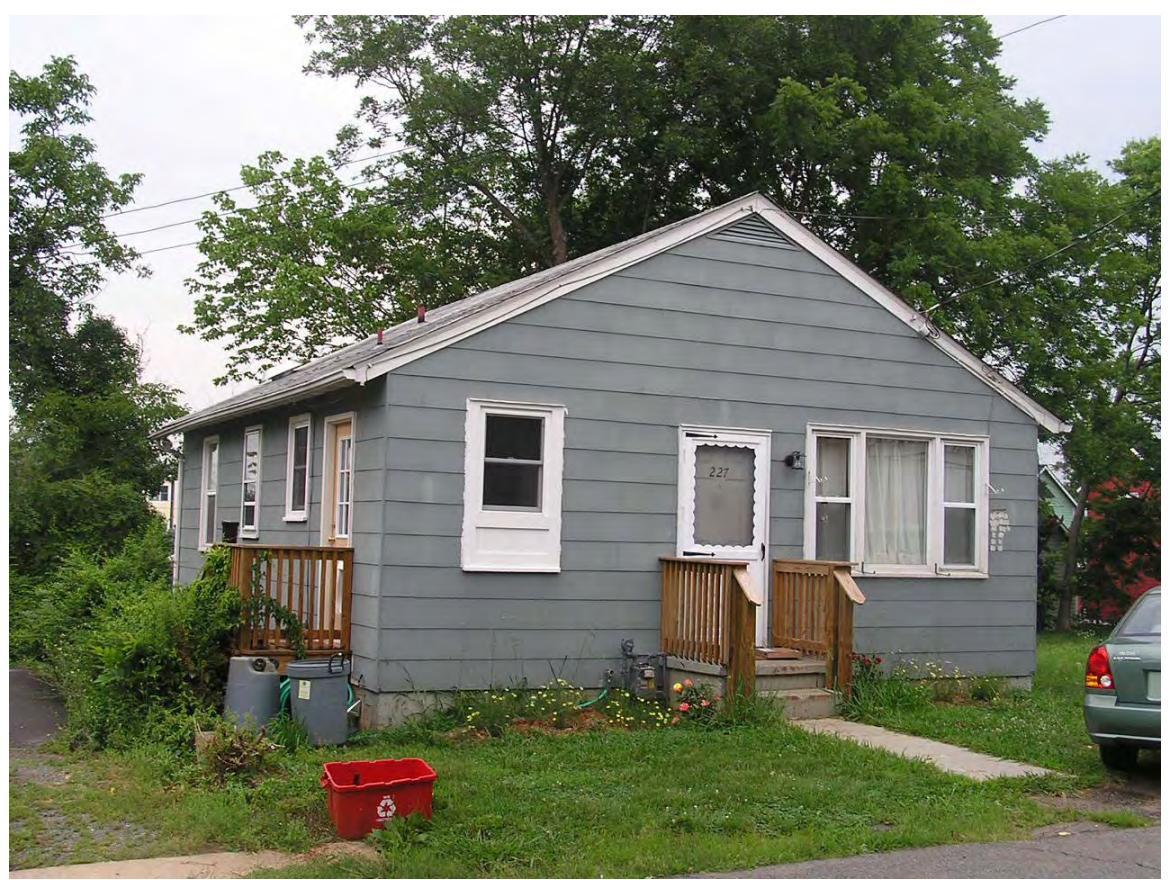
Primary Resource Information: **Single Dwelling**, **Stories 1.00**, **Style: Other, ca 1954** July 2006: Constructed in the mid-1950s, the house is sited perpendicular to the street. The 1-story, 3-bay, gable-end, frame dwelling rests on a concrete block foundation, with exposed rafter ends, new vinyl 1/1-sash windows, asphalt shingle roofing, asbestos siding, and a three-part bay window on the façade.

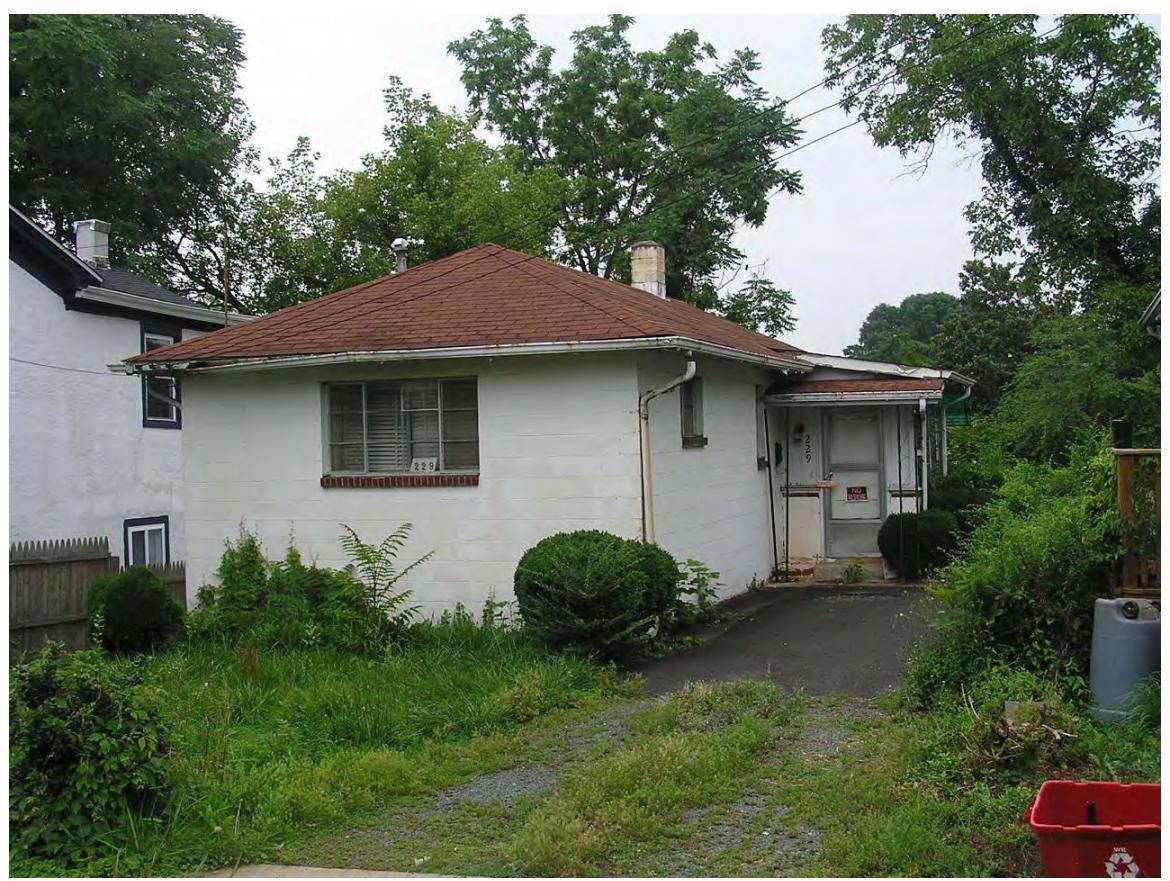
Primary Resource Information: **Single Dwelling**, **Stories 1.00**, **Style: Other, ca 1957** July 2006: Constructed in 1957, the house is sited perpendicular to the street. The 1-story, 1-bay, hip-roofed concrete block dwelling features a hipped roof, overhanging eaves, exposed rafter ends, an interior concrete block flue, steel casement windows with brick sills, and a side lean-to entrance bay with a shed-roofed hood supported by modern metal posts.

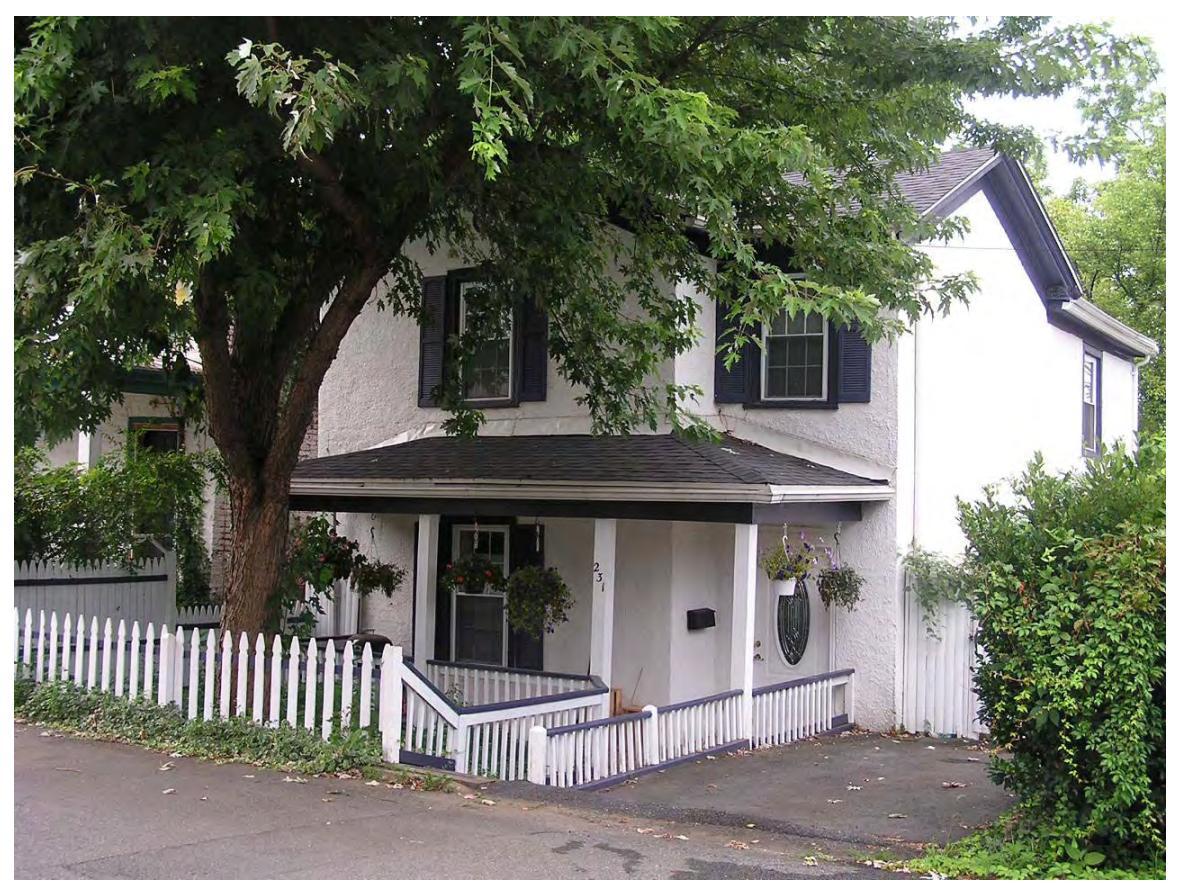
Primary Resource Information: **Single Dwelling**, **Stories 2.00**, **Style: Other, ca 1900** July 2006: This late-19th-century, 2-story, 2-bay, hip-roofed, side-passage-plan, vernacular frame dwelling features a hipped roof with a projecting front cross gable. The roof is clad in asphalt shingles and a central brick chimney pierces it. The frame walls are covered in stucco, the vinyl-clad windows are replacement 6/6-sash, and the house has a plain friezeboard, gable-end returns, a transom over the front door, and a 3-bay hip-roofed front porch with square posts and a modern wooden balustrade. A 2-story wing extends to the rear.

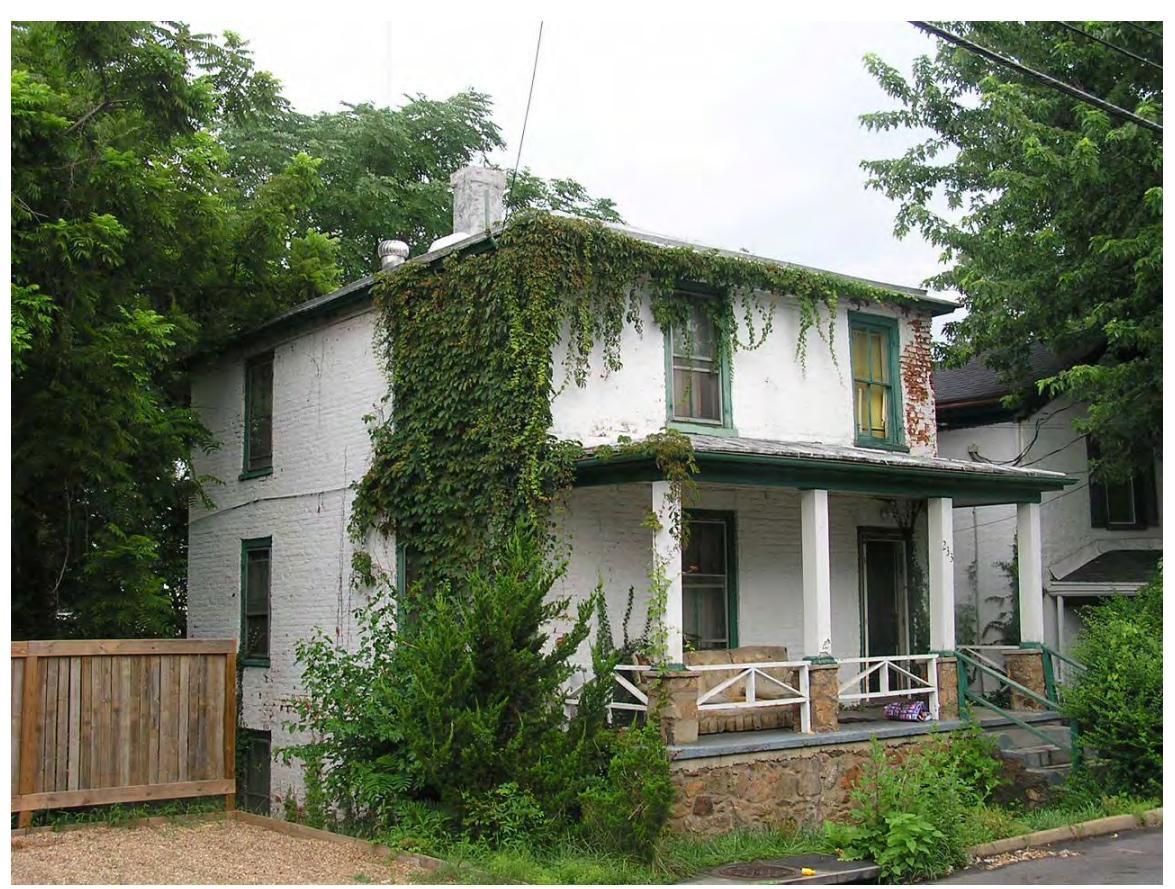
Primary Resource Information: **Single Dwelling**, **Stories 2.00**, **Style: Other, ca 1875** July 2006: This 2-story, 2-bay, hip-roofed vernacular brick dwelling is laid in 6-course American bond. Architectural evidence suggests it was constructed ca. 1870 and it appears on the 1877 Gray's New Map of the area. The house has a full basement in the rear, taking advantage of the banked site. The side-passage-plan dwelling is double-pile and features overhanging eaves, 2/2-sash wood windows with brick jack arches over the first-floor openings, and a central brick flue. The 3-bay hip-roofed front porch has square posts on low stone piers as supports, a modern wooden cross-rail balustrade, and a solid stone foundation.

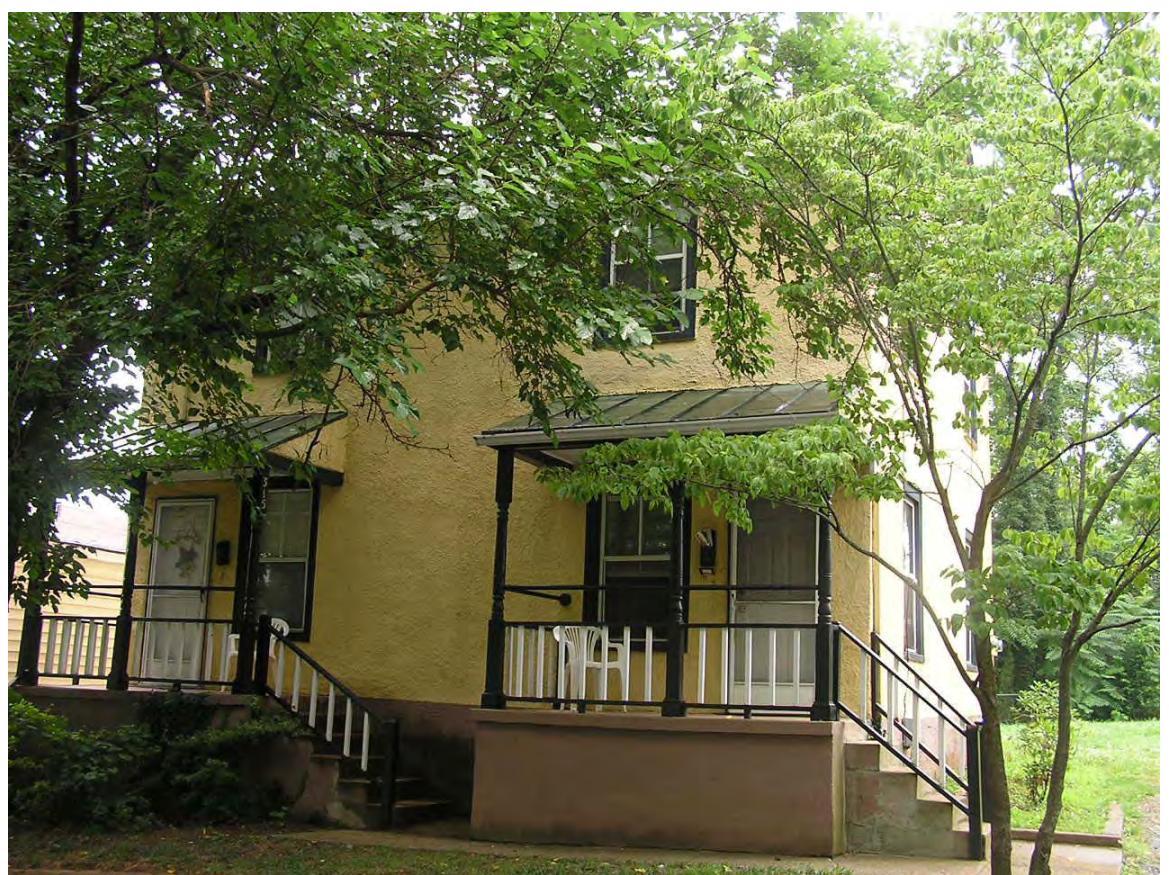
Primary Resource Information: Multiple dwelling, Stories 2.00, Style: Other, ca 1925

July 2006: This 2-story, 4-bay, shed-roofed, gable-roofed, stuccoed frame duplex was constructed ca. 1925. The symmetrical building is comprised of two front entrances: the door is located on the end bay and a 2/2-sash window on the interior bay next to it. Each of these two bays are sheltered by a 2-bay shed-roofed porch with turned posts, plain balusters, and a side entrance. Architectural details include a parged split-level foundation, overhanging eaves, exposed rafter ends, modern vinyl 2/2-sash windows, and a central flue.

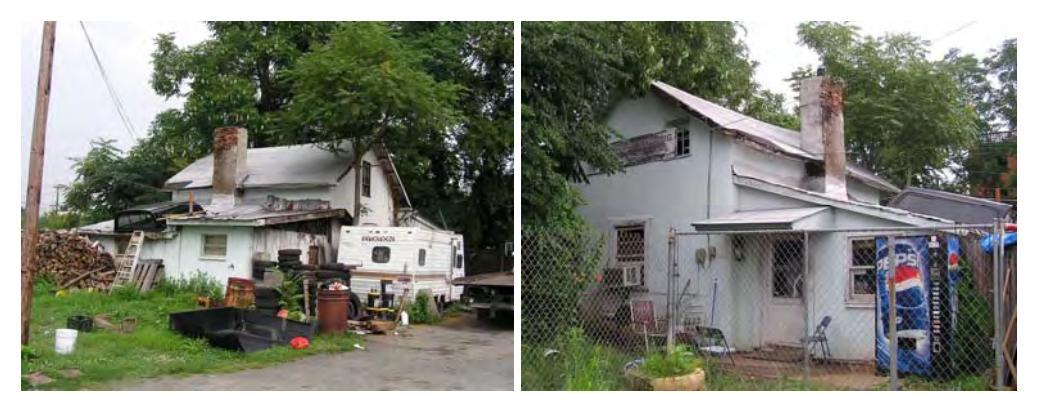
Primary Resource Information: **Single Dwelling**, **Stories 1.50**, **Style: Other, ca 1870** July 2006: Although this 1½-story, 2-bay, frame house is partially obscured by debris in the yard it retains much of its original integrity and appears to date to the late 19th century. It features an exterior brick chimney on the south elevation. The walls are clad in stucco and the gabled roof sheathed in rolled asphalt roofing. The eaves are deeply overhanging with exposed purlin ends. Four-light attic windows are located in the west end and a full-height 4/2 window is in the east gable end. The primary entrance of the building is now along the south side through a 1-story shed-roofed concrete block addition, although this does not appear to be the original entrance into the house. A 1story shed-roofed wing is located along the north side.

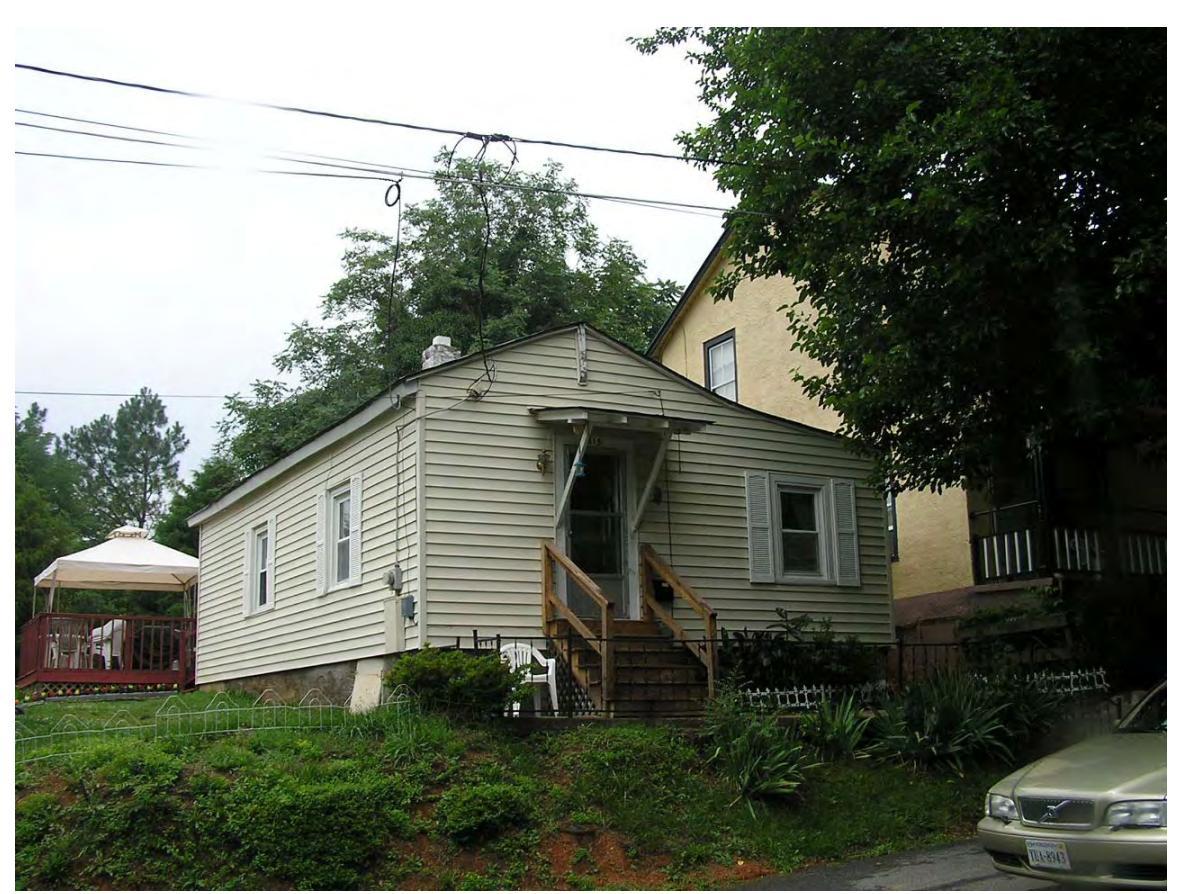
Primary Resource Information: **Single Dwelling**, **Stories 1.00**, **Style: Other, ca 1910** July 2006: This 1-story, 2-bay, gable-end, frame building was constructed ca. 1910 and features a raised brick foundation, vinyl siding, asphalt shingle roofing, new vinyl 1/1-sash windows and vinyl shutters, a central brick flue, and a side, 1-story, lean-to. The central front door is sheltered by a shed-roofed hood supported by wooden brackets. A 1-story wing with an interior flue is located in the rear as well as a modern deck with pergola.

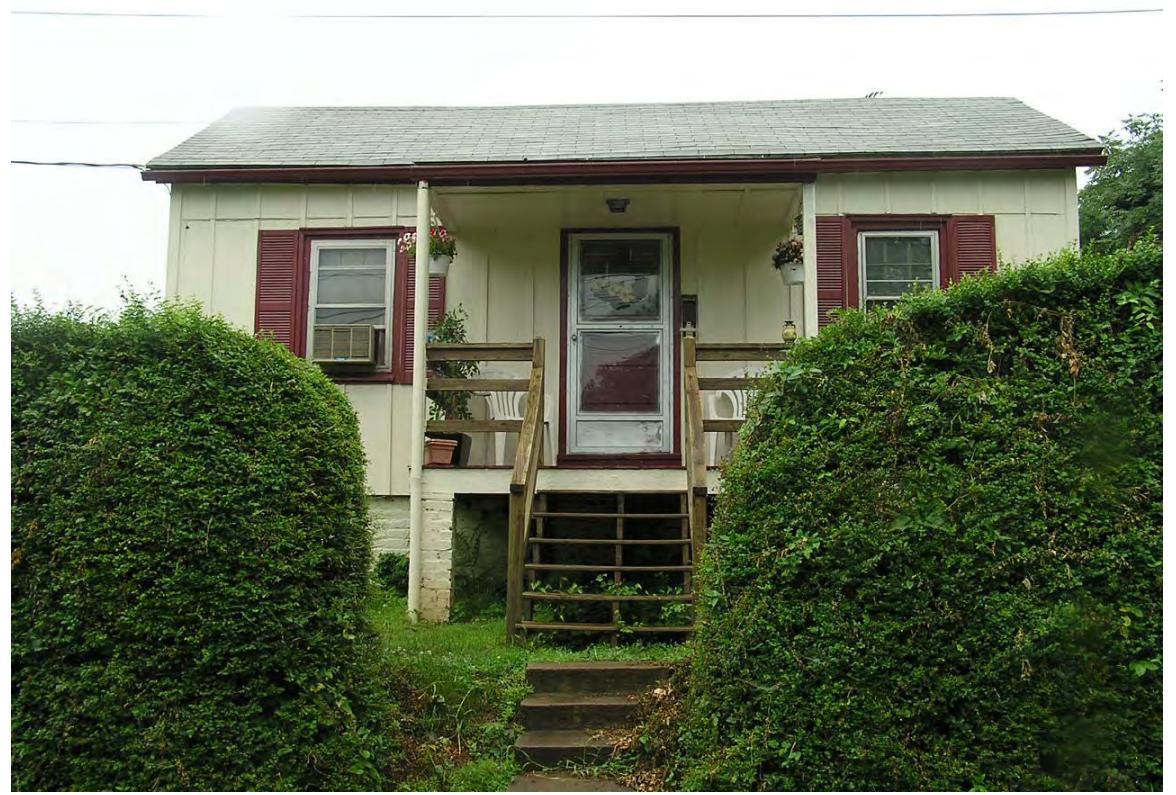
Primary Resource Information: **Single Dwelling**, **Stories 1.00**, **Style: Other, ca 1890** July 2006: This 1-story, 3-bay, frame vernacular dwelling is clad in board-and-batten siding and has an asphalt-shingled gabled roof. Constructed ca. 1890, the house rests on a brick foundation, and features 6/6-sash windows, overhanging eaves, vinyl louvered shutters, and a 1-bay, shed-roofed front porch with square posts. A rear shed-roofed wing contains an interior brick flue.

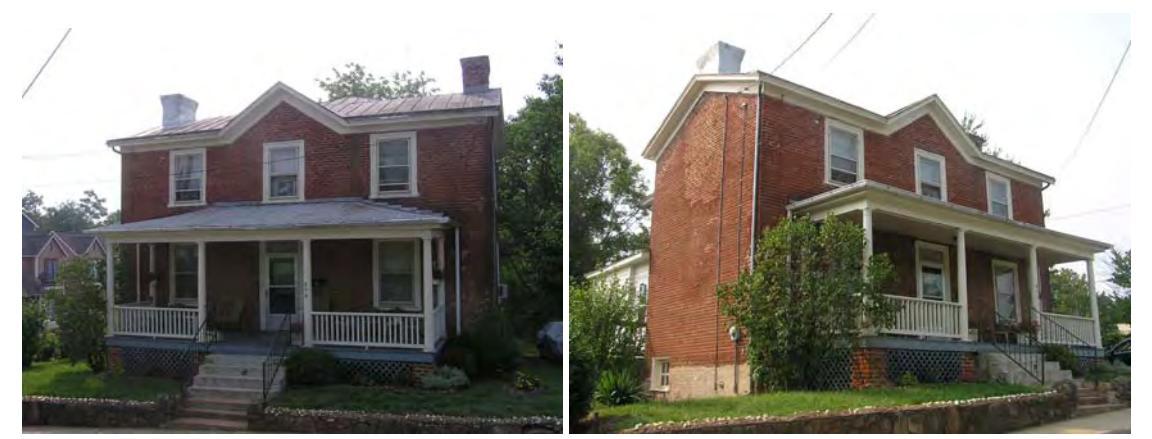
Primary Resource Information: **Single Dwelling**, **Stories 2.00**, **Style: Other, ca 1855** July 2006: This 2-story, 3-bay, brick I-house with a central-front gable is believed to have been constructed in the mid-1850s by Chiles M. Brand. The front brick walls are laid in a 7-course Flemish bond variant and the side and rear brick walls and foundation in 7-course American bond. A mild Victorian interpretation of a vernacular I-house, the dwelling features a gabled roof of standing-seam metal, deeply overhanging eaves, and two interior-end brick chimneys. The house rests on a split-level brick foundation and that is full height in the rear. A large 2-story, hip-roofed, rear brick wing laid in 7-course American bond was constructed in the early 1920s. The house features 1/1-sash windows, a transom over the front door, and a 4-light basement window on the south side. The 3bay, hip-roofed front porch has Tuscan columns and a plain balustrade.

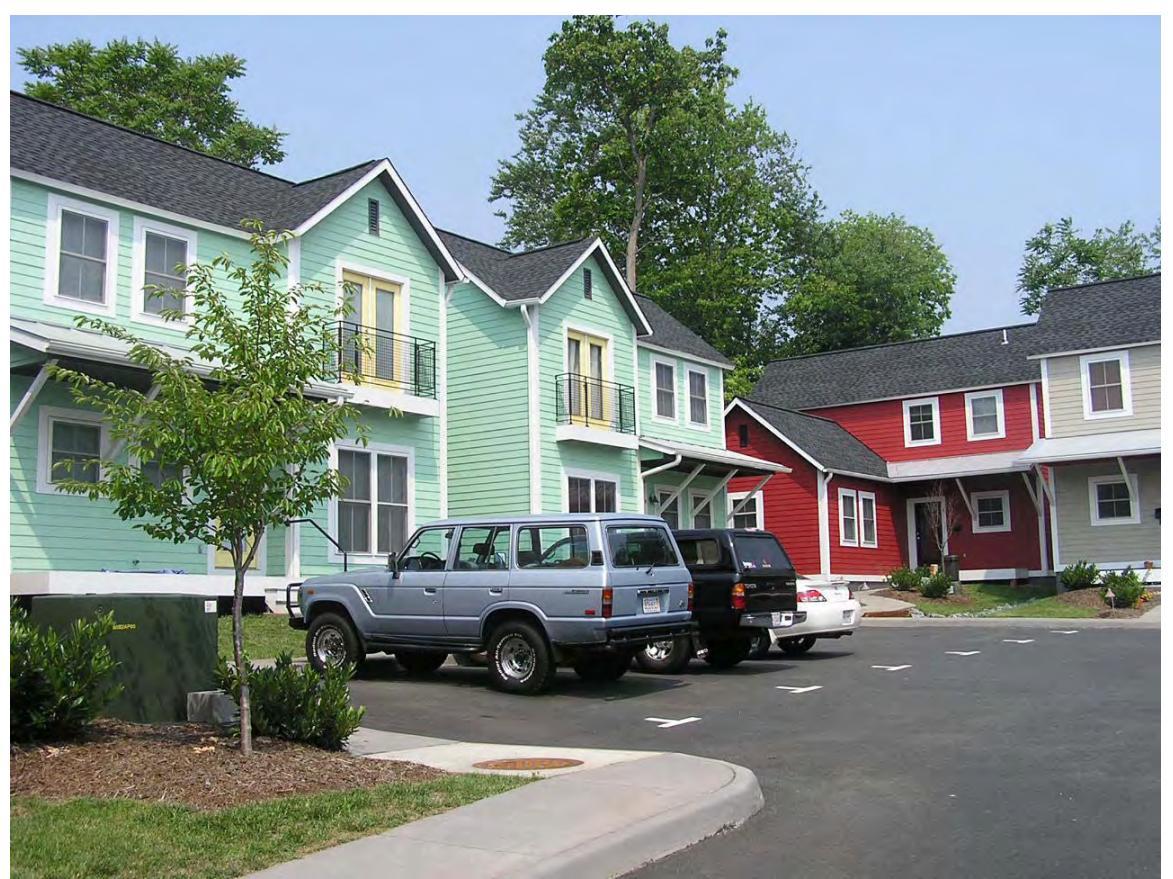
Primary Resource Information: **Single Dwelling**, **Stories 2.00**, **Style: Other**, **2005** July 2006: Constructed in 2005, these six similar, 2-story, cross-gable-roofed frame cottages feature a projecting front cross gable. Very similar in design, they are clad in Hardi-plank siding, roofed in asphalt shingles and feature overhanging eaves, vinyl 2/2sash windows, and shed-roofed hoods supported by wooden brackets over the front entries. They are similar to the set of cottages on the other side of 5th Street. The cottages located directly along 5th Street is three stories in height with a raised basement level.

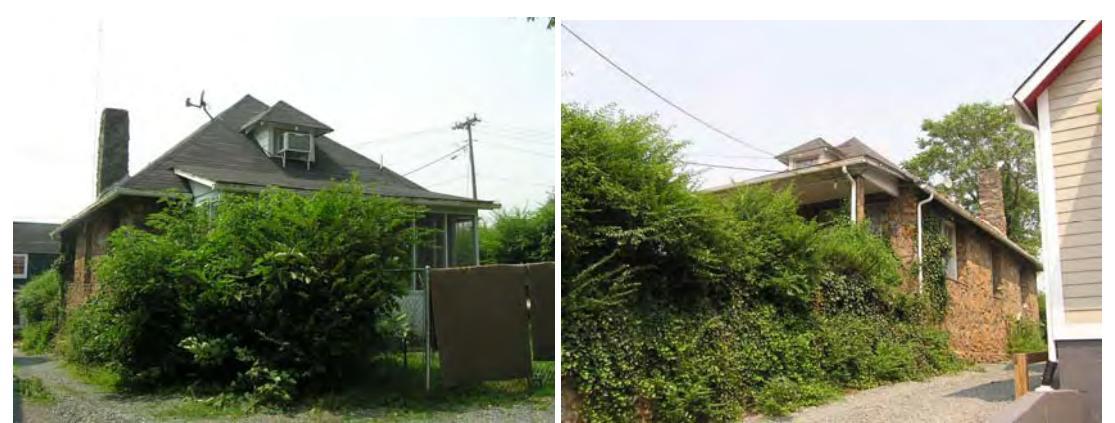
Primary Resource Information: Single Dwelling, Stories 1.50, Style: Bungalow/Craftsman, ca 1925

July 2006: This ca. 1925, 1¹/₂-story, 3-bay, Craftsman bungalow is of stone construction and features a hipped roof clad in asphalt shingles with a front and rear hip-roofed attic dormers that contain 6-light attic windows. Architectural details include single and paired 2/2 sash windows, overhanging eaves, exposed rafter ends, 3-light basement windows, concrete sills, and a large interior stone chimney on the south side that pierces through the eaves. A 3-bay, shed-roofed front porch features square stone posts and the rear shedroofed porch is screened in.

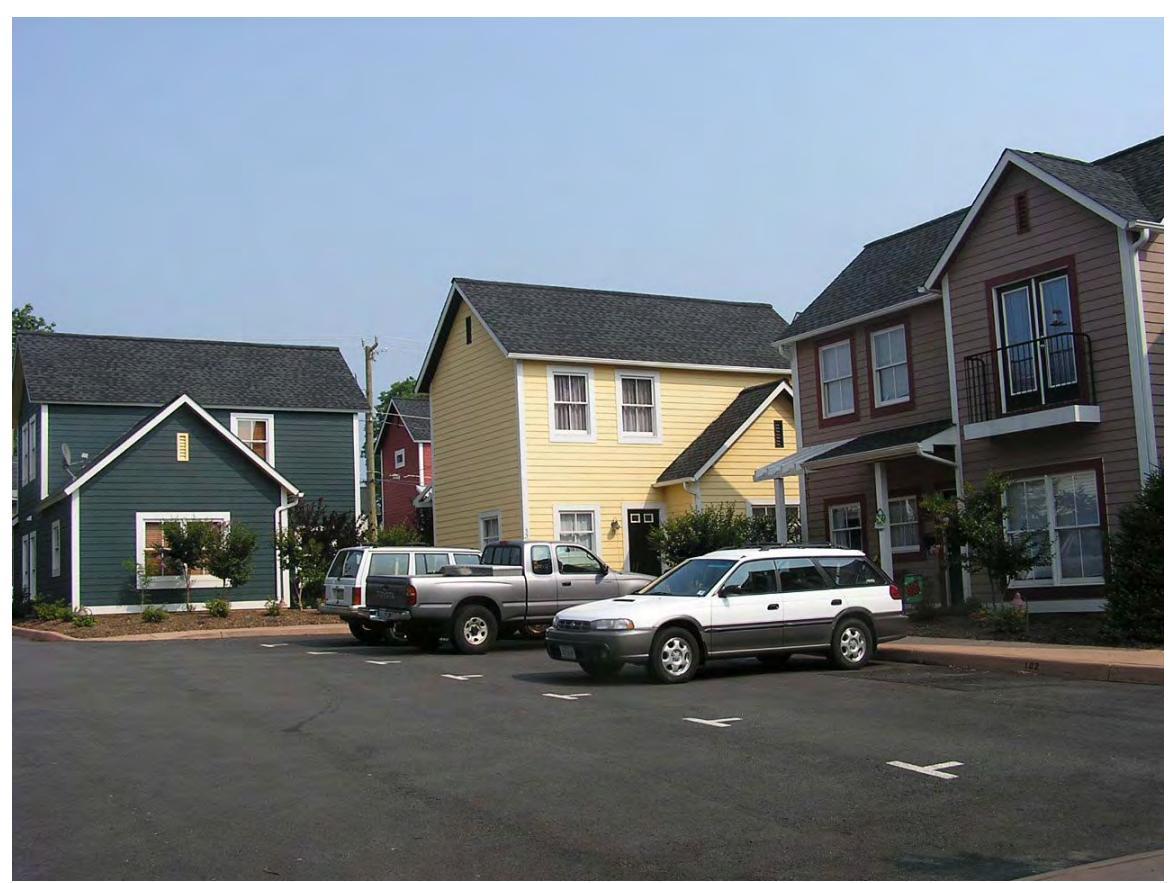
Primary Resource Information: **Single Dwelling, Stories 2.00, Style: Other, 2005** July 2006: Constructed in 2005, these six similar, 2-story, cross-gable-roofed frame cottages feature a projecting front cross gable. Very similar in design, they are clad in Hardi-plank siding, roofed in asphalt shingles, and feature overhanging eaves, vinyl 2/2sash windows, and shed-roofed hoods supported by wooden brackets over the front entries. They are similar to the set of cottages on the other side of 5th Street.

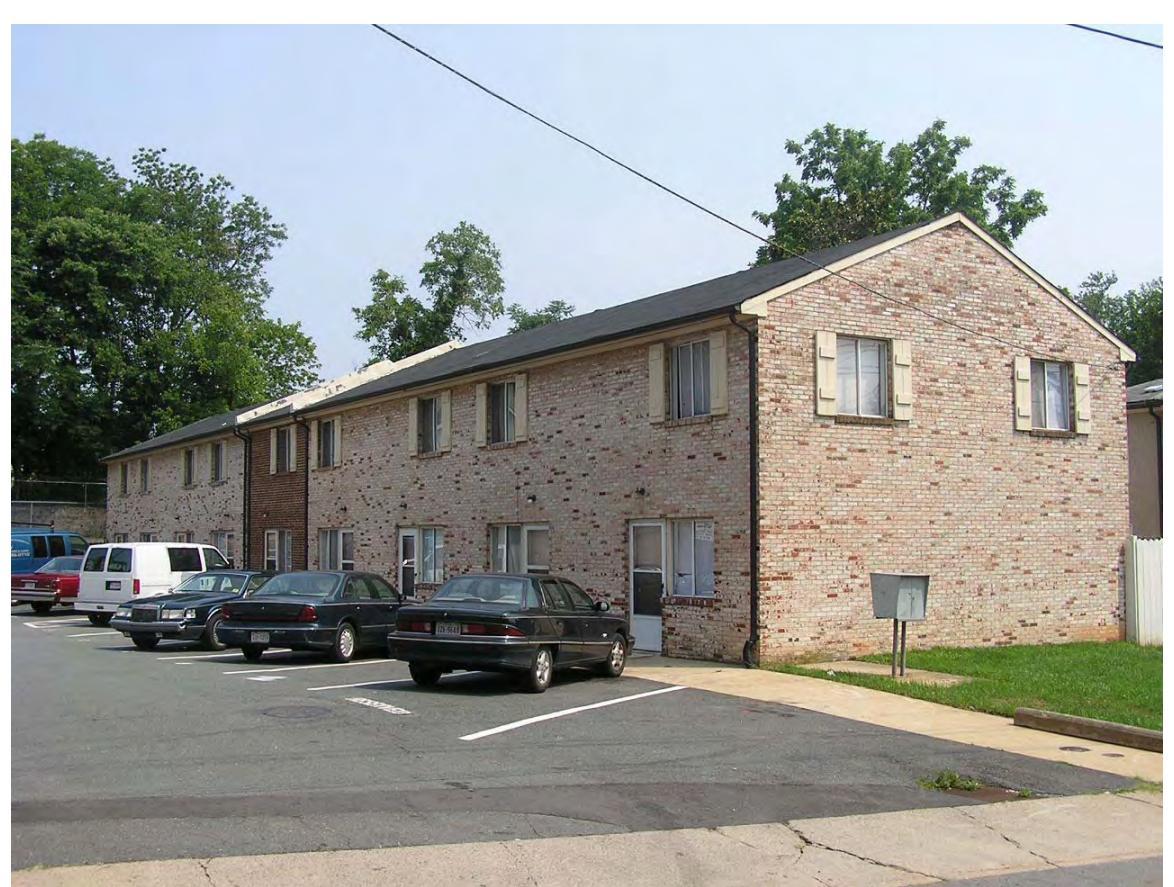
Primary Resource Information: Multiple Dwelling, Stories 2.00, Style: Other, ca. 1972

July 2006: Constructed in 1972, this 2-story, 9-bay, gable-roofed building contains nine townhouse units. Each is marked by a door and window bay and they open up to the parking area along the north side of the building. The walls are brick-veneered and the roof is clad in asphalt shingles. The 1x1 windows are sliding metal casements.

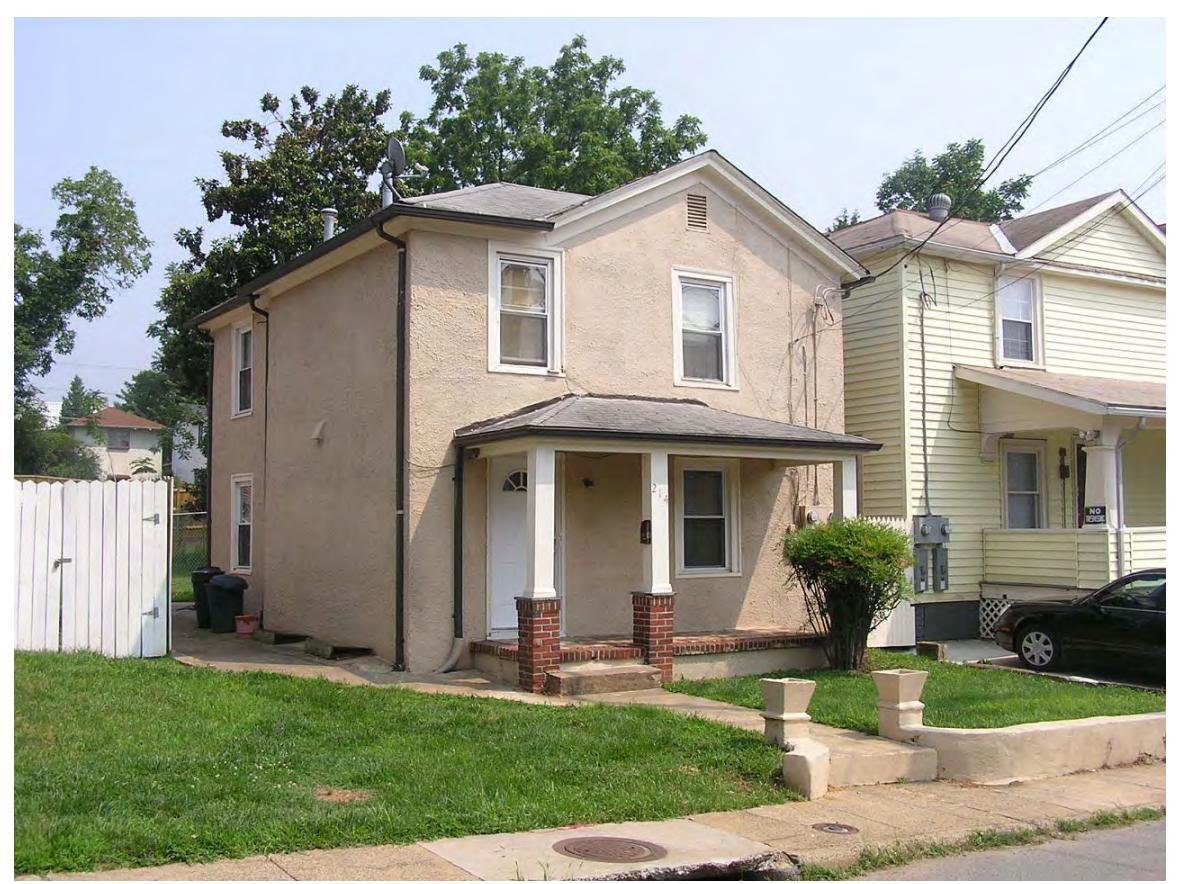
Primary Resource Information: Single Dwelling, Stories 2.00, Style: Other, ca 1915
July 2006: This 2-story, 2-bay, side-passage-plan, vernacular dwelling features a hipped roof with a front cross gable and was constructed ca. 1915. The frame walls are clad in stucco and the roof is covered in asphalt shingles. Architectural details include a louvered attic vent, overhanging eaves, plain friezeboard, and 2-bay hip-roofed front porch with square posts on brick piers and a brick porch floor. The 1/1-sash vinyl windows and metal front door are modern alterations. A 2-story, shed-roofed wing extends to the rear. Individual Resource Status: Single Dwelling Contributing Total:1

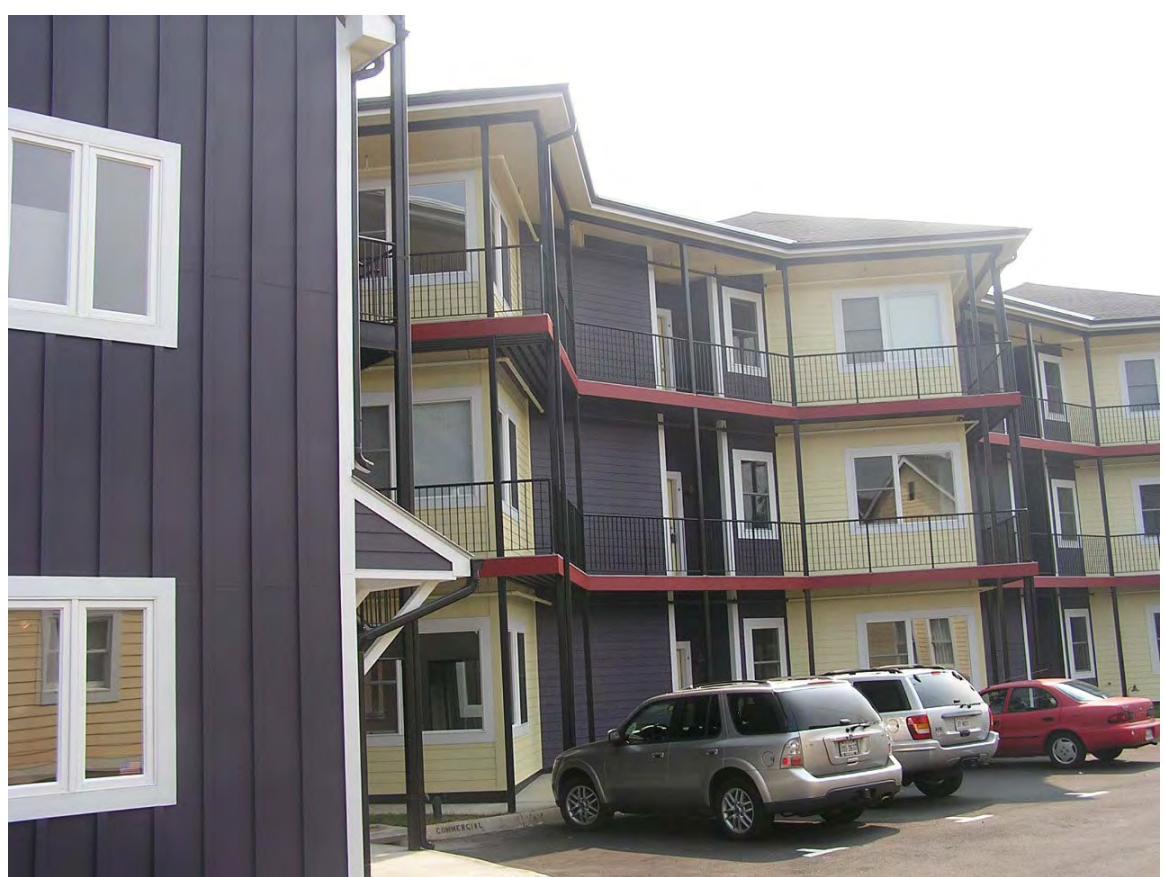
Primary Resource Information: Mixed:Commerce/Domestic, Stories 3.00, Style: Other, 2006

July 2006: This 3-story, gable and hip-roofed modern building has a commercial use on the first floor and condos on the upper floors. Three levels of metal balconies run along the zig-zag-shaped north façade. The building, which is clad in Hardi-plank board-and-batten, is painted purple, and was constructed in 2006.

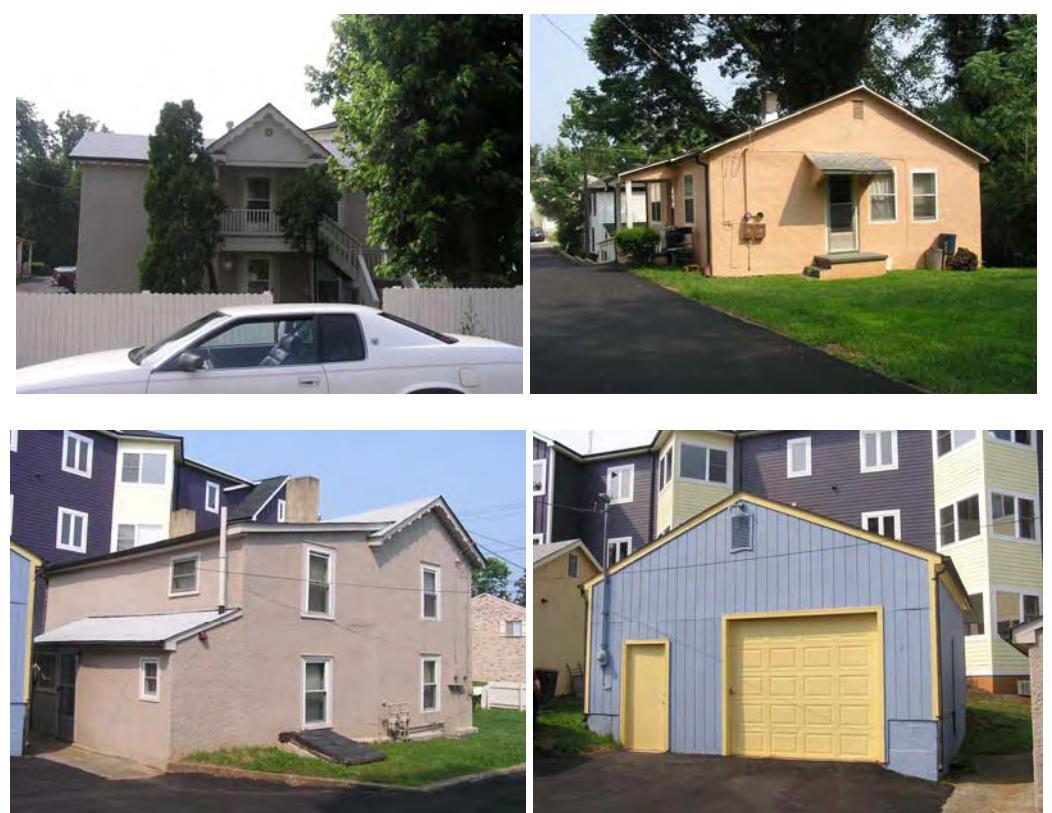
Primary Resource Information: **Single Dwelling**, **Stories 2.00**, **Style: Other, ca 1860** July 2006: This 2-story, 3-bay, gable-roofed, stuccoed vernacular dwelling features a 2story, bi-level, pedimented entrance porch with decorative vergeboard. Believed to have been constructed ca. 1854-1864 by John T. Barksdale the single-pile symmetrical dwelling rests on a low foundation and has an asphalt shingled roof. The deeply overhanging eaves have a scalloped vergeboard on all sides. To the rear are a 2-story shed-roofed wing with a central brick flue and a rear 1-story shed-roofed wing. The 2story, 1-bay front porch has square supports and a modern exterior stair allowing for access to the second-floor central door and porch. All the 2/2-sash windows have been replaced with modern 1/1-sash.

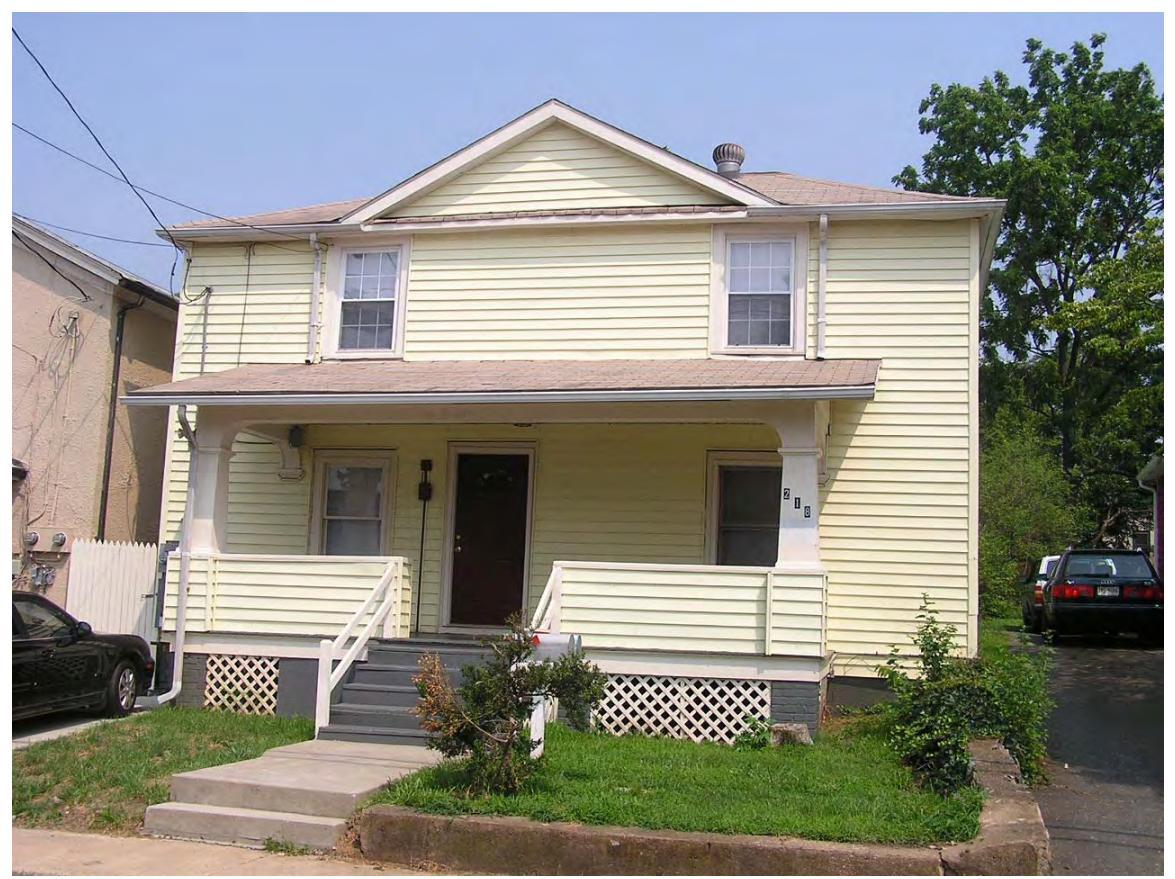
Primary Resource Information: **Single Dwelling**, **Stories 2.00**, **Style: Other, ca 1915** July 2006: This 2-story, 3-bay, hip-roofed, asymmetrical vernacular dwelling features a central pedimented front gable. The house rests on a parged foundation with vinyl siding and asphalt shingle roofing. The 1/1-sash and 6/6-sash vinyl windows are modern. The 1-bay shed-roofed front porch has battered square posts on vinyl-covered piers and a solid vinyl balustrade. The porch has a segmental-arched bay and is supported on a brick pier foundation with lattice between. Other details include overhanging eaves, and a rear partially enclosed rear porch.

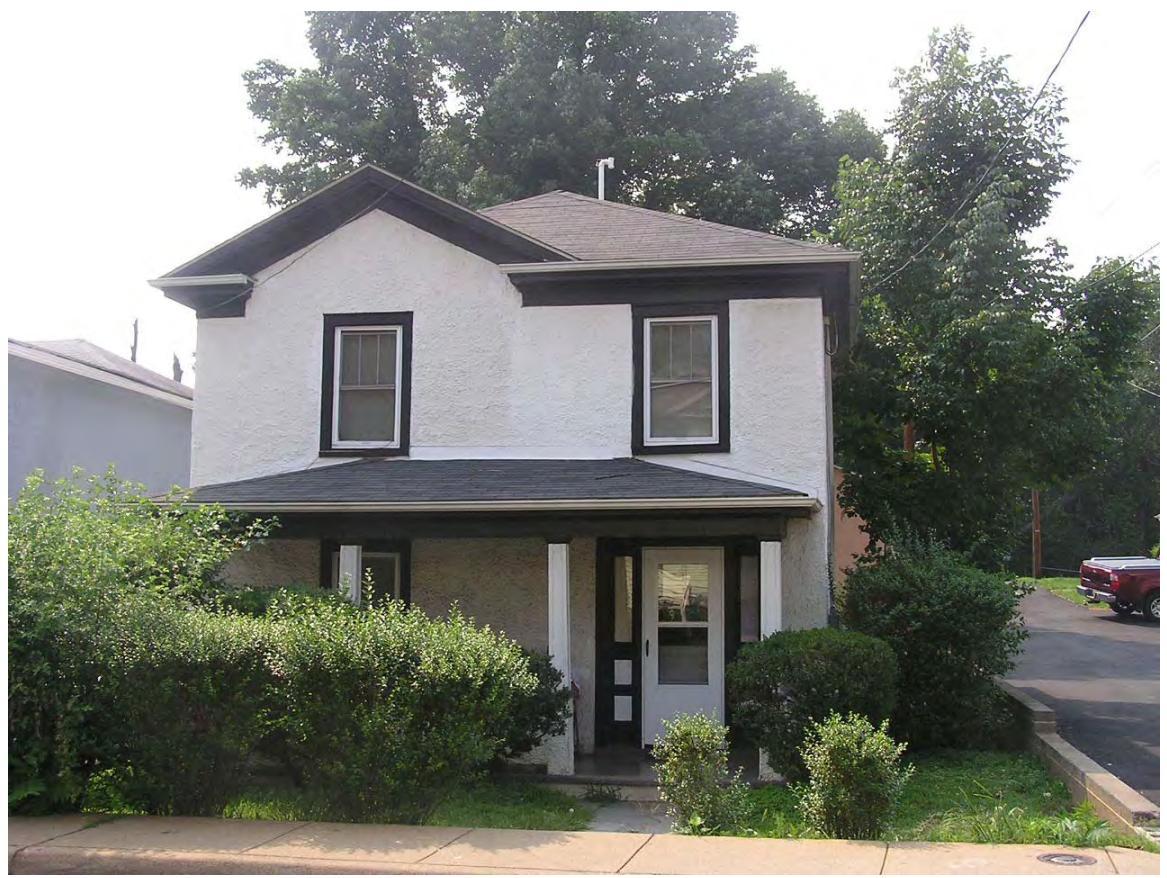
Primary Resource Information: Single Dwelling, Stories 2.00, Style: Other, ca 1900 July 2006: This 2-story, 2-bay, side-passage-plan, vernacular dwelling features a hipped roof with a front cross gable and was constructed ca. 1900. The frame walls are clad in stucco and the roof is covered in asphalt shingles. Architectural details include overhanging eaves, a plain friezeboard, gable-end returns, sidelights around the front door, 4/1-sash windows, and a 3-bay hip-roofed front porch with square posts on stuccoed square piers. A 1-story, shed-roofed enclosed porch is located in the rear. Individual Resource Status: Single Dwelling Contributing Total:1

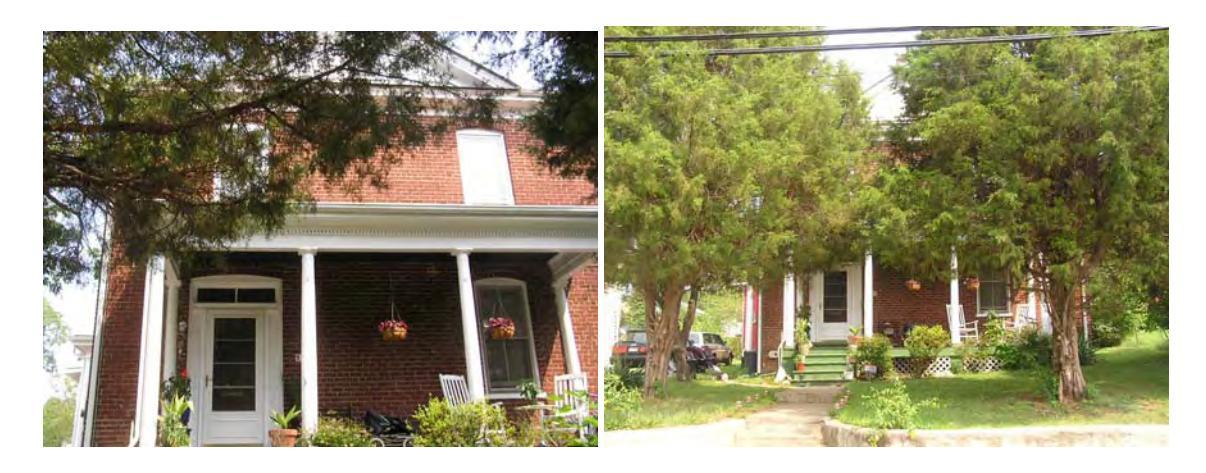
Primary Resource Information: **Single Dwelling**, **Stories 2.00**, **Style: Other, ca 1900** July 2006: This 2-story, 2-bay, side-passage-plan vernacular brick dwelling is laid in 7-course American bond and features a hipped roof with lower cross gables and a rear gable dormer. The well-preserved Victorian-detailed dwelling, constructed ca. 1900, features penciled mortar joints under the porch, a low brick foundation, a 2-light transom with a segmental arch over the front door, basement windows, and a central-front gable with wooden fishscale shingles and an attic window. The 3-bay, hip-roofed front porch has Tuscan column supports and a denticulated cornice. Other architectural details include a large central brick chimney that has been partially parged, a plain wooden frieze, overhanging eaves, wooden shingles and a 4-light attic window in the side cross gable, and a wraparound, partially enclosed side and rear 1-story porch.

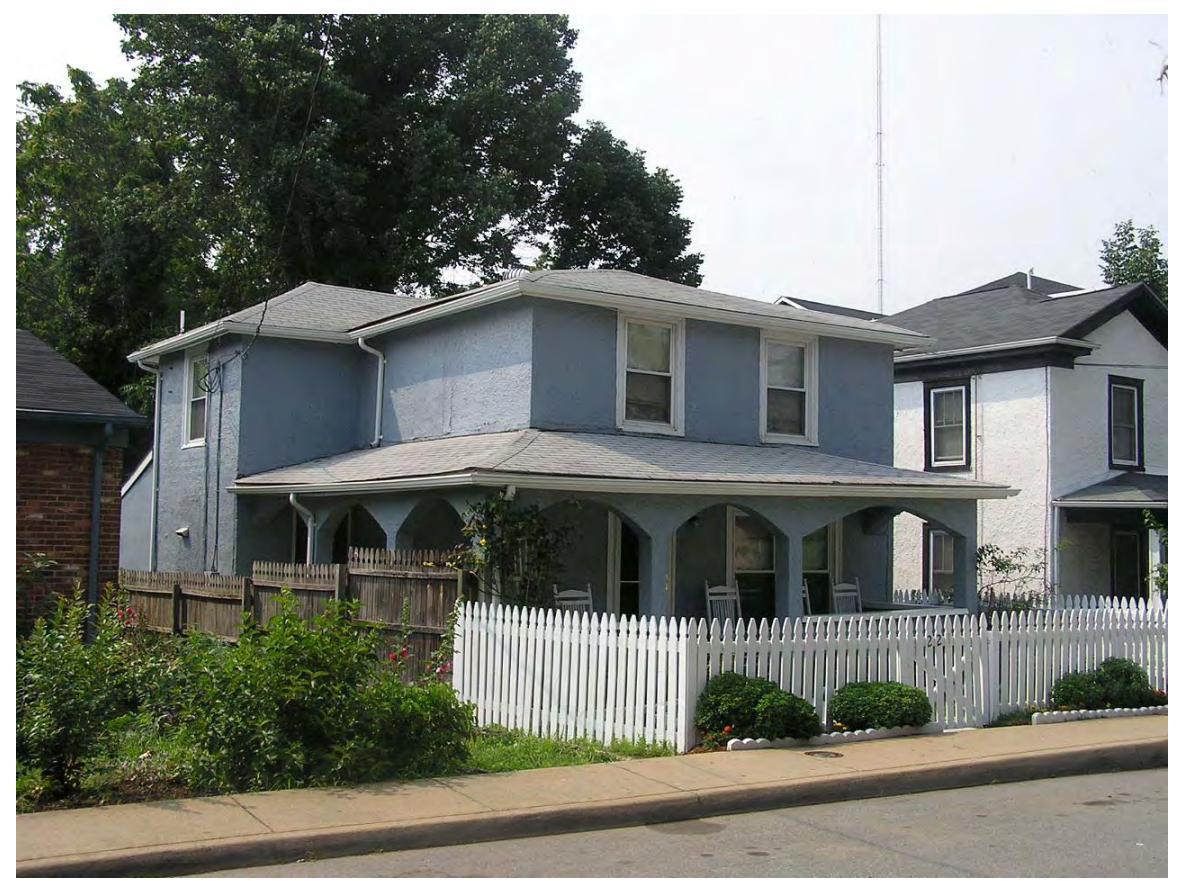
Primary Resource Information: **Single Dwelling**, **Stories 2.00**, **Style: Other, ca 1900** July 2006: This 2-story, 2-bay, side-passage-plan, vernacular dwelling features a hipped roof with a 7-bay wraparound front porch. Constructed ca. 1900, the frame walls are clad in stucco and the roof is covered in asphalt shingles. Architectural details include overhanging eaves, modern 1/1 windows, a rear cross-hipped wing with an enclosed shed-roofed porch and modern rear deck. The 7-bay porch features stuccoed posts and round-arched stuccoed bays.
