307¹/₂ 5th Street SW 104-0213-0181

308 5th Street SW 104-0213-0164

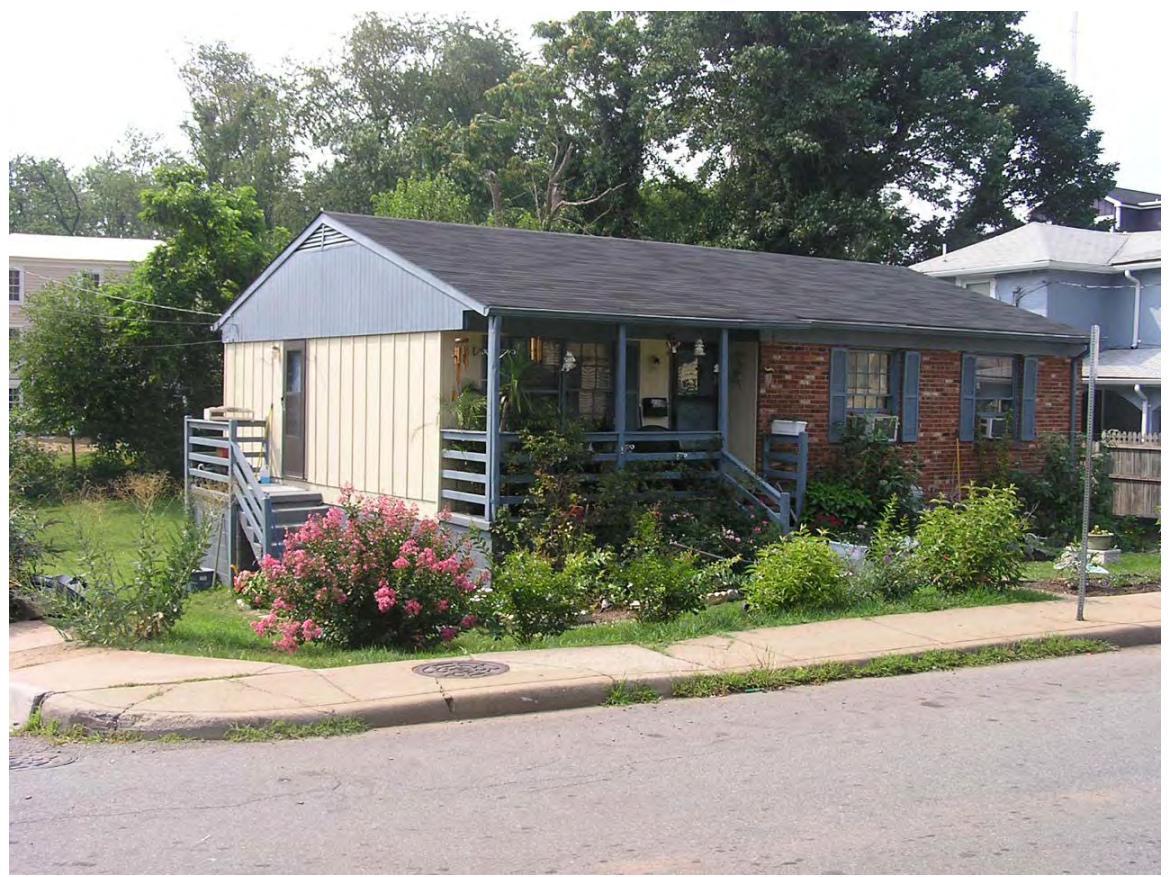
Primary Resource Information: **Single Dwelling**, **Stories 1.00**, **Style: Other, ca. 1973** July 2006: This 1-story, 4-bay, gable-roofed, brick and board-and-batten vernacular dwelling was constructed in 1973 and features 8/8-sash windows, Texture T-111 siding in the gable ends, and an integral 3-bay front porch.

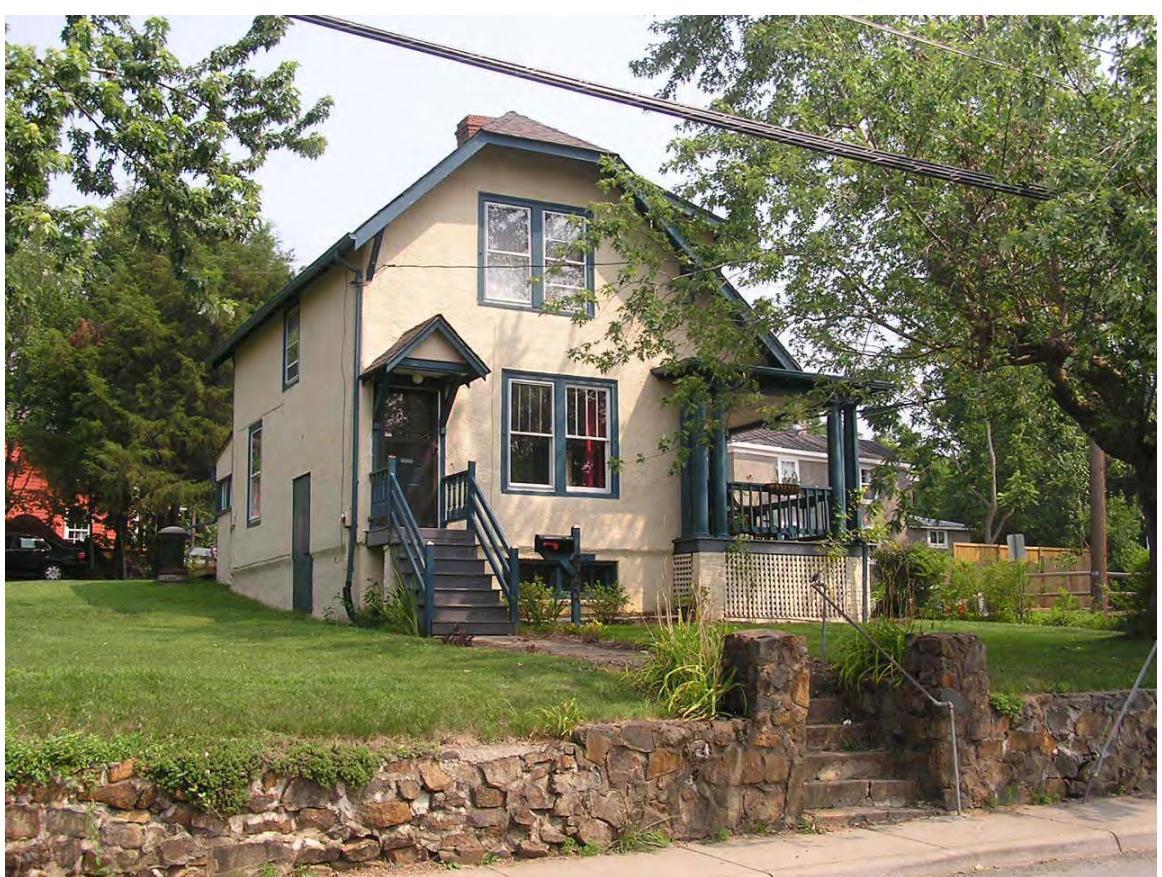
Primary Resource Information: Single Dwelling, Stories 1.50, Style: Colonial Revival, ca 1925

July 2006: This eclectic 1¹/₂-story, 2-bay stuccoed bungalow has a jerkinhead roof with a large shed-roofed side dormer. Constructed ca. 1925, the frame walls are clad in stucco, the foundation is parged, and the roof covered in asphalt shingles. Architectural details include single and paired 4/1 windows, wooden triangular brackets supporting the overhanging eaves, exposed rafter ends, 3-light basement windows, a gable-hood entry supported by triangular brackets, and a partially engaged corner porch with triple Tuscan column supports and a modern wooden railing.

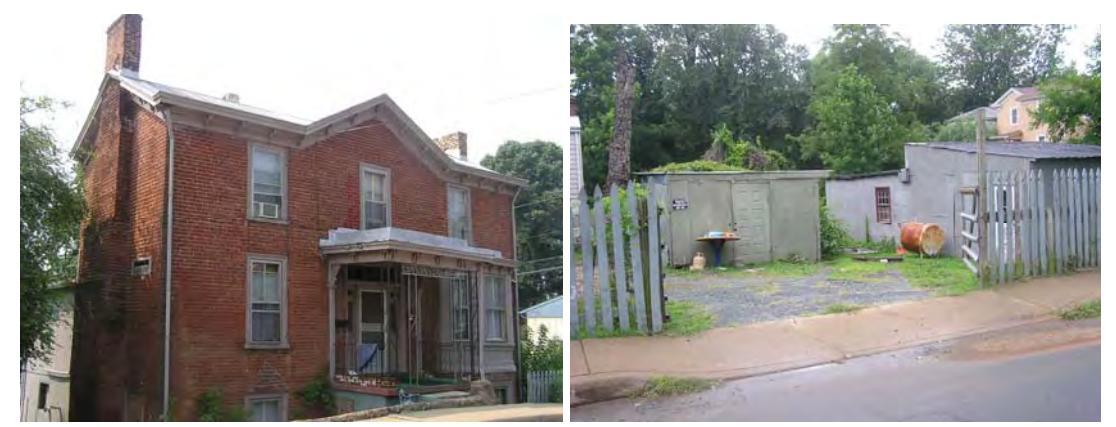
Primary Resource Information: **Single Dwelling**, **Stories 2.00**, **Style: Other, ca. 1870** July 2006: This 2-story, 3-bay, brick I-house with a central-front gable is believed to have been constructed before 1876 when it was sold by John N. Fry to John and Rebecca Shelton, who were living in the house at that time. Architecturally the house appears to have been constructed ca. 1870. The front brick walls are laid in a 7-course-American-with-Flemish-bond and the side and rear brick walls and foundation in 7-course American bond. A Victorian interpretation of a vernacular I-house, the dwelling features a bellcast gabled roof of standing-seam metal, deeply overhanging bracketed eaves, and a projecting polygonal bay window on a brick foundation. The bay window and the 1-bay front porch, which has modern metal supports and a bracketed cornice, both have Mansard roofs. The 2/2-sash windows, two semi-exterior-end brick chimneys that break through the eaves, the 5-light transom and 3-light sidelight around the front door and the basement windows all appear original. A 1-story frame wing on raised basement extends the full width of the rear of the house and appears to have been constructed in several sections.

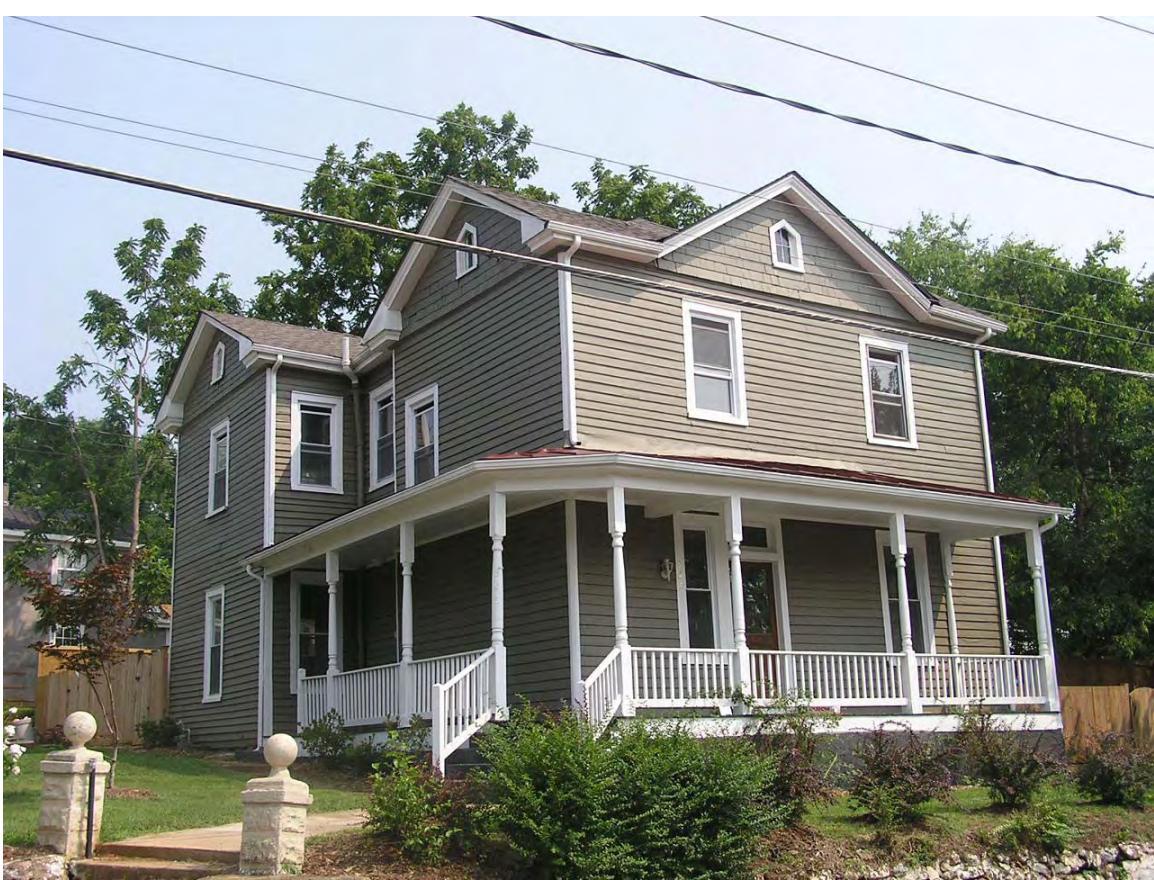
Primary Resource Information: **Single Dwelling**, **Stories 2.00**, **Style: Other, ca 1895** July 2006: This large, rambling, 2-story, 2-bay, Victorian dwelling features a hipped roof with lower cross gables and appears to have been recently renovated. All the 1/1-sash windows as well as the full-light doors are modern replacements. The roof has been covered in asphalt shingles and the chimneys removed. The brick foundation, overhanging eaves, gable-end returns, weatherboarded exterior walls with corner boards, and square wooden shingles and Gothic-arched attic windows in the gable ends appear original. The house features a 7-bay wraparound porch with a corner entry, turned posts and plain pickets. The 2-story cross-gable-roofed rear wing has similar detailing to the front portion.

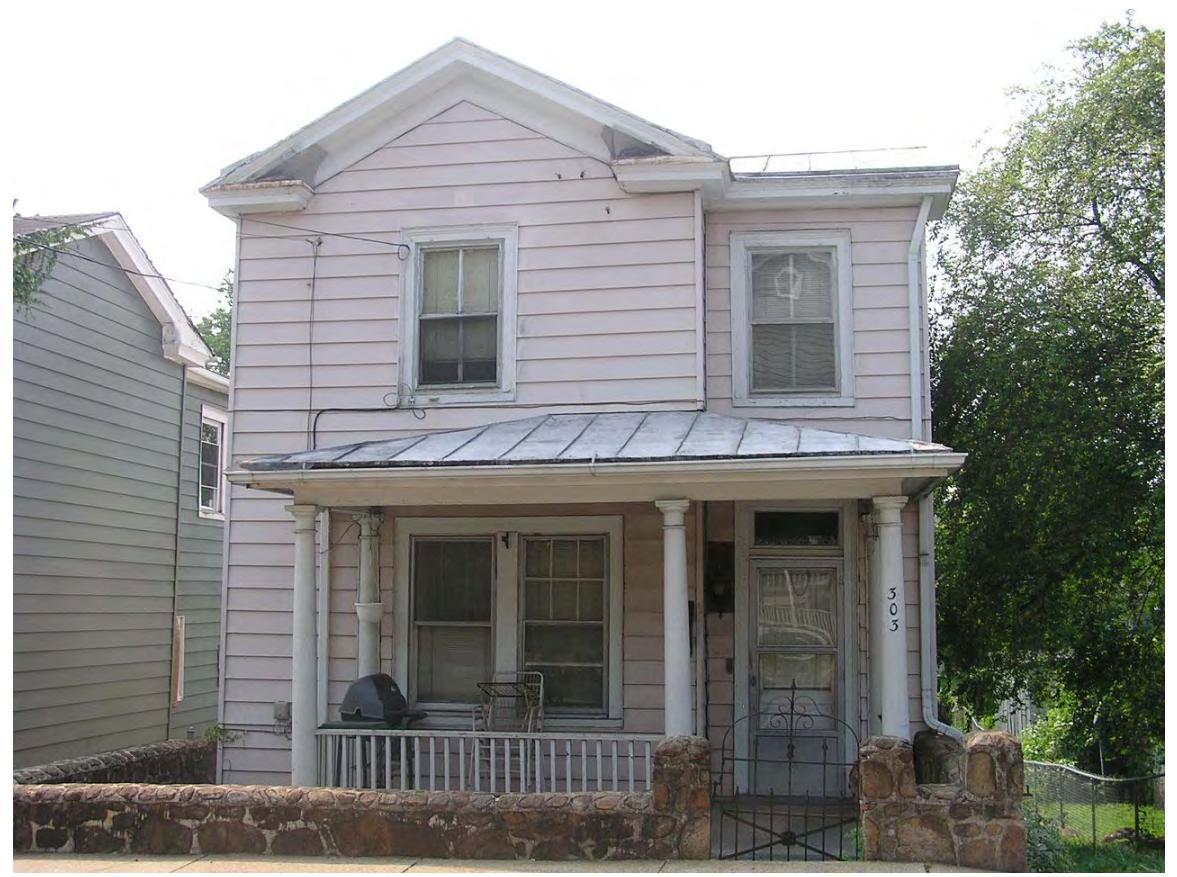
Primary Resource Information: **Single Dwelling**, **Stories 2.00**, **Style: Other, ca 1895** July 2006: This 1890s, 2-story, 2-bay, cross-gable-roofed, side-passage-plan, vernacular frame dwelling features a projecting front cross gable. The roof is clad in standing-seam metal while the walls have been covered with aluminum siding. Because of the sloped site, the parged foundation is split-level. A parged chimney toward the rear of the building was observed. The 2/2-sash windows, plain friezeboard, gable-end returns, front-entry transom, and 2-bay front porch with Tuscan columns and plain balustrade appear original. To the rear is a 1-story wing.

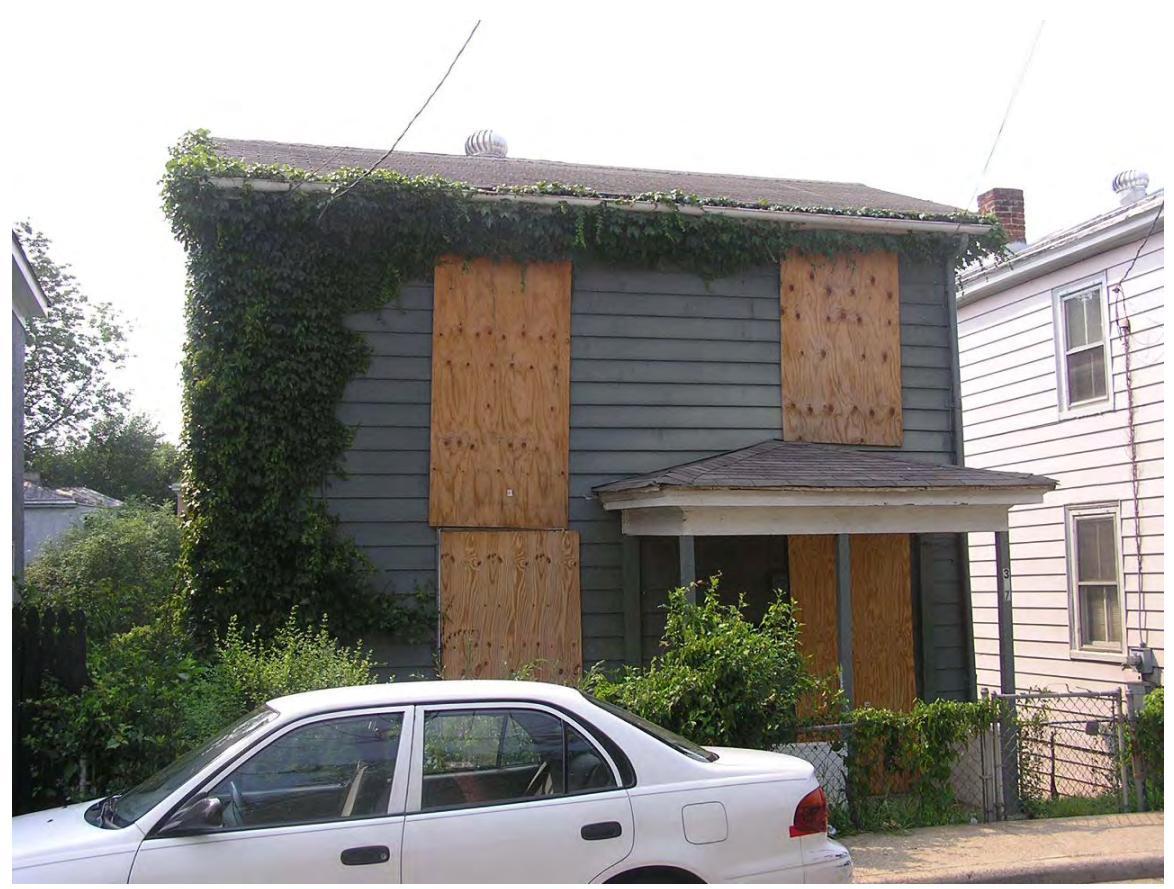
Primary Resource Information: **Single Dwelling**, **Stories 2.00**, **Style: Other, ca 1900** July 2006: This ca. 1900, 2-story, 2-bay, gable-roofed side-passage-plan dwelling is currently vacant and boarded up. The walls are clad in aluminum siding, the roof is covered in asphalt shingles, the cornices have gable-end returns, and a transom is located above the front door. The windows and doors have been covered in plyboard. A 2-story wing extends to the rear. The 2-bay, hip-roofed front porch has square posts and a solid concrete balustrade that extends beyond the porch roof.

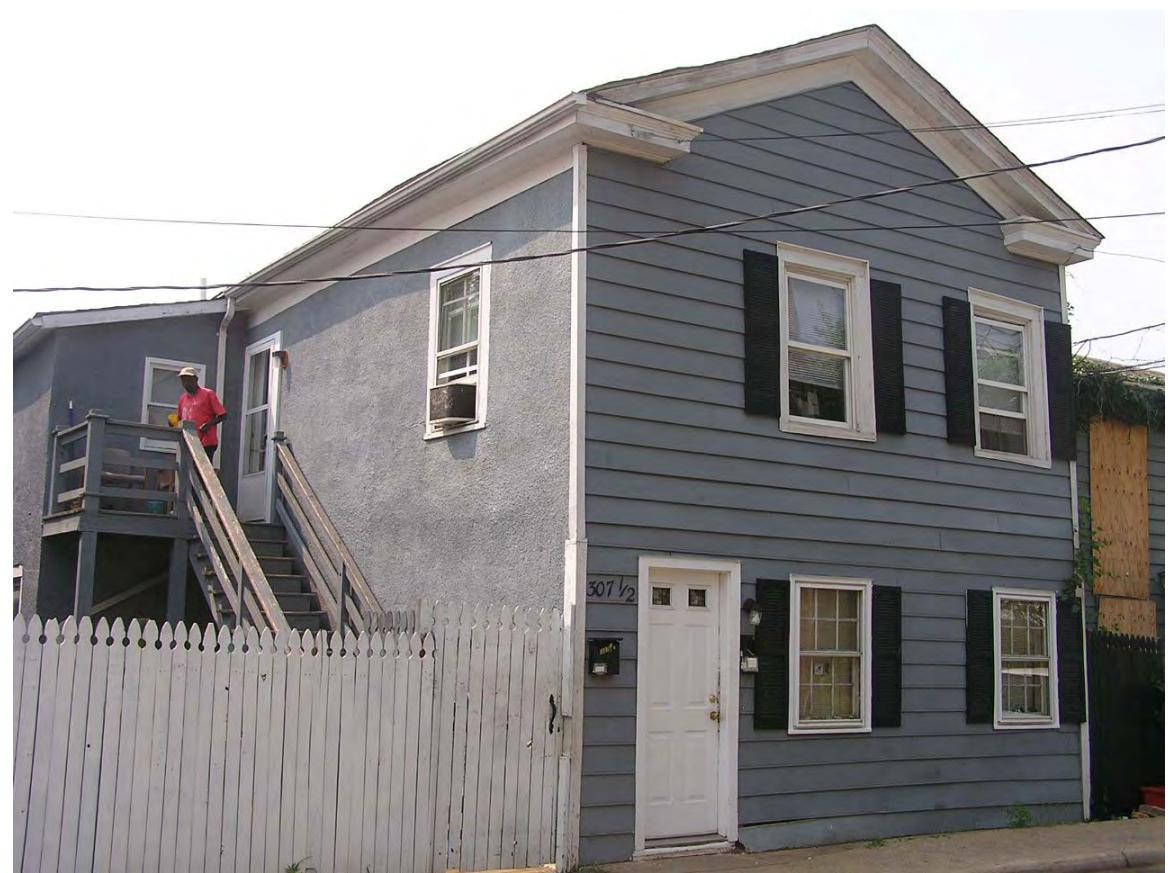
Primary Resource Information: Mixed:Commerce/Domestic, Stories 2.00, Style: Other, ca 1900

July 2006: This ca. 1900, 2-story, 3-bay, gable-end frame building is clad in aluminum siding on the façade and stucco on the sides and rear. The windows and door on the first floor are all modern replacements and suggest that the front originally had a storefront or some other type of opening. The gable-end front features gable-end returns and a boxed cornice. The side elevation shows a plain frieze and original 2/2-sash windows. To the rear is a 2-story shed-roofed wing with a set of modern exterior stairs leading to a second-story apartment.

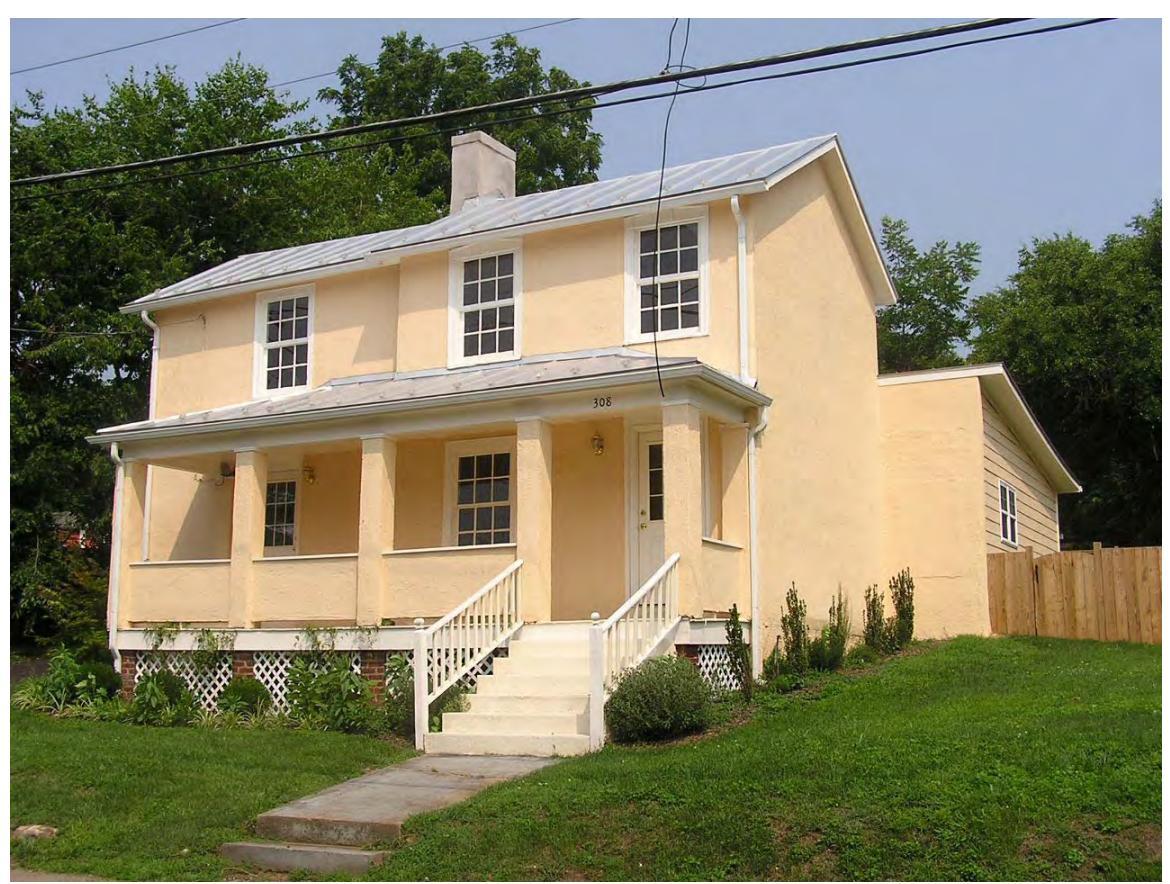
Primary Resource Information: Single Dwelling, Stories 2.00, Style: Other, ca 1890 July 2006: This late-19th-century, 2-story, gable-roofed dwelling is one of three almost identical houses sited next to each other on 5th Street. They are comprised of a 2-bay main block with an exterior-end brick chimney and have a slightly recessed, 1-bay, 1- or 2-story side wing off the side with the chimney. This house is clad in stucco, roofed in standing seam metal, and features overhanging eaves, 6/6-sash windows, and multiple rear 1-story wings. The 4-bay hip-roofed front porch, which has stuccoed square posts, a solid balustrade, and wooden steps and handrail, unites both front sections of the house. Individual Resource Status: Single Dwelling Contributing Total:1

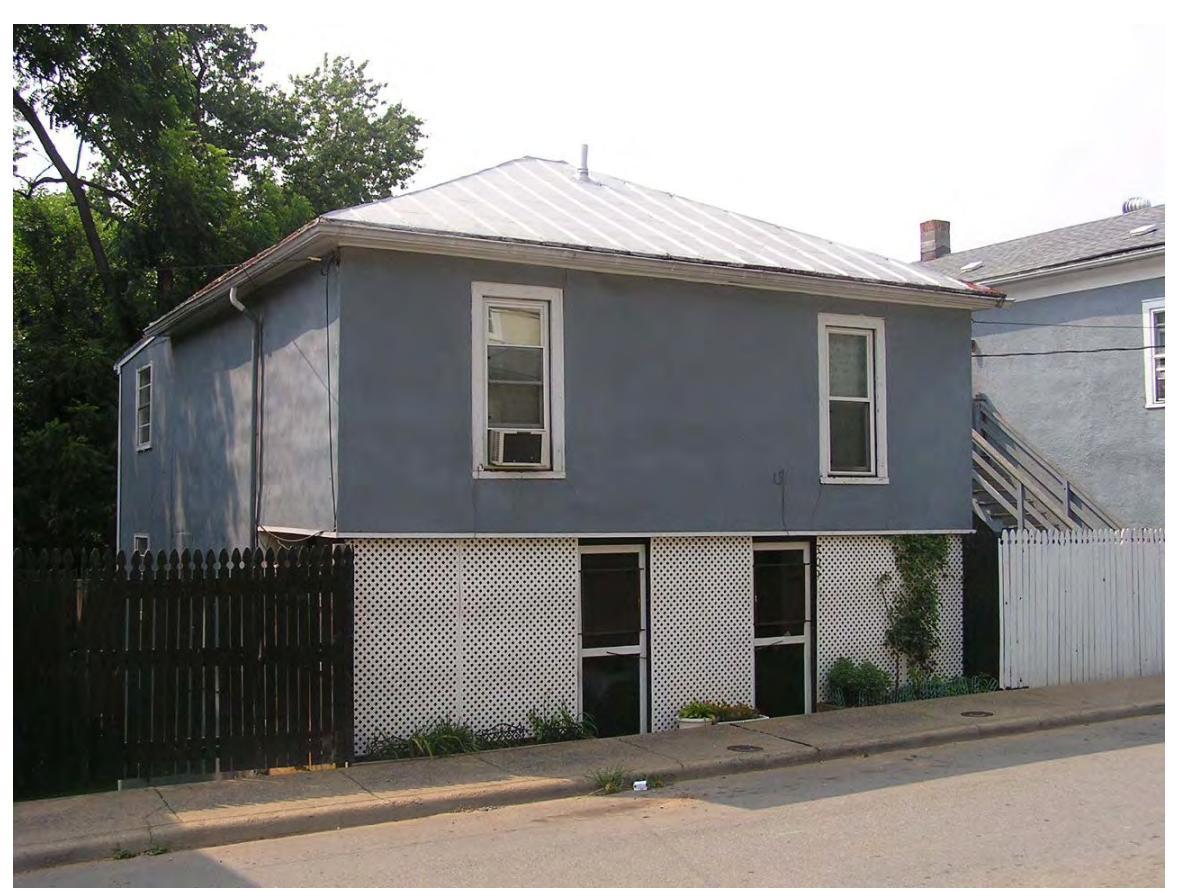
Primary Resource Information: **Single Dwelling**, **Stories 2.00**, **Style: Other, ca 1900** July 2006: This 2-story, 2-bay hip-roofed vernacular dwelling has a cantilevered second floor over an enclosed first floor porch that has two doors and lattice-covered walls. The second floor is clad in stucco and the roof with overhanging eaves is covered in standing-seam metal. The 1/1 windows are modern and the house appears to have a 2-story rear lean-to addition.

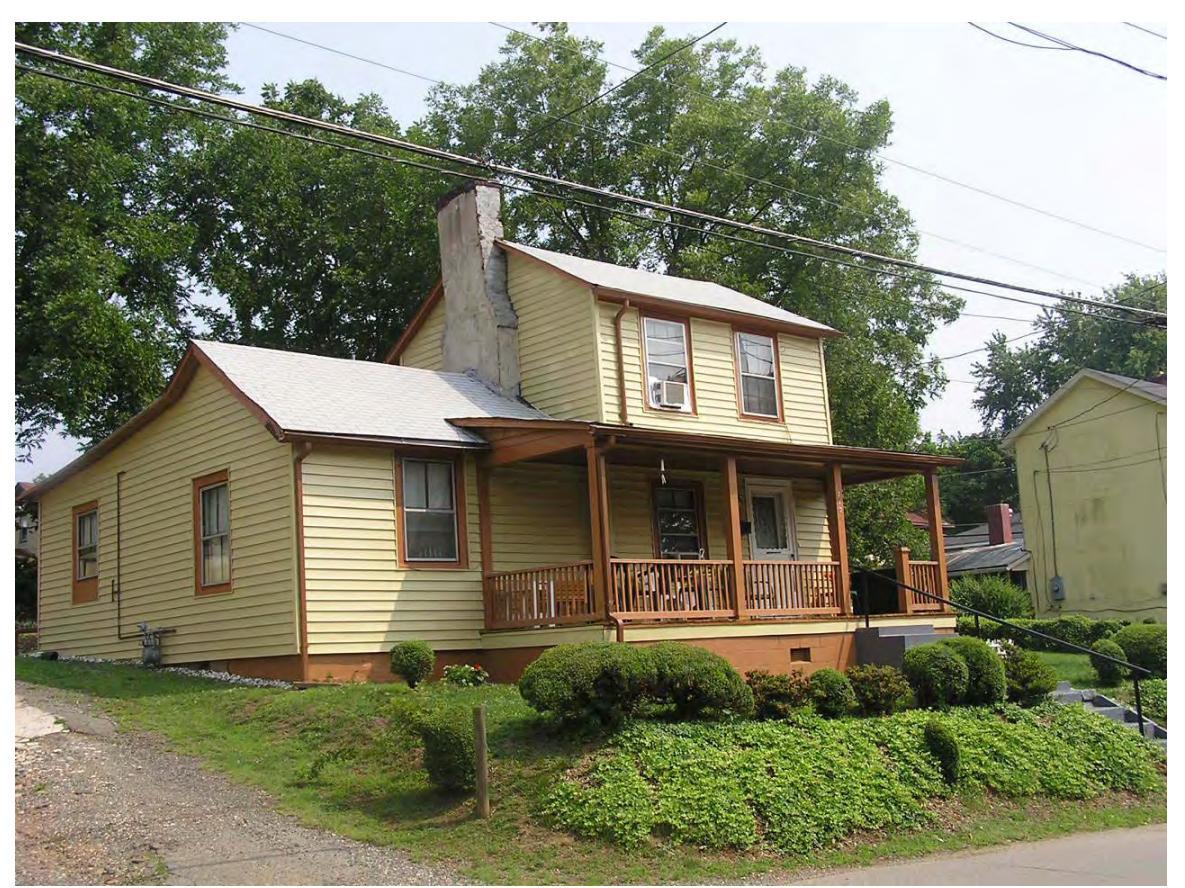
Primary Resource Information: **Single Dwelling**, **Stories 2.00**, **Style: Other, ca 1890** July 2006: This late-19th-century, 2-story, gable-roofed dwelling is one of three almost identical houses sited next to each other on 5th Street. They are comprised of a 2-bay main block with an exterior-end brick chimney and have a slightly recessed, 1-bay side wing off the side with the chimney. This house is the only one of the three with a 1-story side wing: the others have a 2-story side wing. This house, clad in vinyl siding with an asphalt shingled roof, features a parged brick chimney, overhanging eaves, 6/6-sash windows, and multiple rear 1-story wings. The 4-bay hip-roofed front porch, which has square posts, a plain balustrade, and concrete steps, unites both front sections of the house.

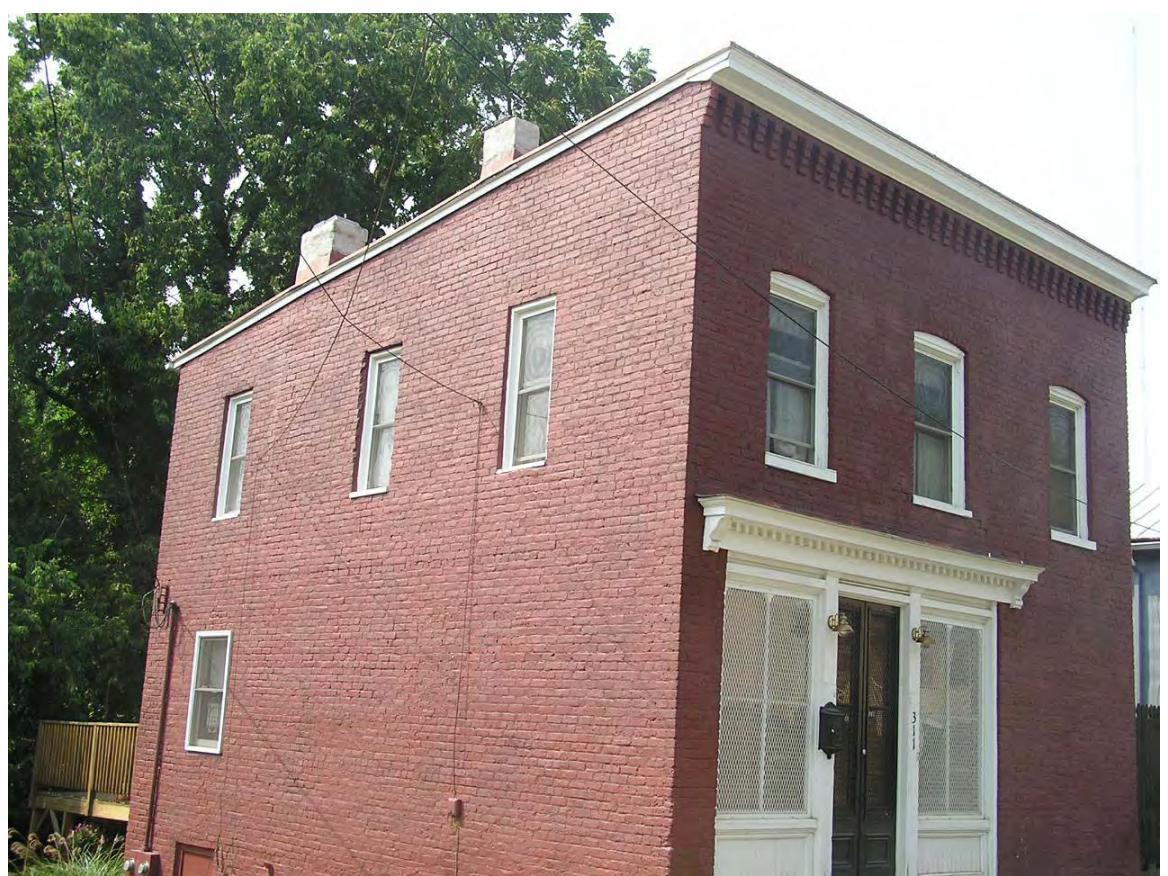
Primary Resource Information: Mixed:Commerce/Domestic, Stories 2.00, Style: Other, ca 1900

July 2006: This 2-story, 3-bay, shed-roofed brick building was constructed at the turn-ofthe century. Commercial use was on the first floor and living space on the second, as was common with many commercial buildings of this era in urban areas. The three-part wooden storefront topped by a denticulated and bracketed entablature is intact and is comprised of large, fixed, 4-light, wood windows over paneled reveals flanking a doubleleaf, wood and glass door. The second floor facade is comprised of three, unevenly spaced, 1/1-sash windows with segmental arches. Two of the windows are centered above the storefront and the third is centered above the blank wall on the first floor, which may have at one time contained a door leading to a second-story stair. The building also features a corbelled brick cornice with overhanging wood entablature, a shed roof, a split-level brick foundation, two interior brick chimneys, and a modern rear deck. The building is now only used residentially.

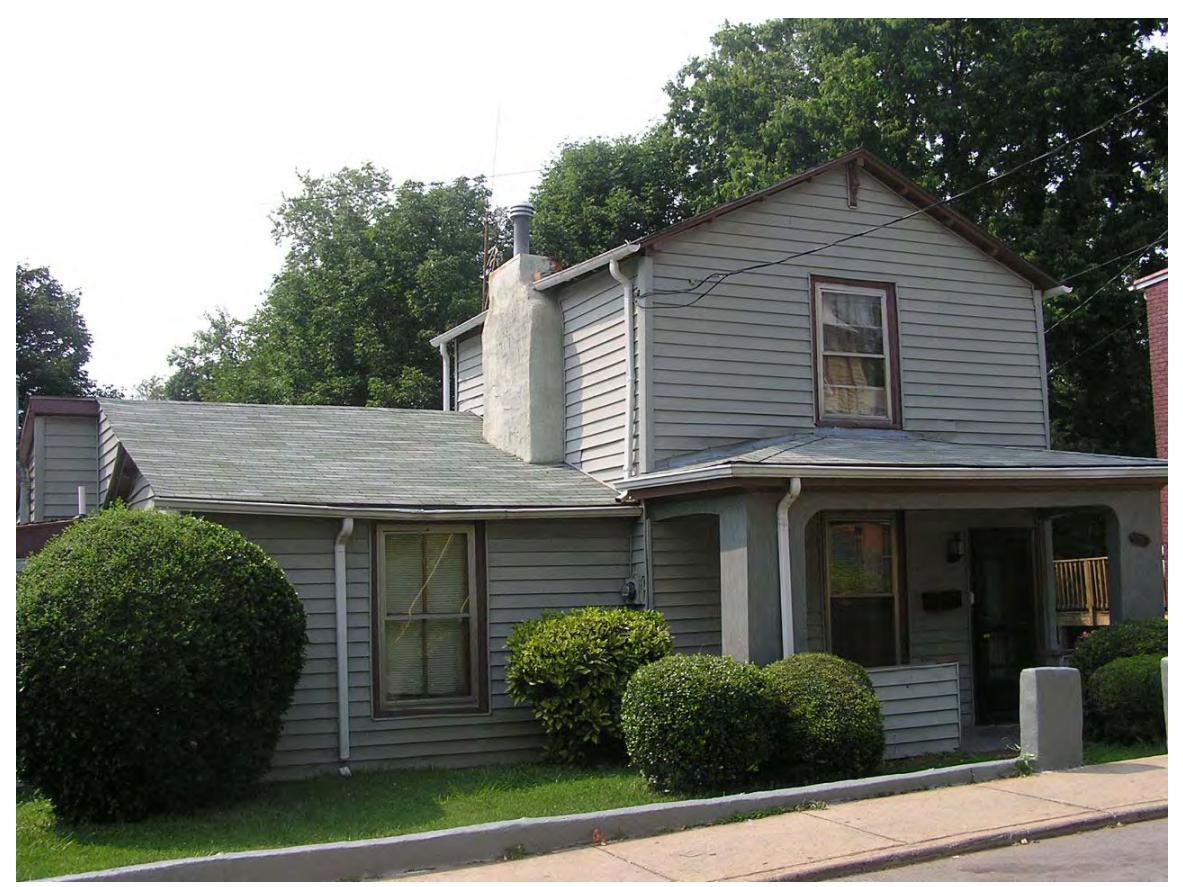
Primary Resource Information: **Single Dwelling**, **Stories 2.00**, **Style: Other**, **ca 1895** July 2006: This late-19th-century, 2-story, gable-end dwelling is one of three almost identical houses sited next to each other on 5th Street and is the best preserved. They are comprised of a 2-bay, gable-end main block with an exterior side brick chimney and each has a slightly recessed, 1-bay side wing off the side with the chimney. The wing has a side gable roof. This house is one of two with a 1-story side wing: the other has a 2-story side wing. The second floor has only a one bay, which is centered in the gable end and is located above the first-floor window. Clad in vinyl siding with an asphalt-shingled roof, the house features a parged brick chimney, overhanging eaves, 2/2-sash wood windows, exposed rafter and purlin ends, a Craftsman-style door, a scroll bracket in the front gable end, and a side 1-story gable-roofed wing with a side wing. The 1-bay hip-roofed front porch, which has rectangular stuccoed posts, a solid balustrade, and a round-arched bay, runs the full width of the main block.

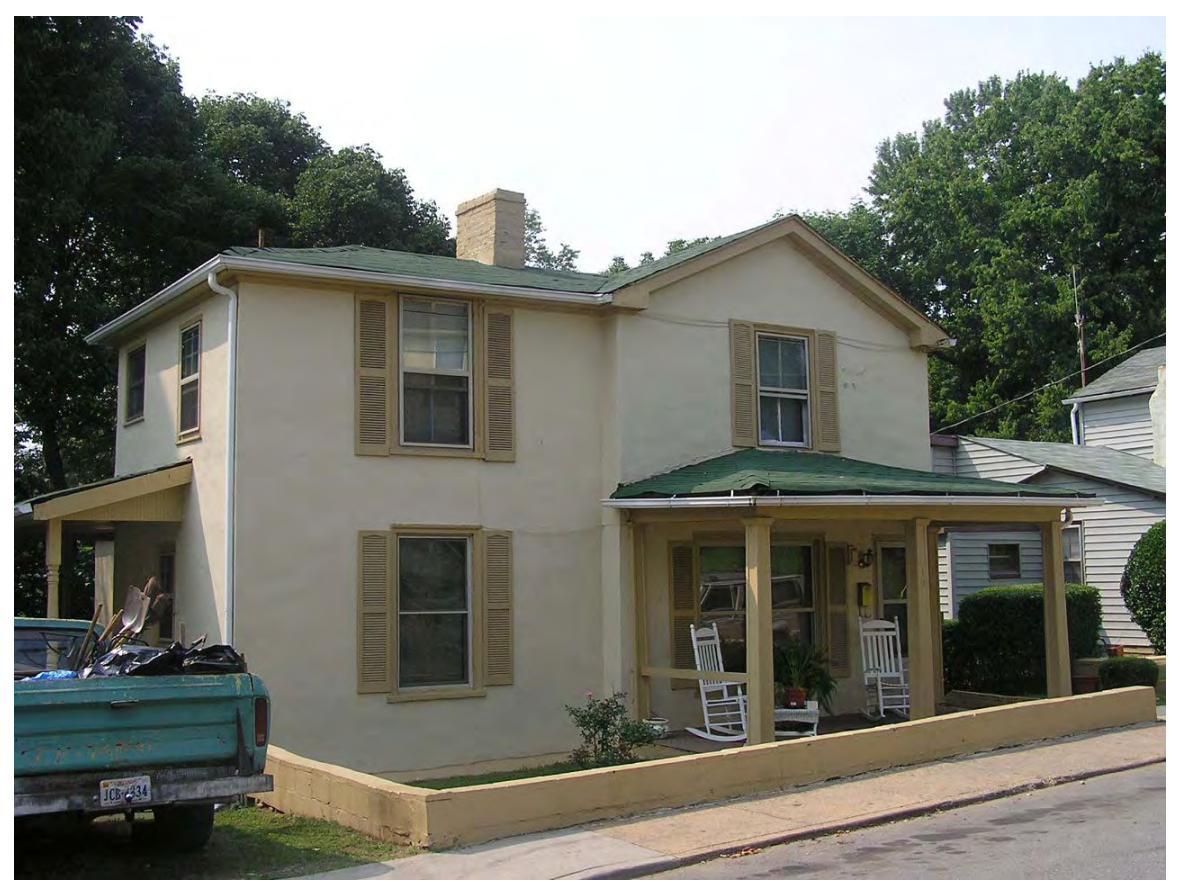
Primary Resource Information: **Single Dwelling**, **Stories 2.00**, **Style: Other, ca 1900** July 2006: This late-19th-century, 2-story, gable-end dwelling is one of three almost identical houses sited next to each other on 5th Street. They are comprised of a 2-bay, gable-end main block with an exterior side brick chimney and each has a slightly recessed, 1-bay side wing off the side with the chimney. The wing has a side gable roof. This house is the only one with a 2-story side wing: the other 2 have 1-story side wings. The second floor has only a one bay, which is centered in the gable end and is located above the first-floor window. Clad in stucco with an asphalt-shingled roof, the house features a brick chimney, overhanging eaves, modern 1/1-windows, some original 2/2-sash windows, modern vinyl shutters, and a side porch off the side wing. The 2-bay hiproofed front porch has paneled square posts as supports and runs the full width of the main block.

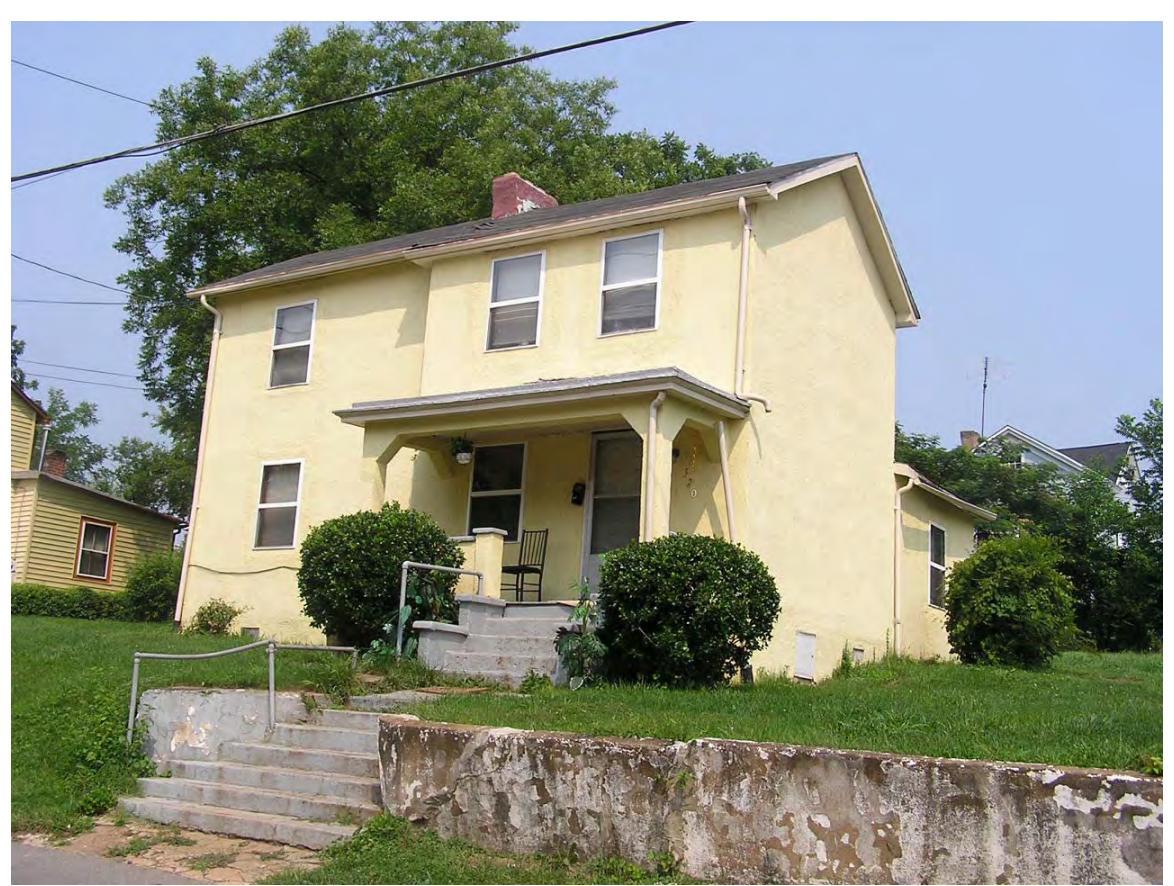
Primary Resource Information: **Single Dwelling**, **Stories 2.00**, **Style: Other, ca 1890** July 2006: This late-19th-century, 2-story, gable-roofed dwelling is one of three almost identical houses sited next to each other on 5th Street. They are comprised of a 2-bay main block with an exterior-end brick chimney and have a slightly recessed, 1-bay, 1- or 2-story side wing off the side with the chimney. This house is clad in stucco, roofed in standing asphalt shingles, and features overhanging eaves, modern 1/1-sash windows, and a rear 1-story wing. The 2-bay hip-roofed front porch, which has stuccoed square posts, and a solid balustrade, only covers the main block of the house.

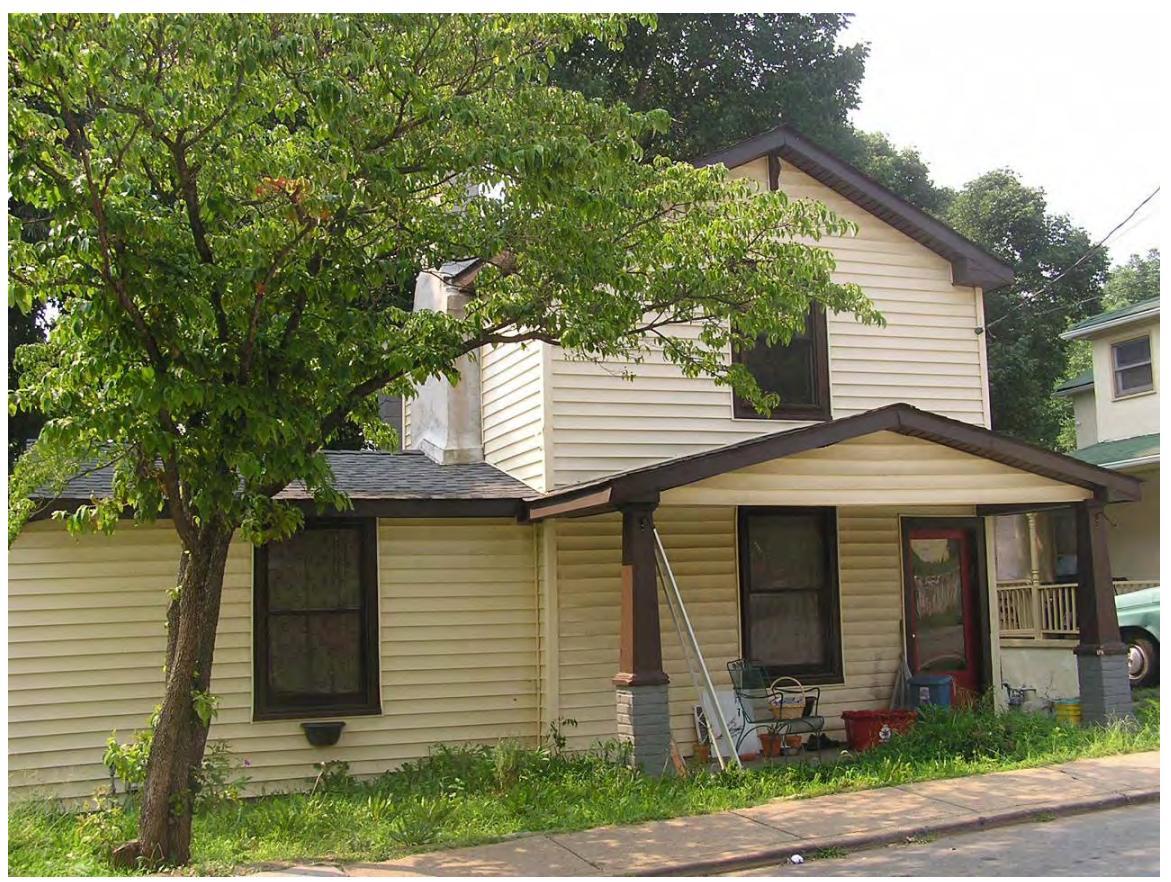
Primary Resource Information: Single Dwelling, Stories 2.00, Style: Other, ca 1895 July 2006: This late-19th-century, 2-story, gable-end dwelling is one of three almost identical houses sited next to each other on 5th Street. They are comprised of a 2-bay, gable-end main block with an exterior side brick chimney and each has a slightly recessed, 1-bay side wing off the side with the chimney. The wing has a side gable roof. This house is one of two with a 1-story side wing: the other has a 2-story side wing. The second floor has only a one bay, which is centered in the gable end and is located above the first-floor window. Clad in vinyl siding with an asphalt-shingled roof, the house features a parged brick chimney, overhanging eaves, modern 1/1-windows, a small scroll bracket in the front gable end, and a side 1-story gable-roofed wing. The 1-bay gabled front porch has battered columns on prick piers and runs the full width of the main block. *Individual Resource Status:* Single Dwelling Contributing Total:1

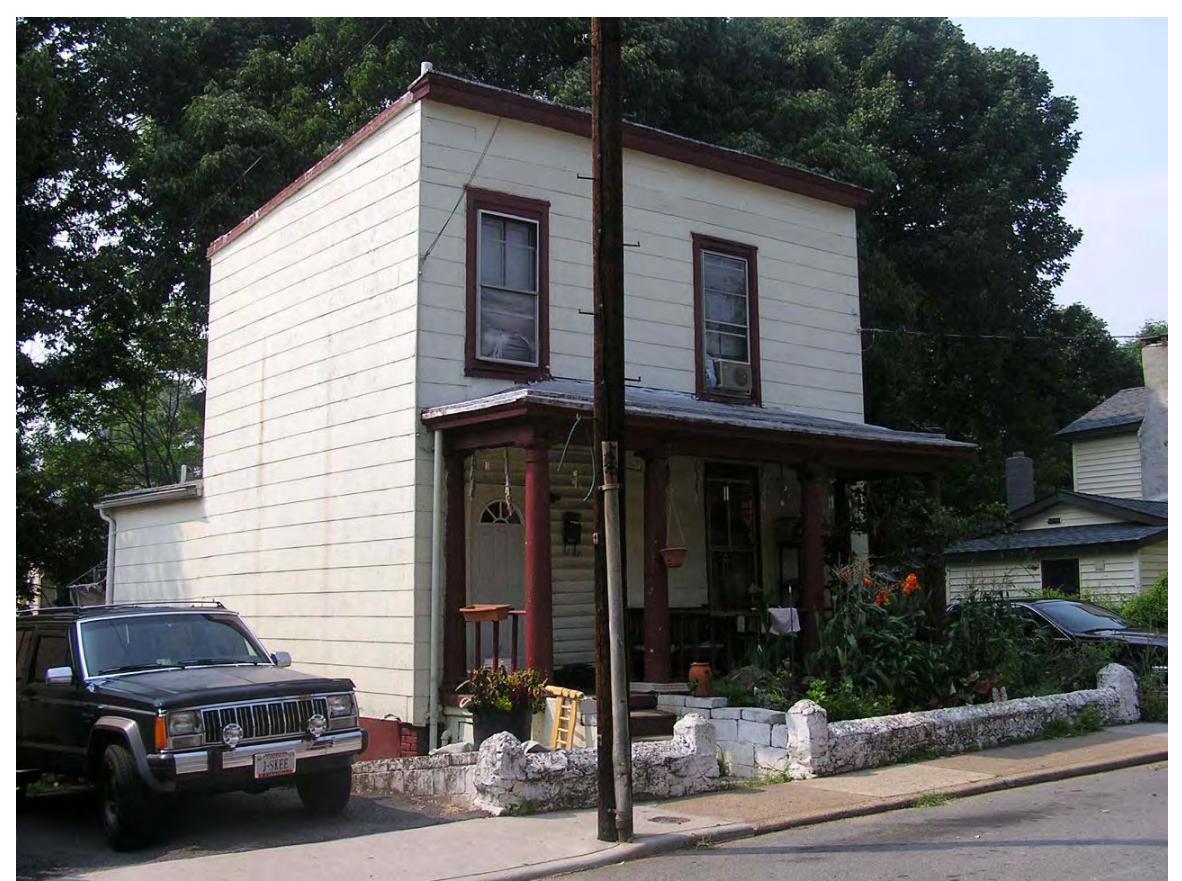
Primary Resource Information: **Single Dwelling**, **Stories 2.00**, **Style: Other, ca 1890** July 2006: This 2-story, 2-bay, side-passage-plan vernacular dwelling features a shed roof with a small bracketed parapet. The house rests on a brick foundation, the walls are clad in asbestos shingles, and the roof is covered in standing-seam metal. The 2/2-sash windows appear original while the front door is a modern replacement. To the rear is a 1-story wing. The 3-bay front porch features Tuscan columns, plain balusters, and a hipped roof.

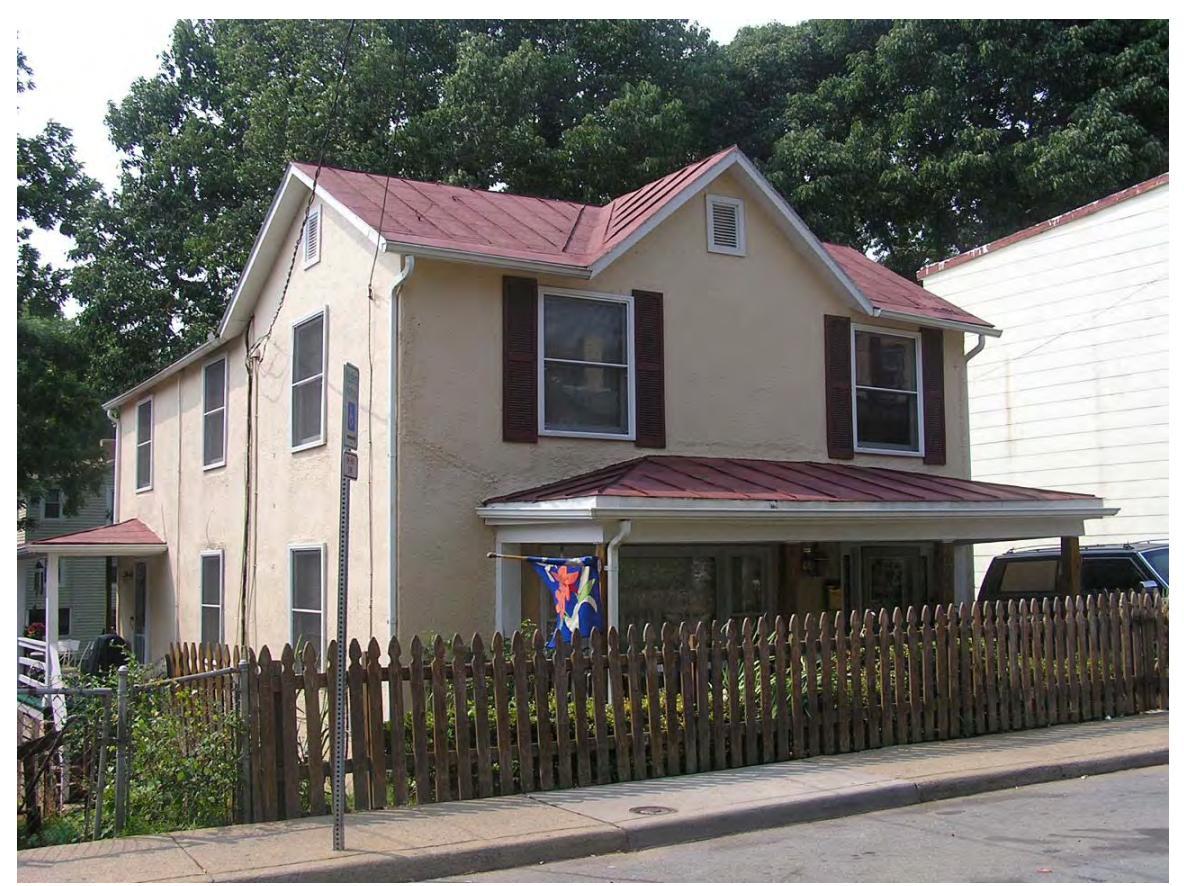
Primary Resource Information: Single Dwelling, Stories 2.00, Style: Other, ca 1890
July 2006: This 2-story, 2-bay, gable-roofed with a central-front gable frame dwelling
was constructed ca. 1890. Neither the two bays nor the front gable are centered within the façade, giving the building an interesting appearance. The stuccoed house has modern
1/1-sash windows, a new bay window on the front, a standing-seam metal roof,
overhanging eaves, a new front door, a rectangular attic vent in the central front gable, a
rear 2-story wing with side entrance and porch, and a 3-bay front porch with square posts.
Individual Resource Status: Single Dwelling Contributing Total:1

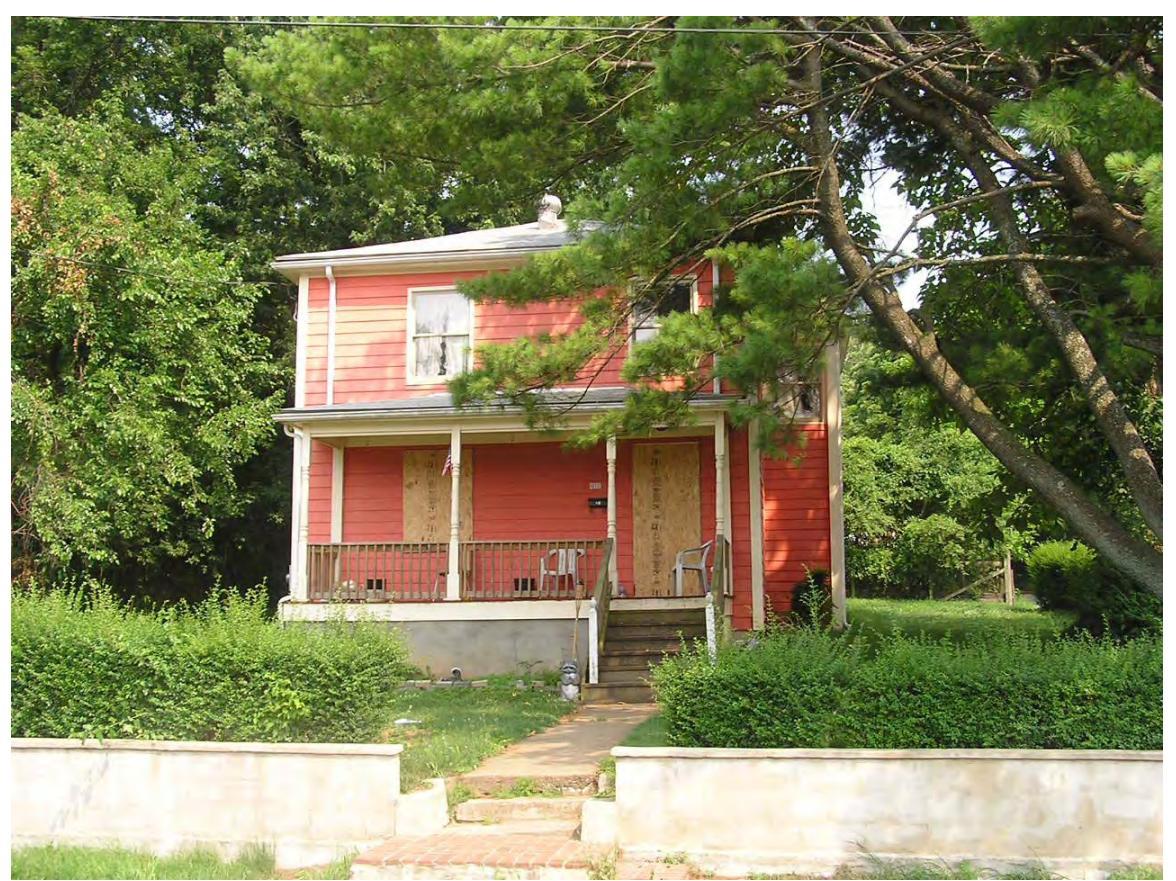
Primary Resource Information: **Single Dwelling**, **Stories 2.00**, **Style: Other, ca 1910** July 2006: This currently vacant, ca. 1910, 2-story, 2-bay, hip-roofed, side-passage-plan, vernacular frame dwelling features an asphalt shingled roof, overhanging eaves, 1/1 vinyl windows (the first–floor openings have been boarded up), a parged foundation, Hardiplank siding, a 2-story rear shed-roofed wing, and a 3-bay front porch with turned posts and a modern balustrade.
