307¹/₂ 5th Street SW 104-0213-0181

308 5th Street SW 104-0213-0164

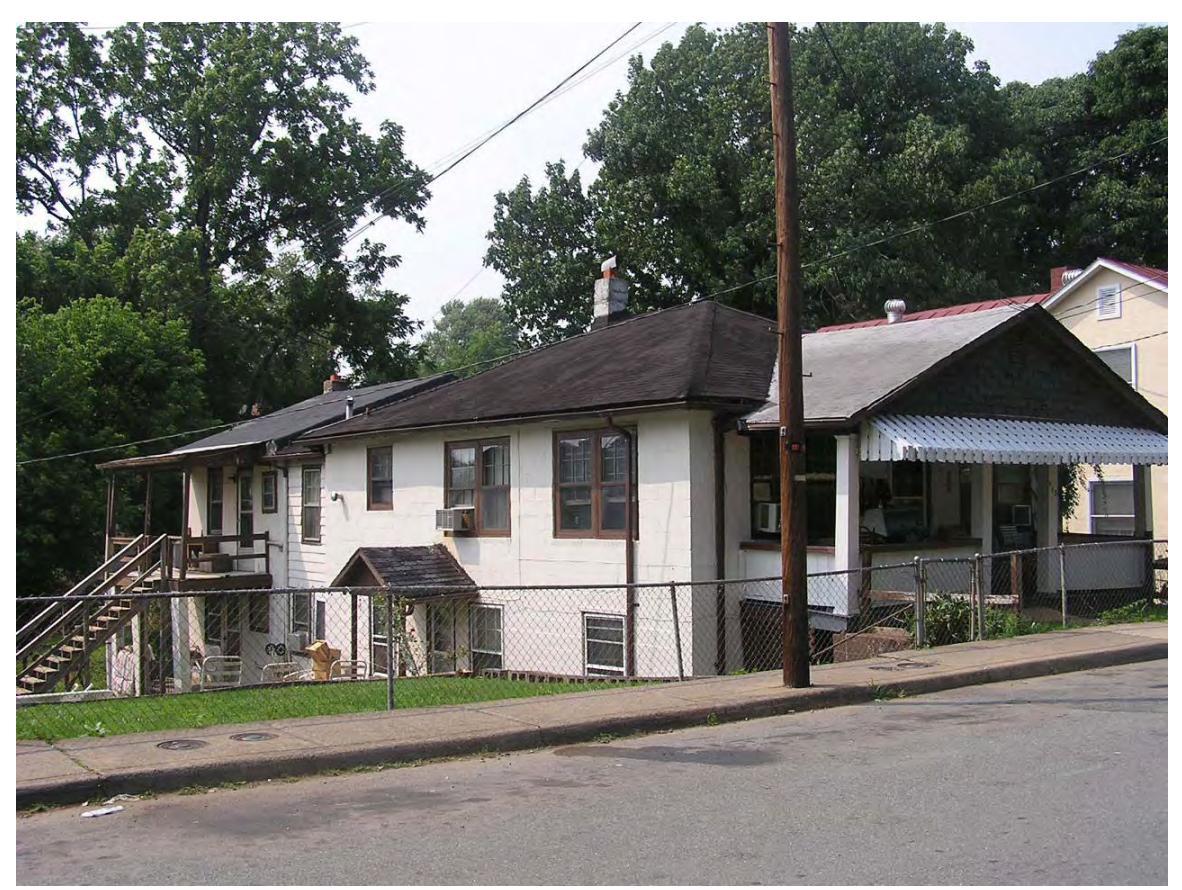
Primary Resource Information: **Single Dwelling**, **Stories 1.00**, **Style: Other, ca 1950** July 2006: This 1-story, 3-bay, concrete block vernacular dwelling appears to have been constructed around 1950. It has a hipped roof, clad in asphalt shingles, with overhanging eaves, exposed rafter ends, and an interior concrete block flue. The paired windows are 6/6-sash and the house has a split-level foundation that opens to a full basement level on the south side. Several rear additions have been made to this house making it quite large. A number of exterior doors suggest that it may have been divided into several living units. The large, pedimented, 3-bay front porch has square columns, a solid balustrade, and an aluminum awing.

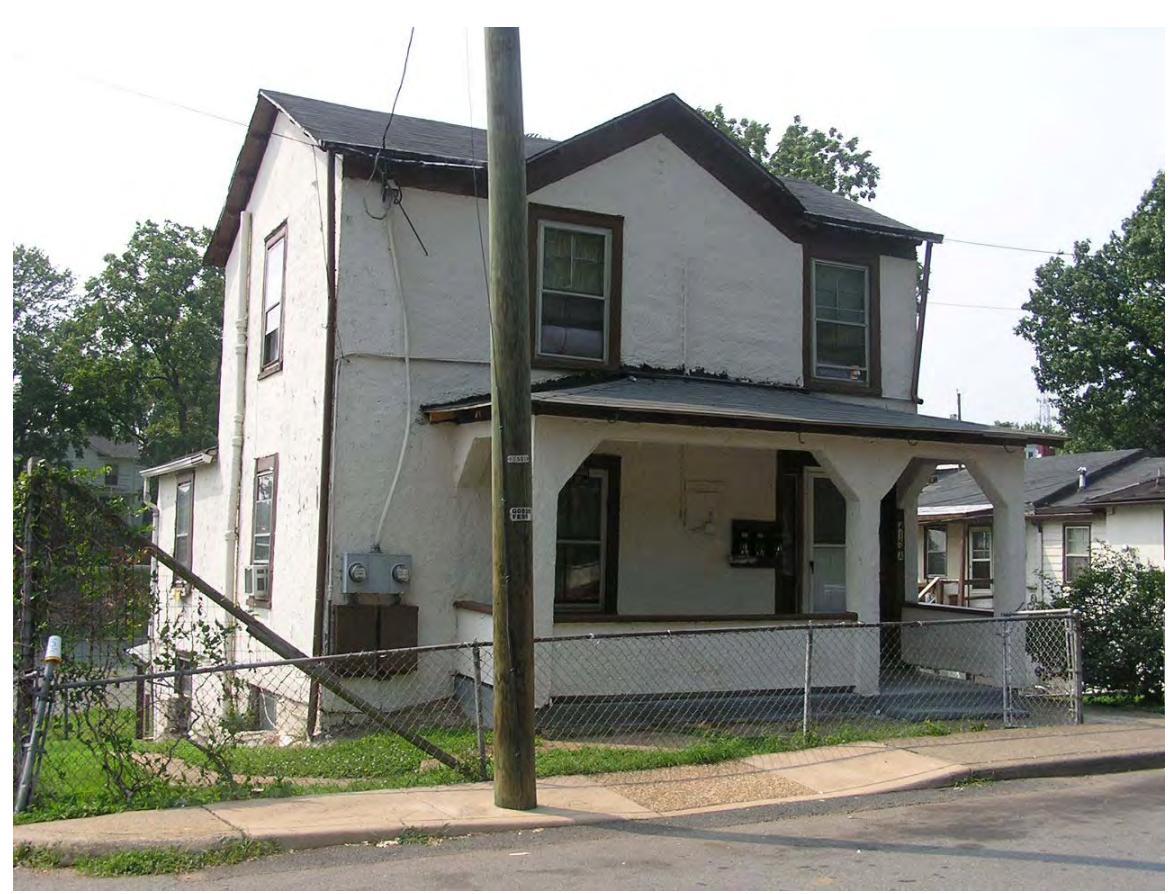
Primary Resource Information: **Single Dwelling**, **Stories 2.00**, **Style: Other, ca 1890** July 2006: This 2-story, 2-bay, gable-roofed with a central-front gable frame dwelling was constructed ca. 1890. Neither the two bays nor the front gable are centered within the façade, giving the building an interesting appearance. The stuccoed house has 2/2-sash windows, asphalt shingled roofing, a 6-light transom and sidelights around the front door, an exterior brick chimney along the rear gable side, overhanging eaves with exposed rafter ends, and a plain friezeboard. The 1-story, gable-roofed, stuccoed rear wing has a side lean-to, a basement entry, and an exterior-end concrete block flue. The 3-bay, hiproofed front porch has square stuccoed supports that form segmental-arched bays, and a solid balustrade.

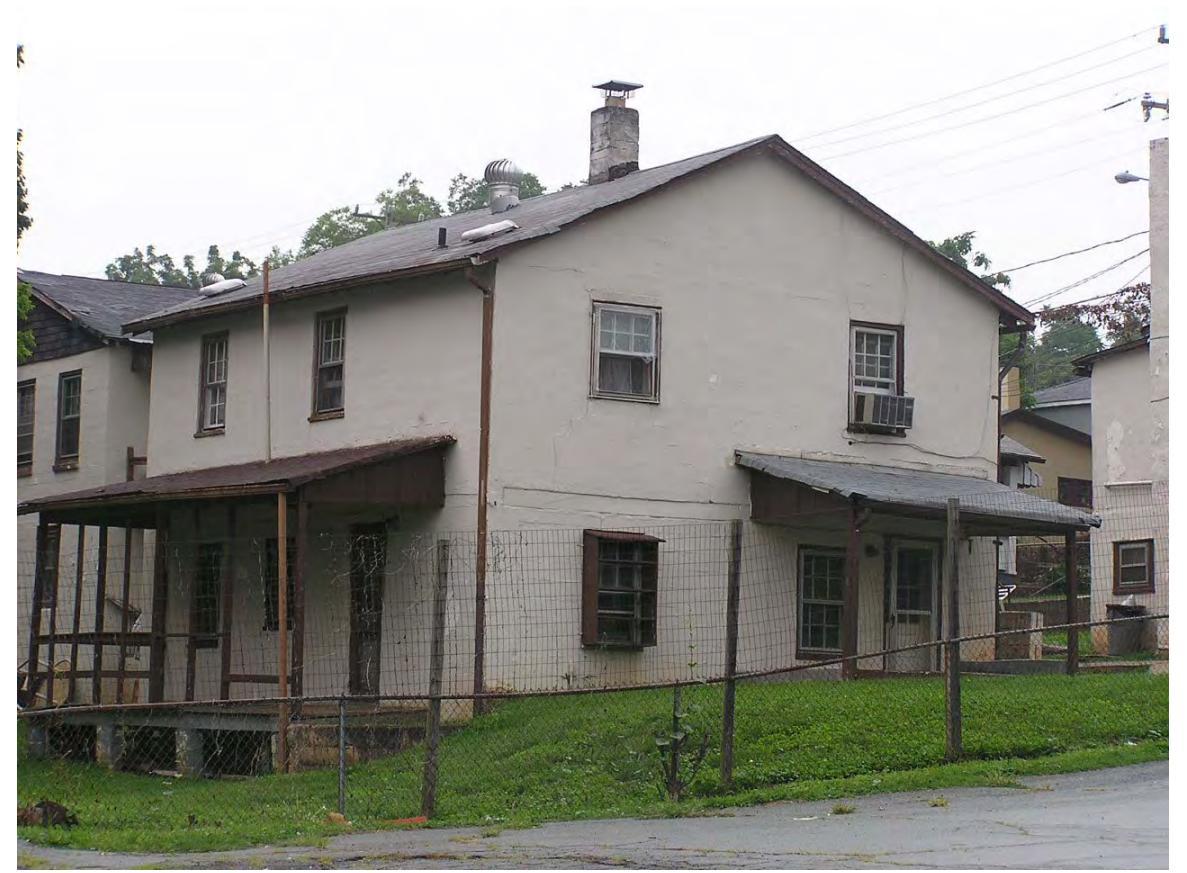
Primary Resource Information: **Single Dwelling**, **Stories 2.00**, **Style: Other, ca 1955** July 2006: Constructed ca. 1955, this 2-story, 3-bay, gable-roofed vernacular dwelling is of concrete block construction on the first floor and frame that has been stuccoed on the second floor. The roof is clad in asphalt shingles and features a central concrete block flue. The windows are 6/6-sash and the house has overhanging eaves, exposed rafter ends, and porches on three sides.

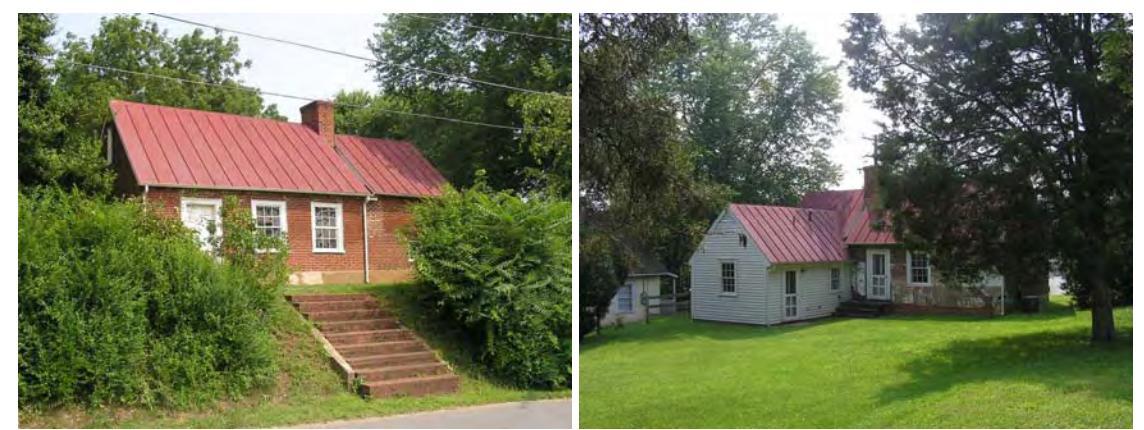
418 5th Street SW 104-0221 Other DHR Id #: 104-0213-0168

Primary Resource Information: Single Dwelling, Stories 1.00, Style: Federal, ca 1832

July 2006: Constructed in 1832, the left three bays of this 1-story brick dwelling are original and follow a side-passage plan. The exterior brick chimney that was originally on the south end of the house was incorporated into the side 1-bay 1-story brick wing that was added in 1892. The walls of the wing were built around the chimney with the exception of the area above the roof level, thus not having to disturb attic windows in the gable end of the original section. The original 3-bay asymmetrical section is laid in Flemish bond brick on the façade and 5-course American bond on the sides and rear. The mousetooth brick cornice, 6-panel front door with architrave trim, 6/6-sash windows, and parged brick foundation are all in good condition. The side brick wing is laid in 7-course American bond, typical of its late-19th century period, but has a matching mousetooth cornice. A rear 1-story frame wing on a brick foundation appears to be a modern addition yet blends in with the rest of the house.

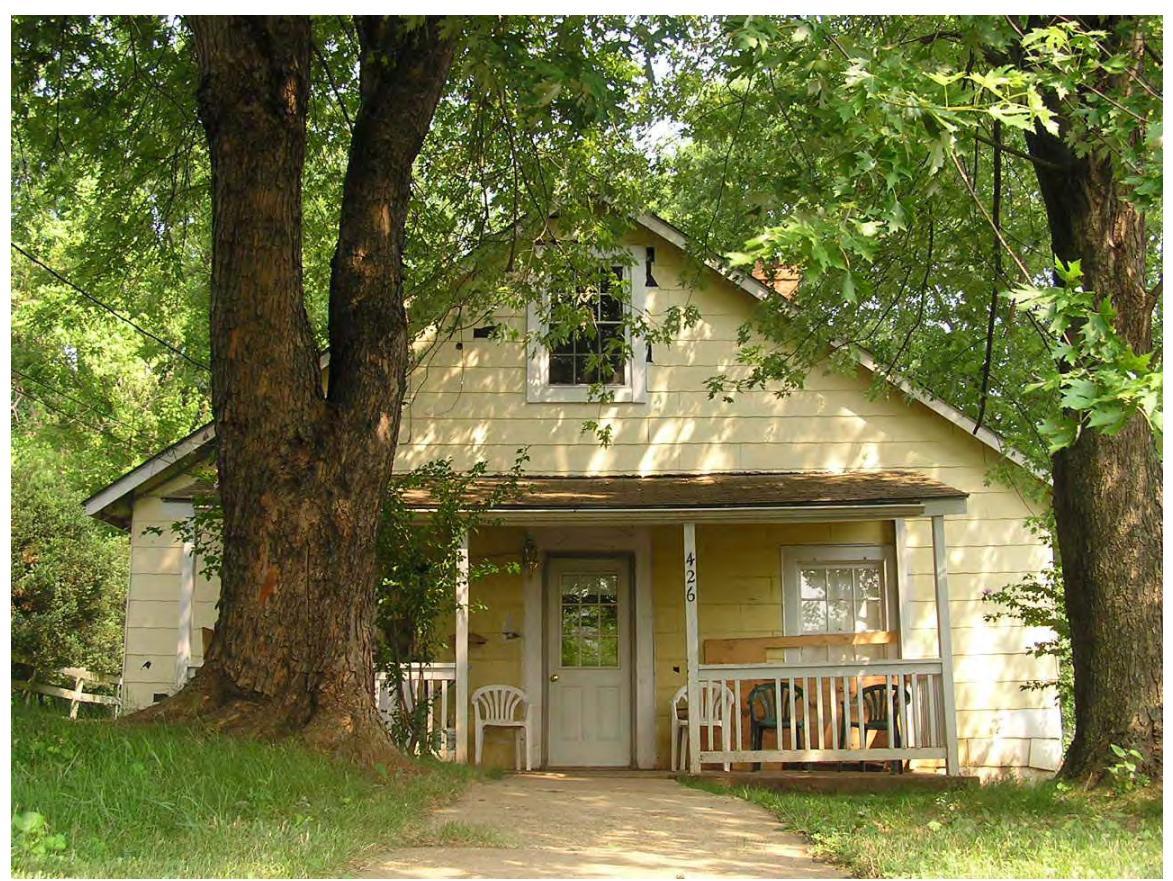
Primary Resource Information: **Single Dwelling**, **Stories 1.00**, **Style: Other, ca 1940** July 2006: Constructed ca. 1940, this 1-story, 3-bay, gable-end vernacular dwelling is clad in asbestos shingle and has an asphalt-shingled roof. The house rests on a concrete block foundation and features 6/6-sash windows, overhanging eaves, a full size attic window in the front gable end, exposed rafter ends, a central interior brick chimney, and a 3-bay shed-roofed front porch with square posts and plain pickets.

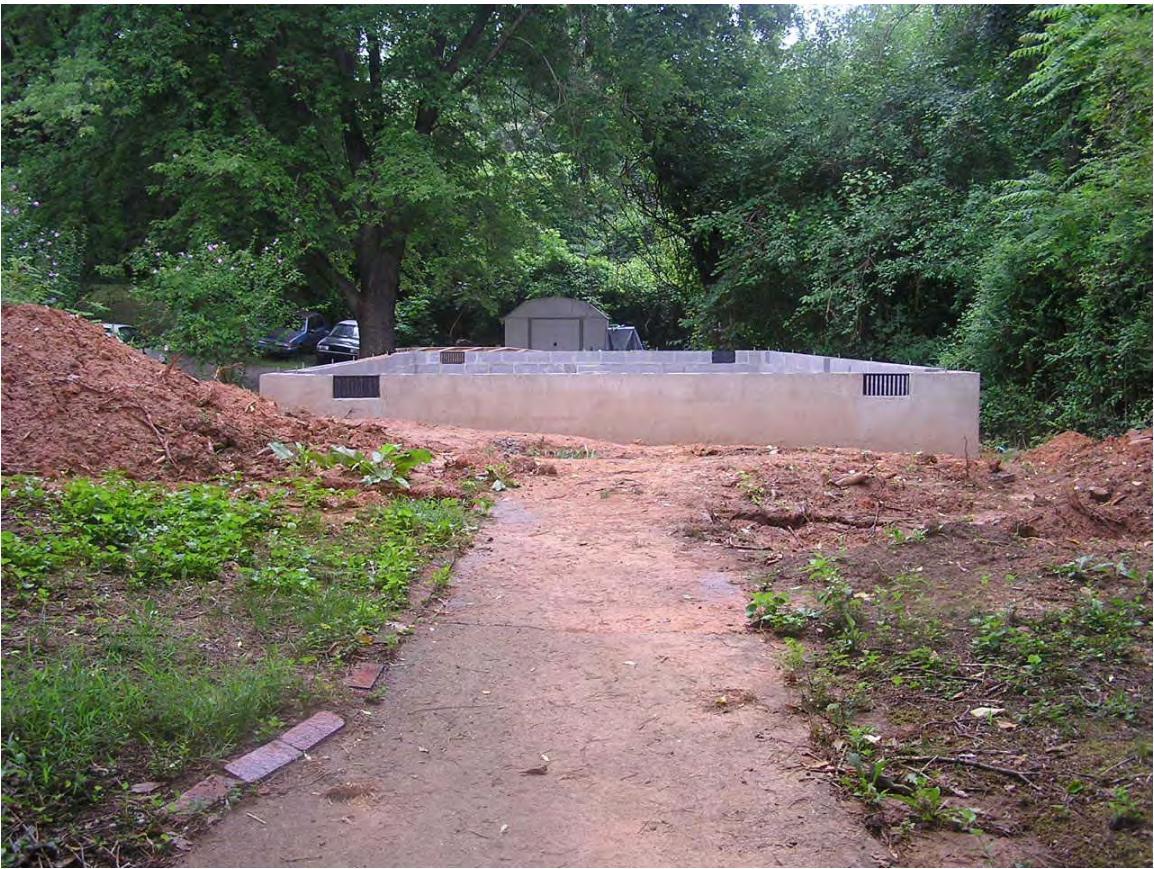
Primary Resource Information: Foundation,

July 2006: This site includes a rectangular concrete block foundation that is currently under construction on this site. The floor joists have not yet been set but the metal vents are in (NC Site).
