VIRGINIA
HISTORIC LANDMARKS COMMISSION

SURVEY FORM

Street address or route number 22 Elliewood Ave

City of Charlottesville - Rugby Rd.-University Corner H.D.

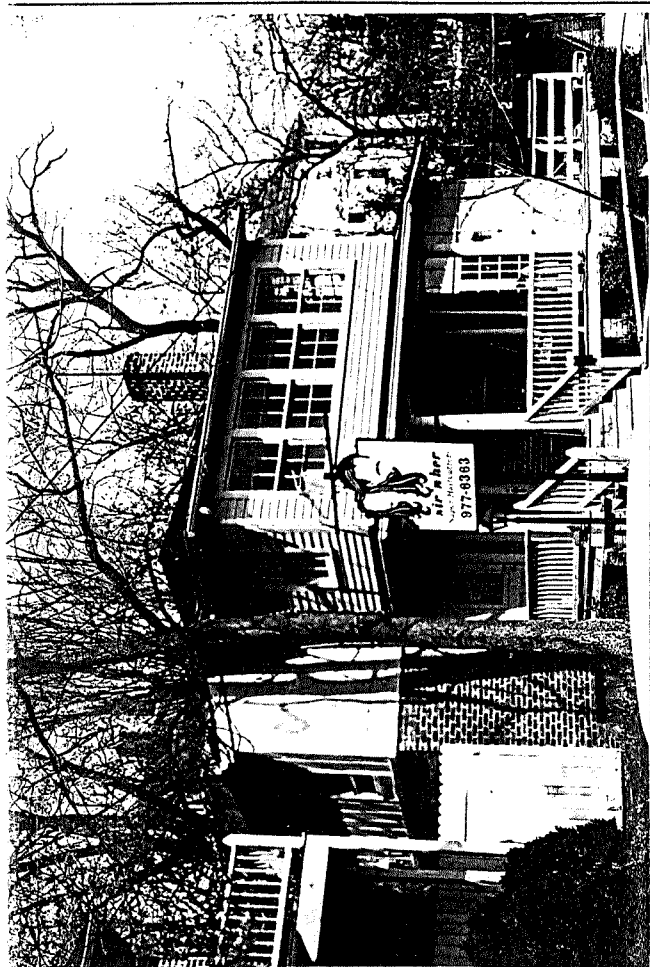
Location and description of entrance **Plain entrance at front (2 front doors)**

This house is very similar to that next door and no. 20, and was probably built by and for the same person--perhaps as rental property.

The only major exterior changes include the addition of a sunroom over the front porch, and a modern one-story frame wing on the N end. The frame extension on the S side is also new or recently remodeled (compare with S wing of no. 20).

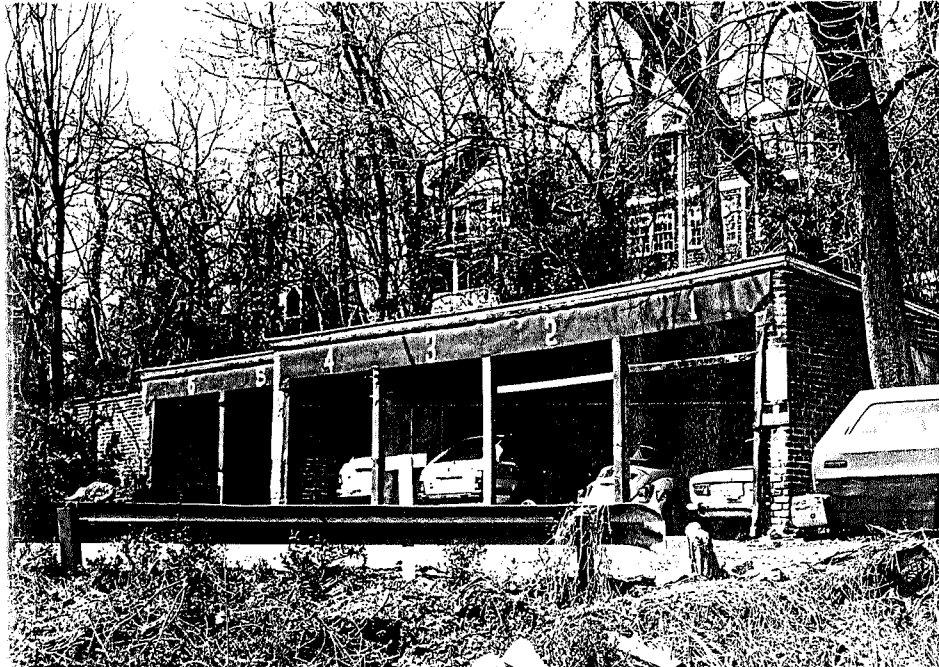
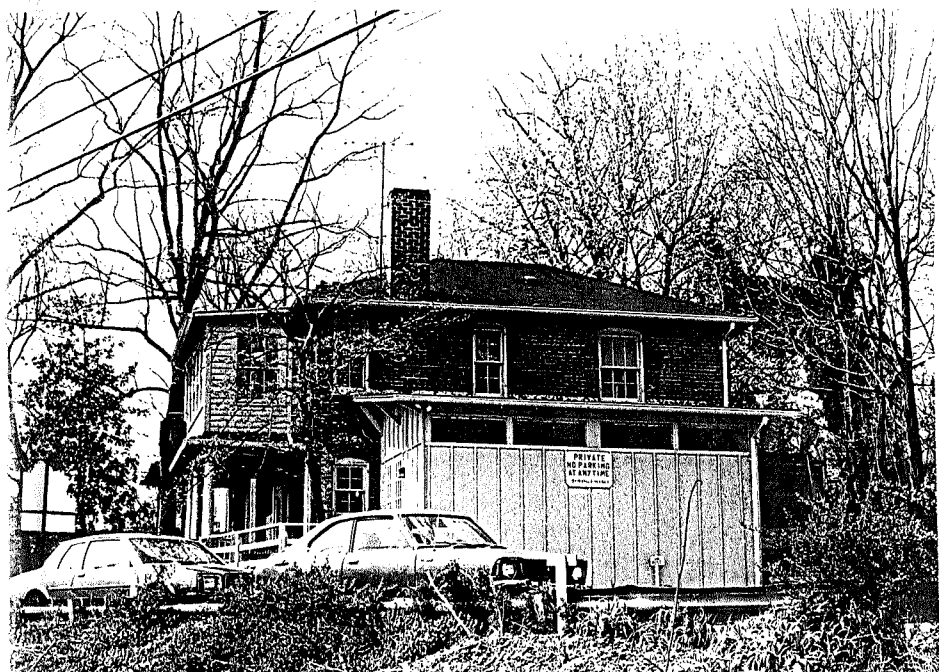
Brick two-story building with rectangular form main block, Craftsman and Colonial Revival elements - two-level front porch has Doric columns and balustrade with square wood spindles, second level of porch has been enclosed; windows have shallow segmentally-arched lintels, and roof edge has brackets evoking exposed rafter ends. A second entrance is located immediately south of main entrance, indicating that the dwelling was probably constructed as a duplex.

Two-story frame section, south wall, either original or built very soon after initial construction; post-1941 one-story frame addition on north side, with shed roof and French doors opening to deck adjoining front porch. Building originally had window blinds, only those on first floor of front facade remain.

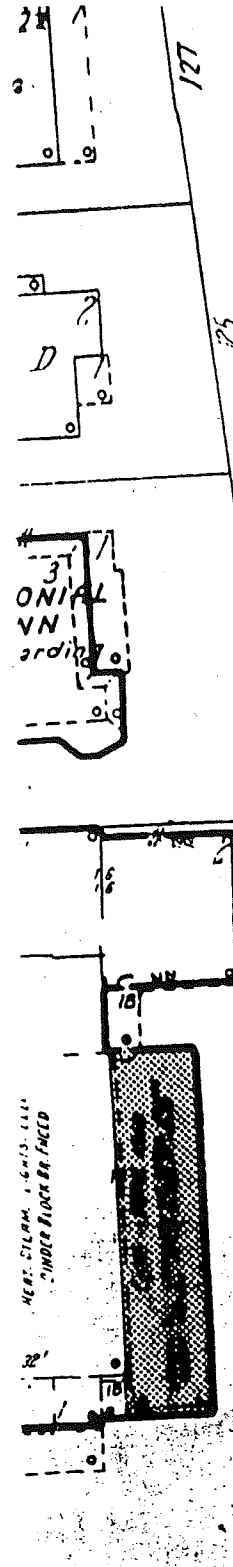
City of Charlottesville
site plan - n.t.s.
6/96 S.E. Smead
PARK'G

EWOOD AV.

demolished

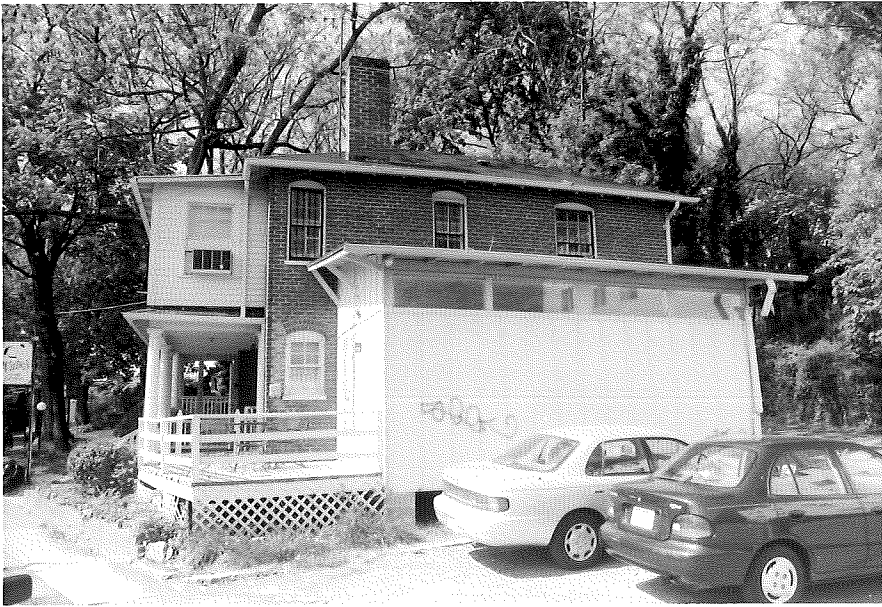
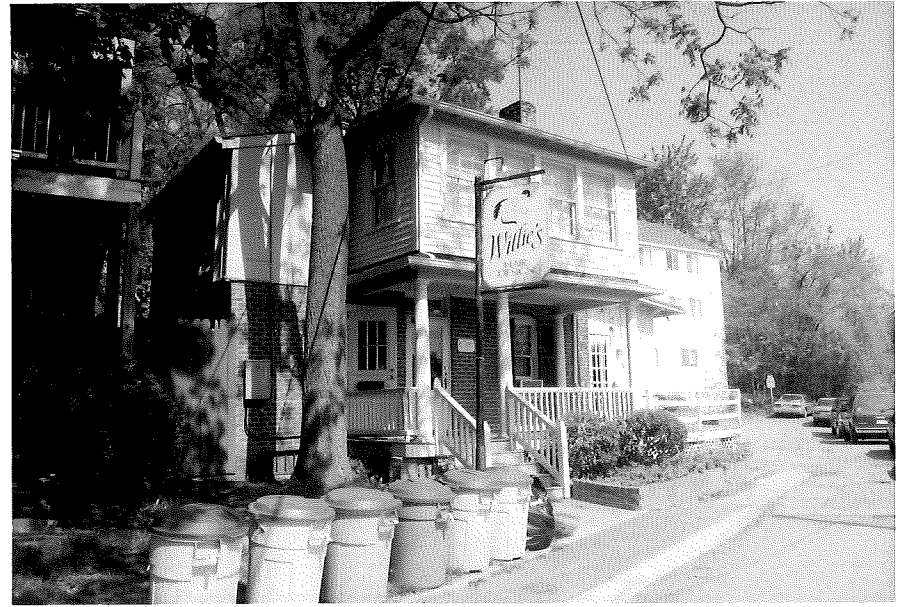
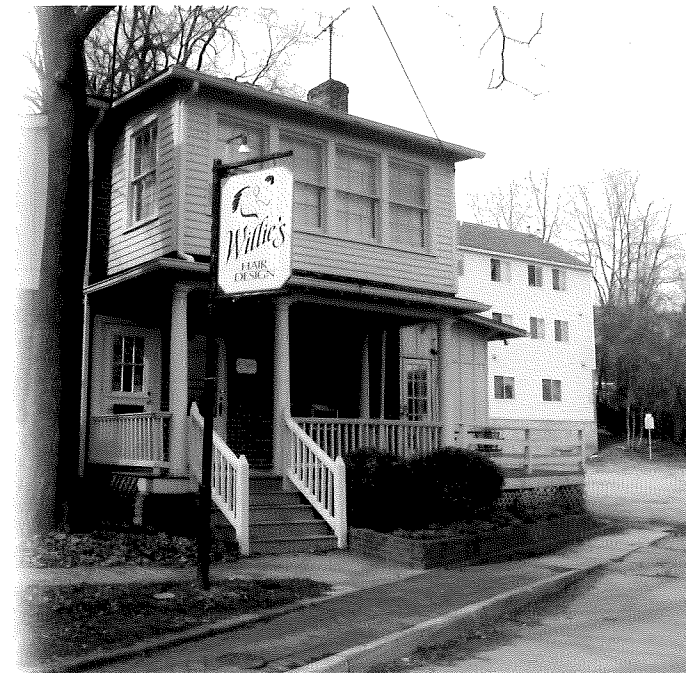
Date 2/25/96 File No. 104-133-43

Contents 3 exterior views
