# VIRGINIA HISTORIC LANDMARKS COMMISSION

## HISTORIC DISTRICT SURVEY FORM

File No. 104-130  
Negative no(s). 7220, 7228

Street address 1701 Gordon Ave.  
Town/City Charlottesville

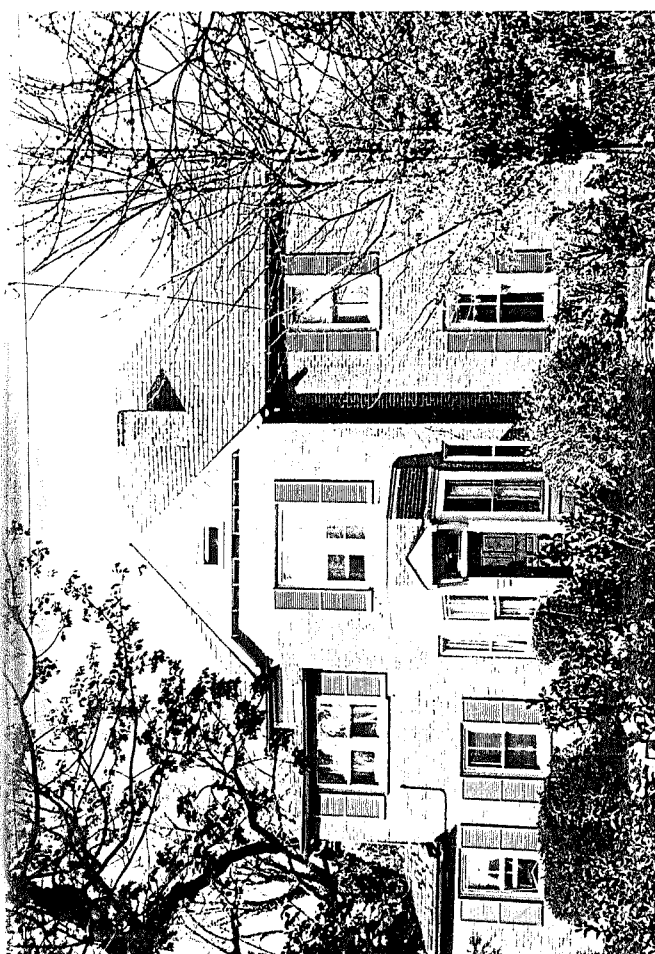
Location and description of entrance <sup>-fronted</sup> Main entrance is on Gordon Ave; plain door with hood leads into projecting polygonal vestibule.

The present building is distinguished by its highly articulated facade and varied roofline. The demi-hexagonal front vestibule is a curious feature. The cross-gables with curved boards recalling half-timbering are a Queen Anne-style influence.
