VIRGINIA HISTORIC LANDMARKS COMMISSION

HISTORIC DISTRICT SURVEY FORM

File No. 104-130

Street address **400 16th St. NW (Ackley Ln.)**
Town/City **Charlottesville**

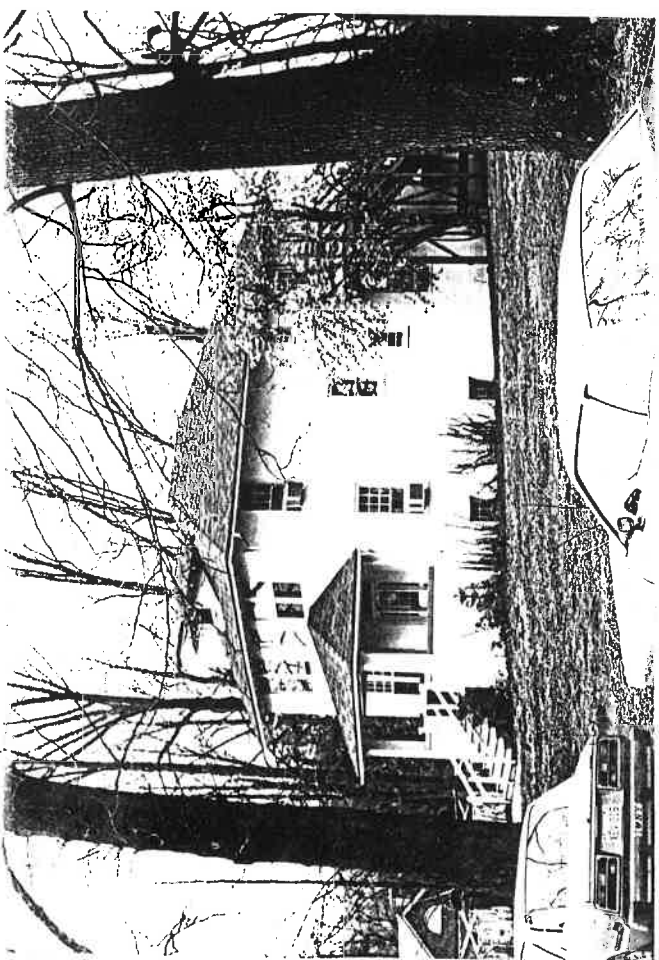
Negative no(s). 7215

Porch	Stories	Bays	General description
<input checked="" type="checkbox"/> yes <input type="checkbox"/> no	<input checked="" type="checkbox"/> 1 <input type="checkbox"/> 3 <input type="checkbox"/> 2 <input type="checkbox"/> ____	<input type="checkbox"/> 1 (center) <input type="checkbox"/> 2 <input type="checkbox"/> 4 <input checked="" type="checkbox"/> 1 (side) <input type="checkbox"/> 3 <input type="checkbox"/> ____	Half-length porch on right side of main facade; hipped roof; square posts.

Location and description of entrance **Glazed door with top- and side-lights.**

This rather plain rectangular house features a single front attic dormer, broad overhanging eaves, an off-center porch, and asymmetrical windows on the side facades. It sits on a slightly-sloping lot and has a raised basement.
