REAR ELEVATION scale: 1/8"=1'-0" 1

EXISTING FRONT ELEVATION scale: 1/8"=1'-0" 3

SIDE ELEVATION scale: 1/8"=1'-0"

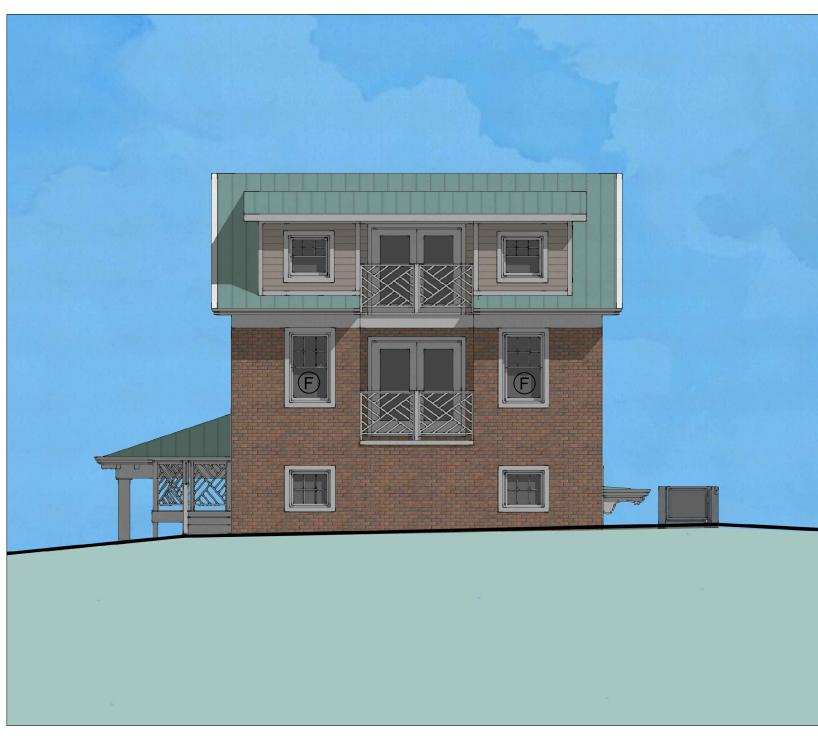
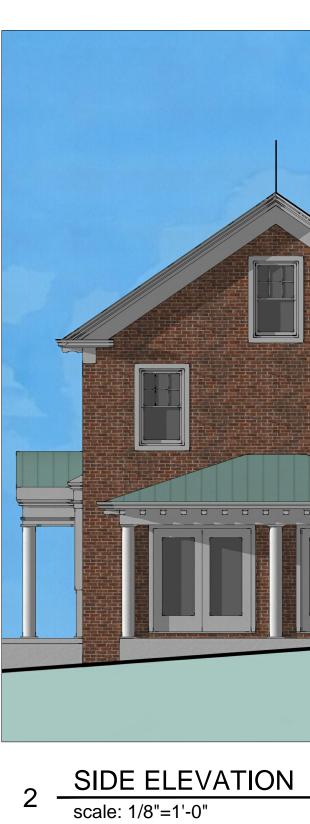
- A This window was to be along cabinetry, and due to the conflict it was decided to be shorter.
- B This window was omitted in construction drawings due to conflict with stair landing and rating difficulty.

- \bigcirc These windows were added during construction to let more natural light in.
- D These 2 windows are along cabinetry, and due to the conflict it was decided to be shorter.

- (E) These existing windows and door did not change, a drawing mistake was on the BAR drawings.
- (F) The windows of the addition do not line up with the existing residence windows as those windows are raised above the head height of the existing doors. There was a translation differentiation from the BAR drawings to the construction document drawings, however, the height difference allows to differentiate between existing and new construction based on National Park Service's Guidelines for the Treatment of Historic Properties

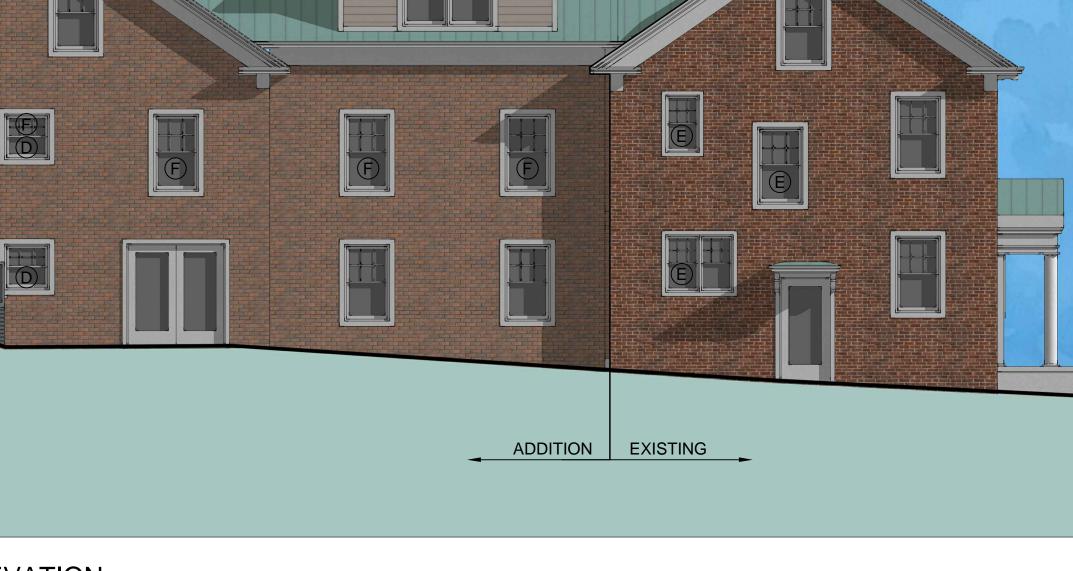
EXISTING ADDITION
