BAR 15-02-04
608 Preston Ave
Tax Parcel 320014000
King Lumber Partners, LLC, Owners/ Mark Green, Applicant
Revisions to renovation plan

**CITY OF CHARLOTTESVILLE
BOARD OF ARCHITECTURAL REVIEW
STAFF REPORT
April 21, 2015**

BAR 15-04-05
608 Preston Avenue
Tax Parcel 320014000
King Lumber Partners, LLC, Owners/ Mark Green, Applicant
Revisions to renovation plan

KING LUMBER BUILDING RENOVATION

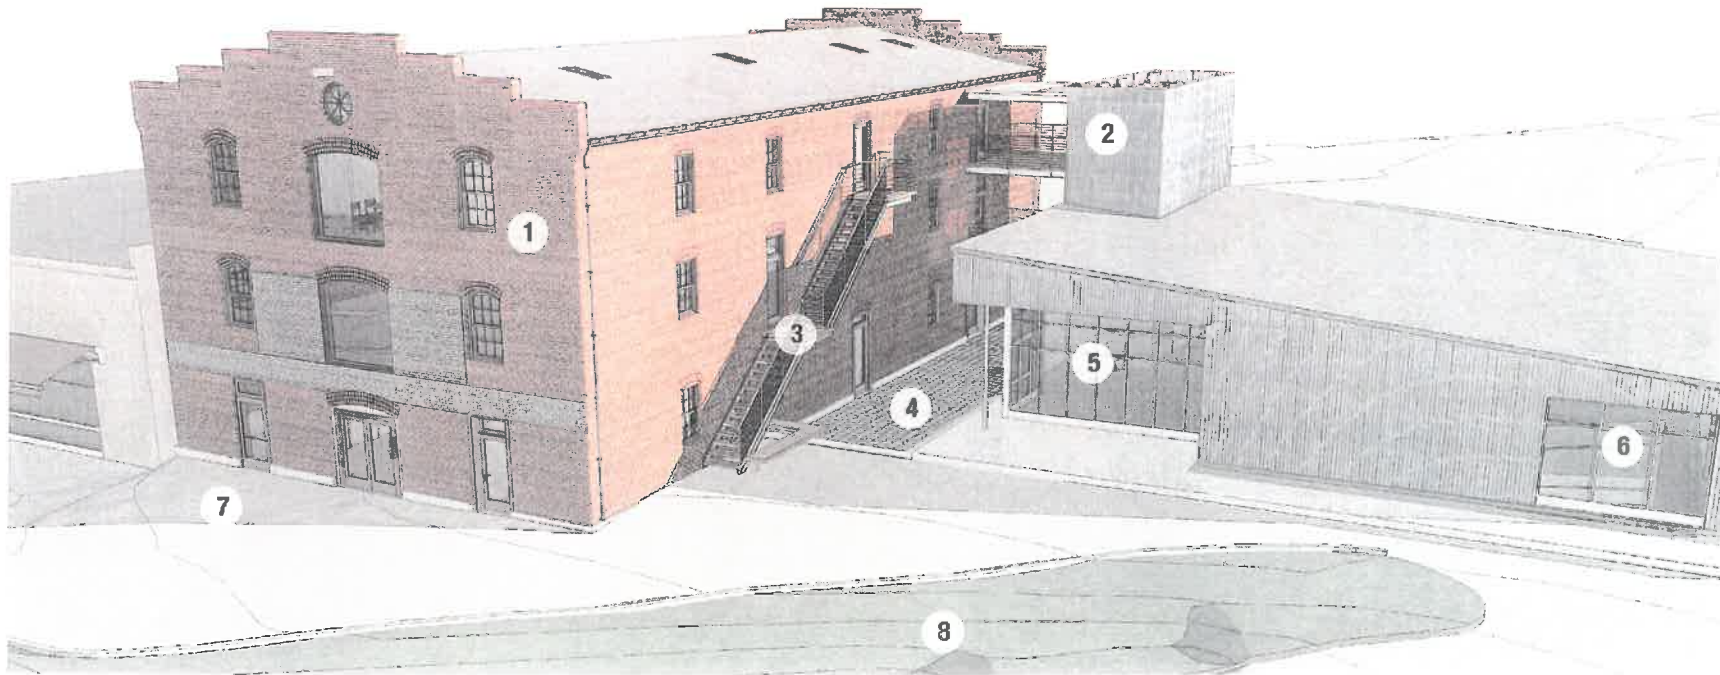
February 17, 2015 approval

1 BRICK TO BE REPAIRED AND REPAINTED

2 NEW STAIR/ELEVATOR TOWER WITH BRIDGES CONNECTING TO WAREHOUSE

3 NEW EXTERIOR STAIR

4 NEW PEDESTRIAN BREEZEWAY BETWEEN WAREHOUSE AND ANNEX

5 EXISTING ANNEX OPENING TO BE RECONFIGURED AS NEW GLAZED STOREFRONT ENTRY

6 EXISTING OPENING TO RECEIVE NEW WINDOW UNIT

7 EXISTING ASPHALT TO REMAIN; REPAIR AS NECESSARY

8 EXISTING LANDSCAPE TO REMAIN (NOT IN PROJECT SCOPE)

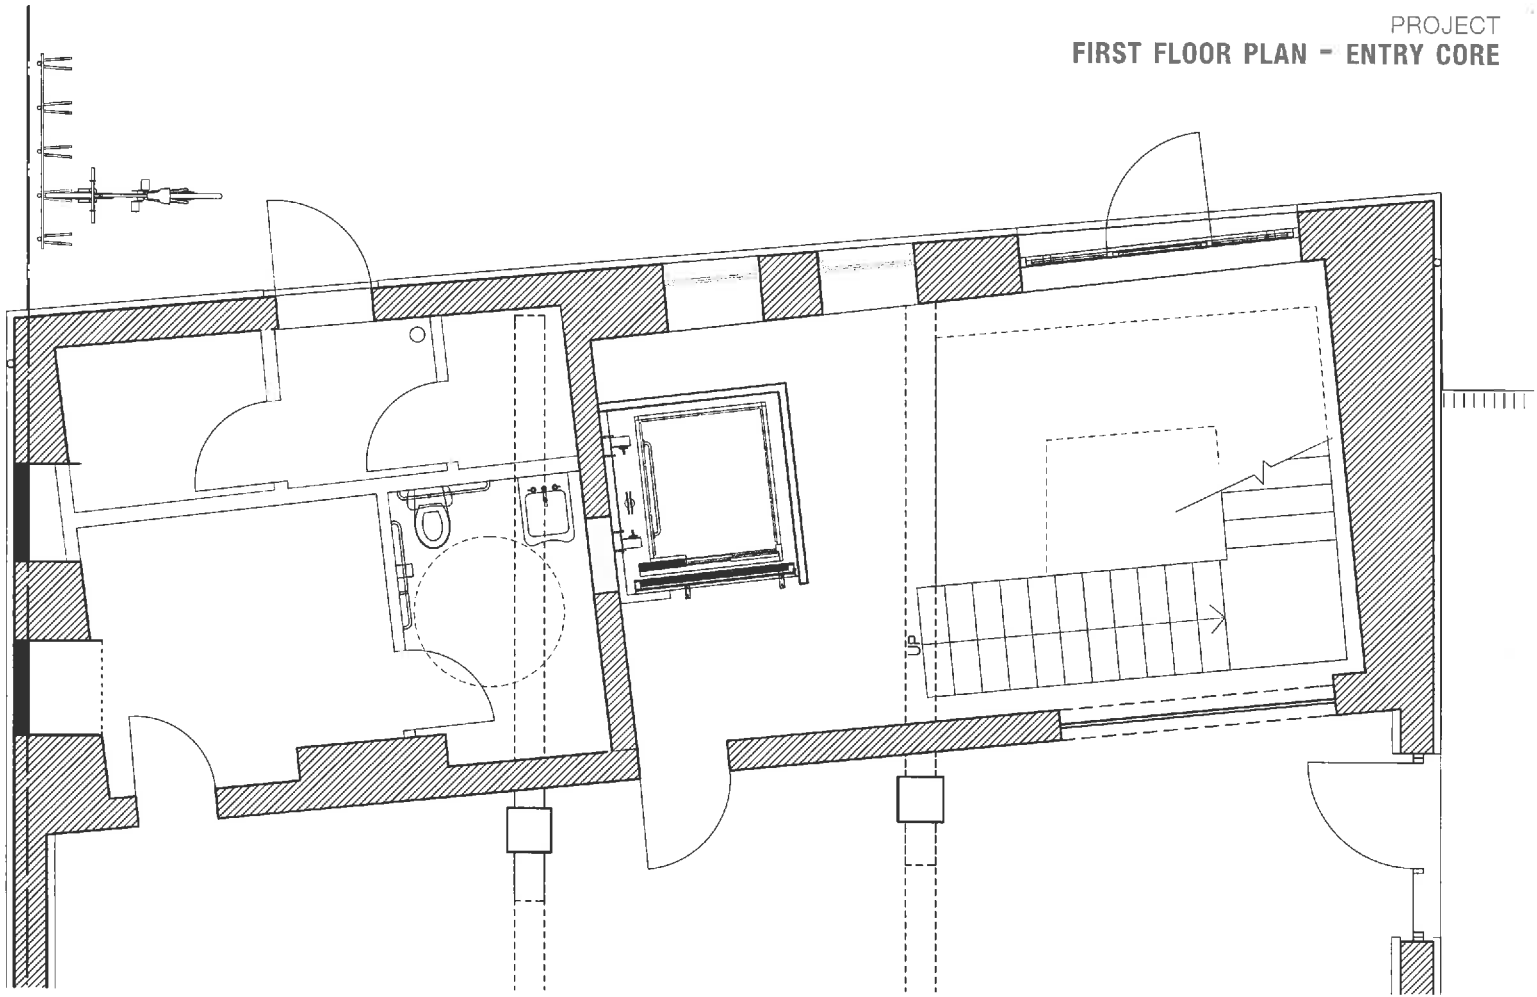
13A

PROJECT
FIRST FLOOR PLAN - ENTRY CORE

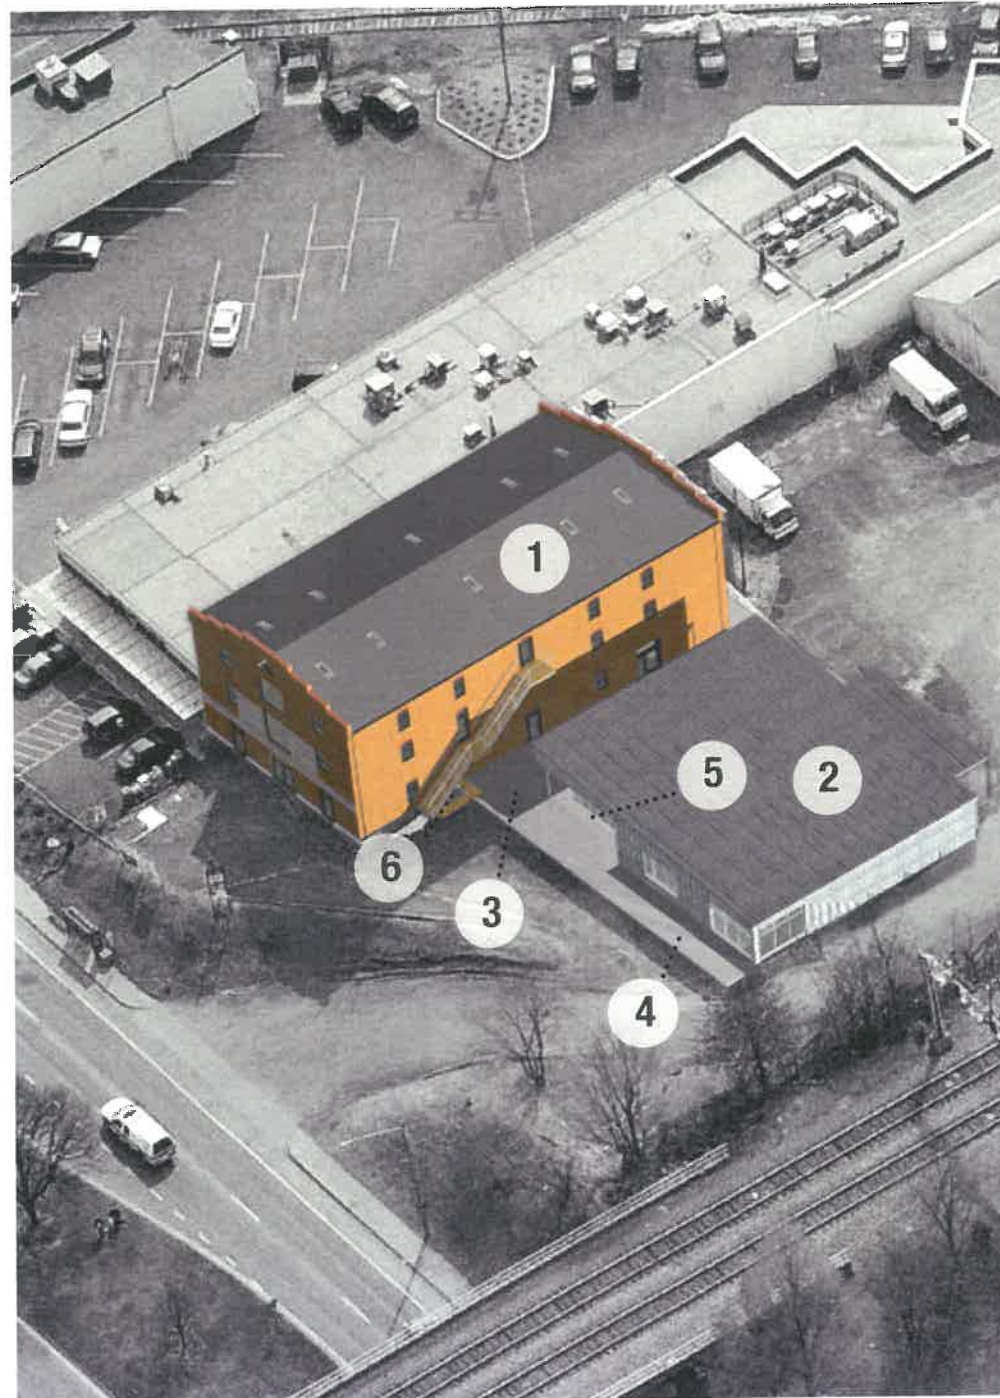
PROPOSED

- 1** KING LUMBER BUILDING
(3 STORY BRICK WAREHOUSE TO BE RENOVATED WITH EXTERIOR GALLERY)
- 2** ANNEX BUILDING
(1 STORY METAL ANNEX TO BE RENOVATED)
- 3** PORTION OF ANNEX TO BE REMOVED AND REPLACED WITH A PEDESTRIAN GALLERY THAT PROVIDES NEW AXIS OF CIRCULATION THROUGH SITE
- 4** SURROUNDING SITE TO REMAIN UNTOUCHED, WITH THE EXCEPTION OF A NEW SIDEWALK ALONG NORTH EDGE OF ANNEX
- 5** NEW CORNER ENTRANCE TO ANNEX, OFF OF PEDESTRIAN GALLERY
- 6** NEW EXTERIOR STAIR

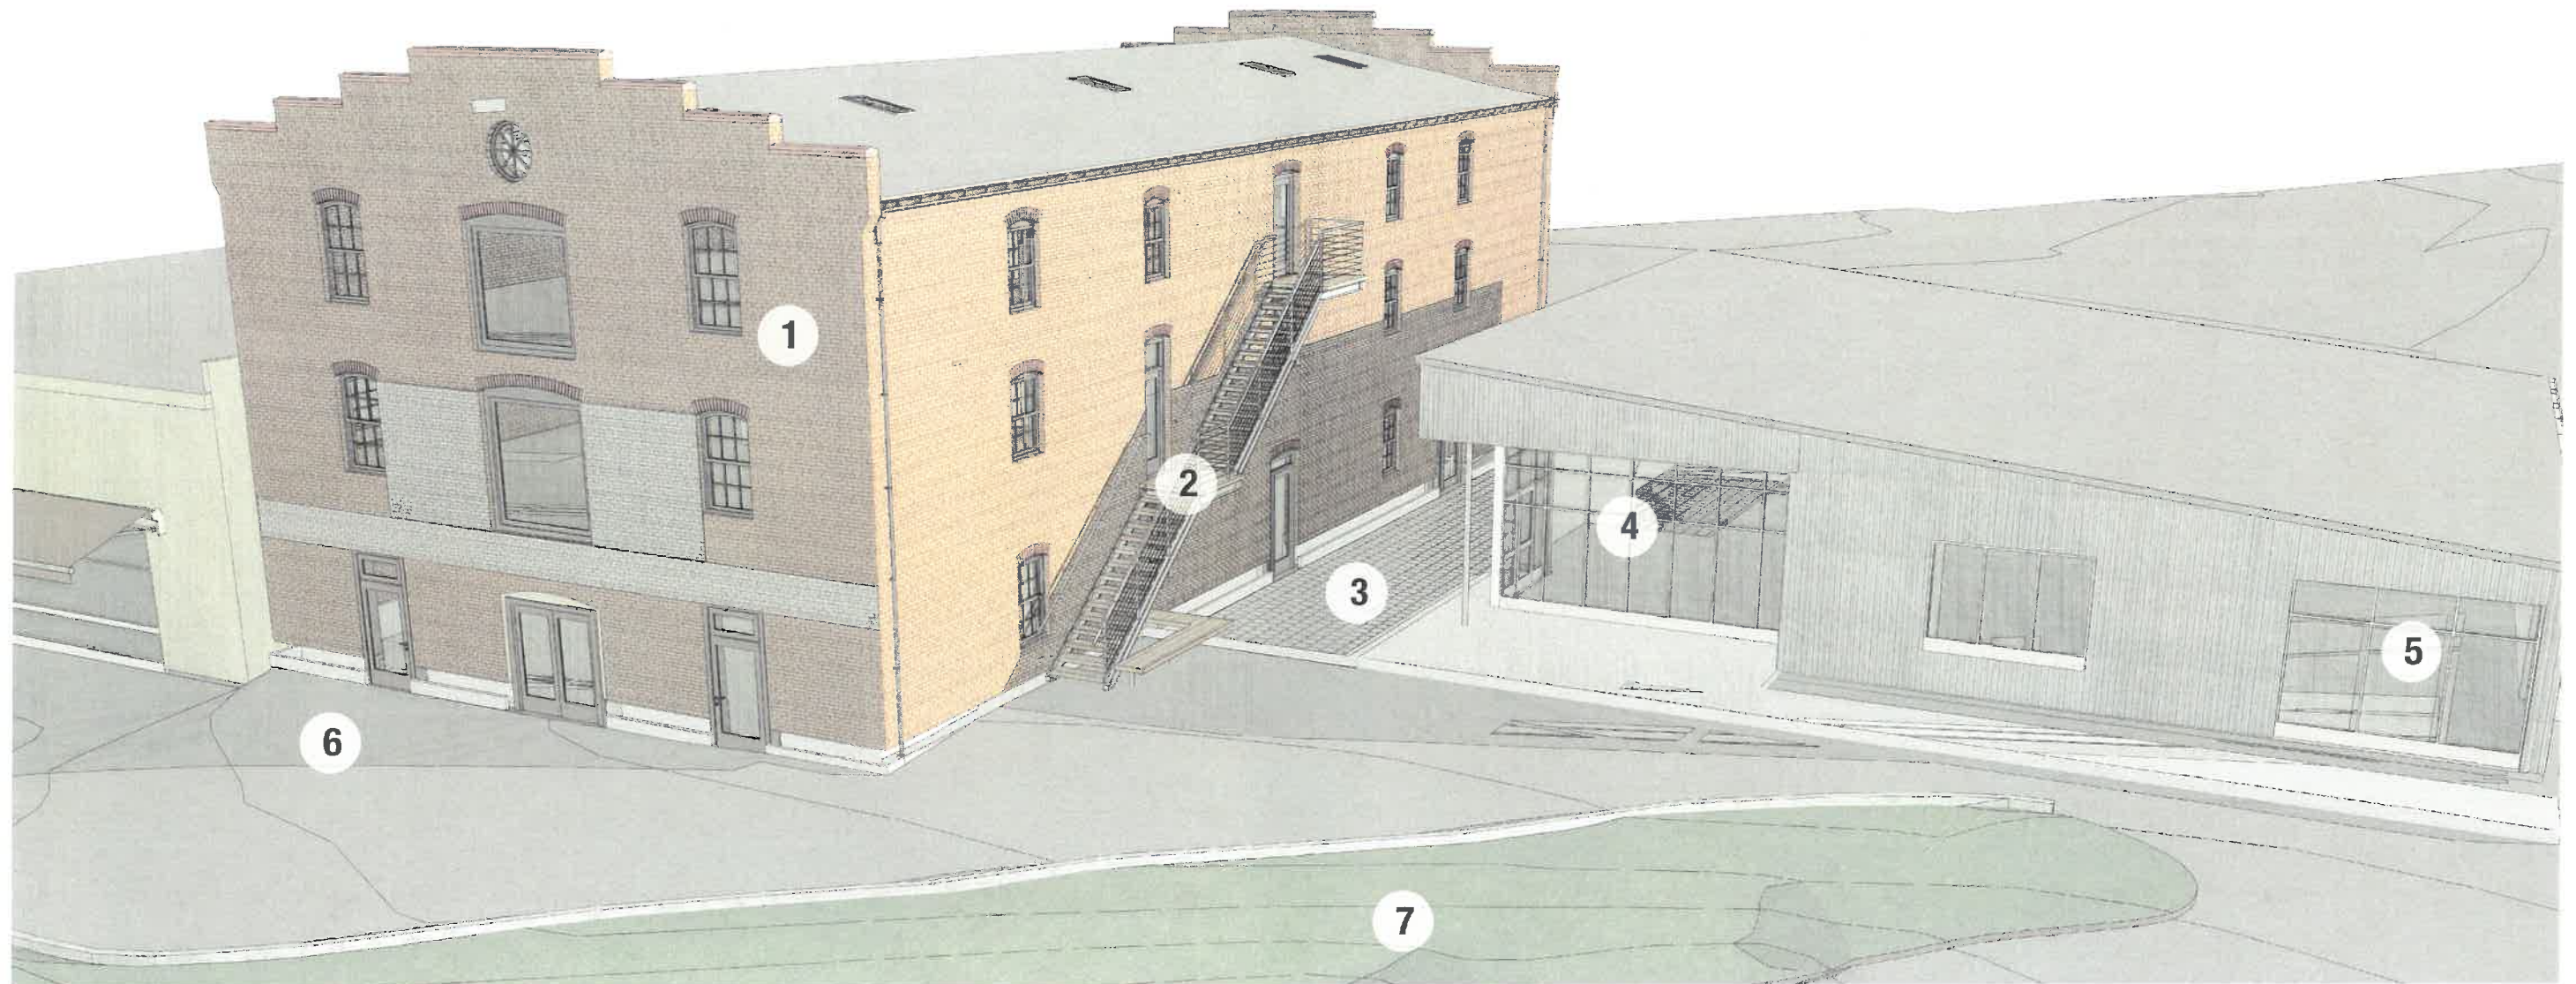
1 BRICK TO BE REPAIRED AND REPAINTED

2 NEW EXTERIOR STAIR

6 EXISTING ASPHALT TO REMAIN; REPAIR AS NECESSARY

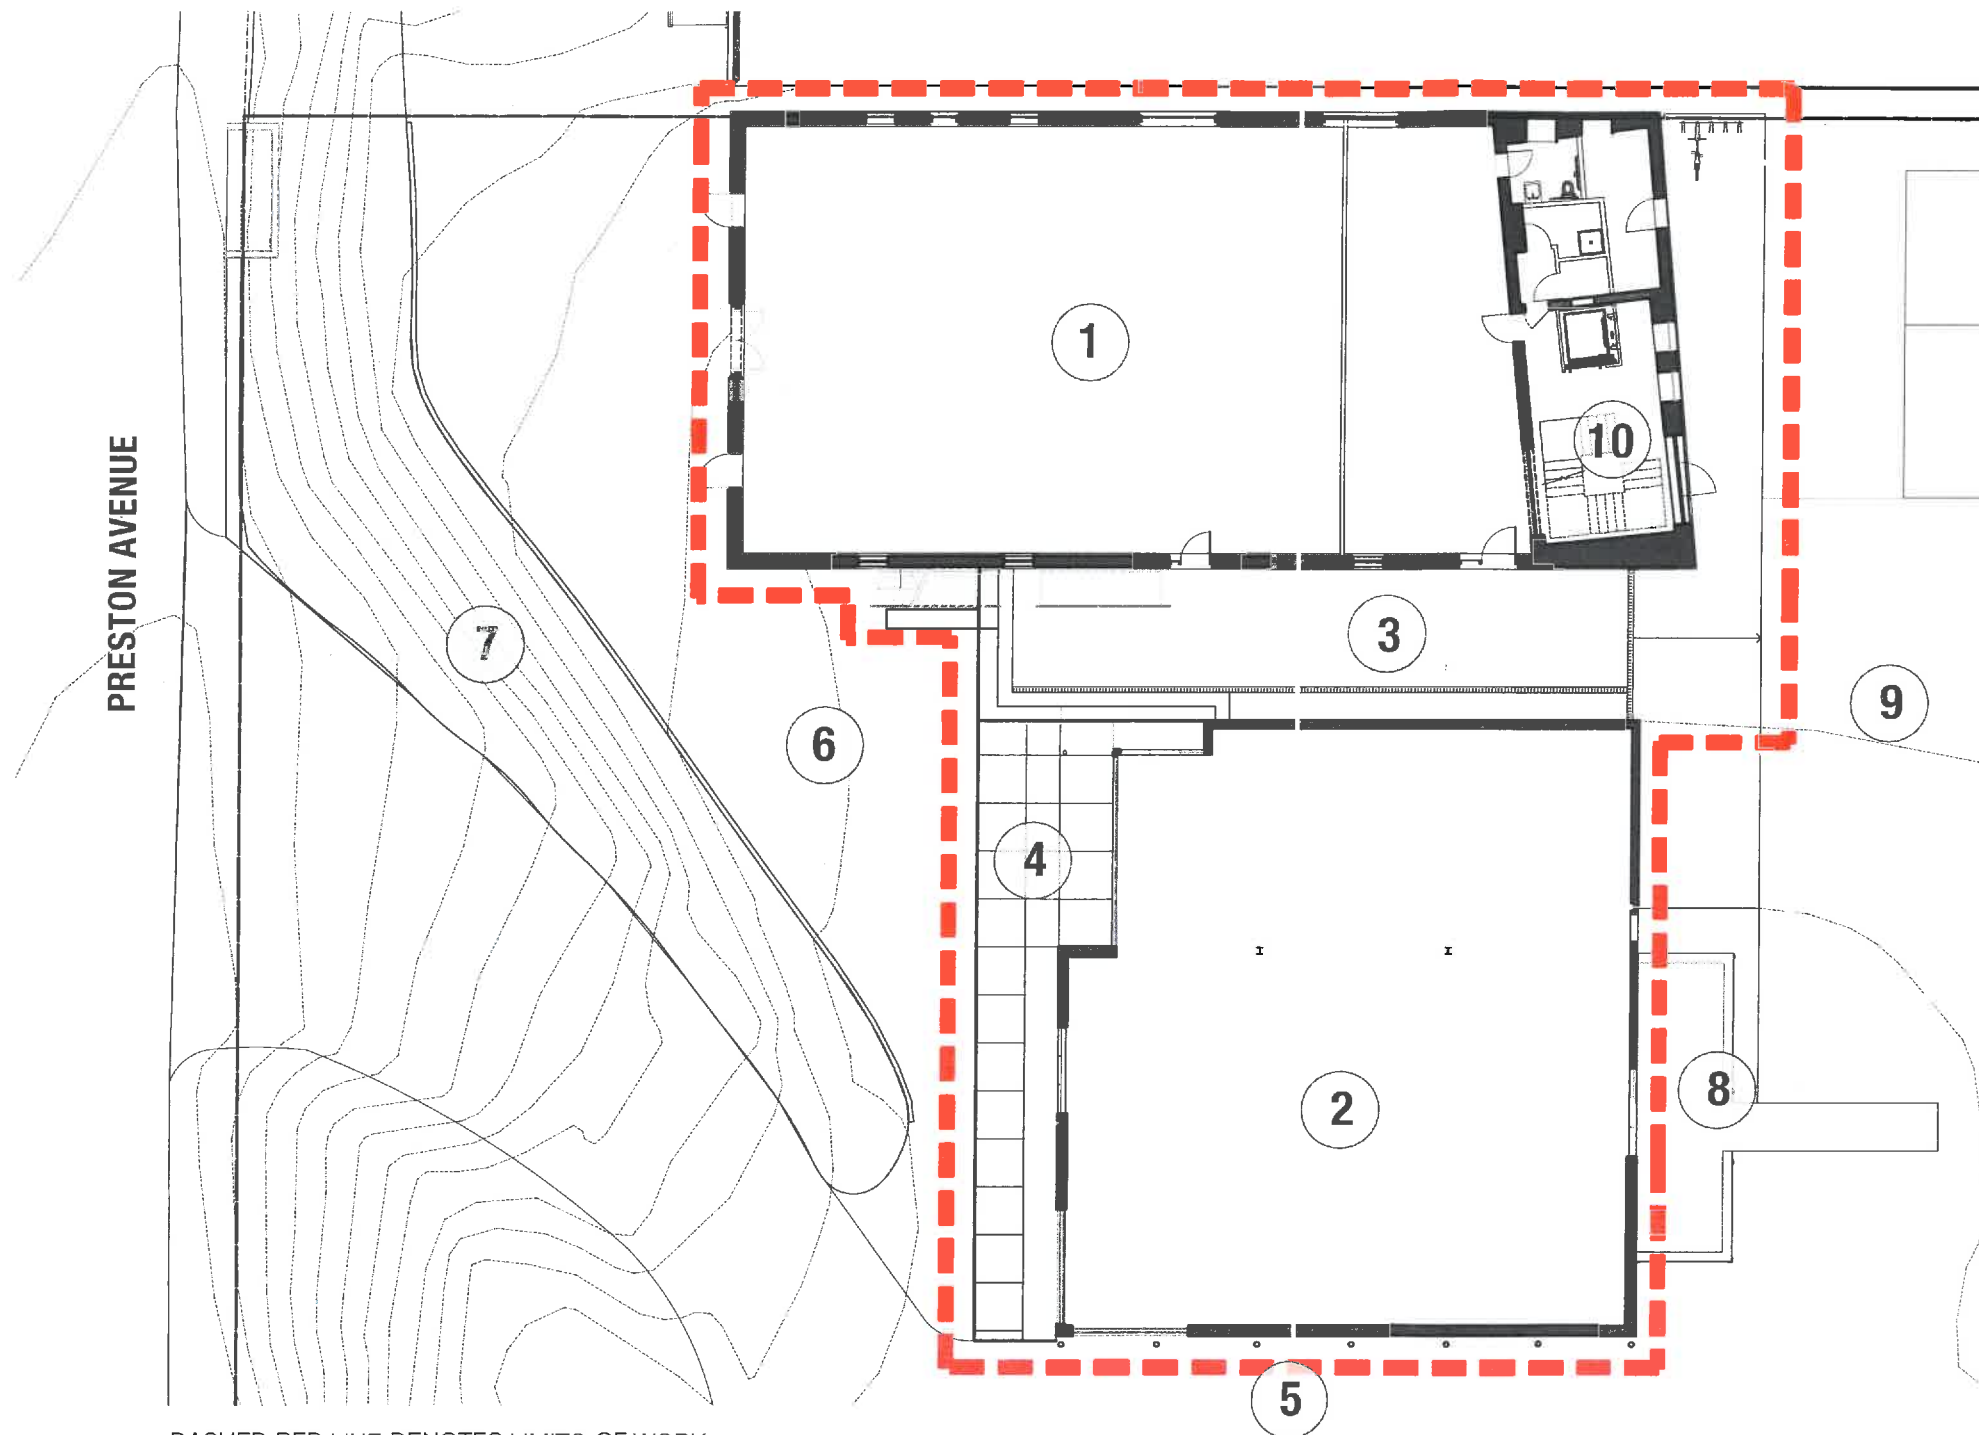
DASHED RED LINE DENOTES LIMITS OF WORK

- 1** KING LUMBER BUILDING
- 2** ANNEX BUILDING
- 3** NEW EXTERIOR GALLERY SPACE BETWEEN THE TWO STRUCTURES WILL PROVIDE A PEDESTRIAN AXIS THROUGH THE SITE
- 4** NEW SIDEWALK PATH ALONG ANNEX
- 5** REPAIR AND REPLACE GUARD AS NECESSARY ON WEST SIDE OF ANNEX
- 6** EXISTING ASPHALT SURFACE TO REMAIN; REPAIR AS NEEDED
- 7** EXISTING PLANTED AREA / MEDIAN TO REMAIN
- 8** EXISTING COVERED BACK PORCH AND ACCESSIBLE RAMP AT ANNEX TO REMAIN
- 9** EXISTING REAR PARKING TO REMAIN
- 10** STAIR AND ELEVATOR MOVED TO INTERIOR OF KING LUMBER BUILDING

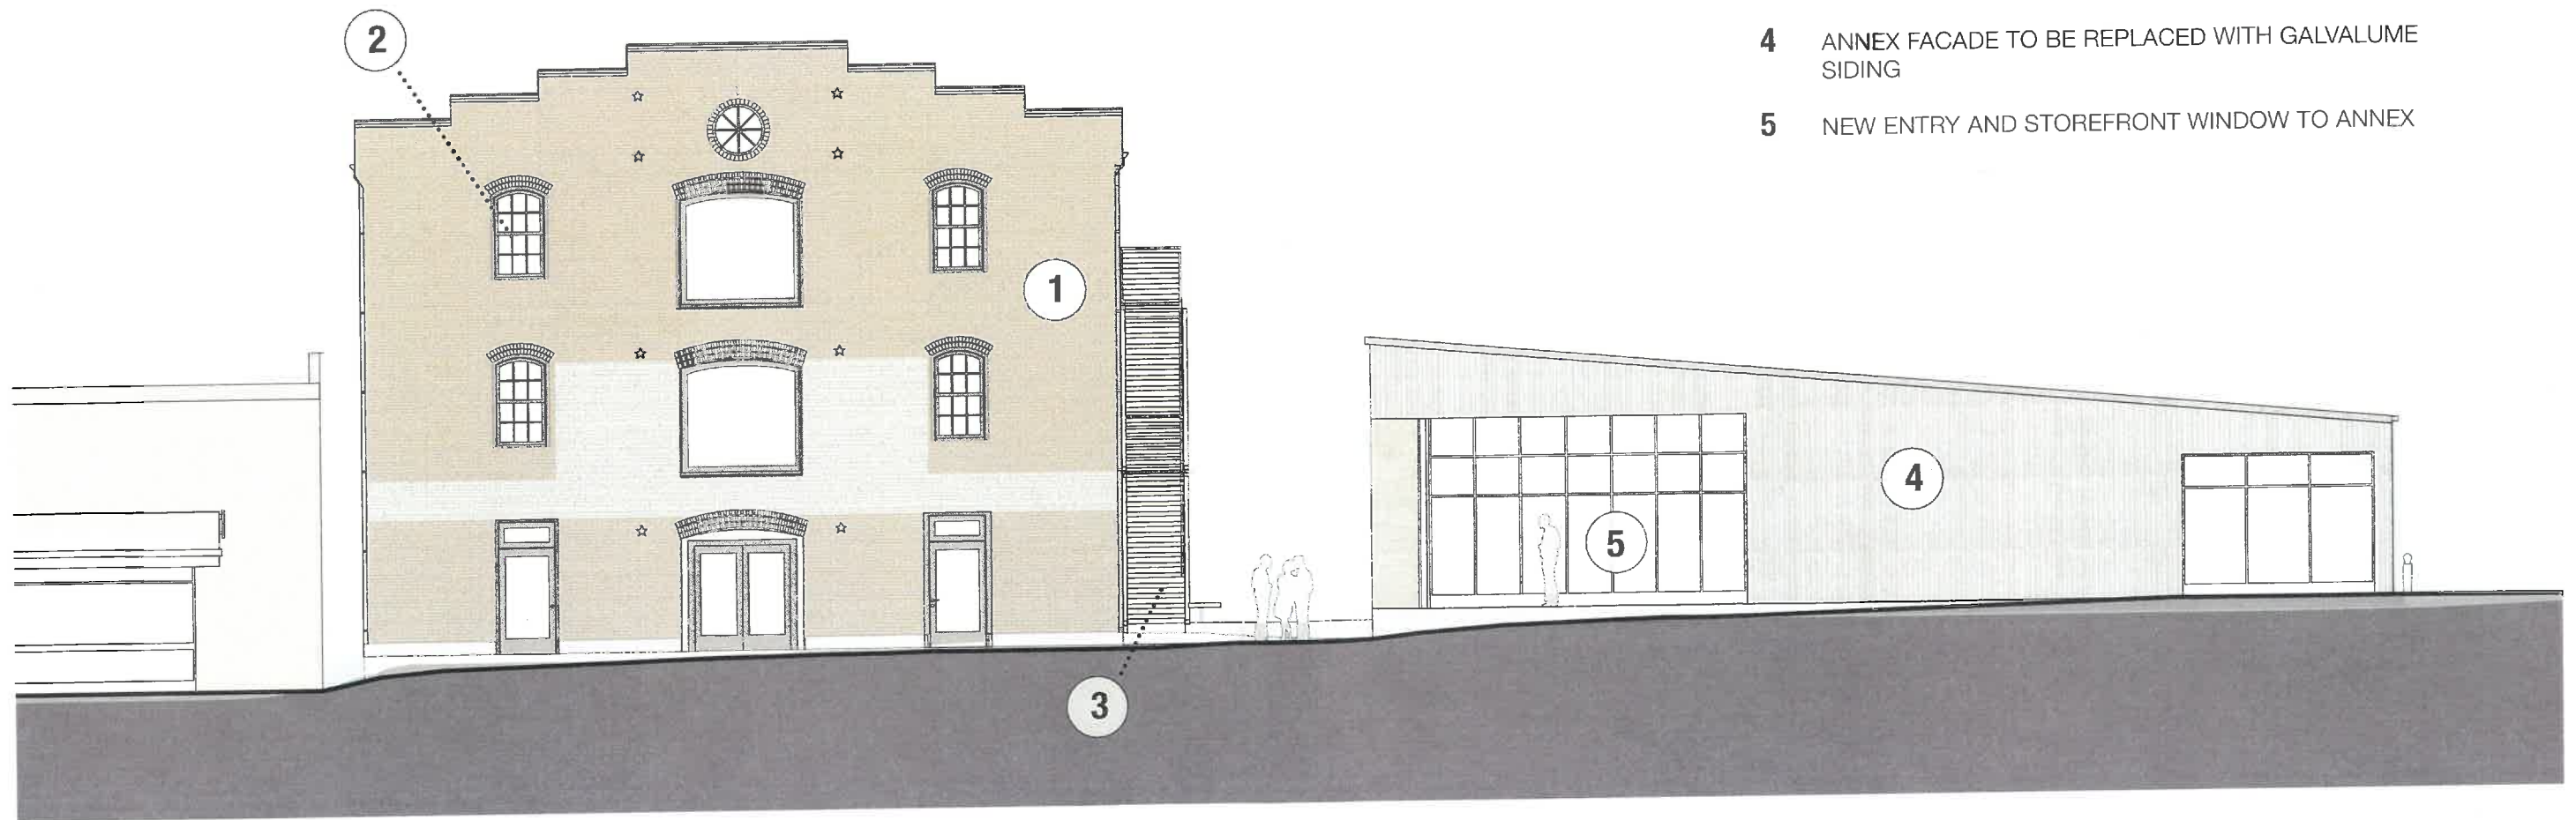
NORTH ELEVATION
SCALE: 3/32" = 1'-0"

- 1 BRICK FACADE TO BE REPAIRED AND REPAINTED
- 2 EXISTING AND BRICKED OPENINGS TO BE RESTORED AND REPLACED WITH NEW WINDOWS AND DOORS
- 3 NEW EXTERIOR STAIR
- 4 ANNEX FACADE TO BE REPLACED WITH GALVALUME SIDING
- 5 NEW ENTRY AND STOREFRONT WINDOW TO ANNEX

Re: the windows on the north

Our intention is to go with arched top center windows on the north elevation - unchanged from our previous submission.

But the arch is more elegant and that's our proposal.

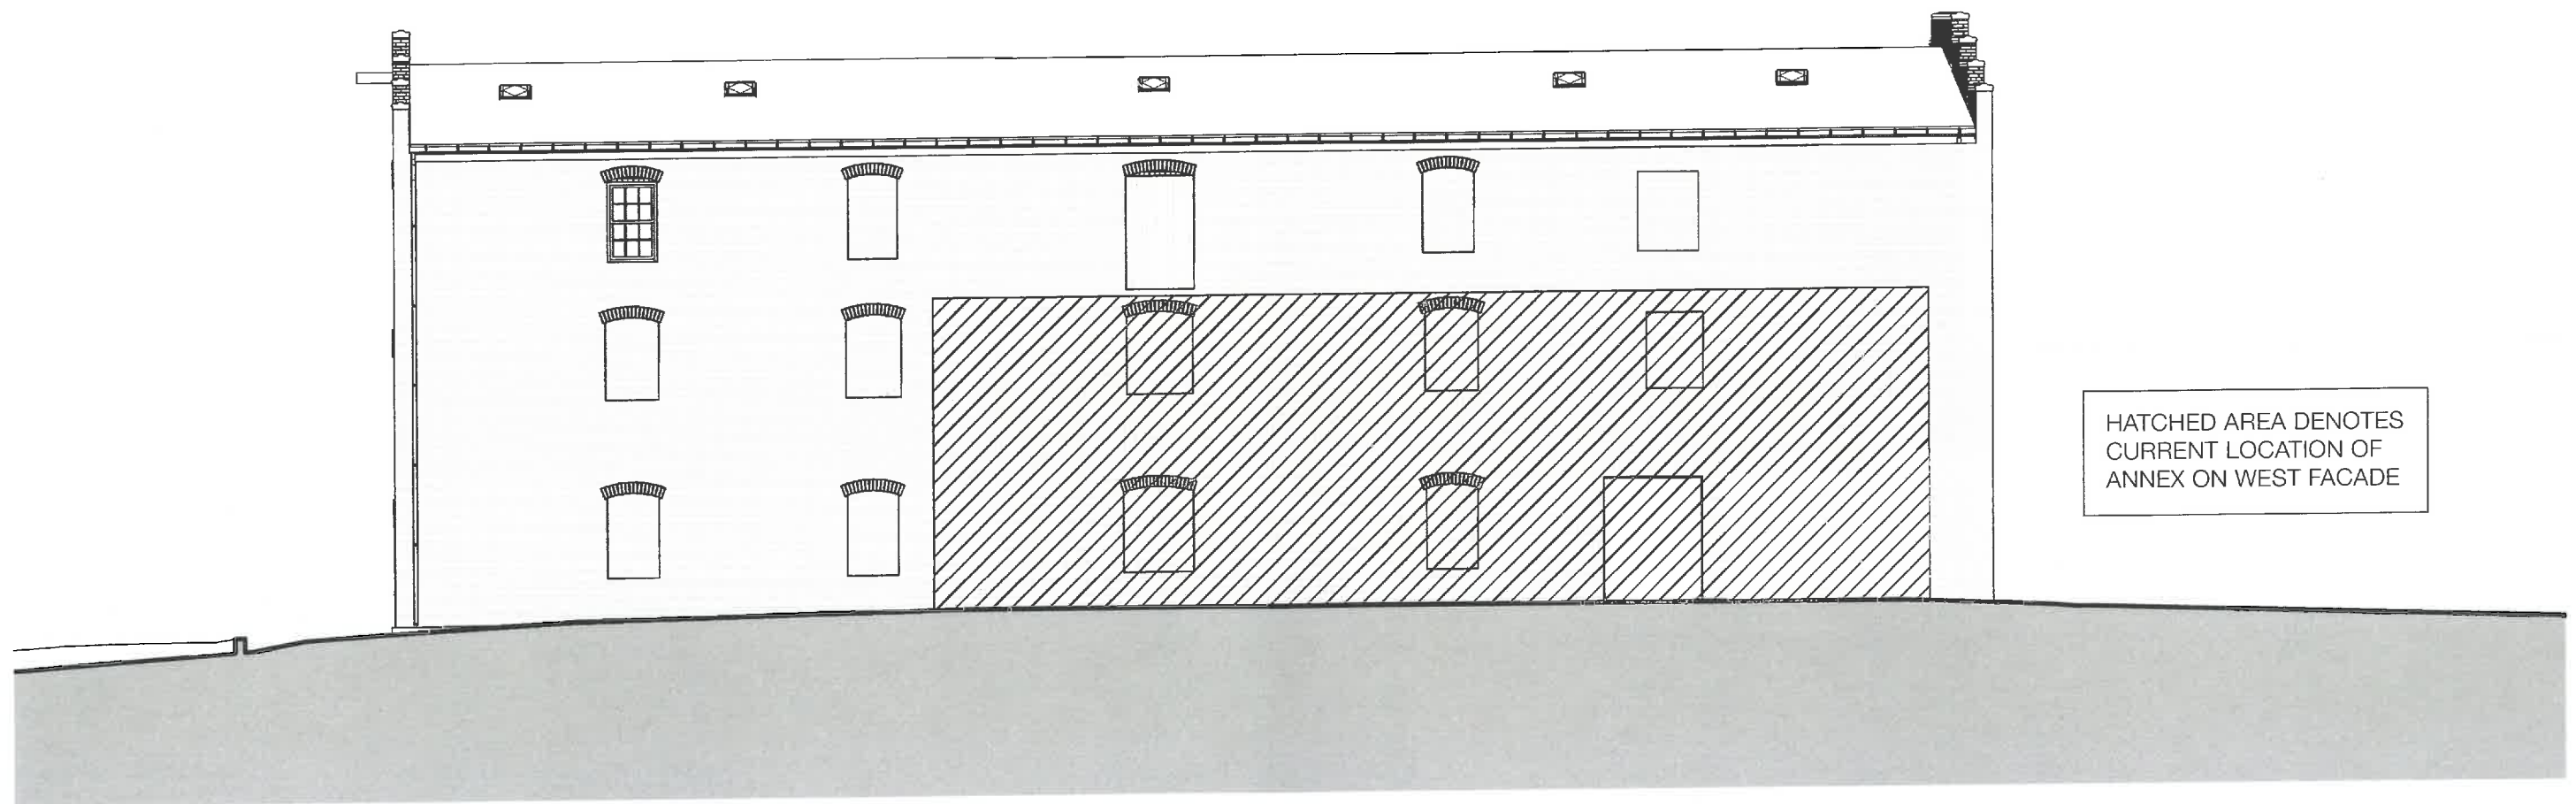
WEST ELEVATION - EXISTING CONDITIONS
SCALE: 3/32" = 1'-0"

HATCHED AREA DENOTES
CURRENT LOCATION OF
ANNEX ON WEST FACADE

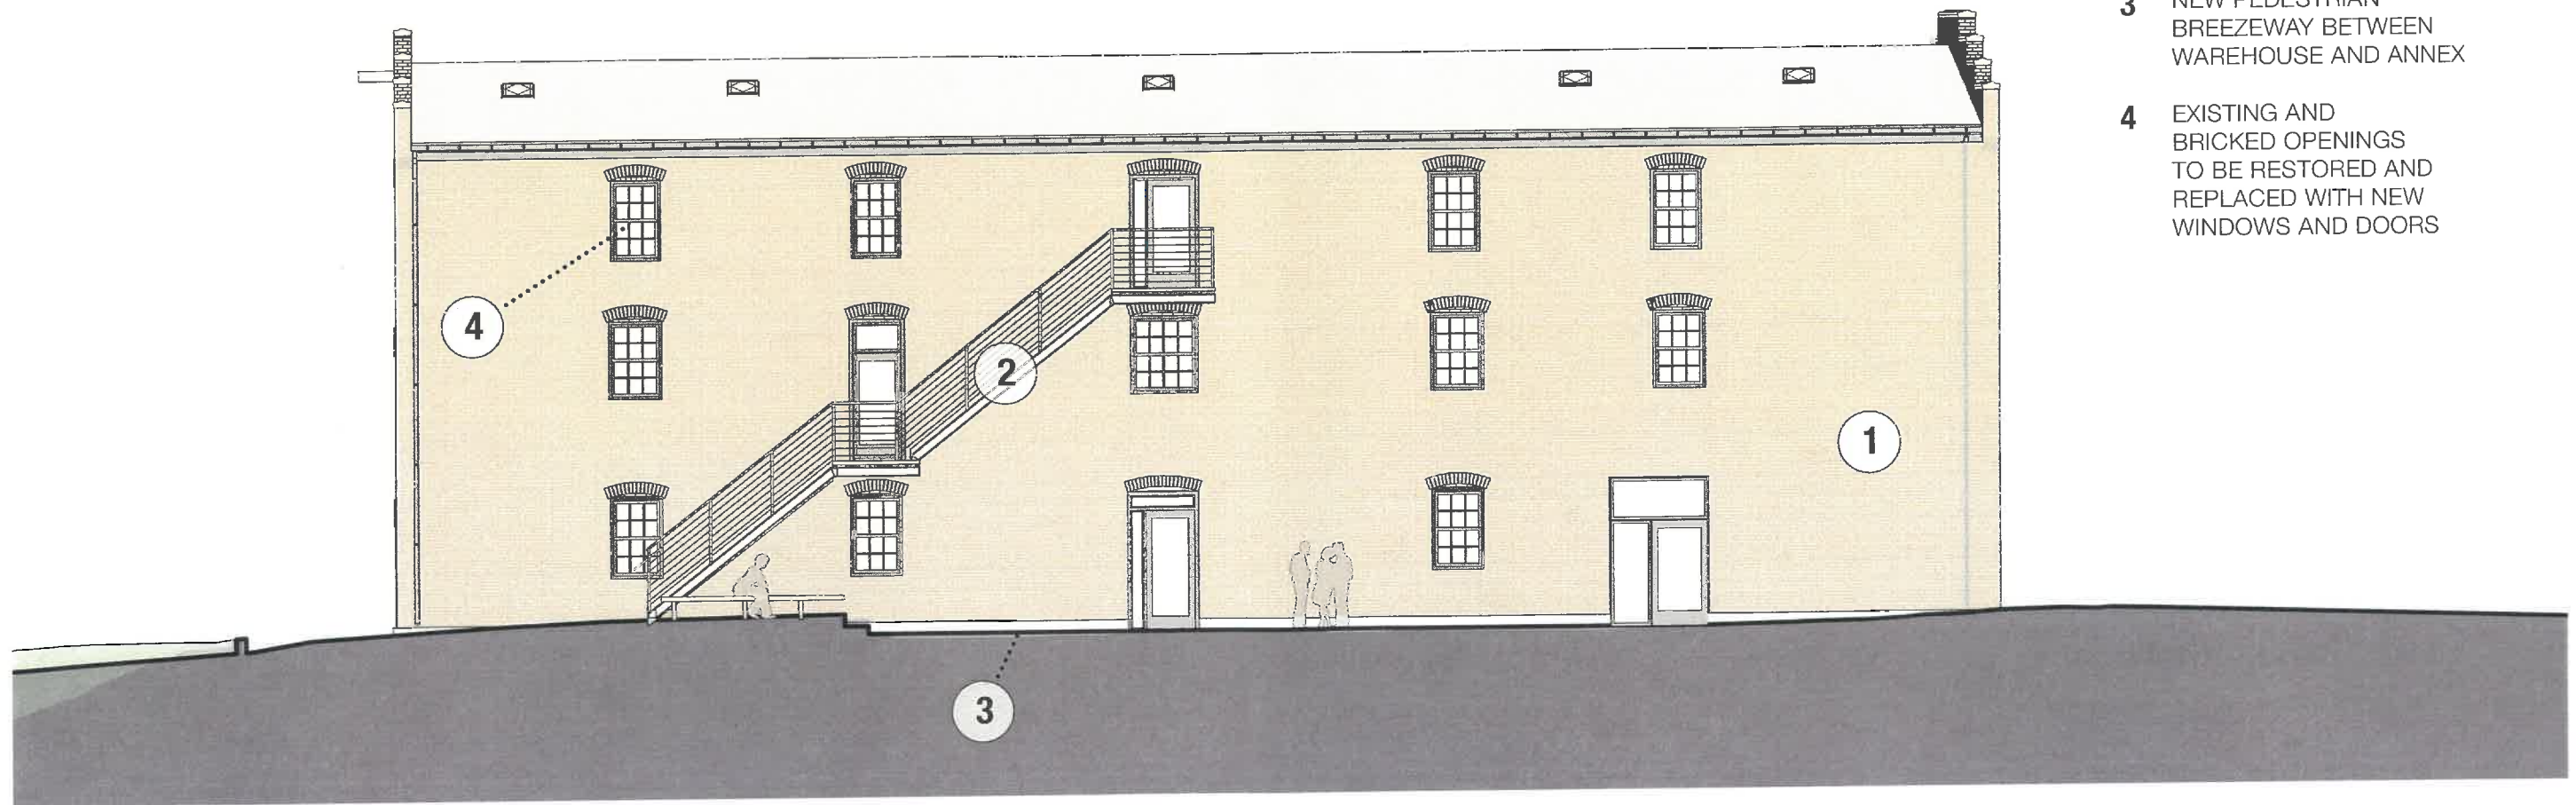
WEST ELEVATION
SCALE: 3/32" = 1'-0"

- 1 BRICK FACADE TO BE REPAIRED AND REPAINTED
- 2 NEW EXTERIOR STAIR
- 3 NEW PEDESTRIAN BREEZEWAY BETWEEN WAREHOUSE AND ANNEX
- 4 EXISTING AND BRICKED OPENINGS TO BE RESTORED AND REPLACED WITH NEW WINDOWS AND DOORS

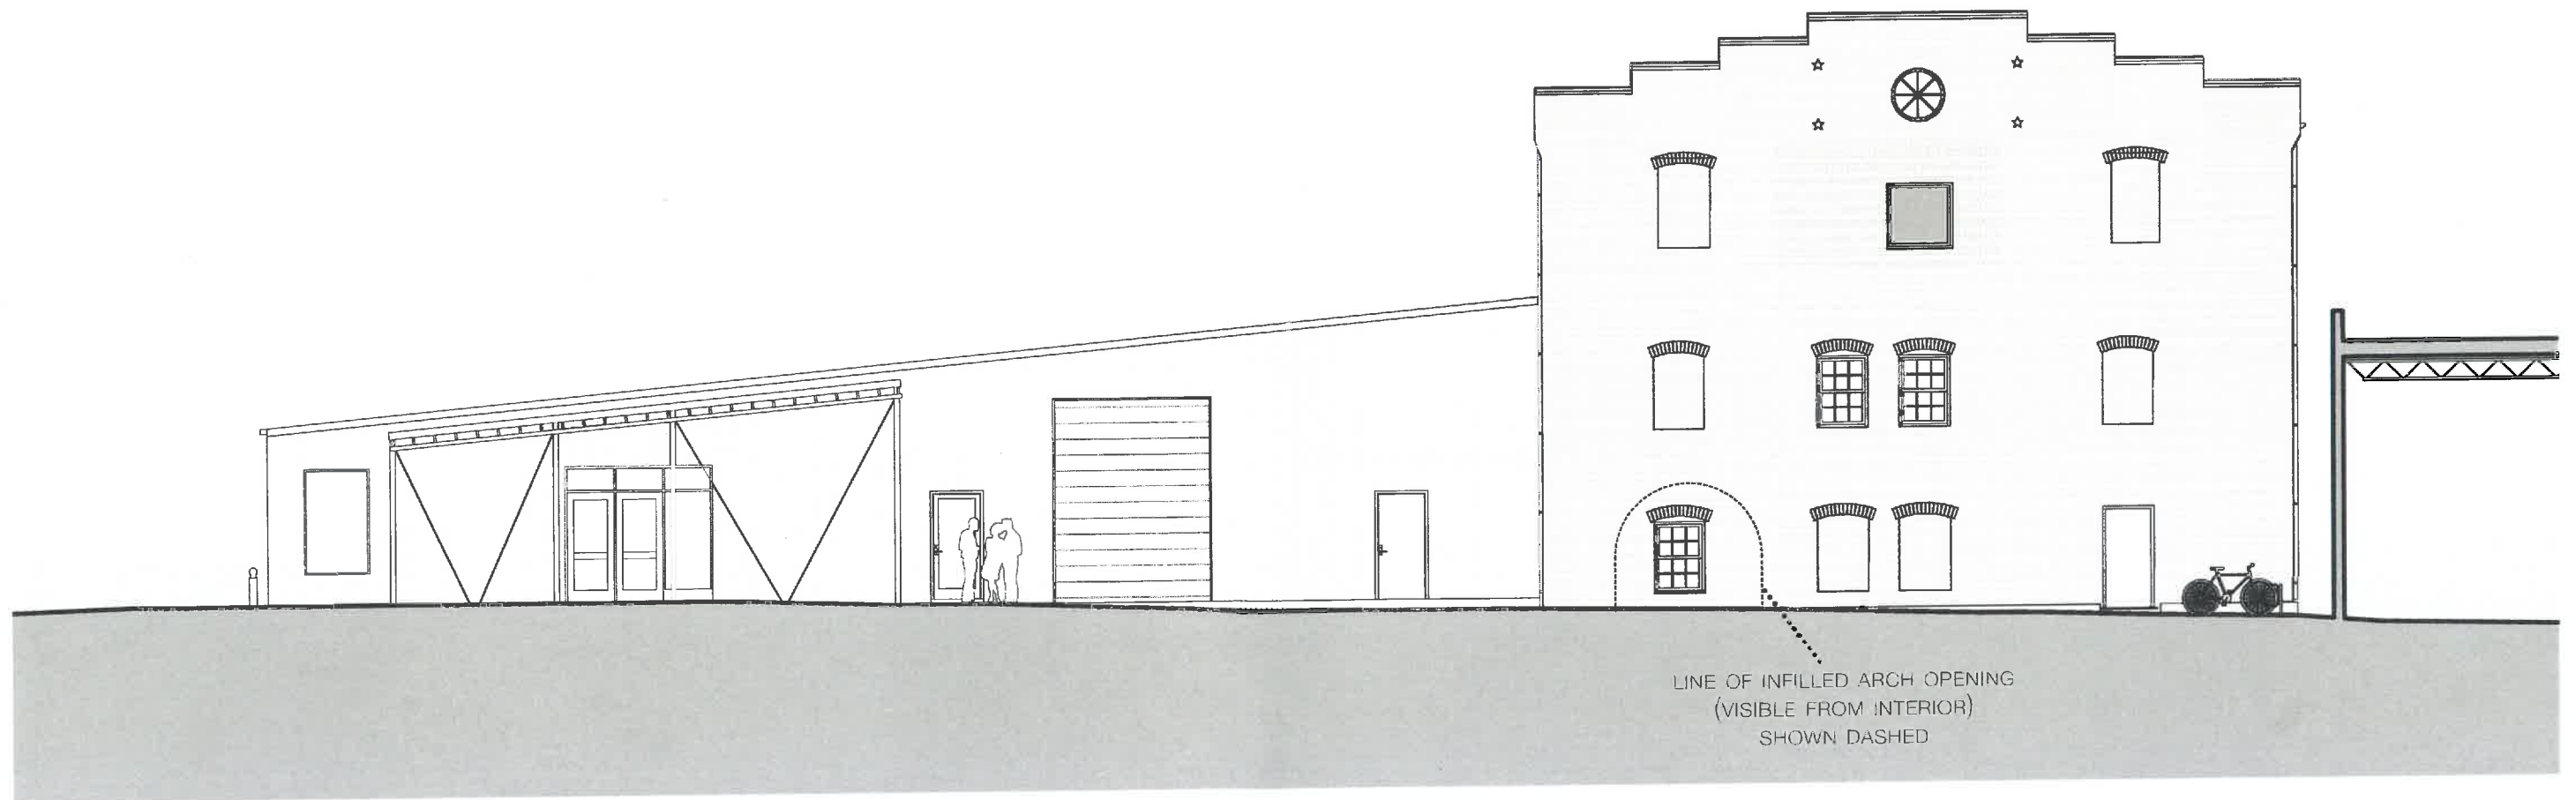
SOUTH ELEVATION - EXISTING CONDITIONS
SCALE: 3/32" = 1'-0"

LINE OF INFILLED ARCH OPENING
(VISIBLE FROM INTERIOR)
SHOWN DASHED

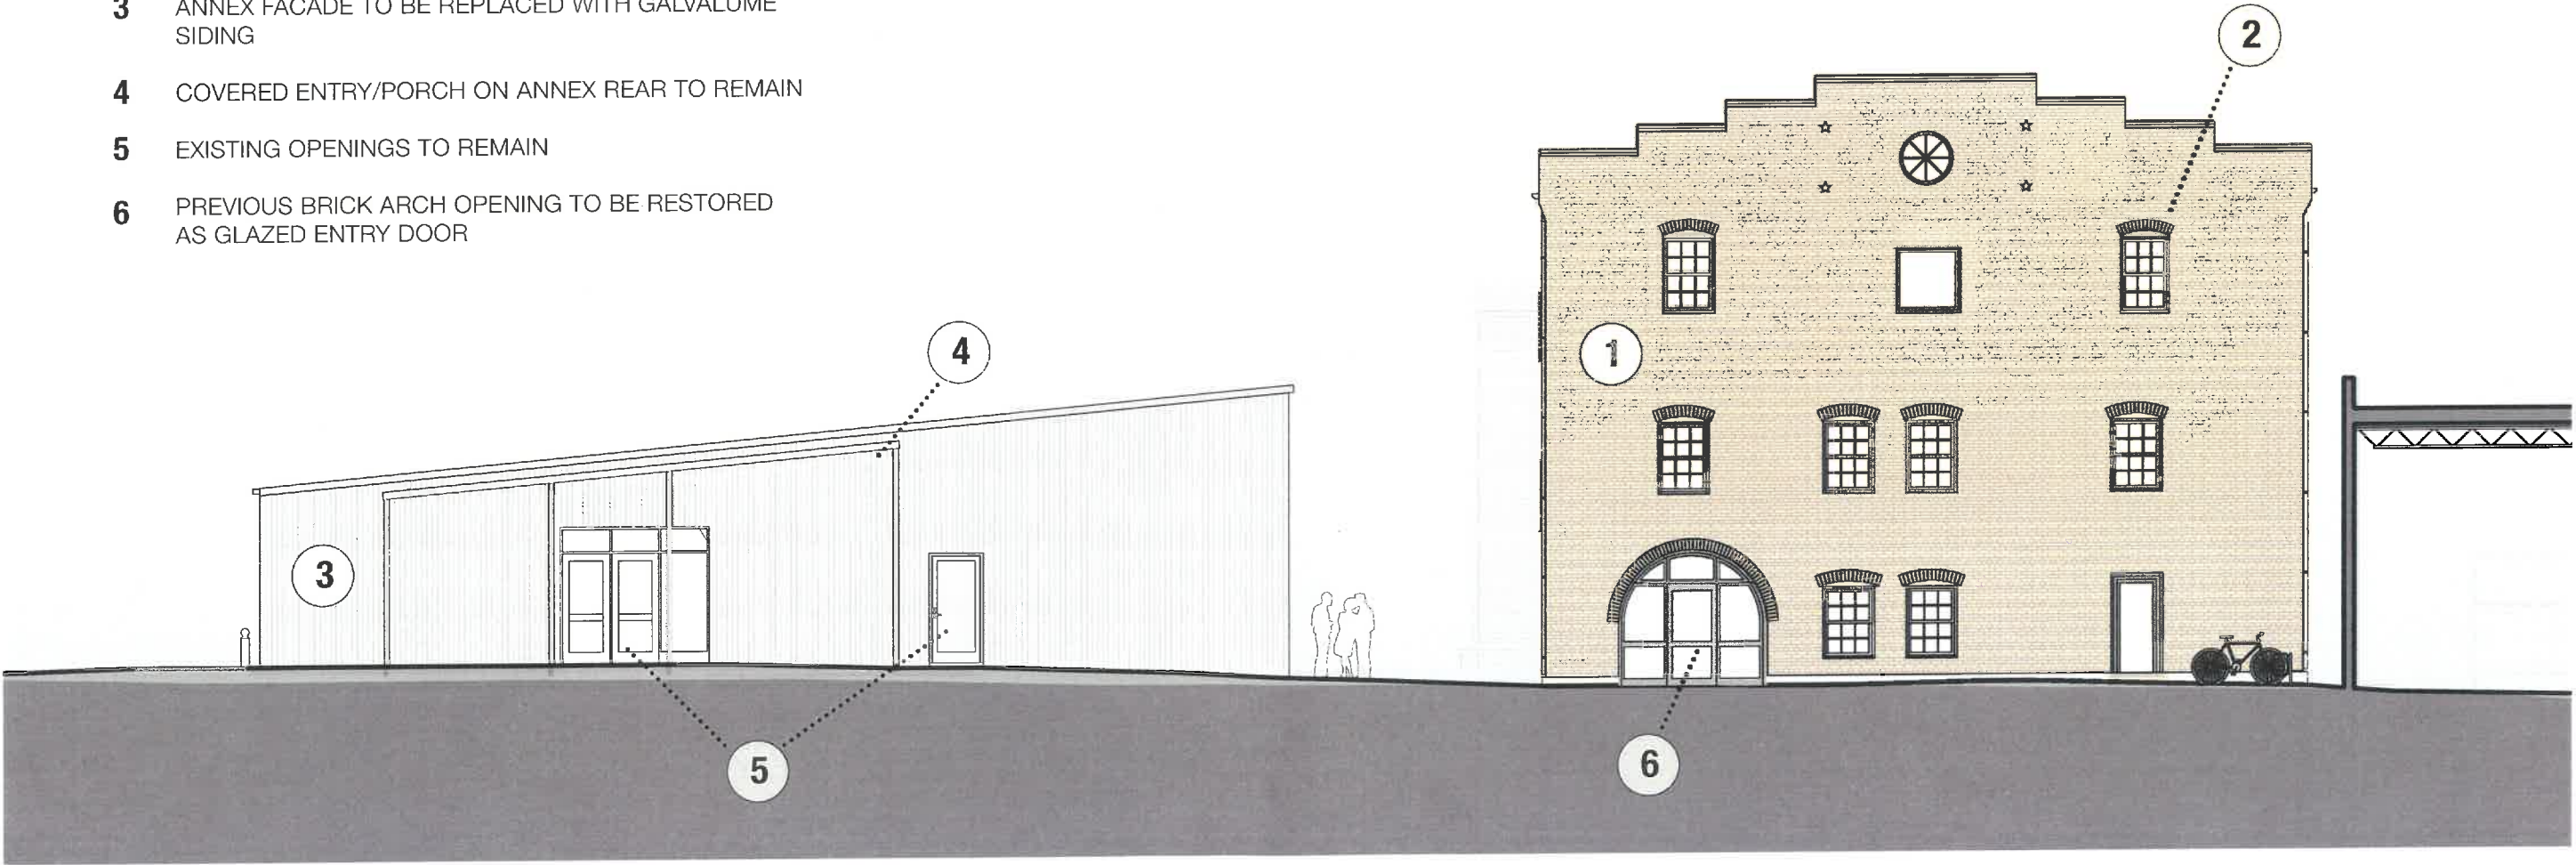
SOUTH ELEVATION
SCALE: 3/32" = 1'-0"

- 1 BRICK FACADE TO BE REPAIRED AND REPAINTED
- 2 EXISTING AND BRICKED OPENINGS TO BE RESTORED AND REPLACED WITH NEW WINDOWS AND DOORS
- 3 ANNEX FACADE TO BE REPLACED WITH GALVALUME SIDING
- 4 COVERED ENTRY/PORCH ON ANNEX REAR TO REMAIN
- 5 EXISTING OPENINGS TO REMAIN
- 6 PREVIOUS BRICK ARCH OPENING TO BE RESTORED AS GLAZED ENTRY DOOR

- The new tower and bridge elements have been eliminated. The stair and elevator will be moved to the interior of the building.
- On the rear elevation a previous brick arch opening will be restored as a glazed entry door.

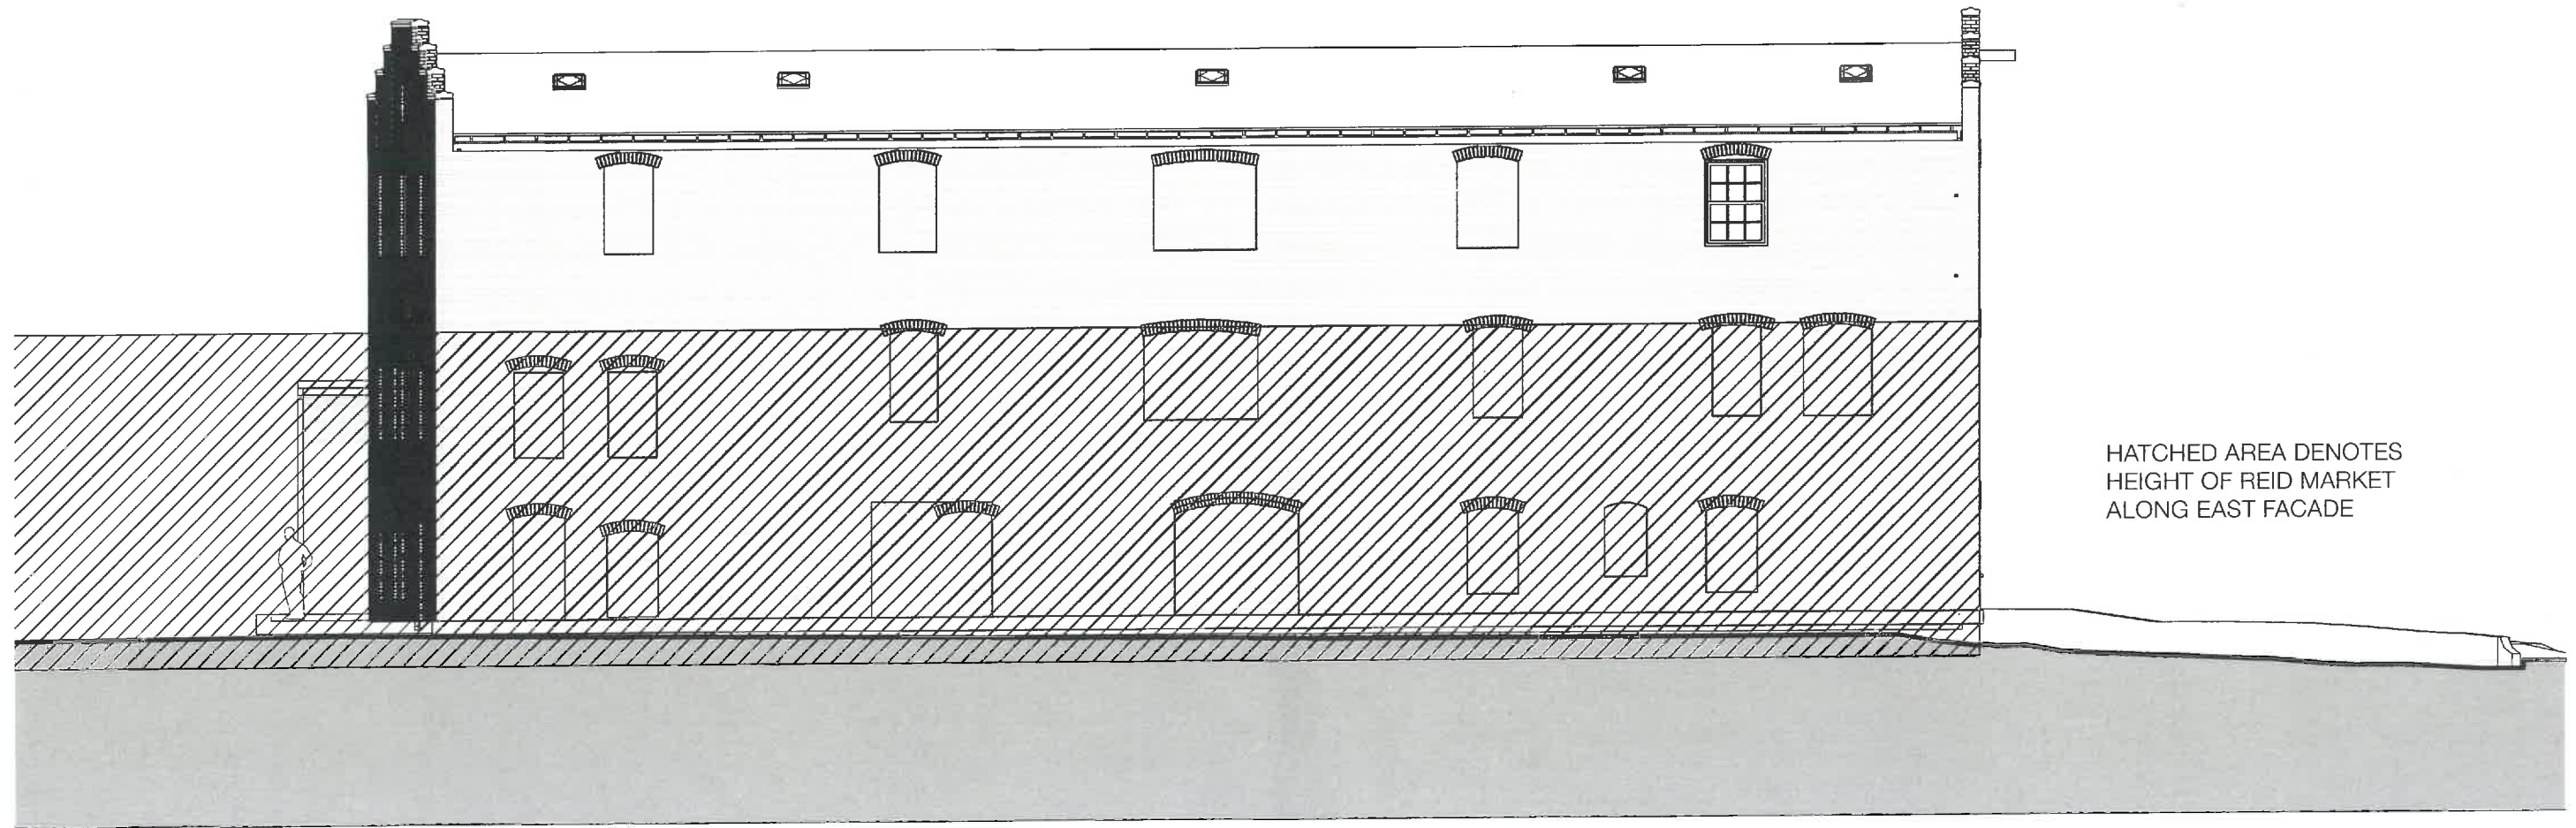
EAST ELEVATION - EXISTING CONDITIONS
SCALE: 3/32" = 1'-0"

HATCHED AREA DENOTES
HEIGHT OF REID MARKET
ALONG EAST FACADE
