BAR 15-02-04
608 Preston Ave
Tax Parcel 320014000
King Lumber Partners, LLC, Owners/ Mark Green, Applicant
Revisions to renovation plan

**CITY OF CHARLOTTESVILLE
BOARD OF ARCHITECTURAL REVIEW
STAFF REPORT
April 21, 2015**

BAR 15-04-05
608 Preston Avenue
Tax Parcel 320014000
King Lumber Partners, LLC, Owners/ Mark Green, Applicant
Revisions to renovation plan

KING LUMBER BUILDING RENOVATION

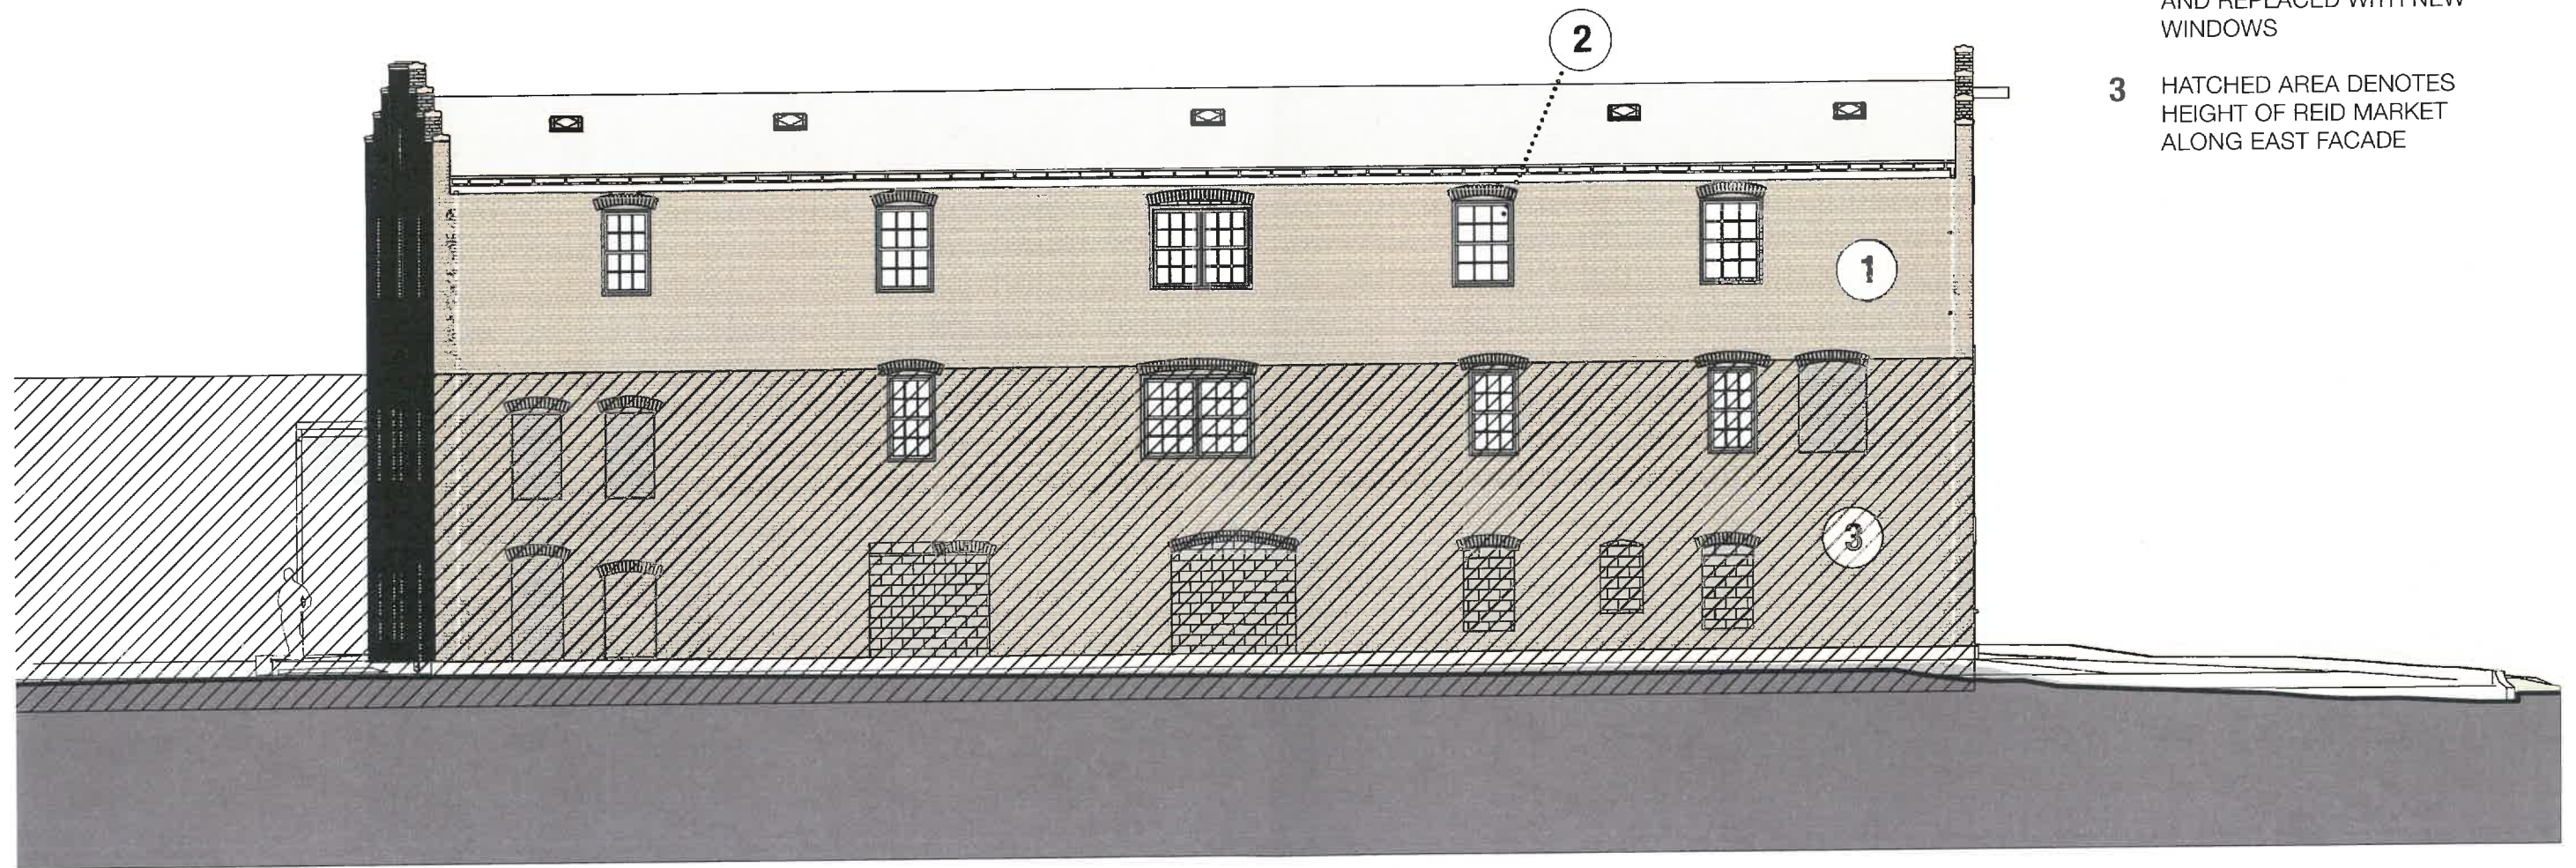
EAST ELEVATION
SCALE: 3/32" = 1'-0"

- 1 BRICK FACADE TO BE REPAIRED AND REPAINTED
- 2 OPENINGS SHOWN AS GLAZED TO BE RESTORED AND REPLACED WITH NEW WINDOWS
- 3 HATCHED AREA DENOTES HEIGHT OF REID MARKET ALONG EAST FACADE

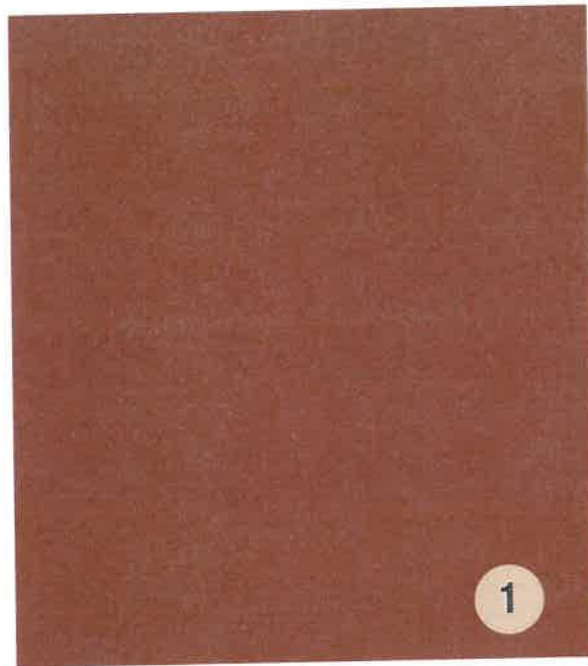
1

- 1** BRICK: PAINTED WITH
BENJAMIN MOORE 2094-30
GIANT SEQUOIA

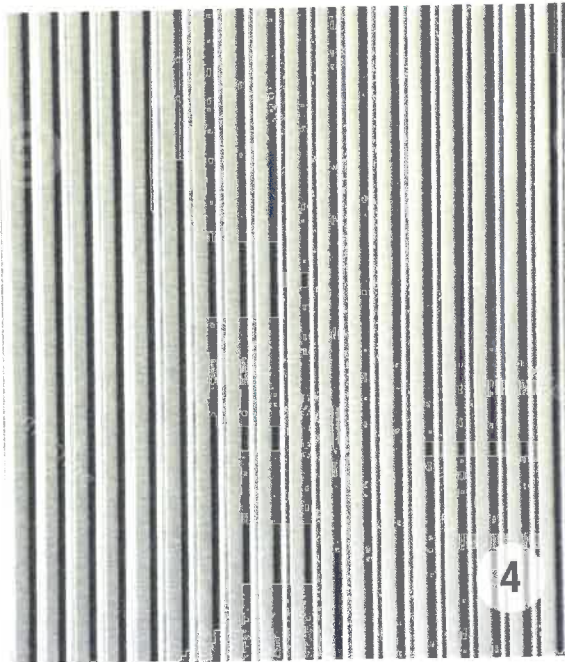
4

- 4** REPLACEMENT SIDING
