Architectural And Historic Survey

STREET ADDRESS: 1614 Brandywine Drive

DATE / PERIOD: c. 1760? & early 1800's, moved 1984

HISTORIC LANDMARKS COMMISSION - DEPARTMENT OF COMMUNITY DEVELOPMENT

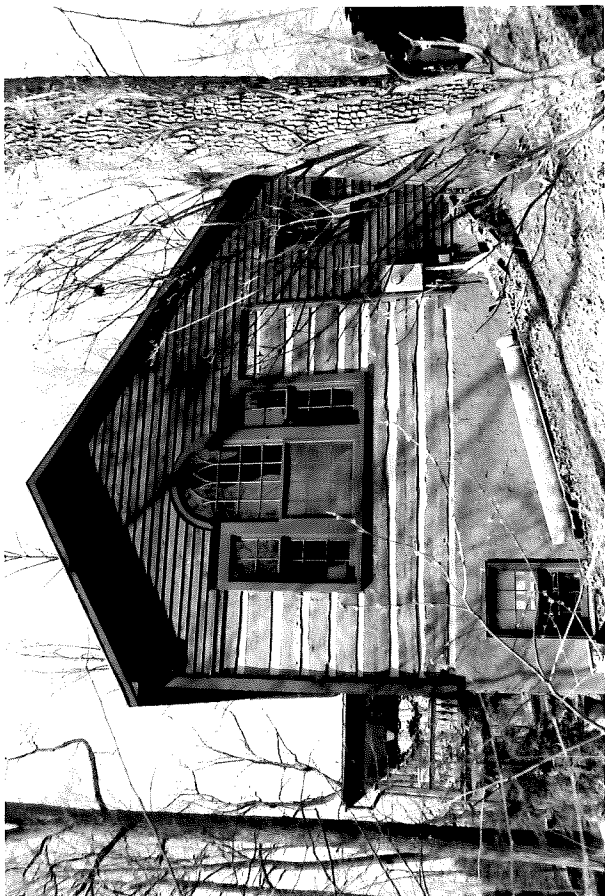
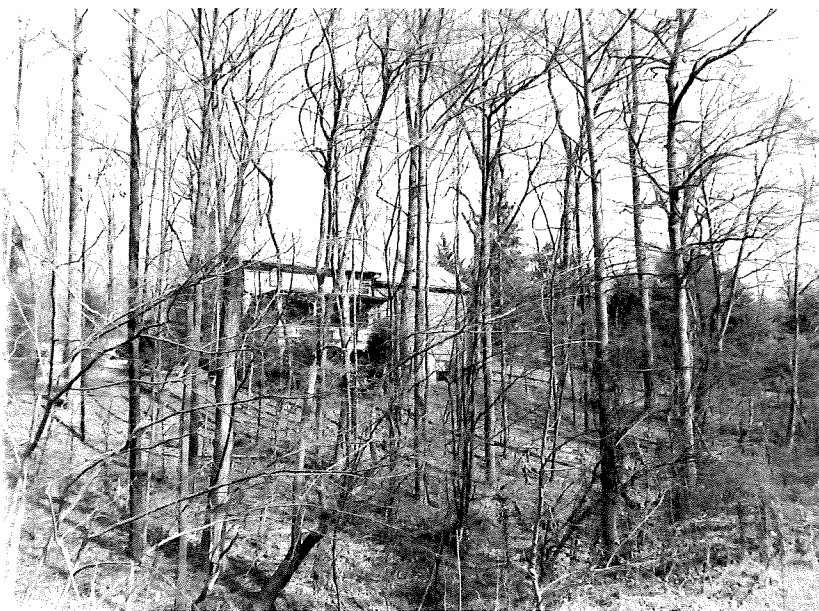
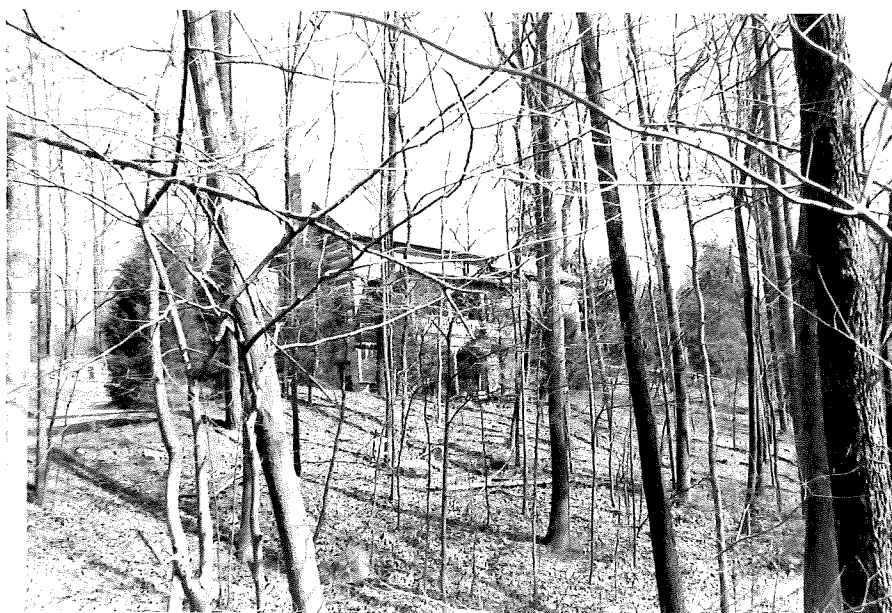
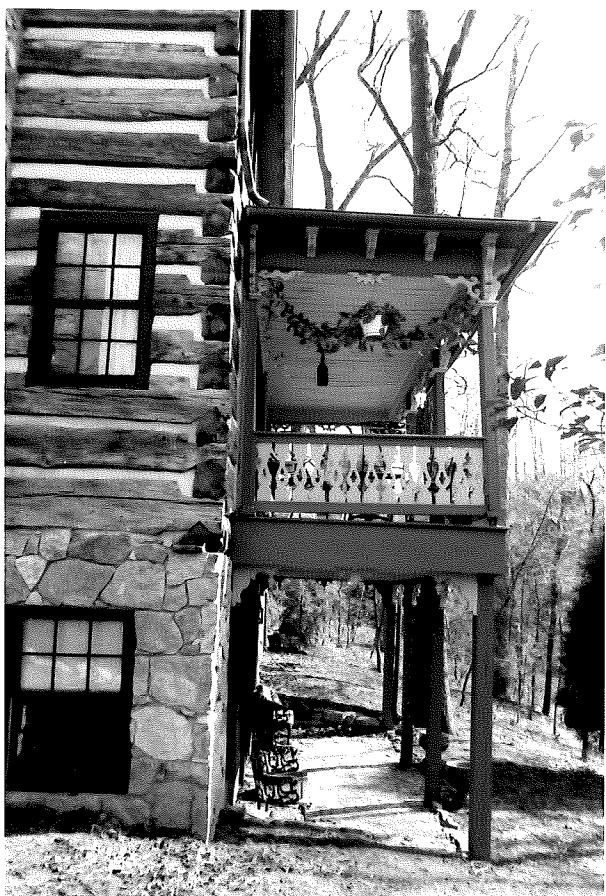
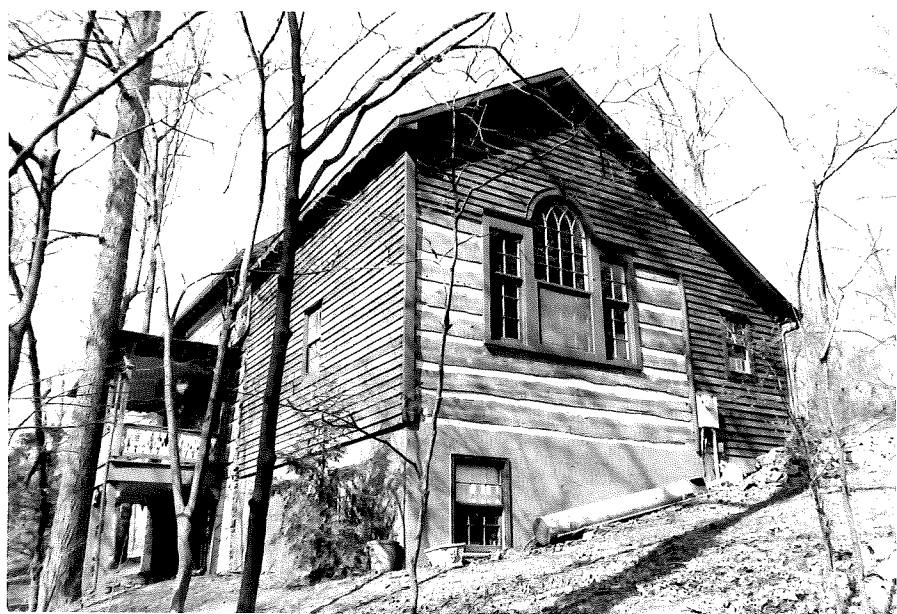
The Caddell House consists of 2-storey and 1½-storey log houses joined end to end. It is set on a foundation of limestone originally used in dependencies at the site of the larger building. The new site is a steep hillside, so that while the foundation is low on the northern side, the basement is above ground on the southern side. Both sections have steep gable roofs covered with standing-seam metal. Both have projecting eaves and verges, boxed cornices, and scalloped wooden eaves trim. First storey windows in this section are double-sash, 6-over-6 light, with plain trim. They are original to the house, but are not 18th century. Second storey windows are slightly narrower 4-over-4 light, and some appear to be replacements. Four-light casement windows flank the chimney at the second storey level. Window and door surrounds are painted dark red. Faded traces of the same color on discarded scraps in the yard suggest that this may have been the original color. The northern facade, with its simple board-&-batten entrance door in the center bay, was originally the rear elevation. A one-storey Victorian veranda painted in two shades of gray-brown covers most of the southern elevation, the original facade. It has a nearly flat hip roof covered with standing-seam metal, a boxed cornice with brackets, a plain frieze with sunrise pendants, rectangular posts with sawn brackets, and an unusual sawn balustrade with a pineapple motif. The stair has been removed. Within the veranda, the wall is faced with flush vertical siding. The former front door, which now only gives access to the veranda, has six panels, the center two of which have been replaced with glass. The screen door has sunburst brackets in all corners. On the present site, there is a basement level porch below the veranda. It has plain square piers, brackets with ball pendants, and sawn pendants between the piers. The basement door has louvered shutters, and basement windows are slightly wider 6-over-6 light. Interior partitions in the two-storey section have been removed to make a single large room on each level. The owners have kept one original, but used a simpler one on the one fireplace that was reconstructed on the new site. The 2-flight enclosed corner stair was relocated in the wing. The wing is a storey and a half in height and was originally a free-standing house. Wall construction is of pit-sawn logs with half-dovetail joints. The walls were once faced with weatherboarding, but the logs are now exposed on the northern and eastern elevations. There is now no chimney in this section; there probably was one at the northwest end where this house was joined to the other. On the northeastern elevation of this section, the roof continues at the same pitch over a small weatherboarded addition with a small porch at its northwestern end. The single Tuscan porch column was salvaged from a different building, as the large 4-paneled Greek Revival entrance door with moulded surrounds and narrow 3-light sidelights over panels. On the interior, two more Tuscan columns (also not original) frame the arch between the addition and the rest of the 1½-storey section. Walls in the addition are faced with vertical paneling. Except for a 4-light casement window on the southern elevation and one in the addition, no original windows remain in this section. A massive Palladian window with Gothic tracery, salvaged from a house near Charlottesville, dominates the southeastern elevation.
