Architectural And Historic Survey

STREET ADDRESS: 133 Chancellor Street	HISTORIC NAME: Saint Anthony Hall
MAP & PARCEL: 9-131	DATE / PERIOD: 1902, c. 1910's
CENSUS TRACT AND BLOCK:	STYLE: Colonial Revival
PRESENT ZONING:	HEIGHT (to cornice) OR STORIES: 2 storeys
ORIGINAL OWNER: The Saint Anthony Alumni Assoc. of Va.	DIMENSIONS AND LAND AREA: 78' x 220' (14,850 sq. ft.)
ORIGINAL USE: Fraternity House	CONDITION: Good
PRESENT USE: Fraternity House	SURVEYOR: Bibb
PRESENT OWNER: The Saint Anthony Alumni Assoc. of Va.	DATE OF SURVEY: Winter 1983
ADDRESS: 308 Albemarle Avenue Richmond, VA 23226	SOURCES: City/County Records Sanborn Map Co. - 1920 Timothy Bishop, "Fraternity Houses at U.VA."

Street address	133 Chancellor St.		
Town/City	Charlottesville		
Historic name	St. Anthony Hall	Common name	same Delta Psi Fraternity House

1. Name of property: Saint Anthony Hall

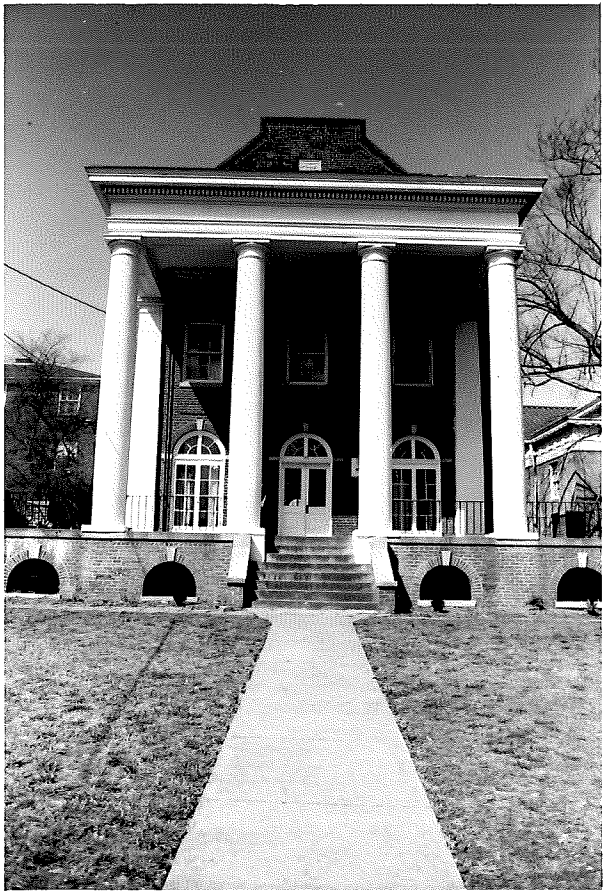
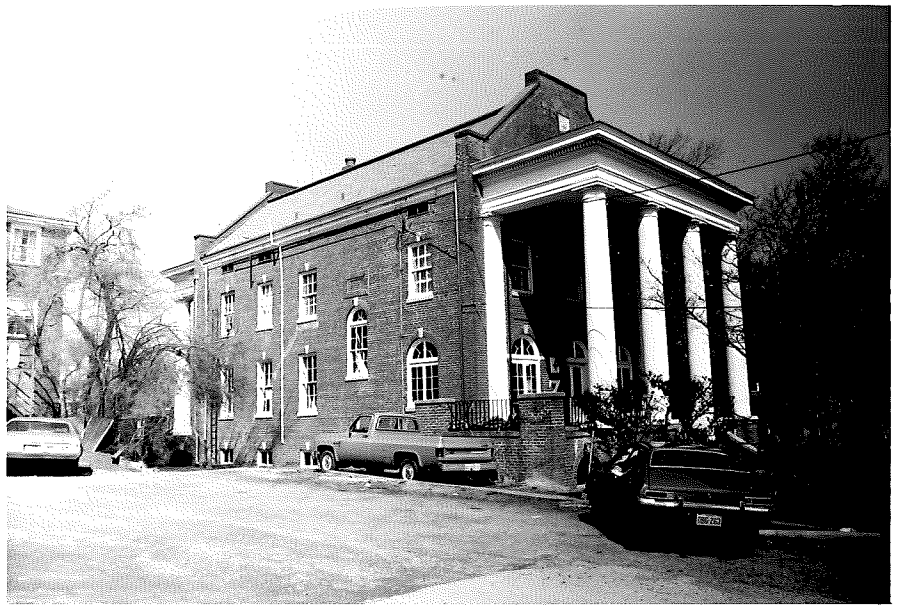
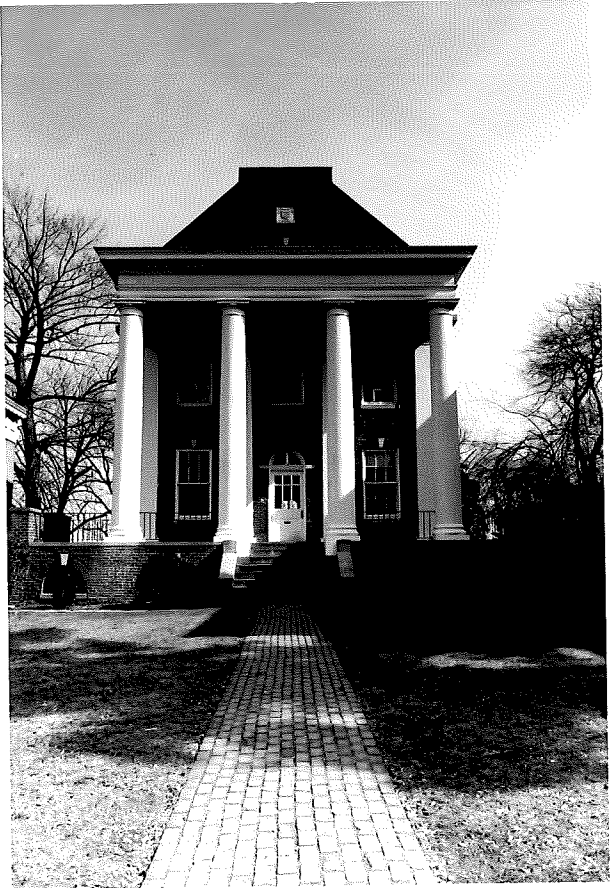
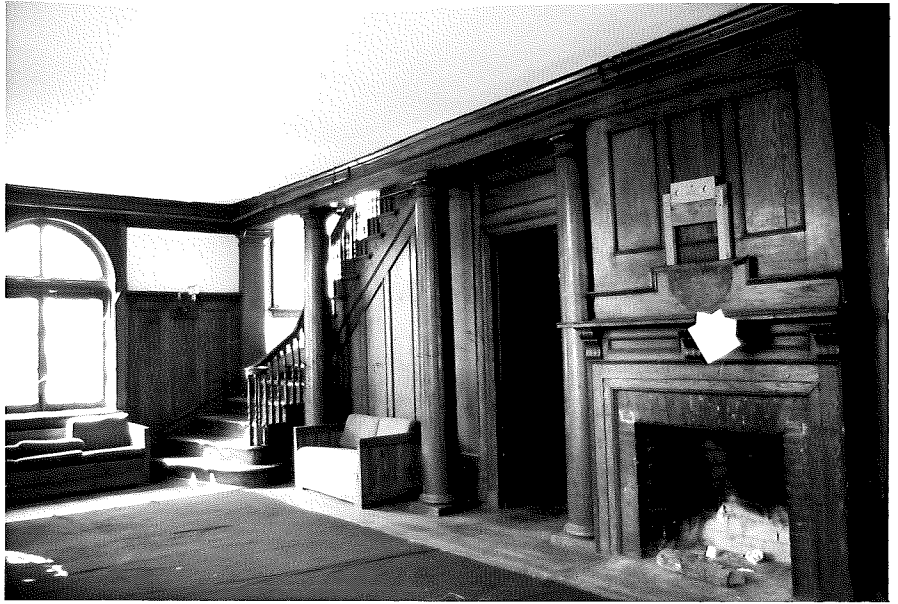
Saint Anthony Hall is a tall and narrow building on a high foundation with 3-bay parapet-gabled facades on both Chancellor Street and Madison Lane. While the basic form is Colonial Revival, many details are Victorian. Walls and foundation are constructed of brick laid in 5-course American bond. Flush bands of vertical headers form the water table and a single stringcourse above the second storey. The high-pitched gable roof is covered with composition shingles and has close eaves with a boxed cornice with dentil moulding. The parapet gables terminate in corner buttresses. There is a circular-headed attic window in the parapet gable above each portico, and above that, a panel with the fraternity insignia. One interior chimney serves two fireplaces. Two-storey flat-roofed Tuscan porticoes cover both eastern and western facades. Their entablatures have dentil moulding. The western (Madison Lane) facade, not having had a portico originally, is also pilastered. The central entrances have round arches with concrete keystones and end blocks. The doors have six lights over a single panel, with half-round transoms with tracery. There is a pair of 12-light French doors with half-round transoms in each side bay of the eastern (Chancellor Street) facade. Most windows are double-sash, 6-over-6 light, with architrave trim and jack arches with stone keystones. Windows at the second level are somewhat shorter, and there are raised brick panels between the first and second levels. There are also several paired 6-light casement windows with half-round transoms with tracery. The 6-over-6 window over the stair landing has a fanlight and a brick panel above it. Basement windows are paired one-light casement, also with jack arches. A one-storey, flat-roofed, rectangular bay window supported on wooden consoles occupies the two western bays of the northern elevation at the first level. It has two double-sash windows with tracery, and fluted pilasters carrying an entablature. The great hall is handsomely paneled in oak. The casement windows and French doors are round-arched and have transoms with tracery. The fireplace has a Victorian mantel. At the rear of the room, a broad staircase with winders and a Victorian balustrade, all in oak, rises behind four oak Tuscan columns.

Brick, five course American bond; two storeys; gable roof with parapet; gable end toward street; three bays; full height porch, full width. Greek Revival. C. 1875. Porch has doric (Roman) columns supporting a full doric entablature central entrance. Fan lights over door and two French doors to either side; top windows six over six double hung (there are three). No project chimneys. No visible additions.

Believed to be the oldest building built for, and continuously occupied by, the same fraternity at the University.

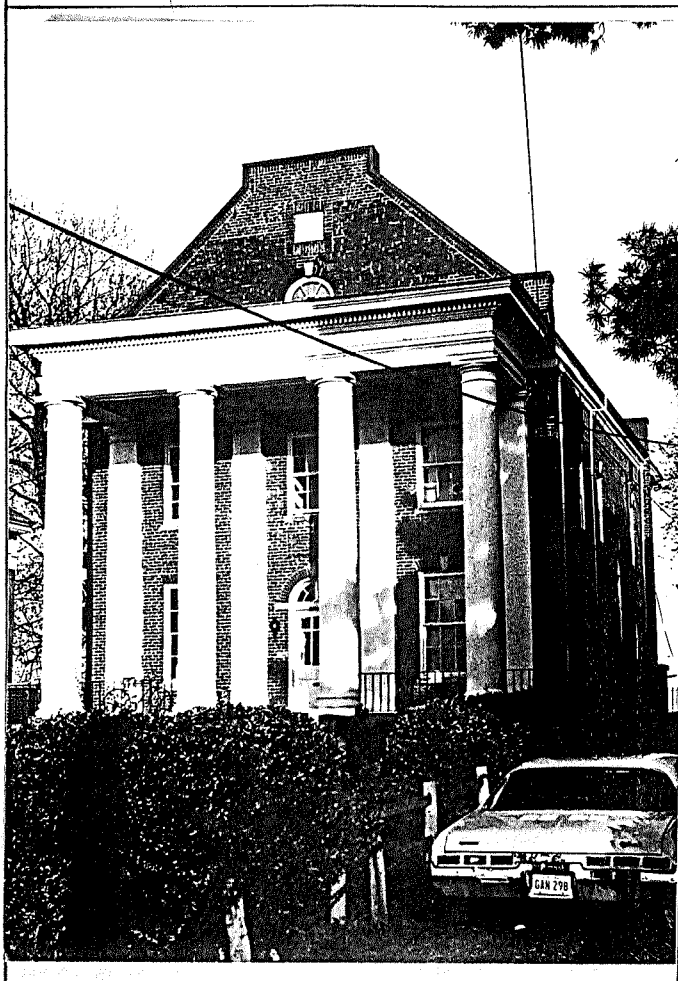
Porch	Stories	Bays	General description
<input checked="" type="checkbox"/> yes <input type="checkbox"/> no	<input type="checkbox"/> 1 <input type="checkbox"/> 3 <input checked="" type="checkbox"/> 2 <input type="checkbox"/> ____	<input type="checkbox"/> 1 (center) <input type="checkbox"/> 2 <input type="checkbox"/> 4 <input type="checkbox"/> 1 (side) <input checked="" type="checkbox"/> 3 <input type="checkbox"/> ____	Monumental tetrastyle Roman Doric portico.

Location and description of entrance: **Central entry with fanlight.**

This, the earliest chapter house built as such at UVa, is also one of the most architecturally distinctive. It features parapet gables and both the east and west front are identical.

The west portico was added in the 1910s when Madison Lane was opened up.

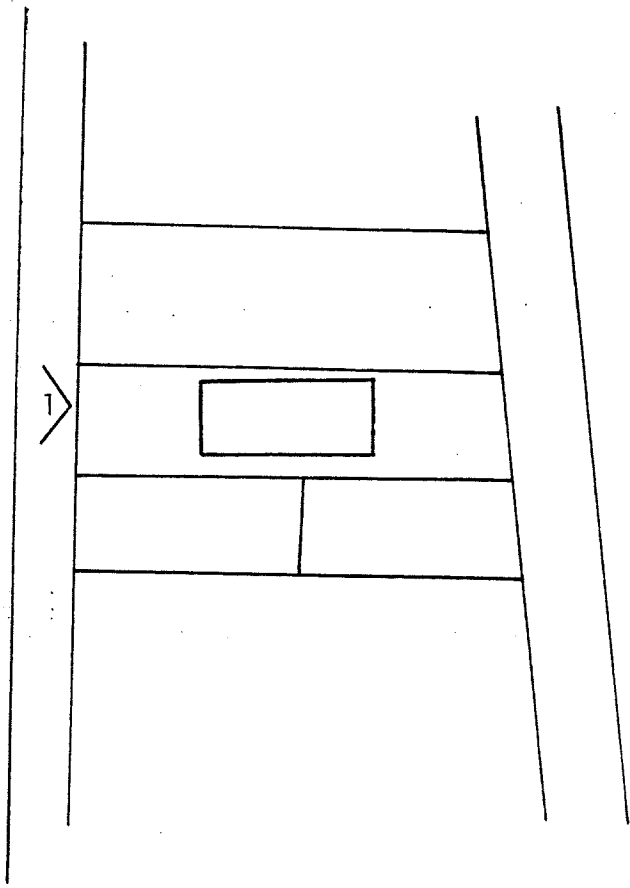
SAINT ANTHONY HALL
133 Chancellor Street

Numbered arrows show location
where photographs were taken

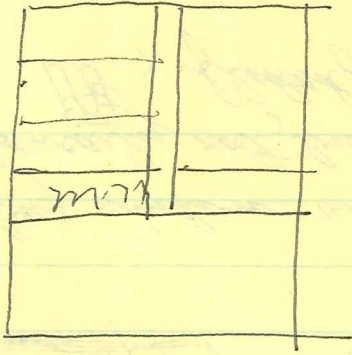
interior

East room paneled completely in oak ^{to tops of windows} ~~to tops of fireplace~~ ^{upon bracketed} ~~fireplace~~
oak cornice ^{of fireplace} Vic fireplace of paneled chimney breast
4 oak T man columns support ~~beam~~ ^{beam} in line w/ chimney,
stair goes behind it; wide 2-fl stair turns corner w/ window
Vic oak bal
