HISTORIC DISTRICT SURVEY FORM

File No. 104-130

Street address 615-19 Preston Place

Town/City Charlottesville

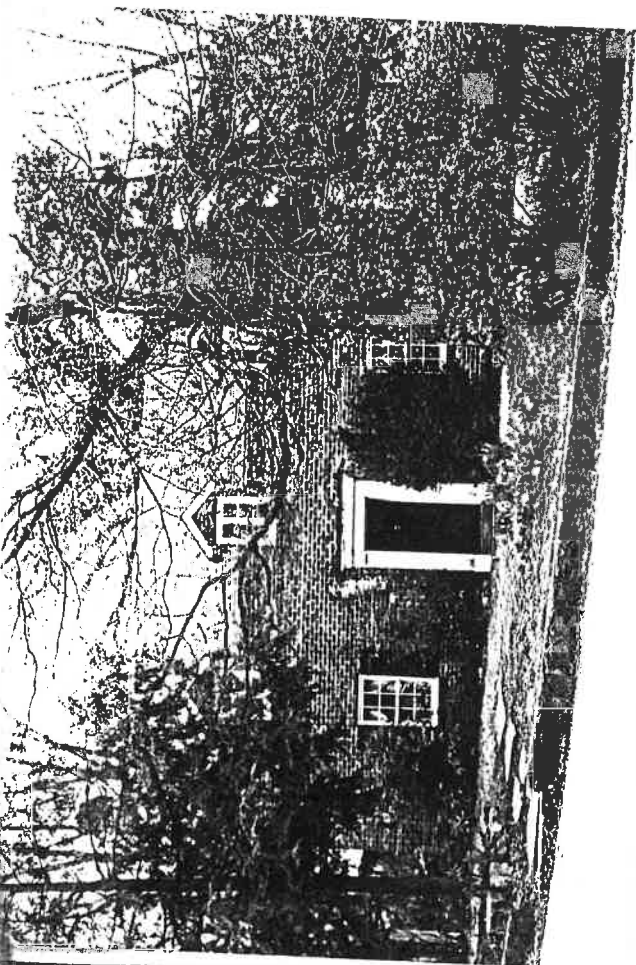
Location and description of entrance Plain entry with simple Classical surround.

This rather unusual Neo Colonial house features true story-and-a-half elevations with dormer windows set partially below the roofline. The house features a corbelled brick cornice and exterior end brick chimneys in the local Virginia 19th-century manner. No. 619 is a one-story rear ell addition.
