# VIRGINIA HISTORIC LANDMARKS COMMISSION

## HISTORIC DISTRICT SURVEY FORM

File No. 104-130
Negative no(s). 7230

Street address **624 Preston Place**  
 Town/City **Charlottesville**  
 Historic name \_\_\_\_\_ Common name \_\_\_\_\_

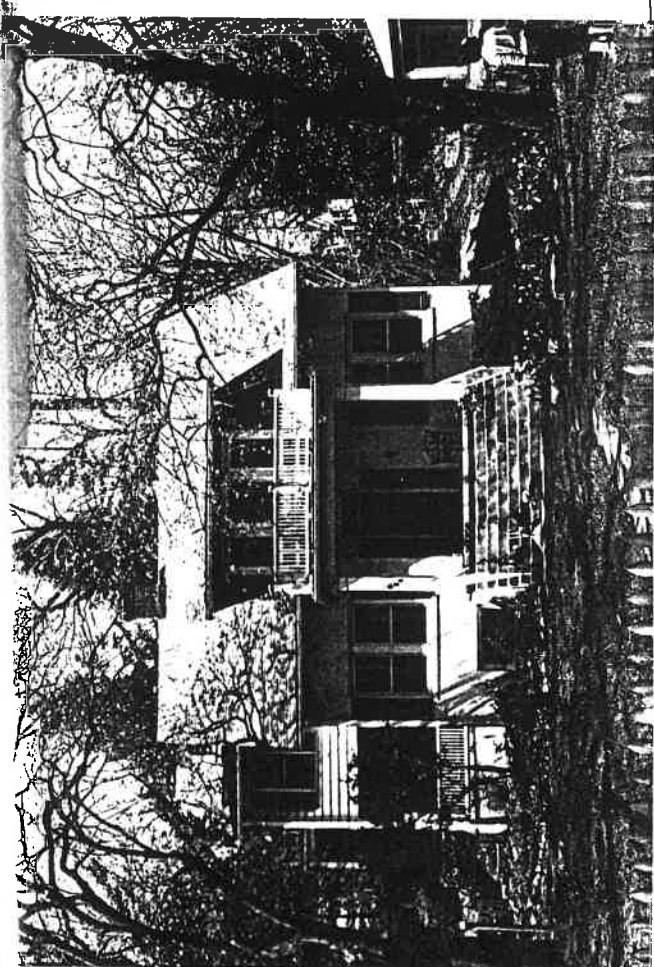
Porch	Stories	Bays	General description
<input checked="" type="checkbox"/> yes <input type="checkbox"/> no	<input checked="" type="checkbox"/> 1 <input type="checkbox"/> 3 <input type="checkbox"/> 2 <input type="checkbox"/> _____	<input checked="" type="checkbox"/> 1 (center) <input type="checkbox"/> 2 <input type="checkbox"/> 4 <input type="checkbox"/> 1 (side) <input type="checkbox"/> 3 <input type="checkbox"/> _____	<b>Distyle front porch with upper deck. Square-section wooden posts.</b>

Location and description of entrance **Central entrance with shutters and toplight.**

Set on a raised basement, this stuccoed Craftsman-style house features a central monitor dormer that opens onto the deck of the front porch. The poured-concrete front steps are probably original.
