STREET ADDRESS: #25 University Circle

HISTORIC NAME: Bray House

HISTORIC DISTRICT SURVEY FORM

Street address 25 University Circle
Town/City Charlottesville

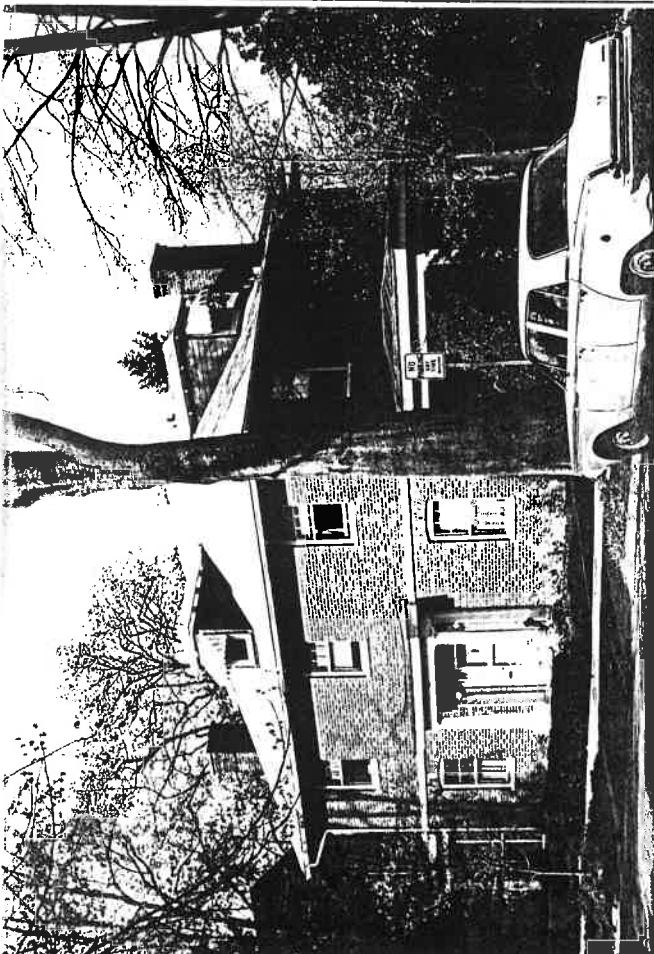
Location and description of entrance Central entrance with geometric-glazed top- and side-lights.

This handsome but austere house features fine Flemish bond brickwork (unusual in the District at this period) and a cast-stone belt line. The broadly-projecting eaves add side porches add interest and balance to the house.
