# VIRGINIA HISTORIC LANDMARKS COMMISSION

## HISTORIC DISTRICT SURVEY FORM

File No. 104-130

Street address 1522 Virginia Ave.

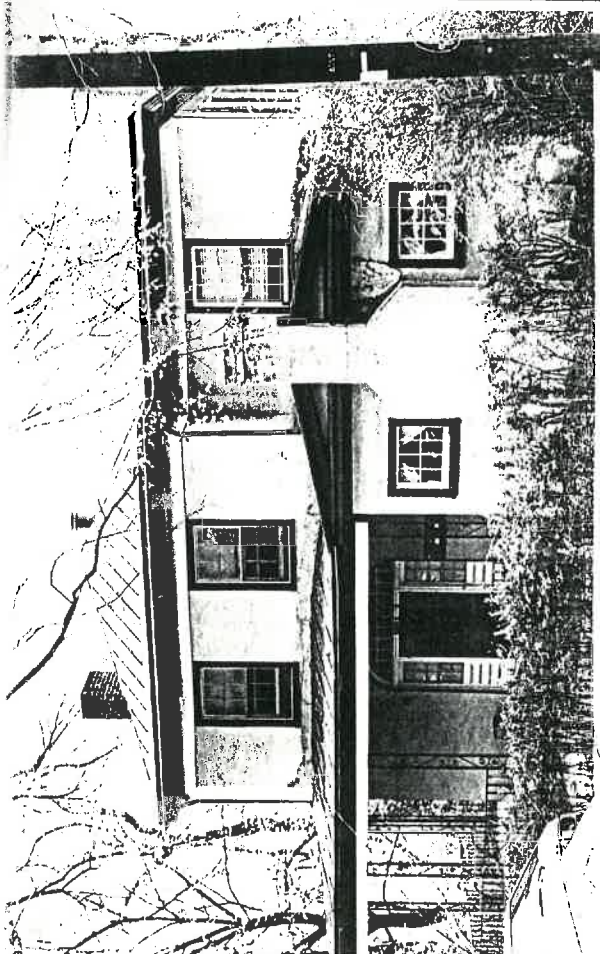
Negative no(s). 7216

Porch	Stories	Bays	General description
<input checked="" type="checkbox"/> yes <input type="checkbox"/> no	<input checked="" type="checkbox"/> 1 <input type="checkbox"/> 3 <input type="checkbox"/> 2 <input type="checkbox"/> _____	<input type="checkbox"/> 1 (center) <input type="checkbox"/> 2 <input type="checkbox"/> 4 <input checked="" type="checkbox"/> 1 (side) <input type="checkbox"/> 3 <input type="checkbox"/> _____	Wraparound front porch with moderate cast-iron supports.

Location and description of entrance **At left side of front. Odd oversized door with sidelights and elliptical fanlight with rectangular muntins.**

This gray-stuccoed house appears to have grown in two or three segments; the one-story wing at the right is certainly an addition. An odd feature is the doorway with rectangular-muntined fanlight.

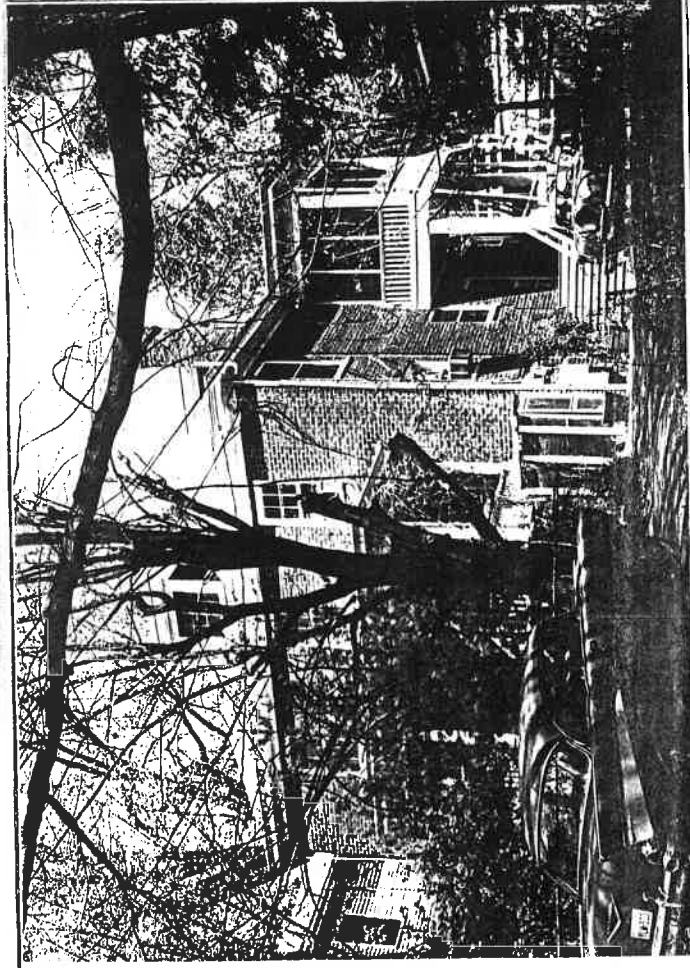
File No. 104-130  
Negative no(s). 7229

Porch	Stories	Bays	General description
<input checked="" type="checkbox"/> yes <input type="checkbox"/> no	<input checked="" type="checkbox"/> 1 <input type="checkbox"/> 3 <input type="checkbox"/> 2 <input type="checkbox"/> _____	<input checked="" type="checkbox"/> 1 (center) <input type="checkbox"/> 2 <input type="checkbox"/> 4 <input type="checkbox"/> 1 (side) <input type="checkbox"/> 3 <input type="checkbox"/> _____	<b>Tetrastyle front porch across half the facade.</b>

This is a rather standard Georgian-style brick house of the period. Note the double-tier side porch. The house sits on a slope, creating a grade-level basement entry at the front.
