**RE: Certificate of Appropriateness Application**

36 University Circle

Margaret Nelsons Spethmann, G.P.A., Owner/Russell Skinner, Applicant  
Front Dormer Redesign

**Nelson Residence**  
Remodeling & Additions  
University Circle  
Charlottesville, Virginia

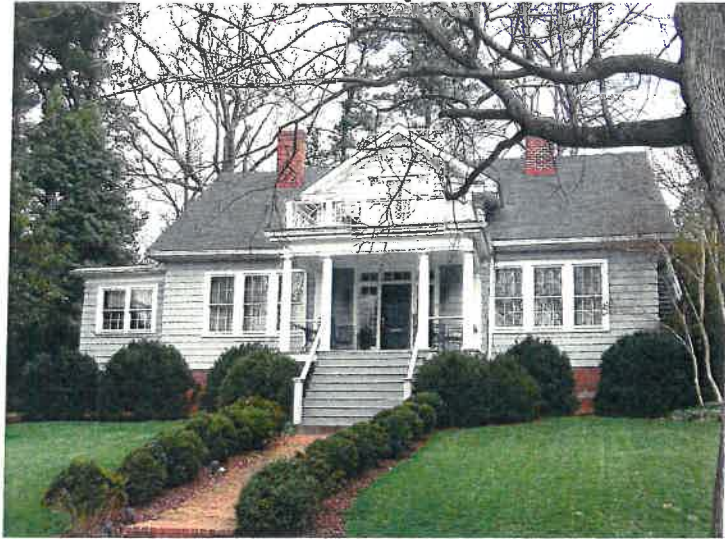
### 36 University Circle

This 1 ½-story, frame Colonial Revival-style dwelling was constructed in the 1910s. Details include: weatherboard siding; raised basement; gable roof with front cross gable; symmetrical 3-bay front; 1-bay front porch with paired Tuscan posts; grouped windows; entry with floor-length sidelights; interior brick chimneys; and side wing. This slightly altered house features a central cross-gable opening onto the top of the front porch. It was probably built for Dr. Fletcher D. Woodward, Professor of Medicine at UVA in the 1920s and contributes to the District.

This property (36 University Circle) is a contributing structure in the Rugby Road- University Circle-Venable Neighborhood ADC District. The survey is attached. The Colonial Revival dwelling was constructed circa 1911-1916.

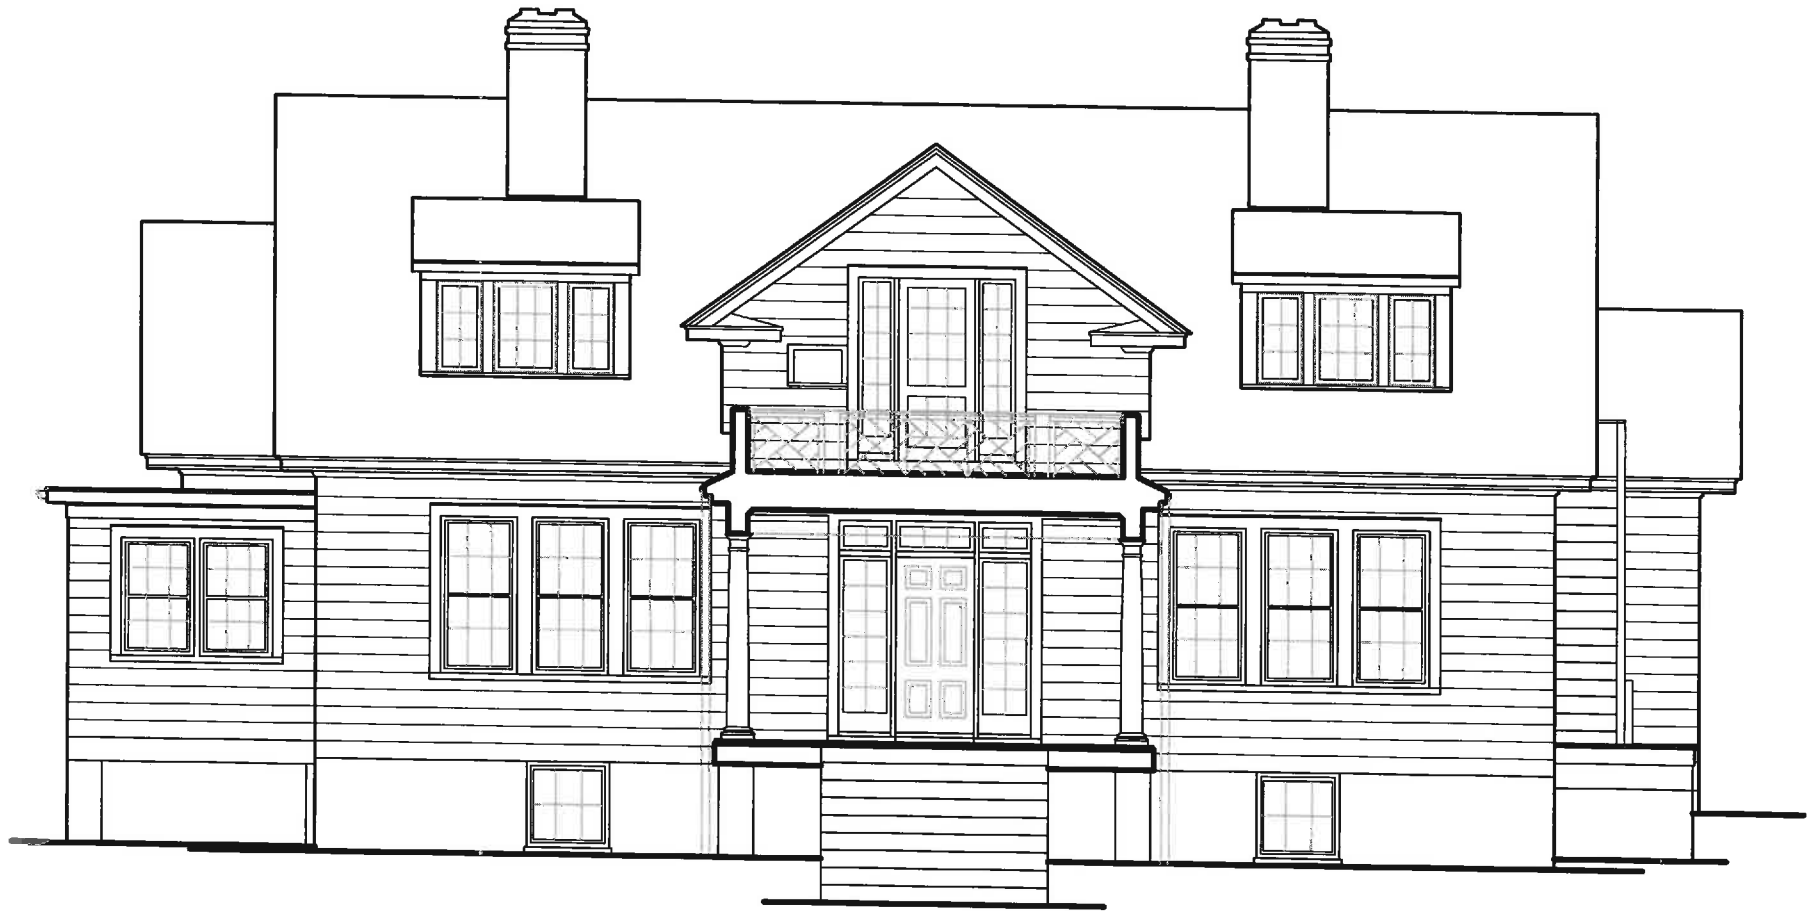
1  
A.I. 1/4" = 1'-0" 06-21-16

Approved version  
Received at BAIR meeting 6/21/2016

- **Keep existing windows, but with new storms**
- **Patching/repairing the existing shingles after removing the aluminum siding**
- **Move to a two dormer option as shown on the drawings submitted to the BAR at the meeting.**

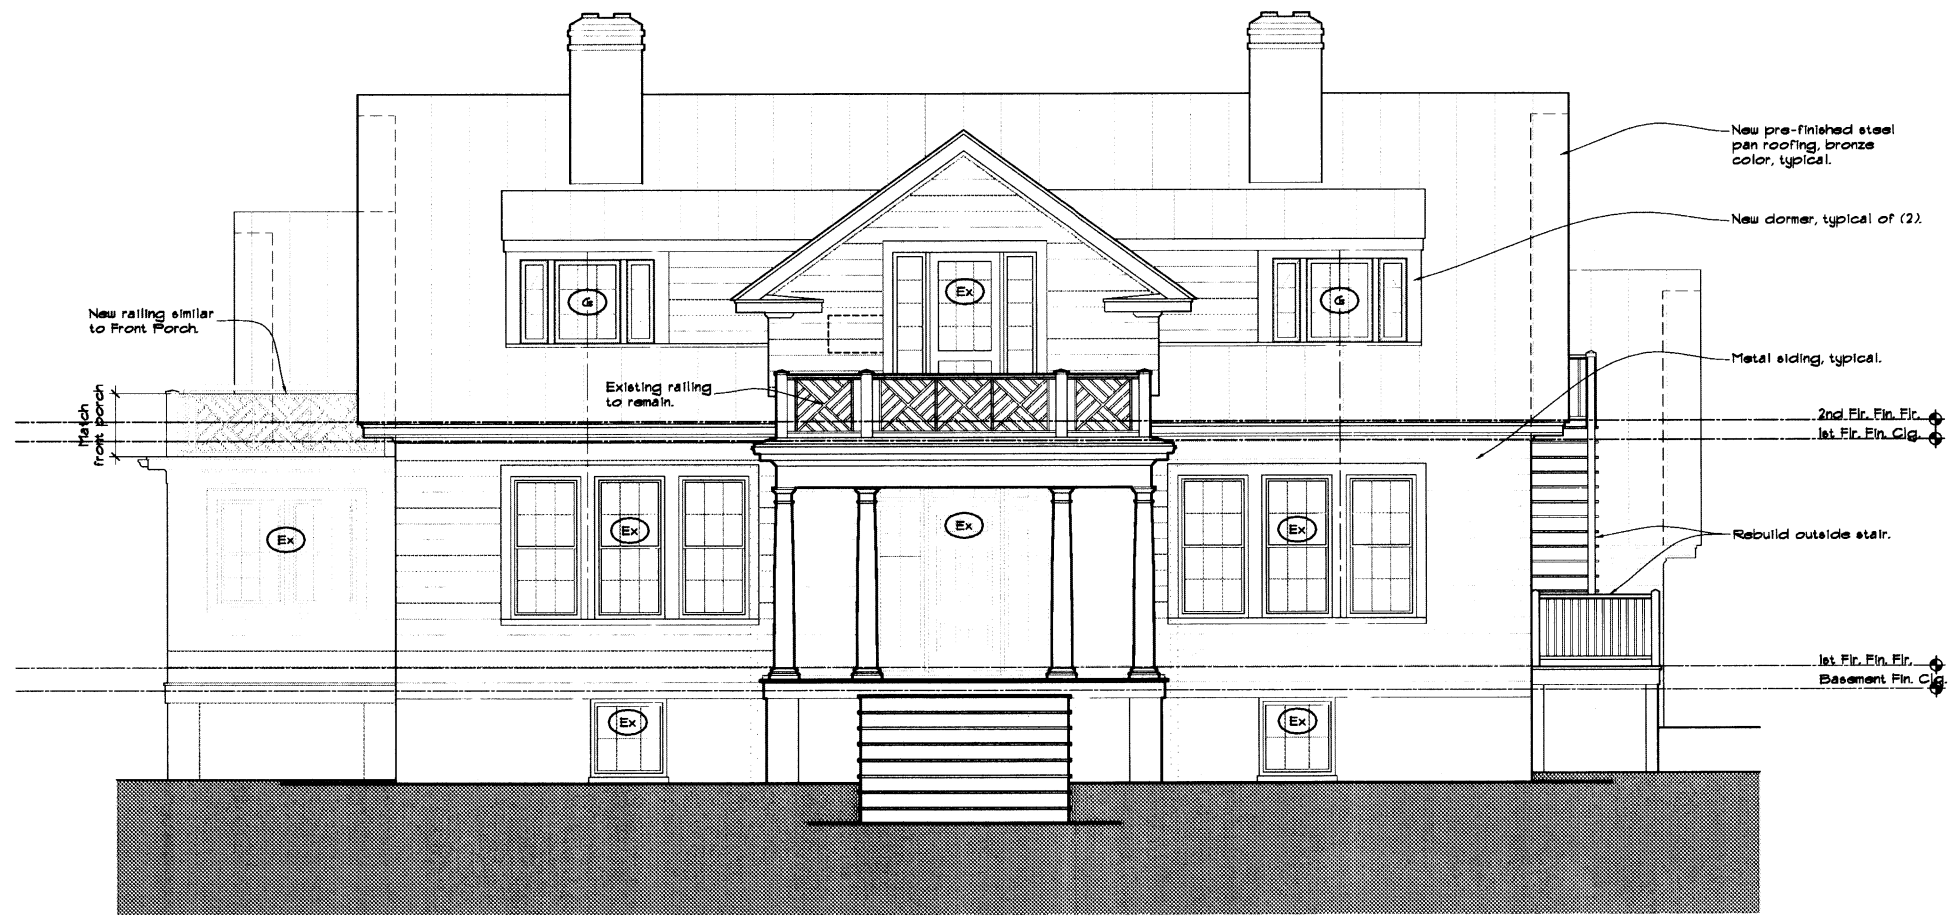
Front Elevation - Proposed  
Scale: 1/4" = 1'-0"

1. **Dormers:** Attached you will find a drawing showing both the previous dormer design and the new proposed dormer. The client is quite enthusiastic about the added upstairs space this new design affords.
2. **Siding:** The plan now is to tear off the aluminum siding, patch, replace and repair, as required, the existing cedar shingles and paint them in a weathered gray color for uniformity. We will keep the Board informed as the uncovering commences, if our plan needs to be amended.
3. **Windows:** Keep the existing windows and replace the existing old storm windows with previously BAR approved Velv-a-lume storm windows, by West Windows

The applicant has provided a new design for the two dormers on the front façade, and has decided to keep the original windows, and has provided additional information on the condition of the siding.

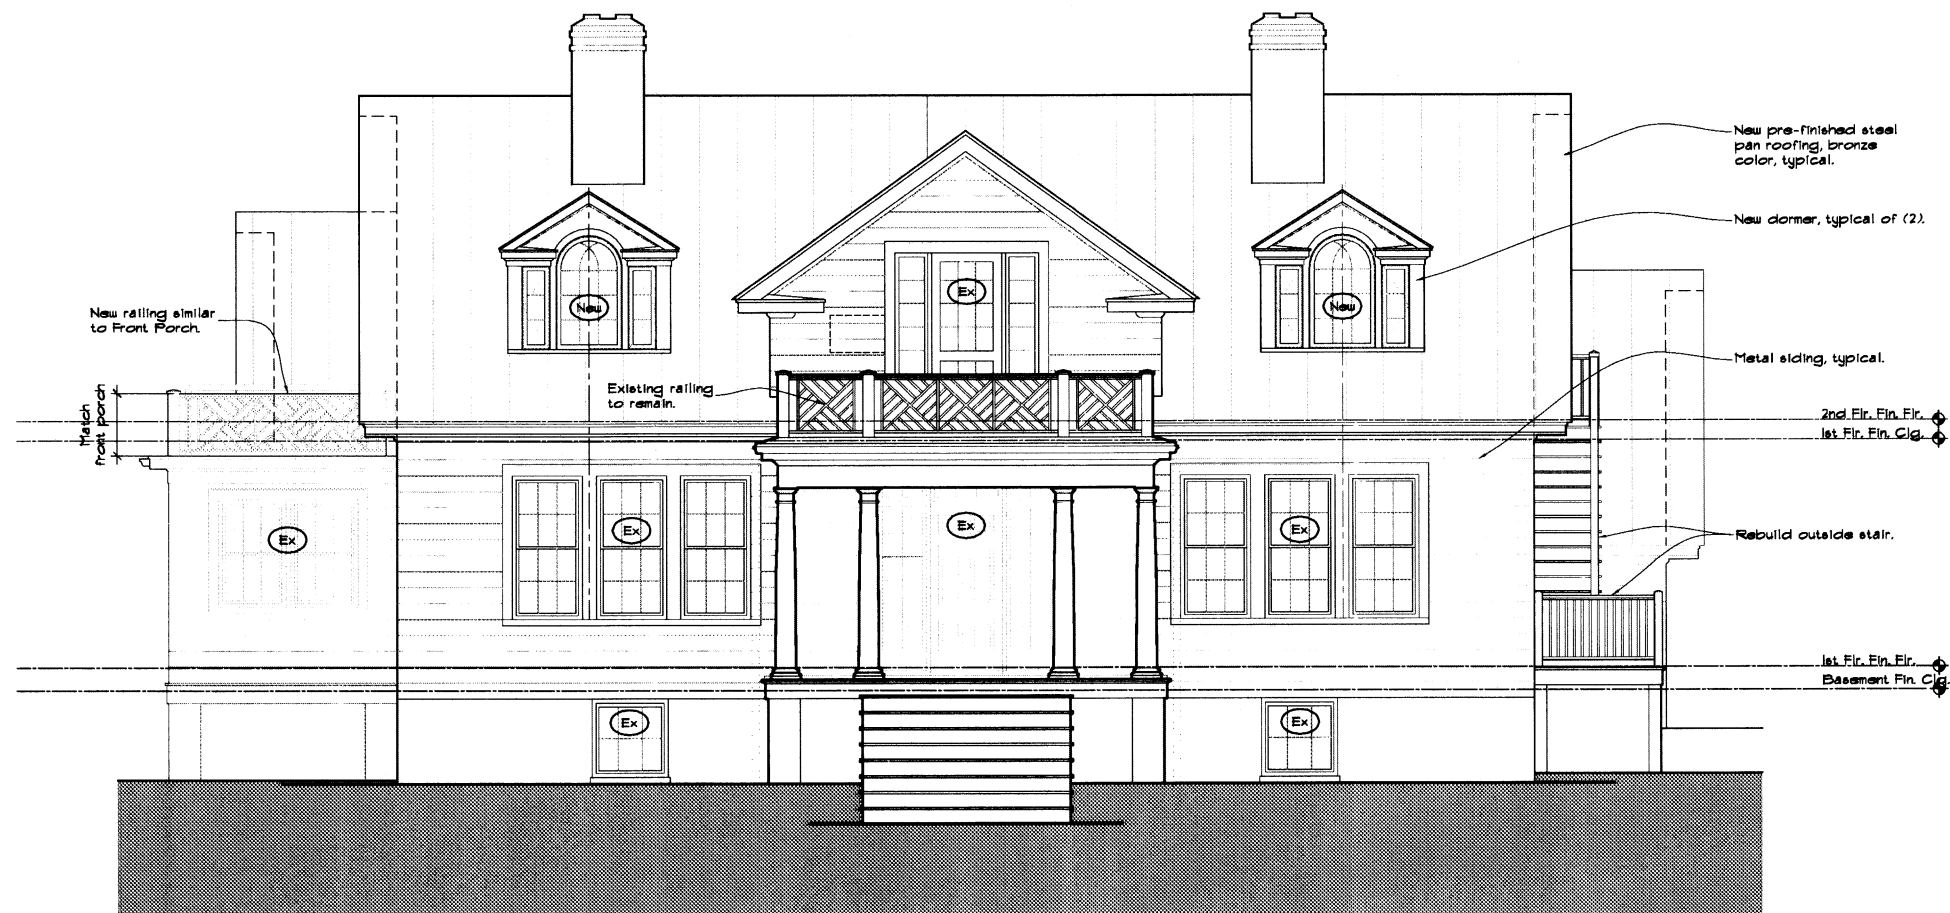
Front Elevation - Submitted  
Scale: 1/4" = 1'-0"

*Not approved*
