VIRGINIA HISTORIC LANDMARKS COMMISSION

SURVEY FORM

Historic name County/Town/City <u>ALBEMARLE/CHARLOTTESVILLE</u> Street address or route number <u>411 ALTAMONT CIRCLE</u> USGS Quad <u>CHARLOTTESVILLE WEST</u> Original owner Original use <u>RESIDENTIAL</u> Present owner Present owner address Present use Acreage	Common name Date or period Architect/builder/craftsmen Source of name Source of date Stories Foundation and wall const'n Roof type
---	---

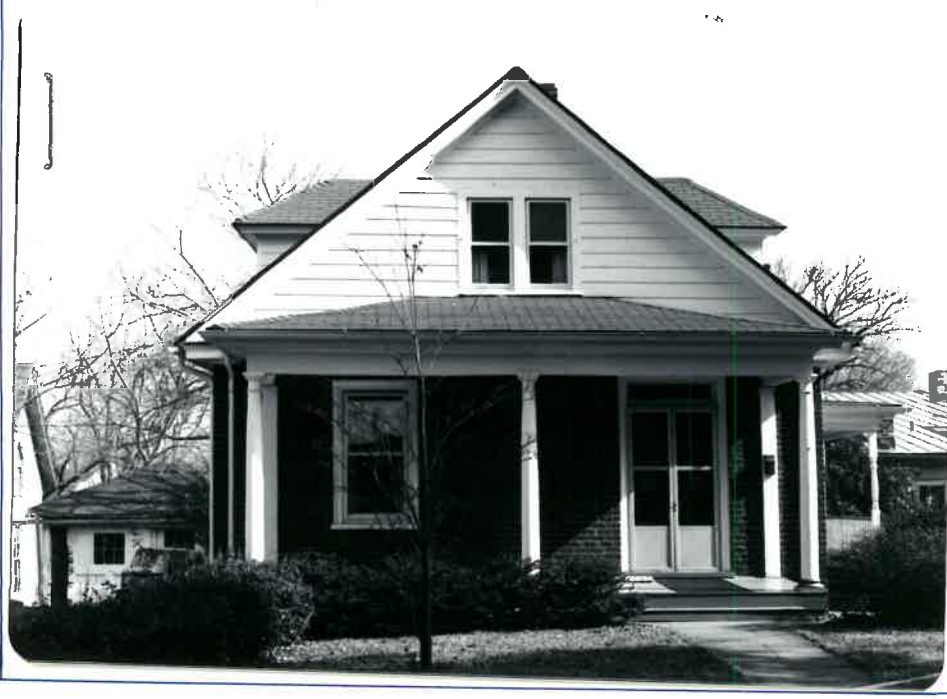
File no. 104-72A
Negative no(s). 10 (5074)

State condition of structure and environs
GOOD
 State potential threats to structure
 Note any archaeological interest

BRICK (1 1/2 ^{6-course} AMERICAN BOND) AND ^{frame} WOOD. 1 1/2 STORIES. GABLE ROOF, END TO STREET, WITH OPPOSITE DORMERS. 2 BAYS. 1 STORY, 2 BAY HIPPED ROOF PORCH WITH DORIC COLUMNS AND PLASTER RETURNS. ^{Col. Rev. Cottage CA 1920} ~~QUEEN ANNE, CA. 1900.~~ ENTRANCE SOUTH BAY. DOUBLE DOORS, FIXED PANES ABOVE. 1/1 DOUBLE HUNG SASH, DOUBLE SASH IN GABLE END. 2 CENTRAL CHIMNIES. ASBESTOS TILE ROOF. HORIZONTAL WOOD SIDING IN GABLE END.
