## **VIRGINIA** HISTORIC LANDMARKS COMMISSION

**SURVEY FORM**

Common name ADVANCE SPEVICE CENTER County/Town City CHAR ON SULLE

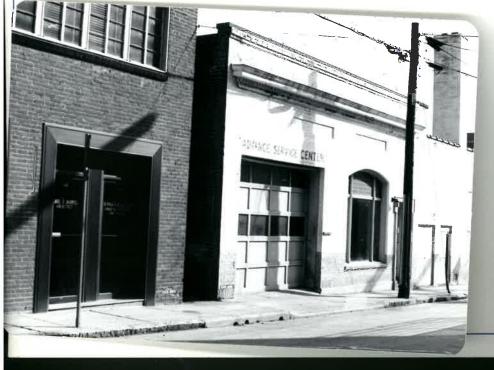
BRICK (STREATHER BOND); ONE STORY; FLAT ROOF; 3 BAYS. COMMERCIAL VERNACULAR. . C. 1730. ENTRANCE IN SOMPHERNMOST BAY. CENTRAL BAY HAS SEEMENDAL ARCH IN BRICK OVER 3 DART PLATE GLASS WINDOW. 2 RETAINBULAR PLANETS BRICK BETWEEN FIRST AND SECOND STORY. BRICKS PROJECT AT CORNICE LINE. METAL ENTAPHATURE WITH POX CORNICE AND DENTILS APPLIED TO FACADE BETWEEN ROOF AND PAWAS SERVICE CENTER FORMS ADDITION TO ADVANCE AUTO CEMER WHICH FROM E MAIN STREET
