VIRGINIA
HISTORIC LANDMARKS COMMISSION

SURVEY FORM

Historic name _____ Common name Chan House Restaurant
County/Town/City Charlottesville
Street address or route number 918 W Main St.

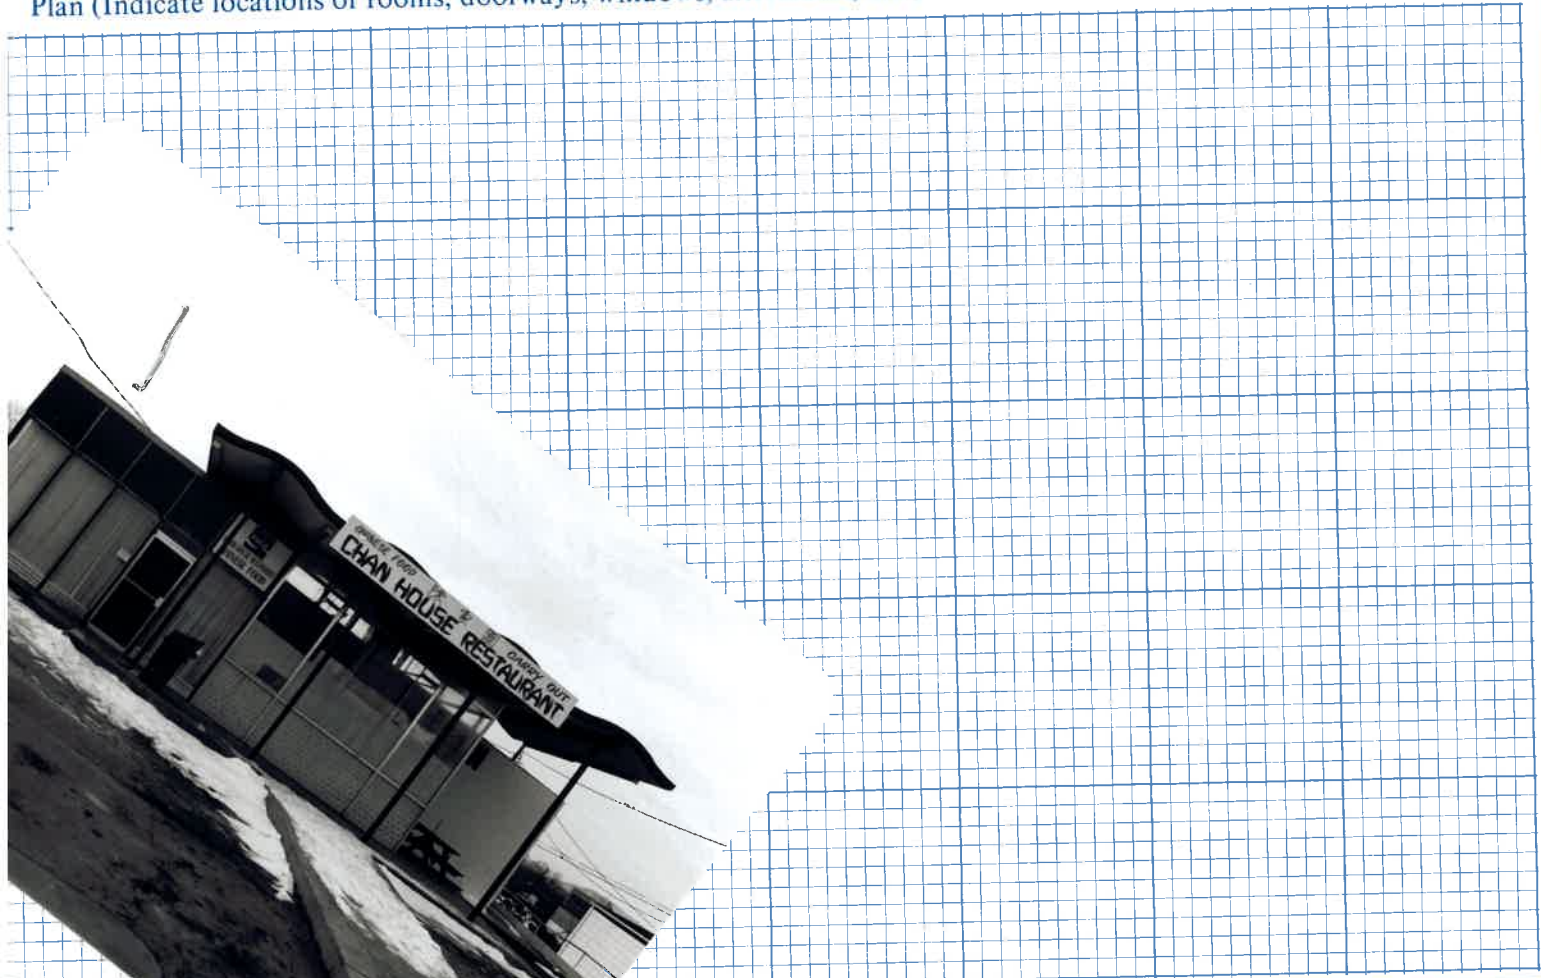
Plan (Indicate locations of rooms, doorways, windows, alterations, etc.)

918: glass and metal walls, brick foundation under eastern three bays, west bay is of cinderblock construction; 1 story; flat roof w/ undulating metal roof supported by metal poles over western 3 bays; 4 bays; vernacular modern style; Ca. 1966; eastern two bays have metal panels over plate glass windows and door, 3rd bay has brick panels beneath plate glass which extends beyond wall to immediately beneath metal canopy; entrance in 2nd (E to W) bay; windows are fixed plate glass in metal frames, door is commercial plate glass in metal frame; 1 central vent; no additions or alterations.
