VIRGINIA HISTORIC LANDMARKS COMMISSION

SURVEY FORM

Historic name	Common name <i>Fayerweather Hall</i>
County/Town/City <i>Albemarle, Charlottesville</i>	
Street address or route number <i>109 Rugby Road</i>	
USGS Quad <i>Charlottesville West, Va.</i>	Date or period <i>1893</i>
Original owner	Architect/builder/craftsmen <i>Carpenter and Peebles of Norfolk</i>
Original use <i>gymnasium</i>	Source of name
Present owner <i>University of Virginia</i>	Source of date
Present owner address	Stories
Present use <i>School of Art</i>	Foundation and wall const'n
Acreage	Roof type

HISTORIC DISTRICT SURVEY FORM

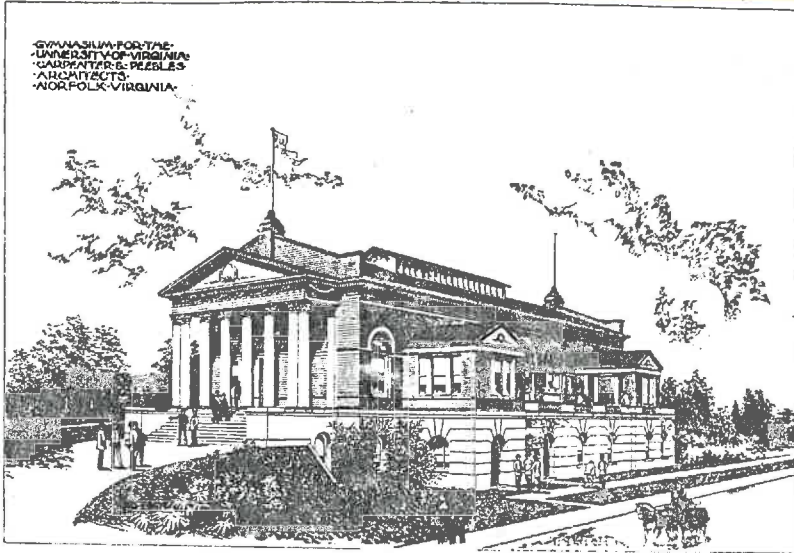
128. Fayerweather Hall, 1893

109: brick (American bond); 3 bays; full-scale pedimented portico; Colonial Revival, 1893; portico supported by 8 Corinthian columns (2 paired at ends) with reflected end pilasters; full entablature with dentil cornice; louvered fan in pediment; double gable roof on central bay; perpendicular gable roofs on both wings; 9/9 lights in sliding wooden sash in wing windows; no windows in center bay; raised basement; rectangular fan over entrance double doors.

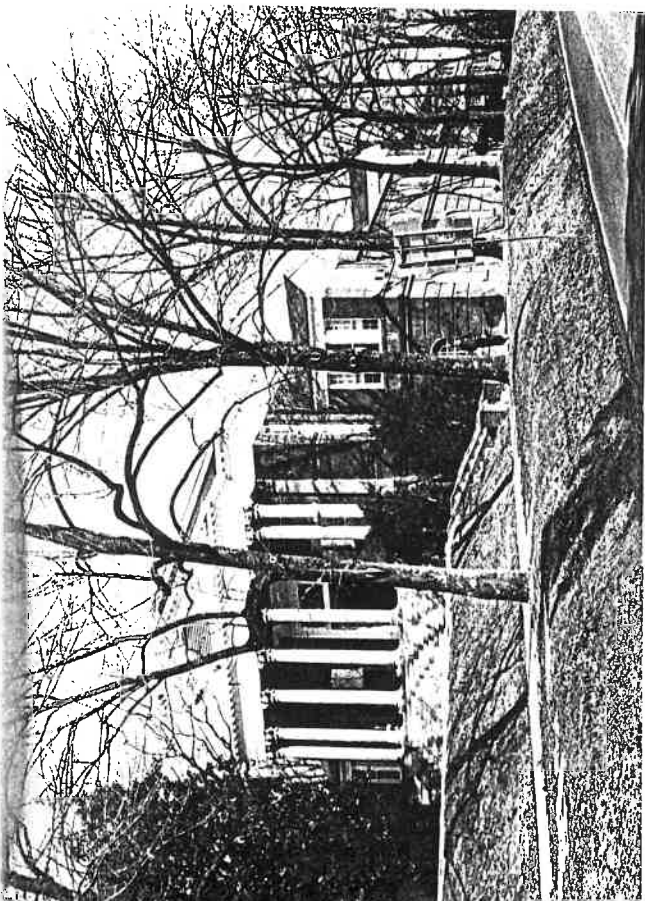
Historic name Fayerweather Hall

Location and description of entrance Overscale entry with aedicule surround and toplight with "sunburst"-shaped muntins.

One of the finest buildings on the UVa campus, Fayerweather Hall was built as a gymnasium but since the mid-1920s has functioned as classrooms, first for the School of Architecture, and now for the Dept. of Fine Arts.

The building is constructed of a pleasant color deep-red handmade brick which contrasts nicely with the white wooden pediments and cornices. Molded bricks and terra cotta trim is used liberally, and the basement story is rusticated.
