**CITY OF CHARLOTTESVILLE, VIRGINIA  
CITY COUNCIL AGENDA**

# BLIGHT REMEDIATION PLAN – 610 RIDGE ST. | 2015

**RE: 610 Ridge Street, Charlottesville, VA – Structural Observation  
DMWPV Project 1504-40**

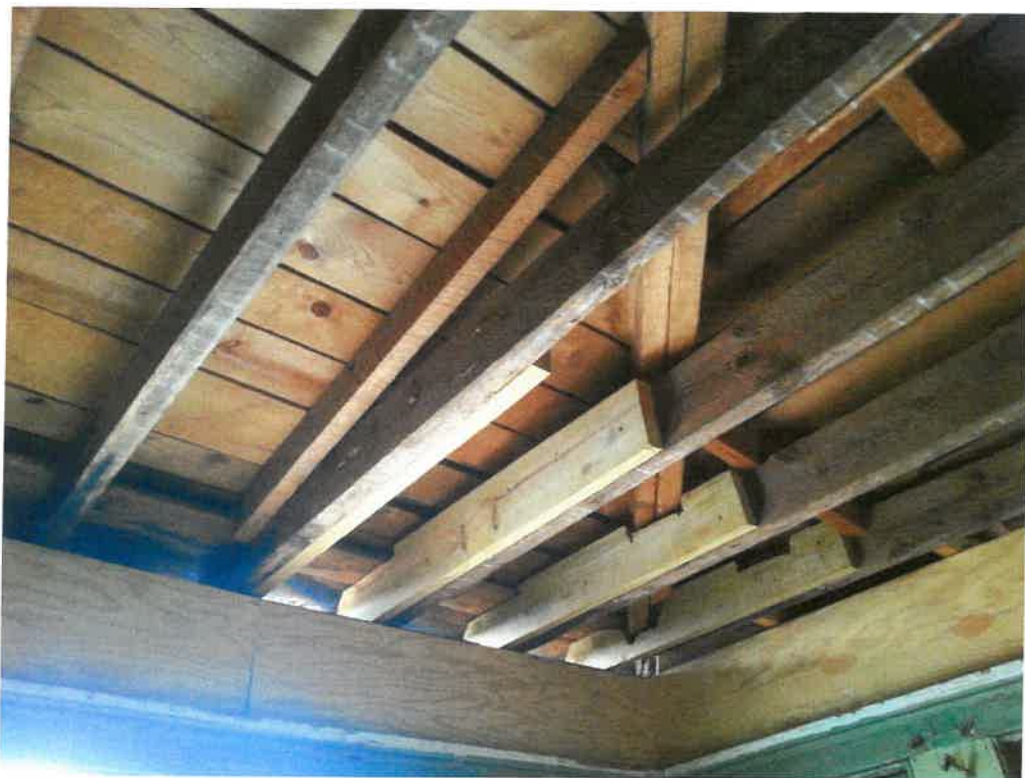
5. Upstairs bedrooms – several rafter ends are rotted and in need of repair. Studs are exposed in exterior wall and exhibit signs of insect infestation. The drywall ceiling is bowed significantly in the center. Roof rafter repairs have been started but not finished at rear bedroom/porch area.

Photo 1 - Partially completed back roof repairs

In our opinion, the home is in generally fair to poor structural condition. Extensive repairs are required due to neglect and active water leaks. Of particular concern is the deteriorated floor framing near the door into the kitchen from the middle room. In our opinion, this area of floor is a safety concern and requires repairs or replacement for safe occupancy. We further recommend that unsupported and detached plaster ceiling and stucco areas be removed. All water leaks and openings in roof and walls should be addressed. Rotted rafter ends are extensive and require repairs.

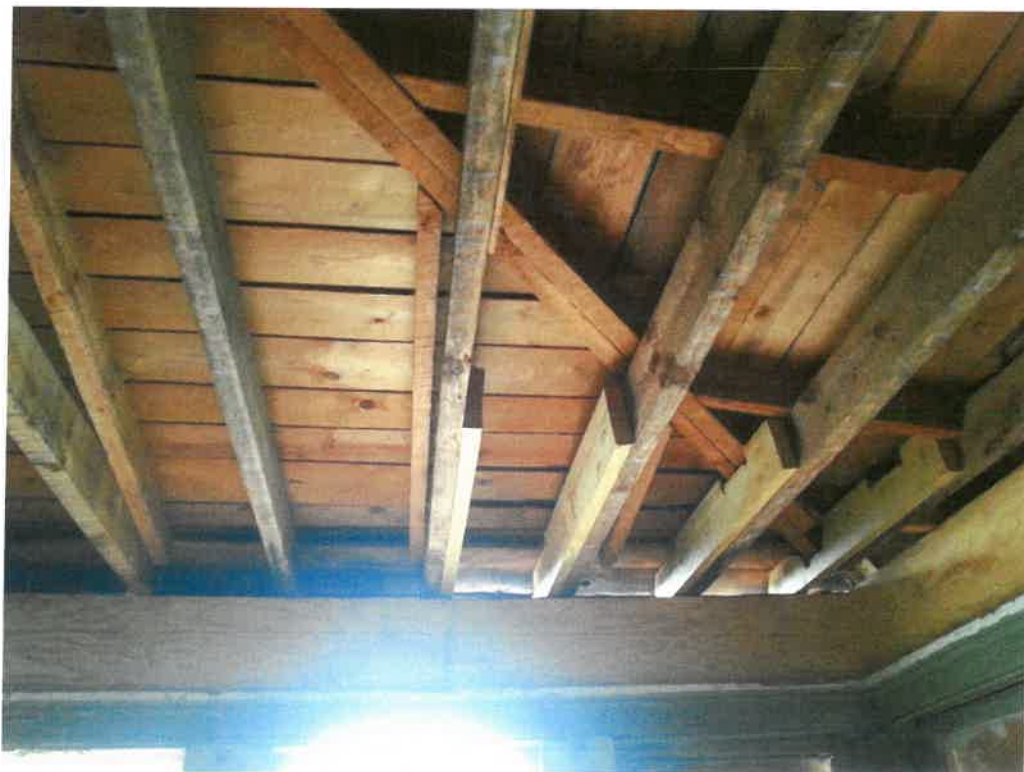
Photo 2 – Partially completed back roof repairs

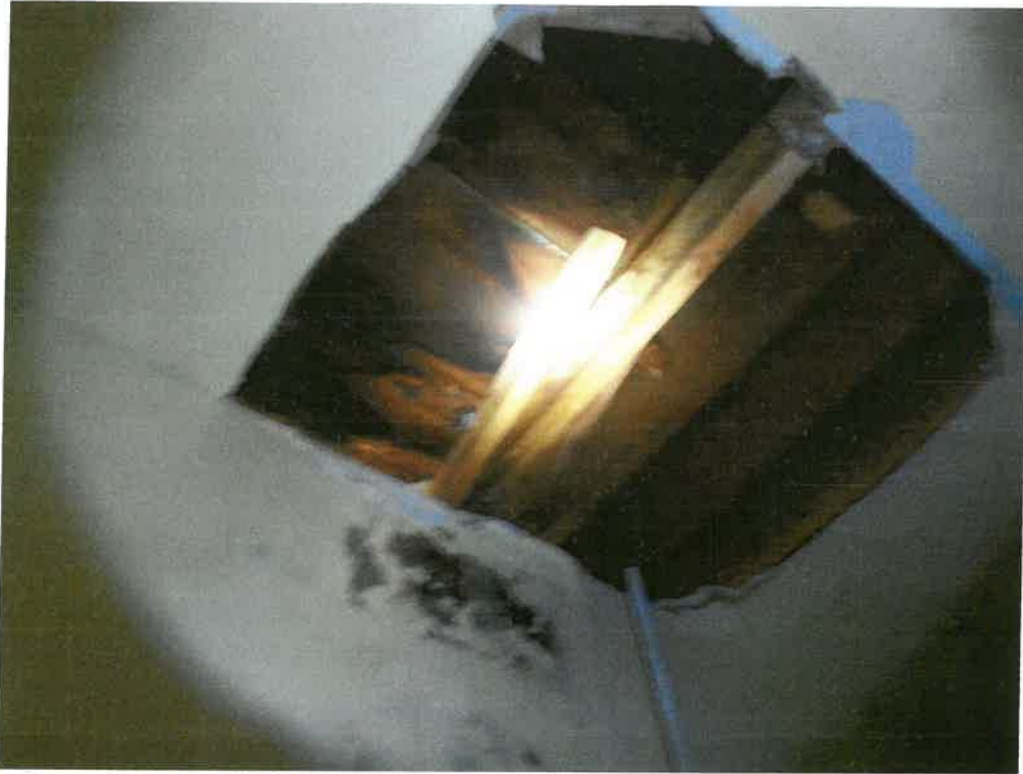
1. Several areas exhibit signs of active water leaks, with openings at roof and walls.
2. Upstairs and downstairs ceilings have holes where ceiling appears has failed or is in process of failing due to leaks.

Photo 3 – Active leak, damaged ceiling, mold and deteriorated wood framing

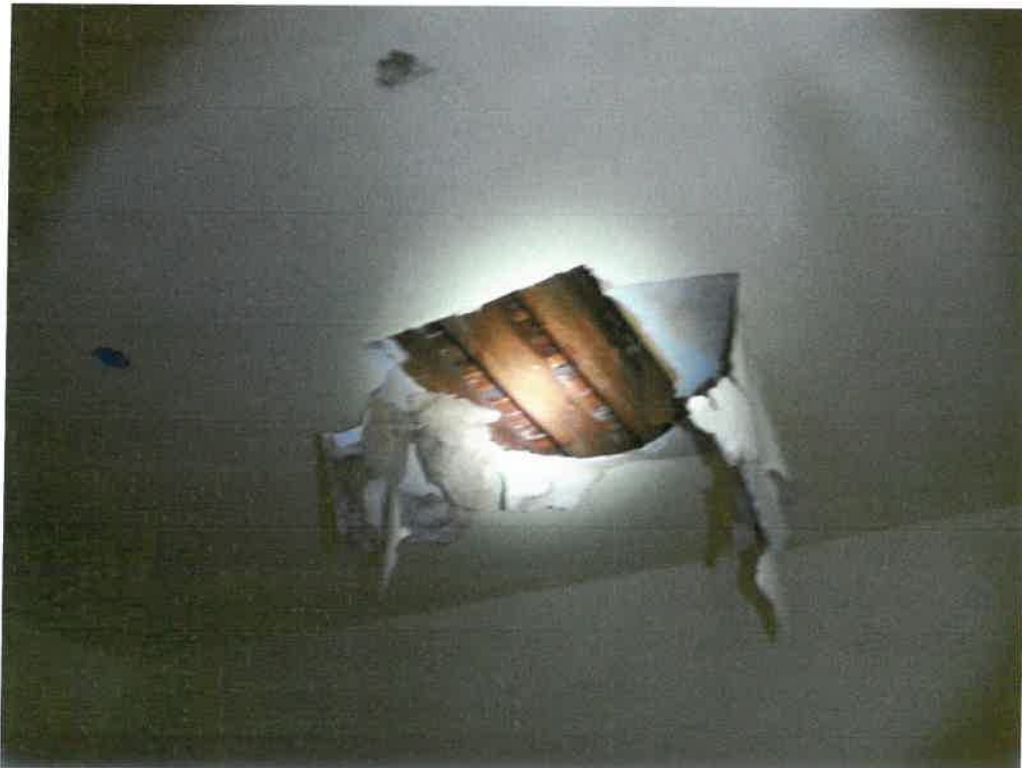
Photo 4 – Damaged ceiling area
