**Subject:** BAR Actions - June 19, 2018 - 801 East High Street

BAR 18-05-06 801 East High Street Tax Parcel 530194000 Core Knowledge Foundation, Owner/, Applicant Roof replacement (change of material)

## CITY OF CHARLOTTESVILLE BOARD OF ARCHITECTURAL REVIEW STAFF REPORT June 19, 2018

Roof replacement (change of material)

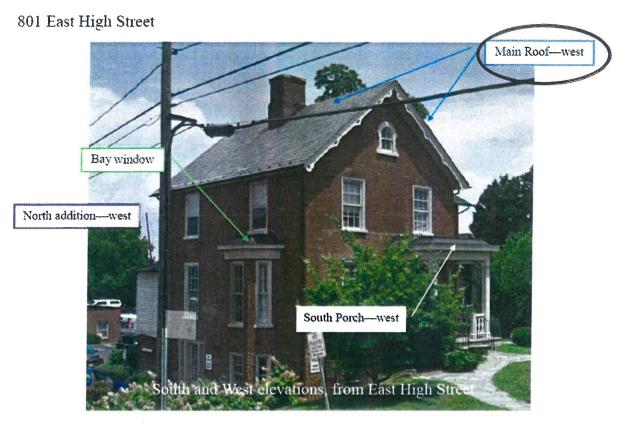
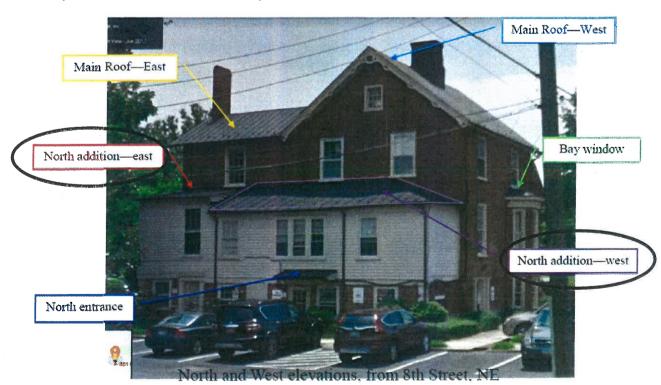
- The section of the roof we are replacing is Main Roof West
- We are having the slate that is on there currently removed due to safety reasons
- To replace the slate we are having 26-Gauge pre-painted "Kynar paint finish" Metal put in its place
- This is the same metal that has been previously approved for other sections of the roof (North Addition East and West)

Request to remove the existing slate from the hipped roof on the original, c1872, western portion of the building, and replace with painted, standing seam metal. New roof to be 26-gauge, prefinished metal. (Note: The hipped roof on the east wing of the building--constructed sometime between 1877 and 1896—is standing seam metal.)

Color to match previously installed metal roofing on the eastern portion of the building.
