Property Information

Name Explanation Function/Location	Name House, 920 Morton Lane
--	---------------------------------------

Current - 920 Morton Lane

Event Type: Survey:Phase I/Reconnaissance

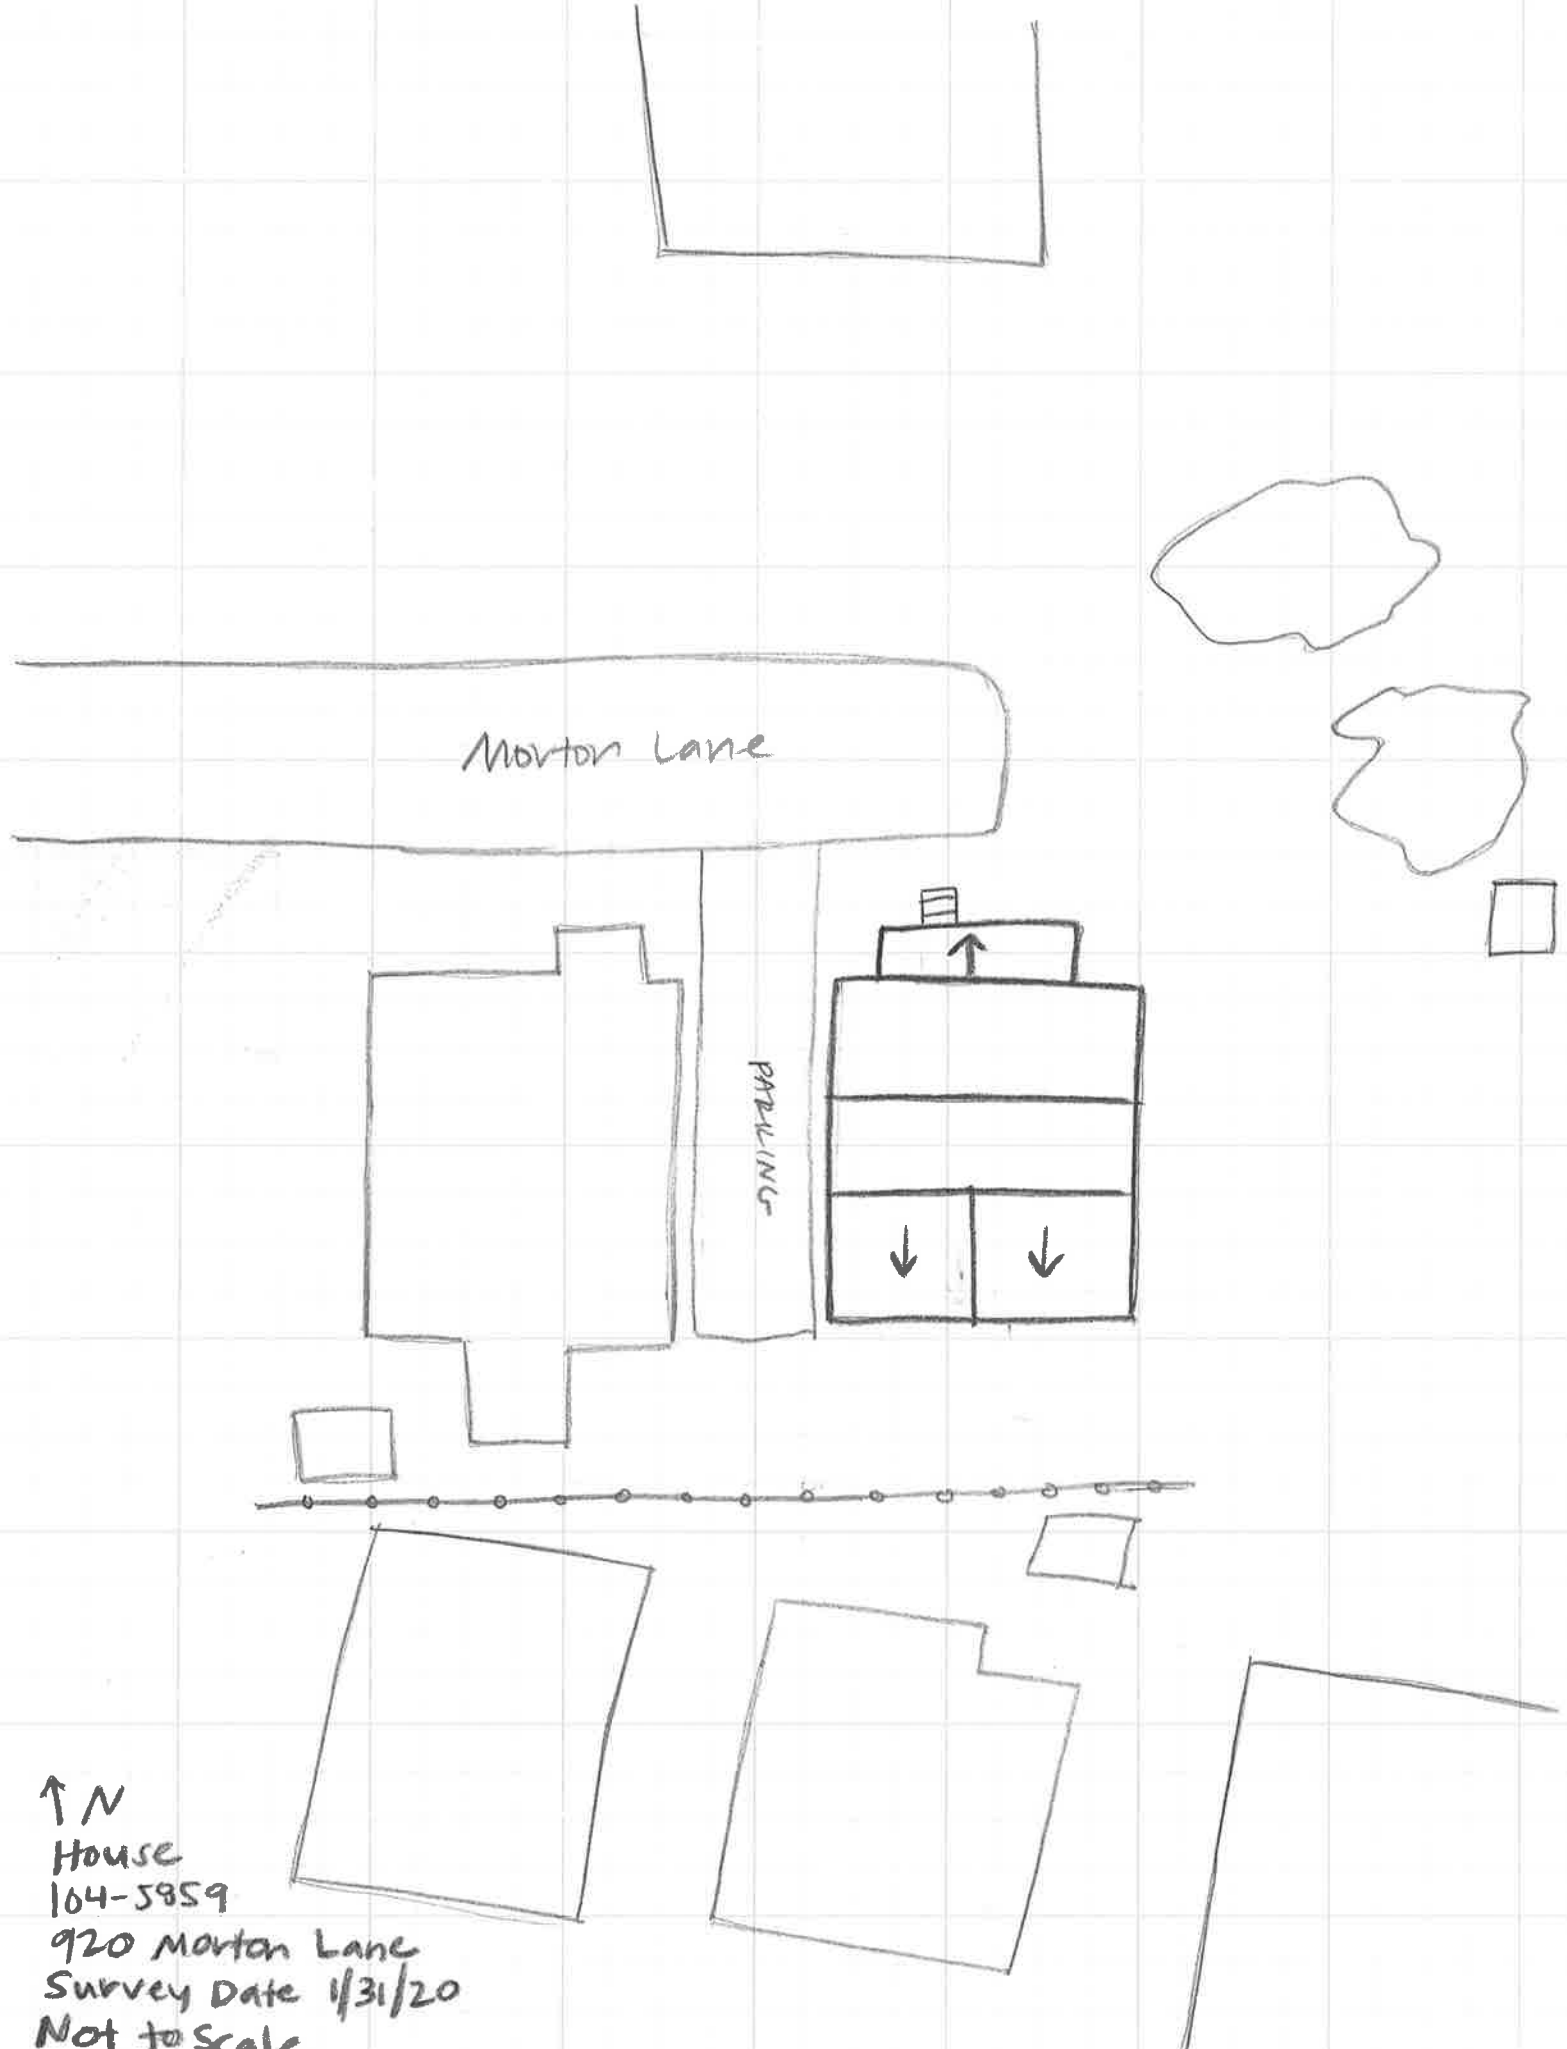
↑ N
House
104-5859
920 Morton Lane
Survey Date 1/31/20
Not to Scale

January 2020: This one-story house is located on the south side of Morton Lane at the dead end. It is one of two houses facing the small road. There is a large tree in the northeast corner of the lot. This property consists of a house. Morton Lane is gravel and seems more like a driveway than a public road.
