Identification

Survey

STREET ADDRESS: 101 W. Main Street MAP & PARCEL: 33-255 CENSUS TRACT AND BLOCK: 1-312 PRESENT ZONING: B-4 ORIGINAL OWNER: Leterman Company ORIGINAL USE: Department Store (1899), Ban': (1911) PRESENT USE: Shoe Store & Offices PRESENT OWNER: H&M Shoe Store, Inc. ADDRESS: 101 W. Main Street Charlottesville, Virginia HISTORIC NAME: Leterman/Jefferson National Bank Building DATE / PERIOD: 1899 and 1911 STYLE: Victorian HEIGHT (to cornice)OR STORIES: 3, 2 storeys DIMENSIONS AND LAND AREA: 27.83' x 103.25' (2873 sq.ft) CONDITION: Good SURVEYOR: Bibb DATE OF SURVEY: Spring 1979 SOURCES: City Records Sanborn Map Co. - 1920 Charlottesville City Directories

HISTORIC LANDMARKS COMMISSION - DEPARTMENT OF COMMUNITY DEVELOPMENT

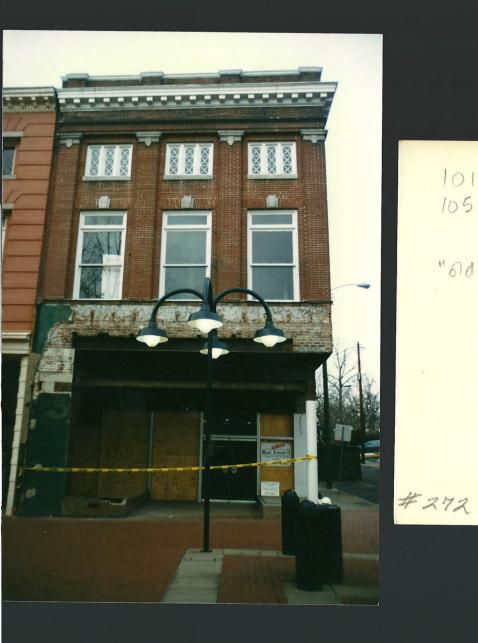
101 W. MAIN ST. 105 N. 155 ST.

This former bank building must have been an imposing structure before its vertical lines were interrupted by a glass storefront with a massive canopy. It is three storeys tall and three bays wide. Construction is of brick laid in stretcher bond in the 3-storey 1911 front section and in 5-course American bond in the 2-storey 1899 rear section. The new glass storefront has a recessed entrance loggia. A Mansard-roofed canopy covered with red pressed tin projects far out over the sidewalk on both the facade and the First Street elevation, replacing the original heavy wooden storefront entablature and obscuring much of the facade. Above the storefront, the facade is recessed between brick pilasters with stone capitals at each end and between the bays. This is repeated with coupled pilasters on the single bay of the First Street elevation. Windows at the second level are double-sash, 1-over-1 light, with shallow transons, matching those in the side bays of the Leterman Building, but with jack arches and store keystones. The short windows at the third level are the same size as those in the Leterman Building, but are triple casement with triangular lights. A projecting wooden cornice with modillions extends across the facade and First Street elevation. Above it, the pilasters continue on the concrete-capped parapet. This 3-storey front section has a shed roof covered with tar-and-gravel sloping toward the rear. Behind it, the 2-storey rear section into two distinct sections. The rear section with its lower ceilinged mezannine level may have always been used as office space. Access is by a side entrance between the two sections. In each of the first three bays, there is a 3-part thermal window at the first level with moulded mullions and stone sill, and two tall windows with shallow transoms at each level, segmental-arched at the first level and jack-arched with keystones at the second, and a short segmental-arched basement window. A projecting wooden cornice on the parapet with shallow transoms at each level, segmenta
